Houspect

Building inspection

Job ID: 91385

Address: 12 Jankurna Street, Baynton WA

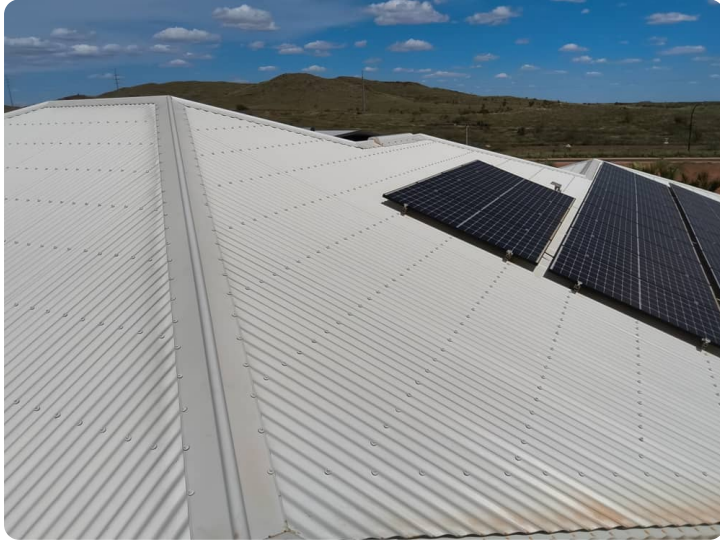
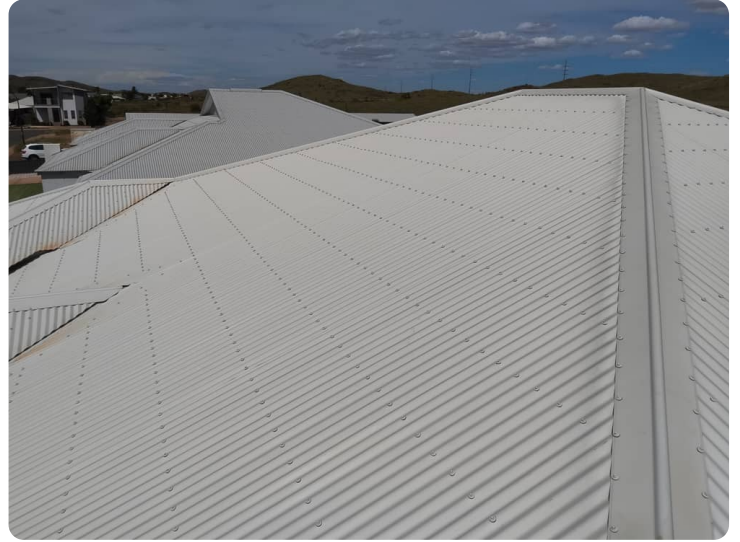
1. Roof covering

The roof covering is constructed of colorbond. The condition of the roof covering is satisfactory in relation to its age and will require normal ongoing maintenance.

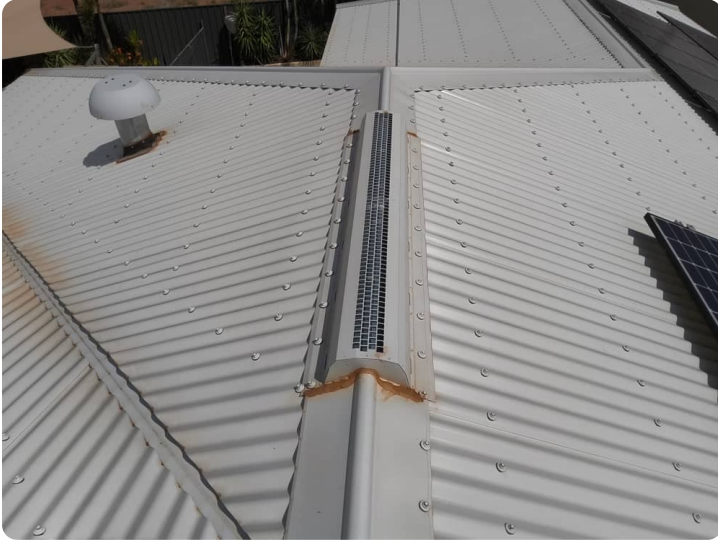
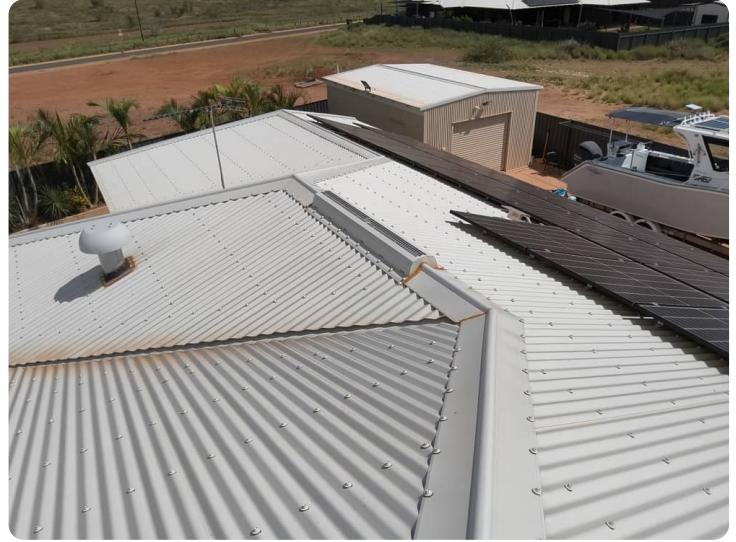
3. Roof vents

The roof vents are painted and constructed of metal. The condition of the vents is satisfactory in relation to their age and will require normal ongoing maintenance.

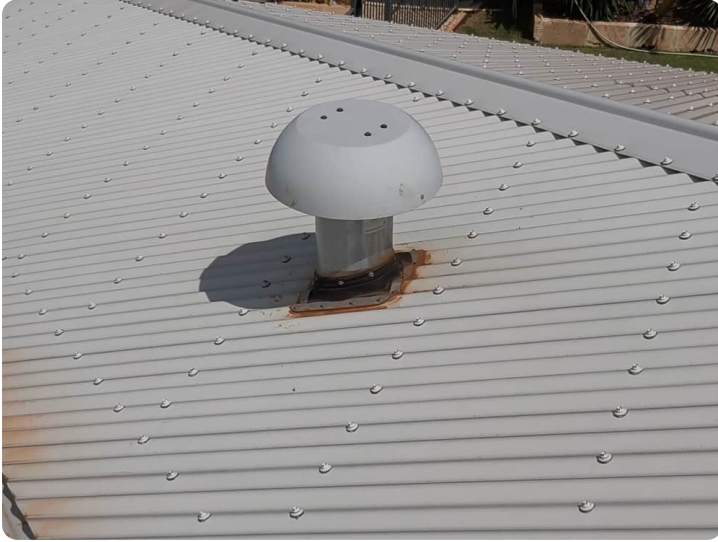
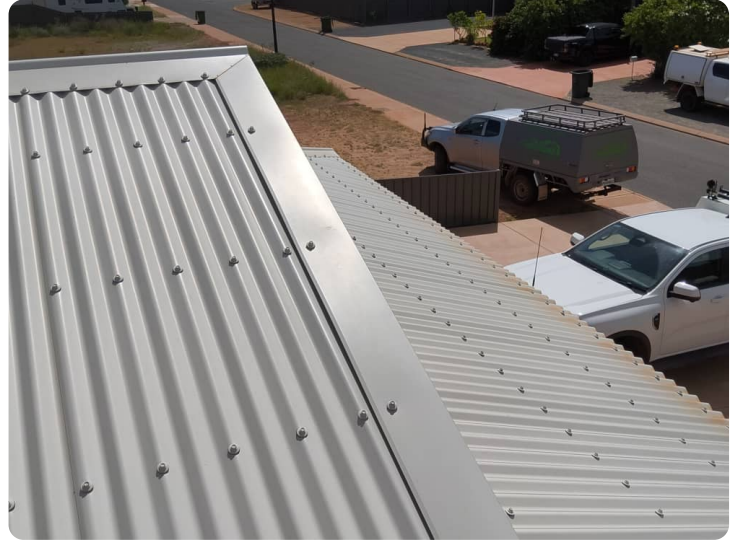
4. Flashings

The flashings are covered with a variety of finishes and are constructed of a mixture of materials. The condition of the flashings is satisfactory in relation to their age and will require normal ongoing maintenance.

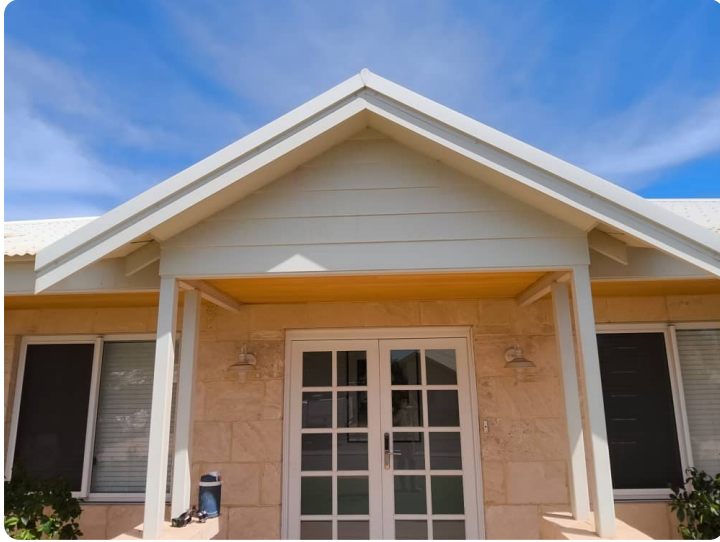
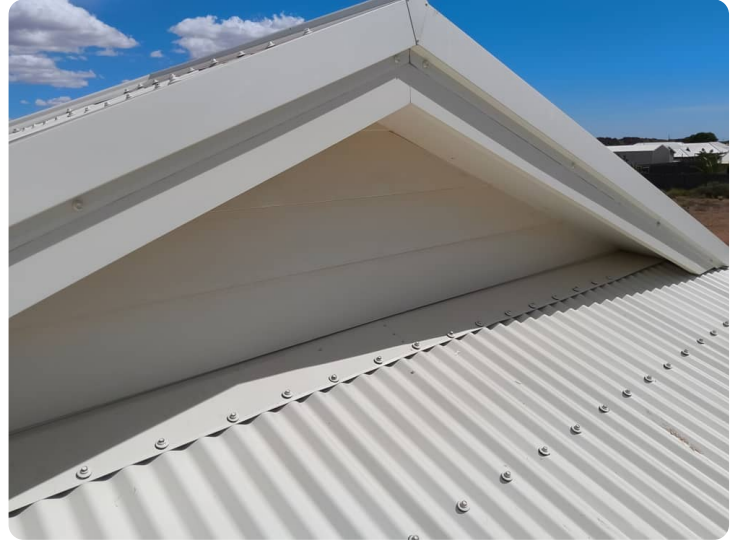
5. Gables

The gables are painted and constructed of fibre cement. The condition of the gables is satisfactory in relation to their age and will require normal ongoing maintenance.

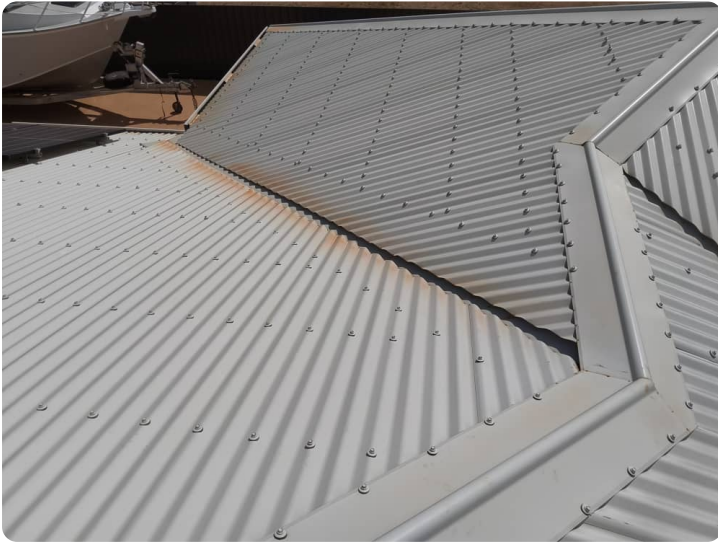
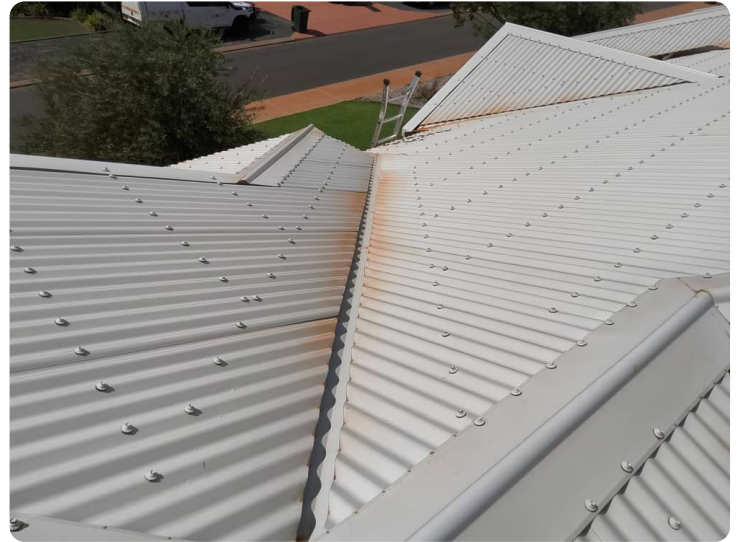
6. Valleys

The valleys are constructed of metal and have a colorbond covering. The condition of the valleys is satisfactory in relation to their age and will require normal ongoing maintenance. The valleys appear to be relatively free of debris.

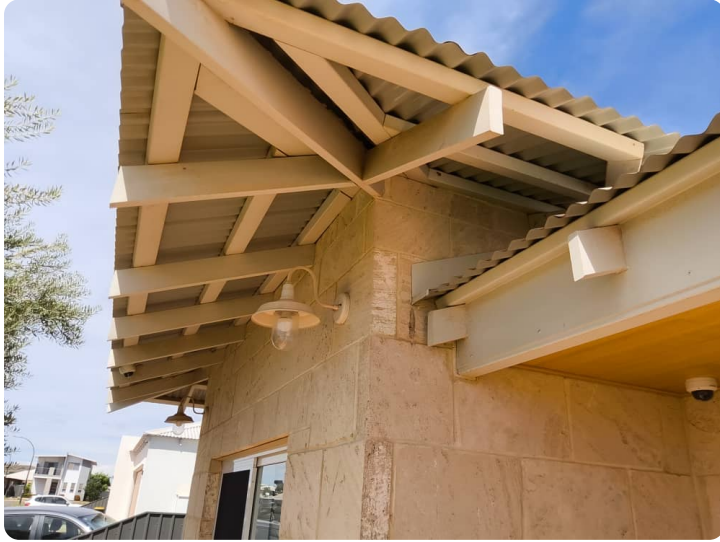
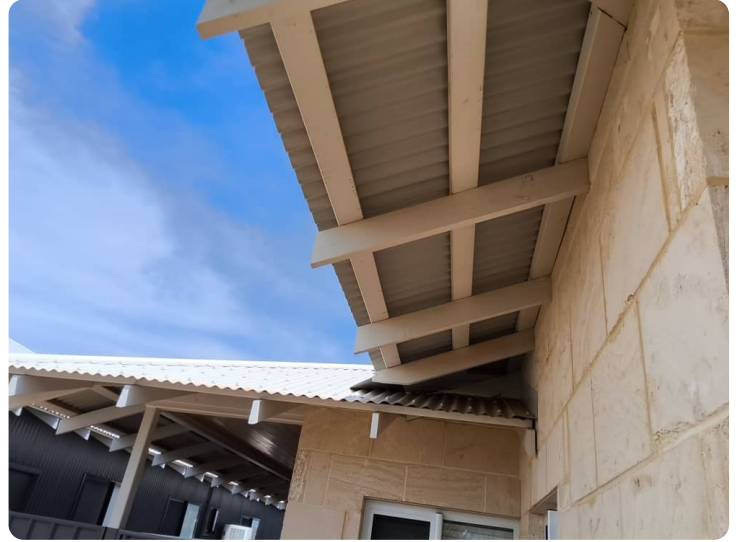
7. Eaves

The eaves are exposed and constructed of exposed rafters. The condition of the eaves is satisfactory in relation to their age and will require normal ongoing maintenance.

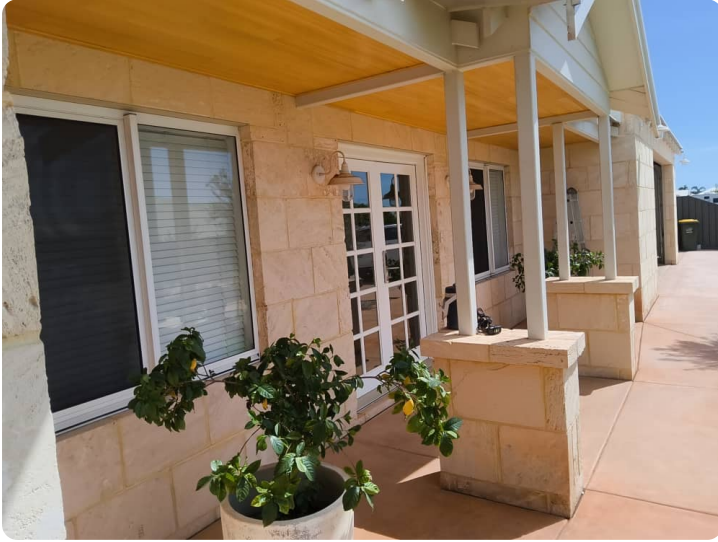
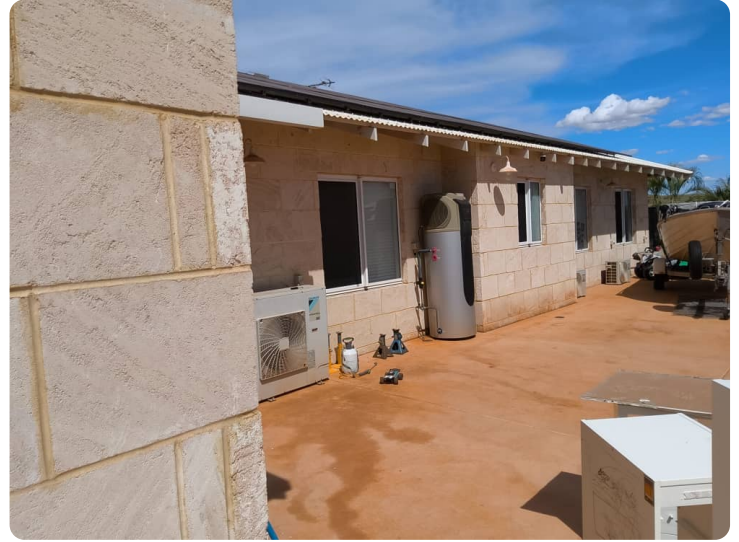
8. External walls

The external walls are constructed of limestone. The condition of the walls generally is satisfactory in relation to their age and will require normal ongoing maintenance.

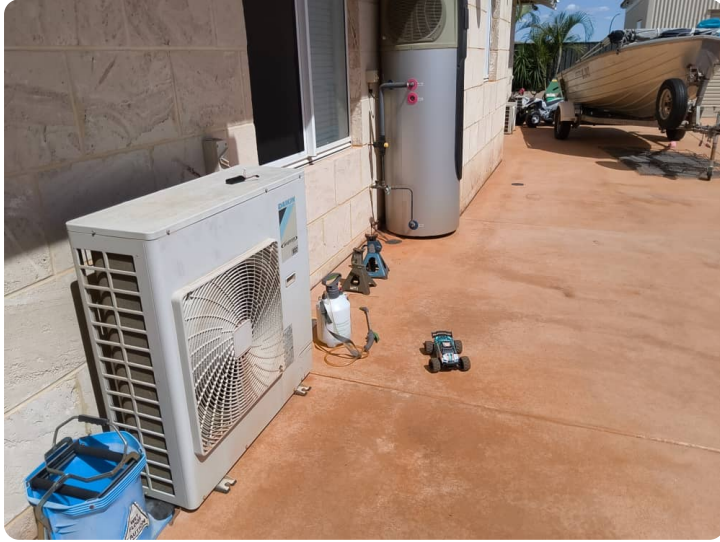
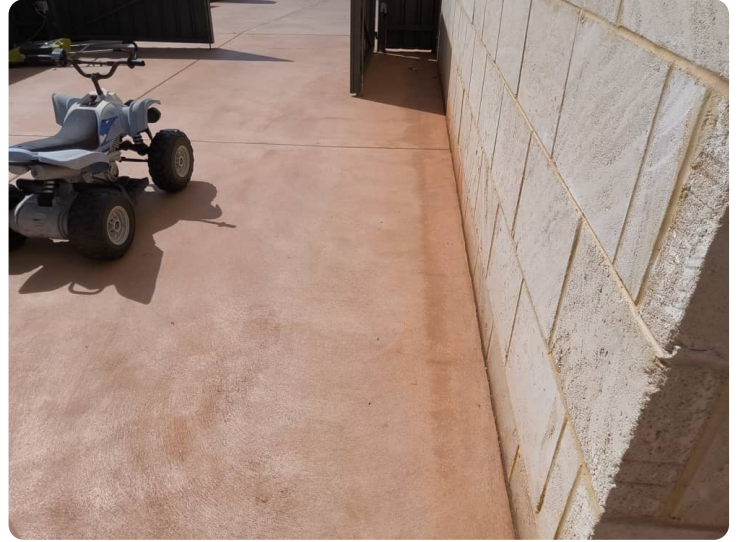
9. Footings

The footings are below ground and cannot be seen. The condition of the footings cannot be determined.

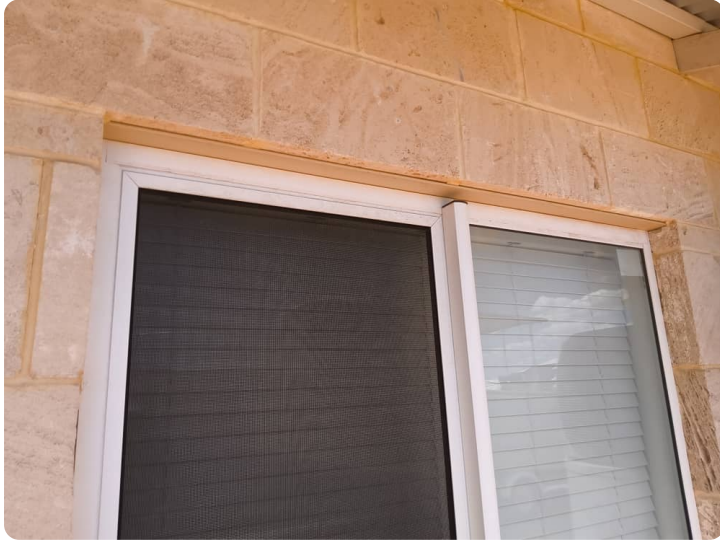
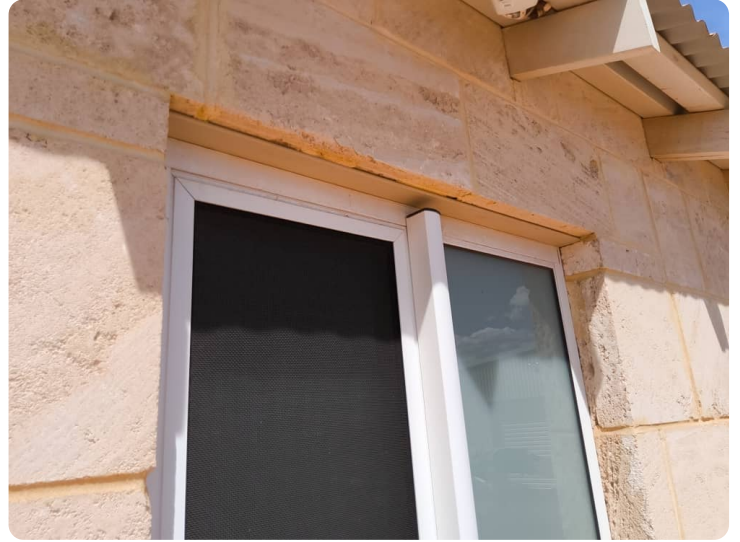
10. Lintels

The external lintels are (or partially are) constructed of steel. The condition of the lintels is satisfactory in relation to its age and will require normal ongoing maintenance.

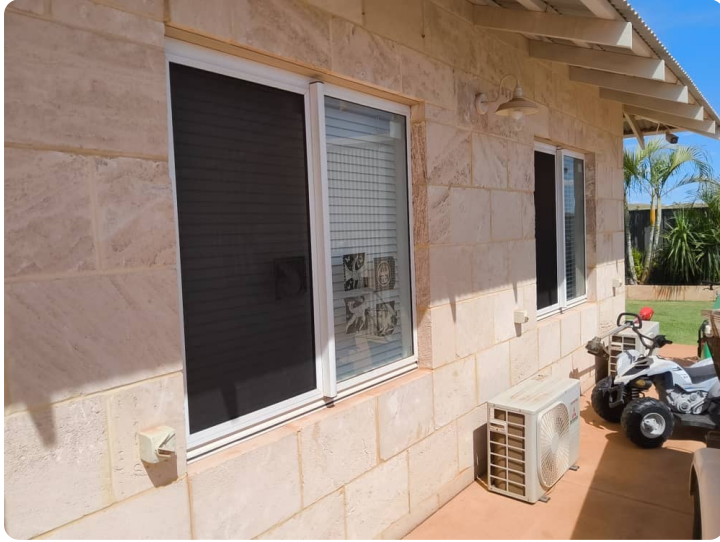
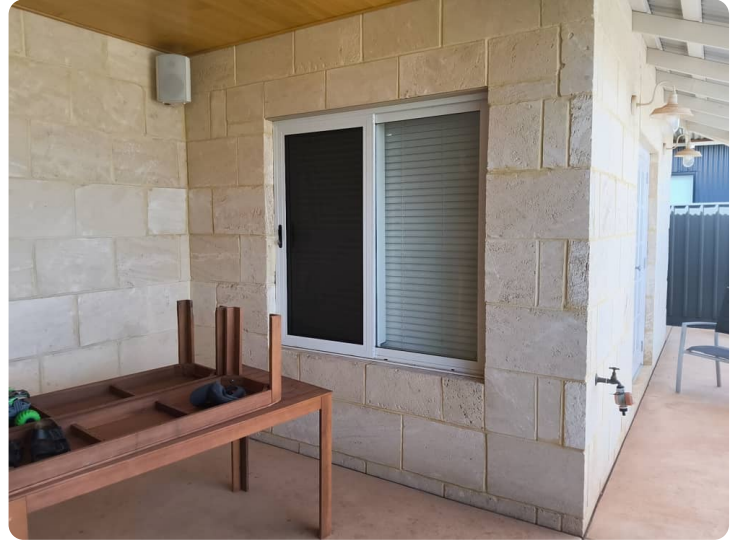
11. Windows and window frames

The window and window frames are primarily constructed of aluminium. The condition of the window and window frames is generally satisfactory in relation to its age and will require normal ongoing maintenance.

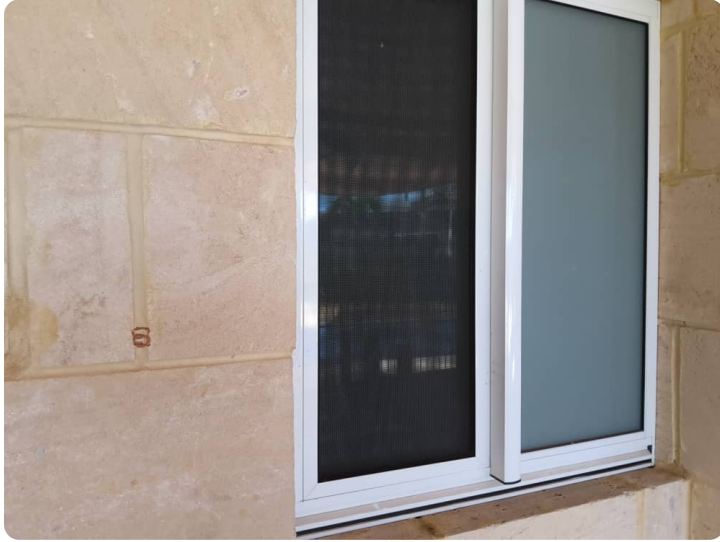
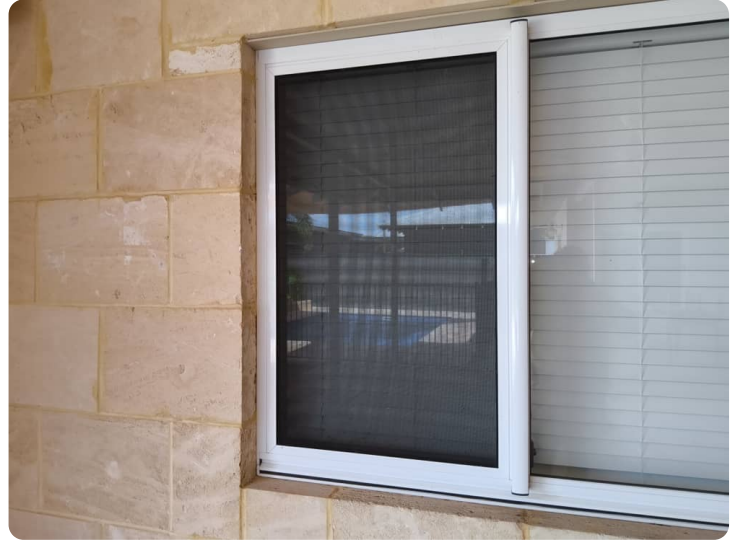
12. Window fly screens

Fly screens have been installed to all of the windows. The condition of the window fly screens is generally satisfactory in relation to its age and will require normal ongoing maintenance.

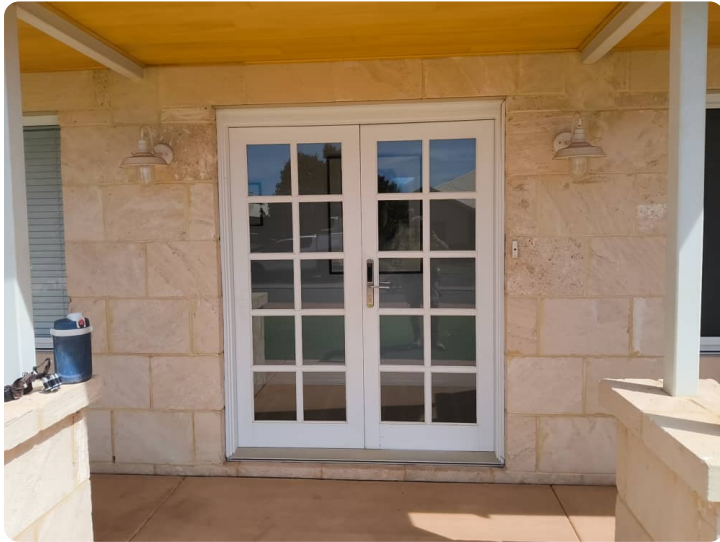
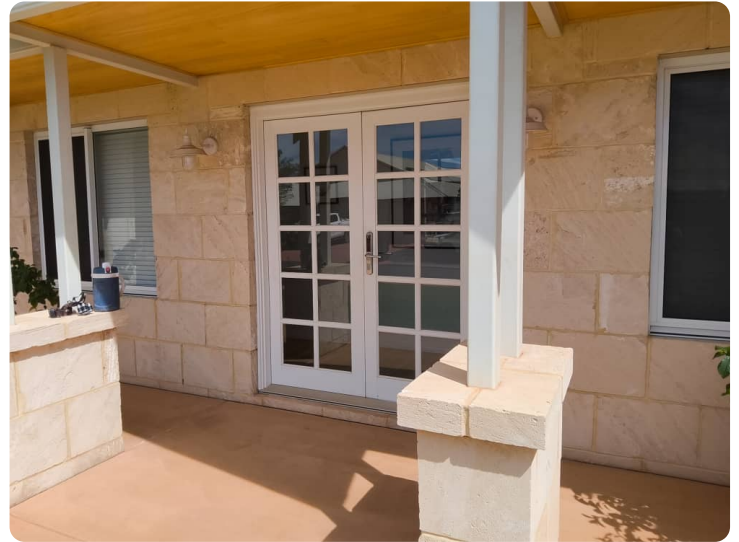
13. Front door

The front door is constructed of timber and glass. The condition of the front door is satisfactory in relation to its age and will require normal ongoing maintenance. Deadlocks have been installed. A security screen door has not been fitted.

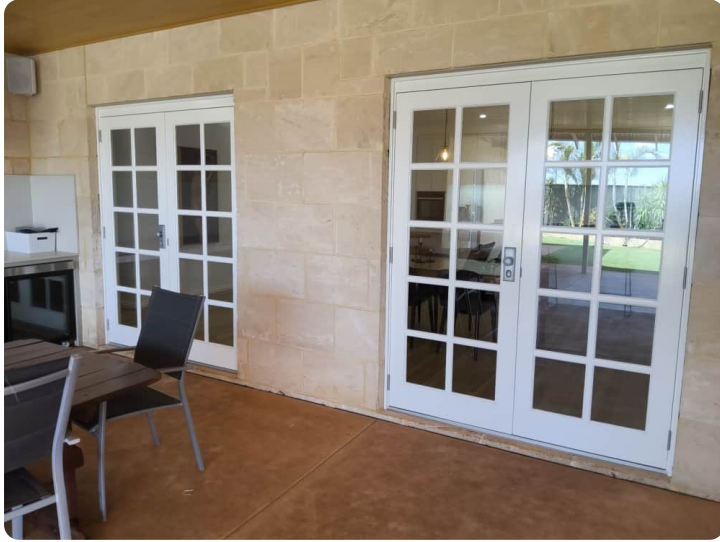
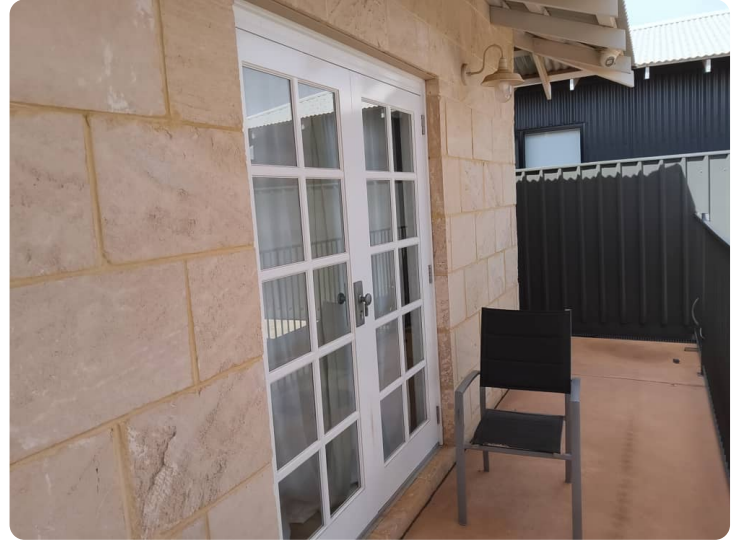
14. Other external doors

Other external doors are constructed of timber framed and predominately glass. The condition of the other external doors is satisfactory in relation to its age and will require normal ongoing maintenance.

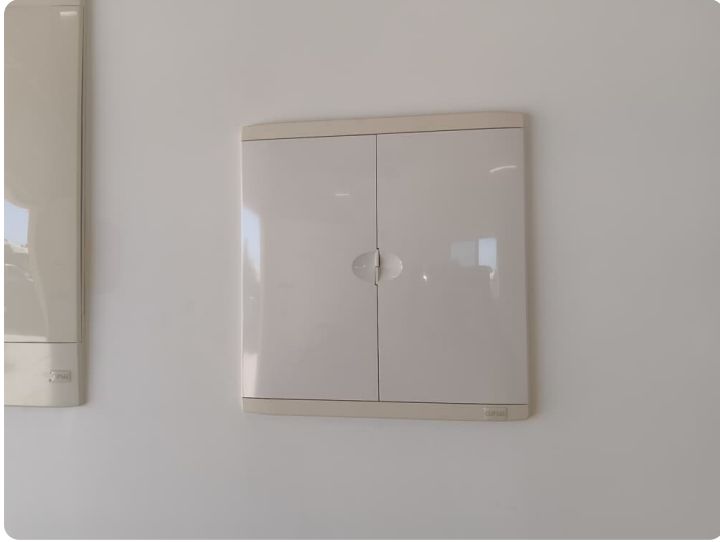
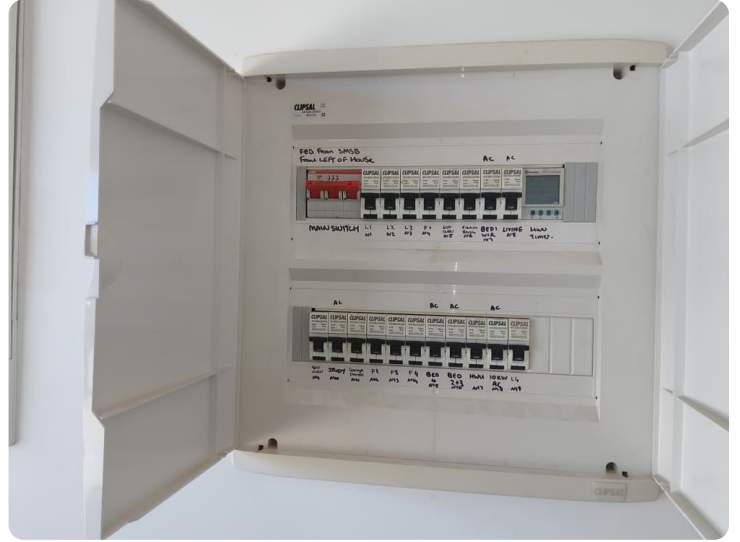
16. Residual Current Devices

There were multiple Residual Current Devices (RCD)(s) noted in the meter box or sub meter box. The RCD(s) were not tested. It is suggested that an Electrical Compliance Certificate be obtained in relation to the RCD(s).

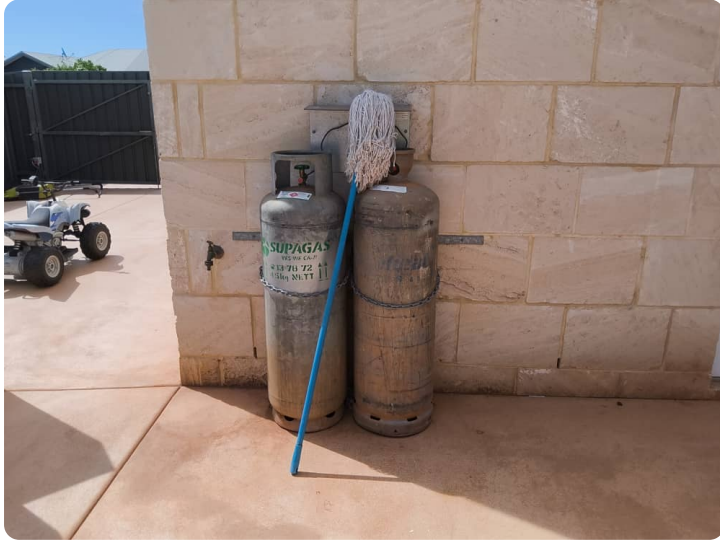
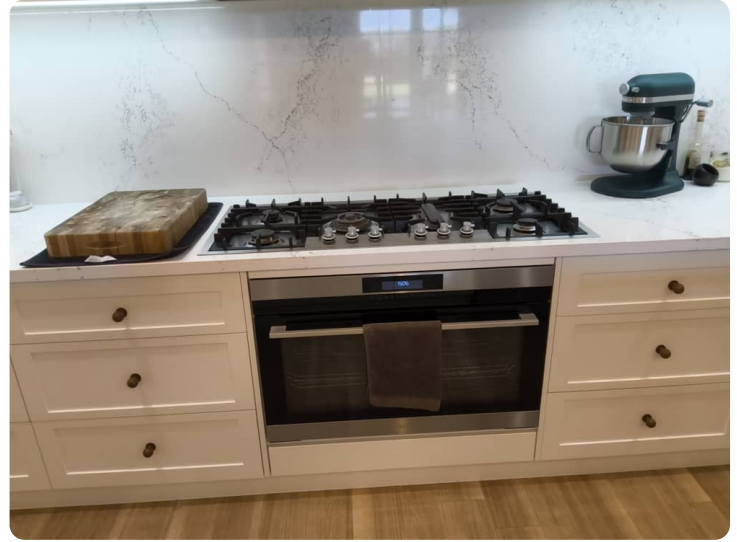
18. Gas Supply

Gas supply to the property is via LPG bottles. While on site the inspector could not smell detectable gas leaks.

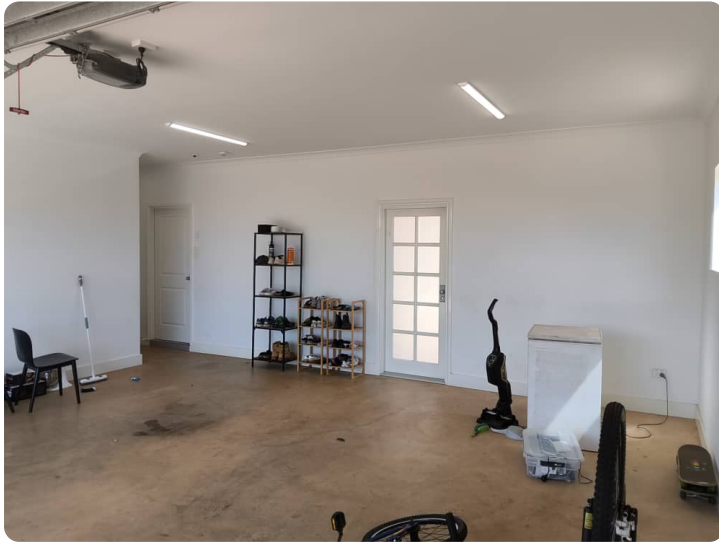
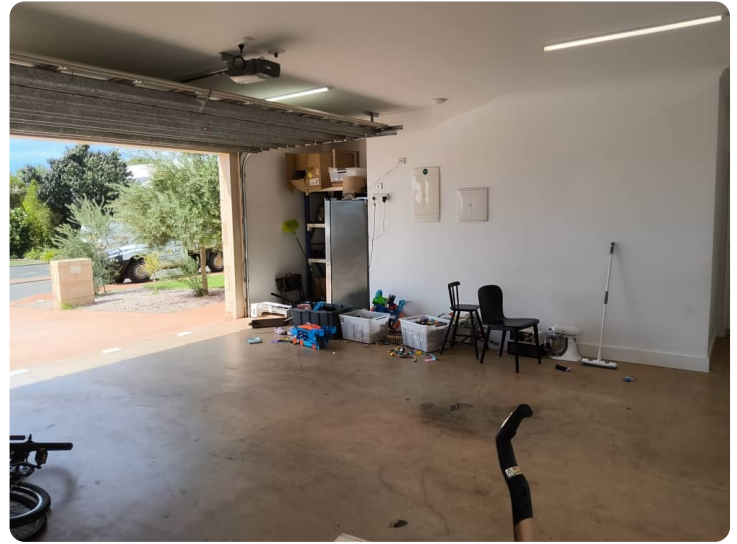
19. Carport or Garage (Primary)

There is a primary garage on the property constructed of same materials as the primary structure. The condition of the carport or garage is satisfactory in relation to its age and will require normal ongoing maintenance. Access and visibility of the area was restricted by stored items.

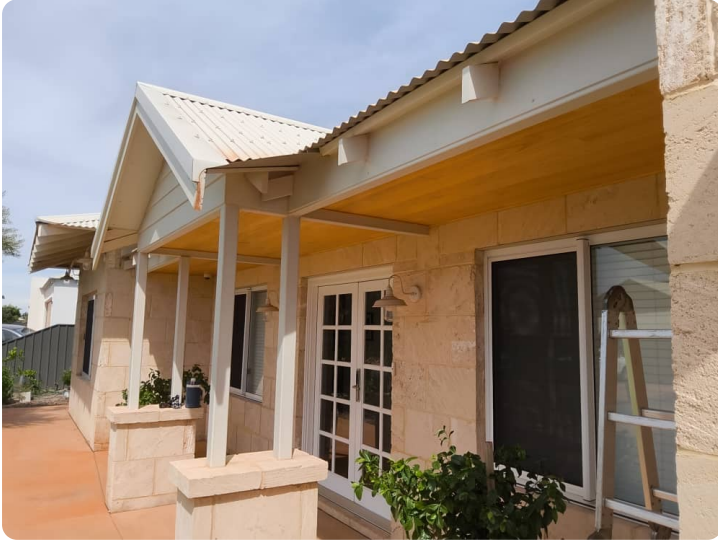
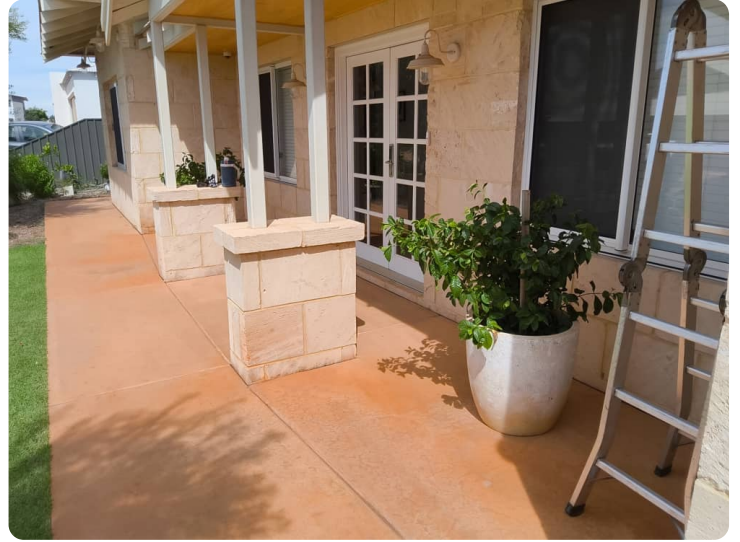
20. Veranda (Primary)

The primary veranda is constructed of same materials as the primary structure. The condition of the veranda is satisfactory in relation to its age and will require normal ongoing maintenance.

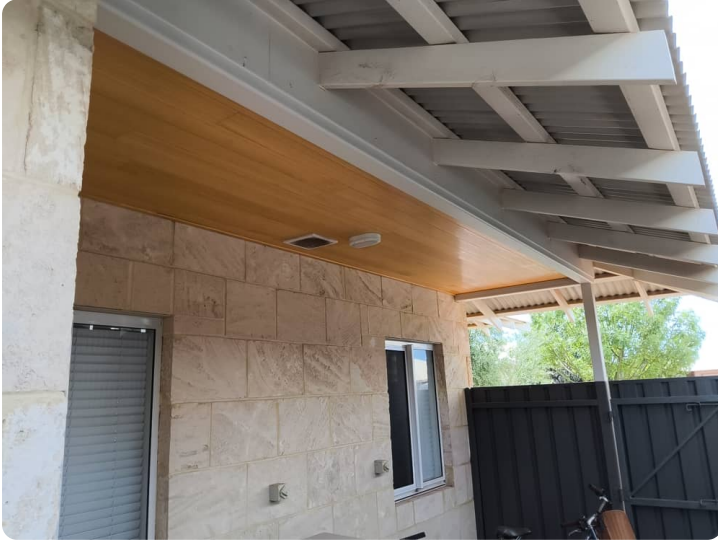
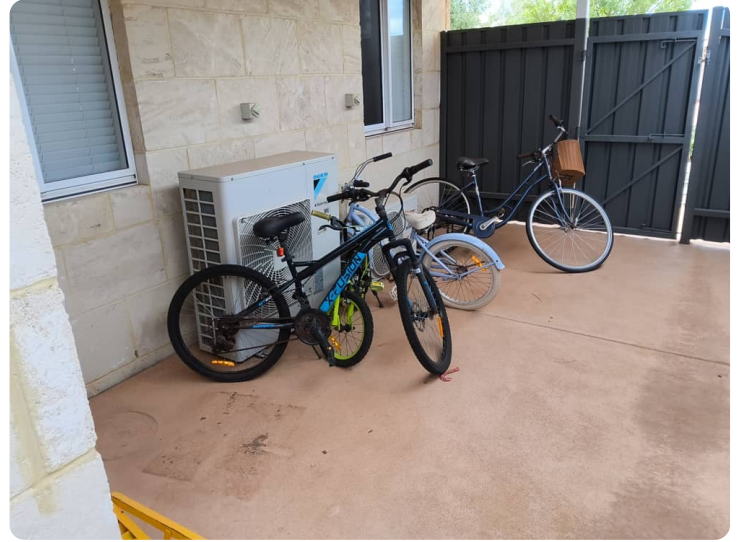
21. Veranda (Secondary)

The secondary veranda is constructed of same materials as the primary structure. The condition of the veranda is satisfactory in relation to its age and will require normal ongoing maintenance.

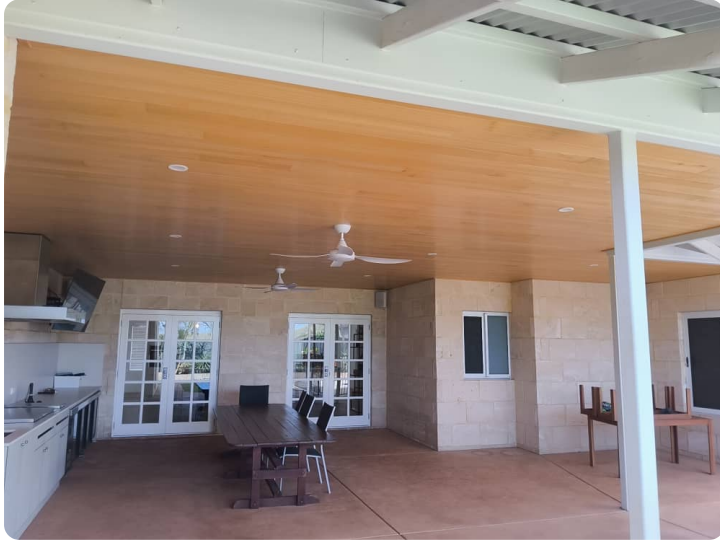
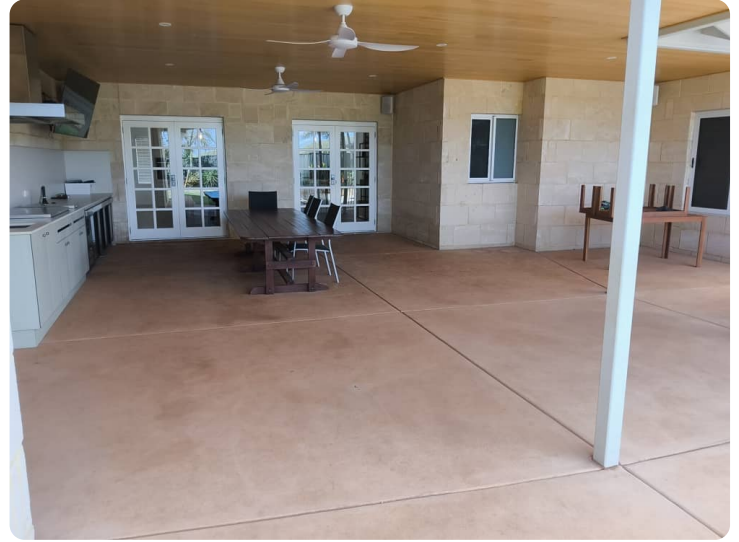
22. Alfresco (under main roof)

The alfresco under the main roof is constructed of same materials as the building. The condition of the alfresco is satisfactory in relation to its age and will require normal ongoing maintenance.

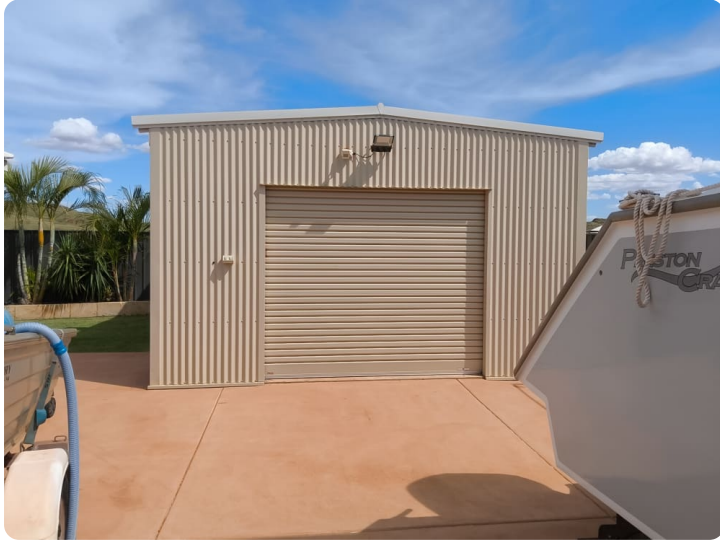
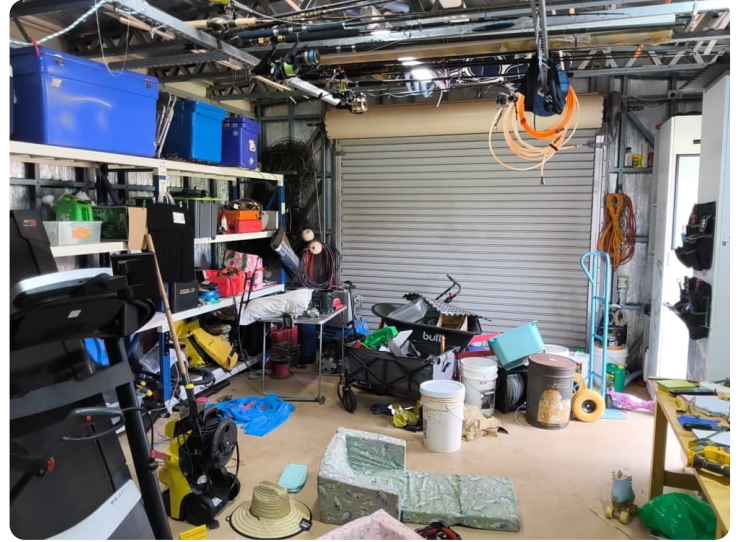
23. Large shed

The large shed is constructed of metal. The condition of the large shed is satisfactory in relation to its age and will require normal ongoing maintenance. Access and visibility of the area was restricted by stored items.

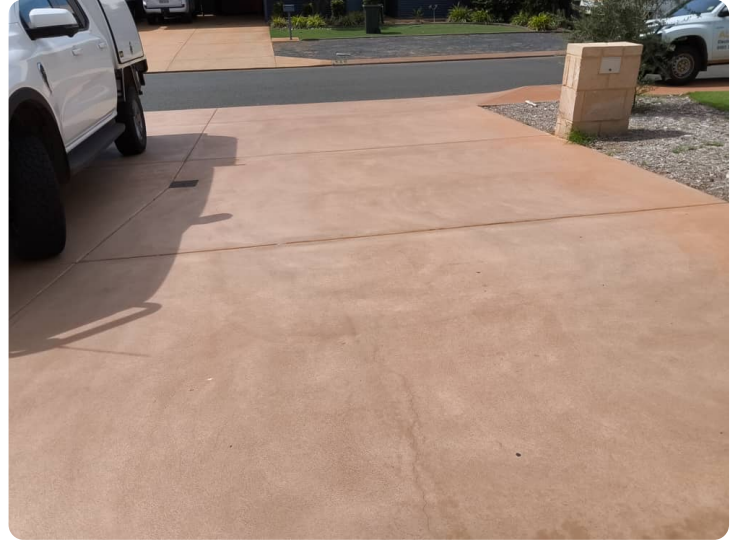
24. Driveway

The driveway and cross over is constructed of concrete. The condition of the driveway is satisfactory in relation to its age and will require normal ongoing maintenance.

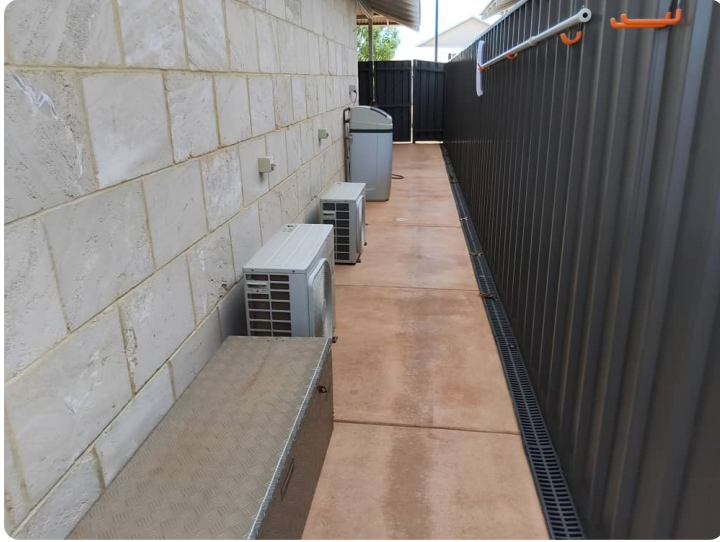
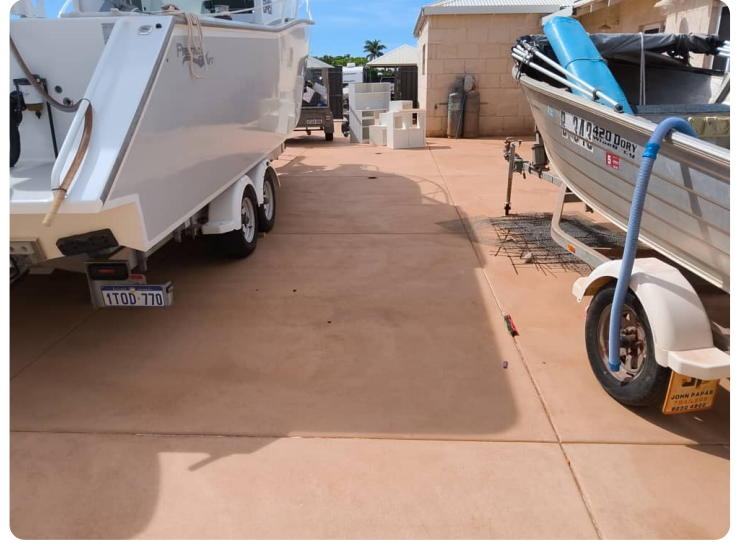
25. External walkways and paved areas

The external walkways and paved areas are constructed of concrete. The condition of the external walkways and paved areas is satisfactory in relation to its age and will require normal ongoing maintenance.

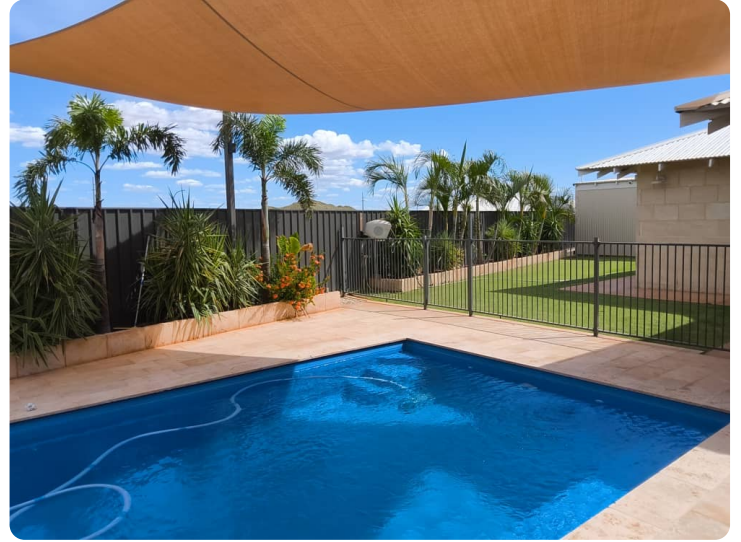
26. Fences - boundary

The boundary fences are constructed of metal. The condition of the boundary fence is satisfactory in relation to its age and will require normal ongoing maintenance.

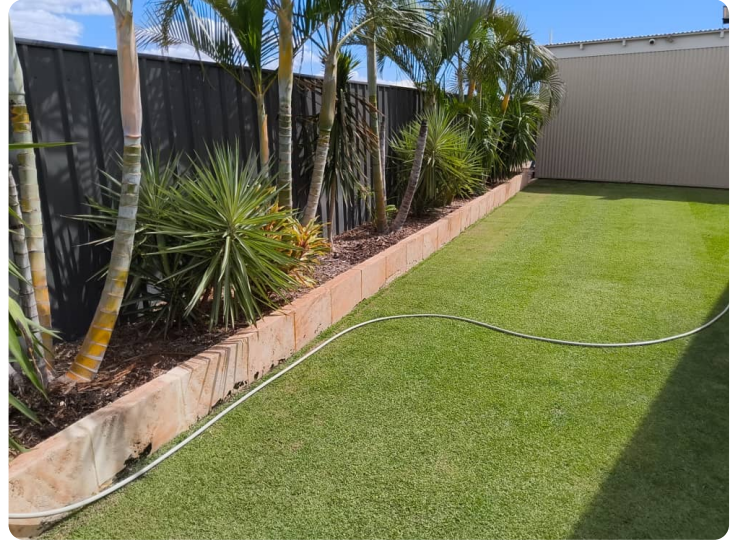
27. Retaining walls

The retaining walls are constructed of limestone or concrete blocks. The condition of the retaining wall is satisfactory in relation to its age and will require normal ongoing maintenance.

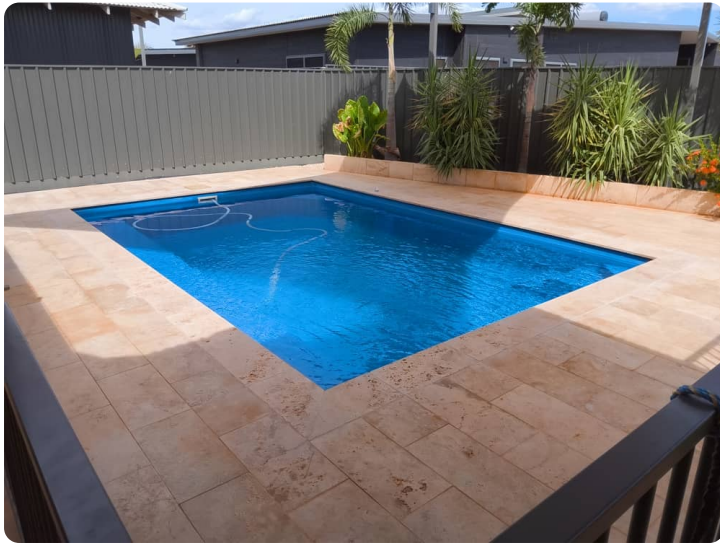
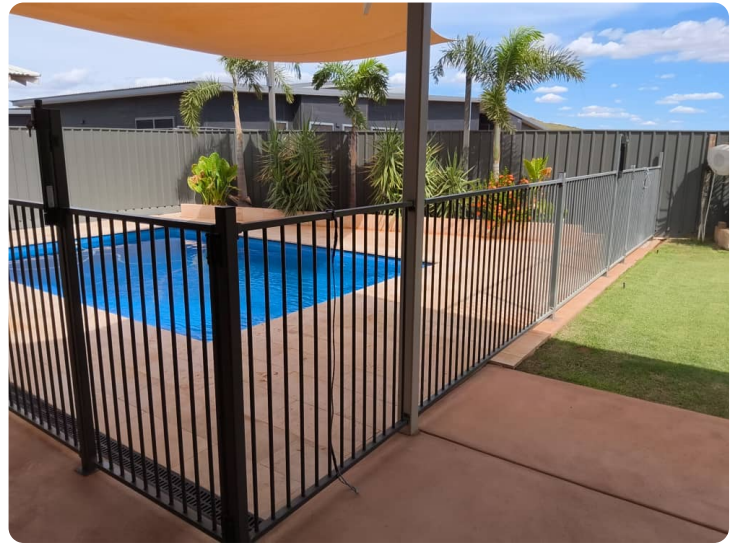
28. Pool (isolation fencing)

The pool is situated below ground. The external pool on the property is constructed of fibreglass. In relation to subsidence to the ground immediately adjacent to the pool, no significant subsidence was noted. There is isolation fencing installed around the pool. The isolation fencing and gates appear to be consistent with current pool fencing requirements. It is recommended that a copy of the previous Council Pool Safety Compliance Certificate is obtained. It is recommended that a pool maintenance contractor review and confirm the operation of all pool equipment.

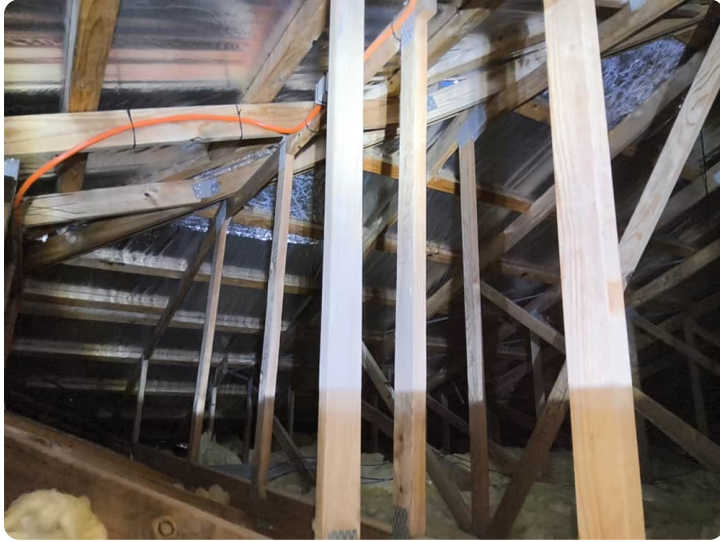
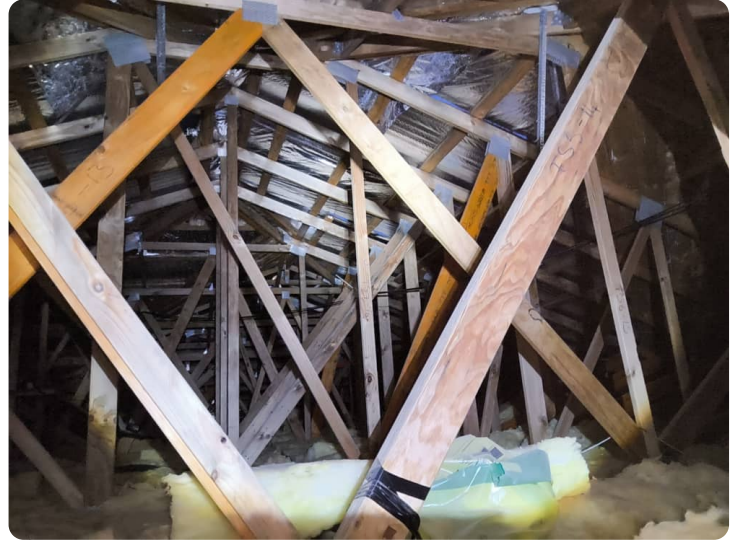
29. Under side of roof cover

The condition of the underside of the roof cover could not be determined as sarking had been installed.

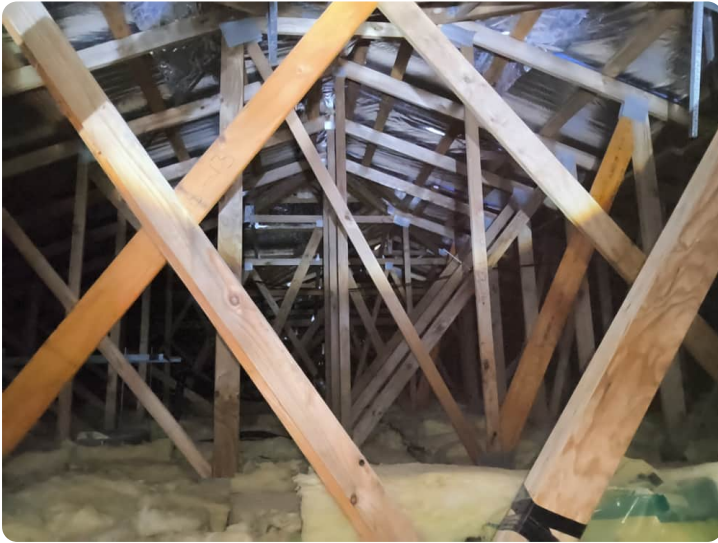
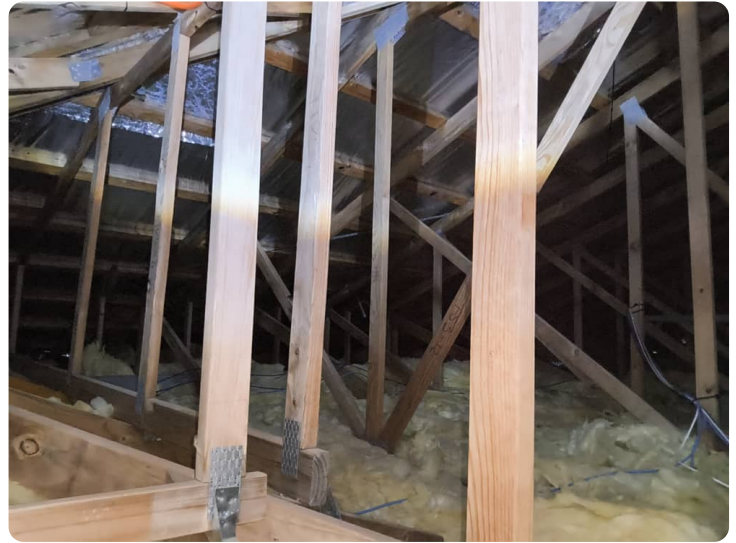
31. Roof frame

The roof frame type is a timber truss. The condition of the roof frame is satisfactory in relation to its age and will require normal ongoing maintenance. Access to the roof space was restricted by the pitch of the roof, insulation, ducting or other items. The inspector estimates that visibility was available to more than 75% of the area.

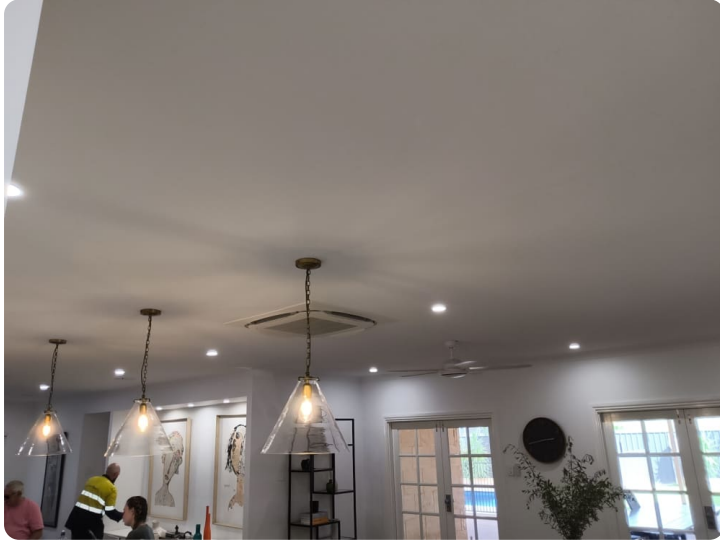
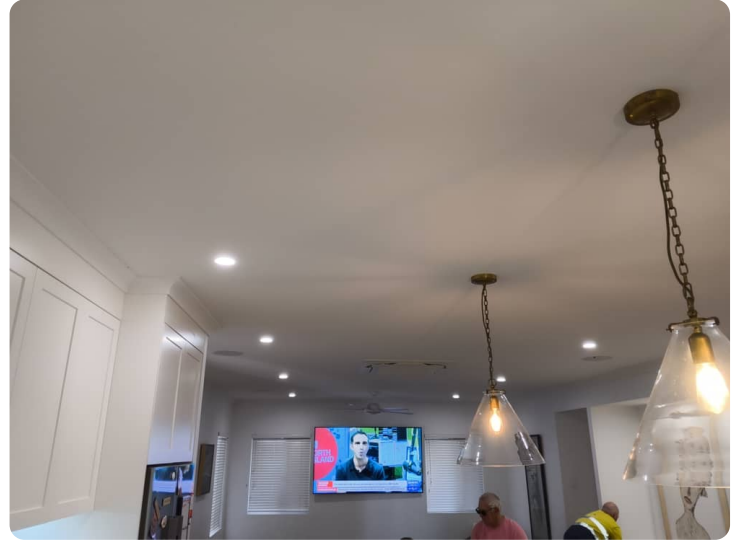
33. Ceilings

The ceilings are constructed of plasterboard with cornices constructed of plasterboard. The condition of the ceilings is satisfactory in relation to its age and will require normal ongoing maintenance.
