Houspect

Building inspection

Job ID: 91385

Address: 12 Jankurna Street, Baynton WA

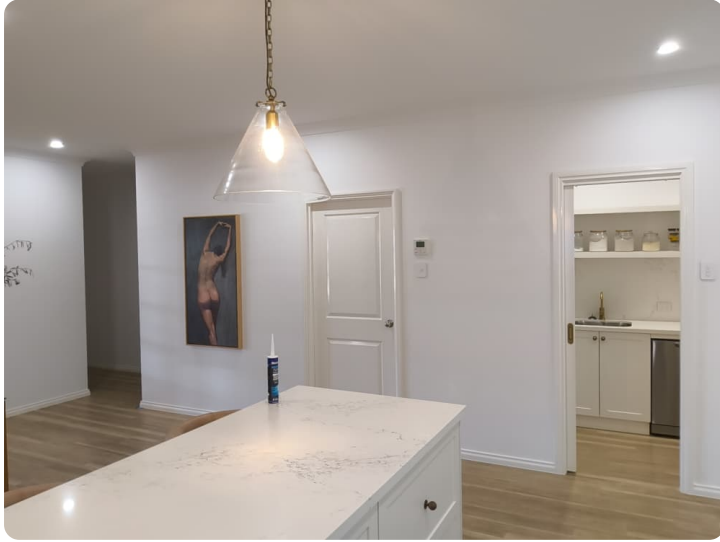
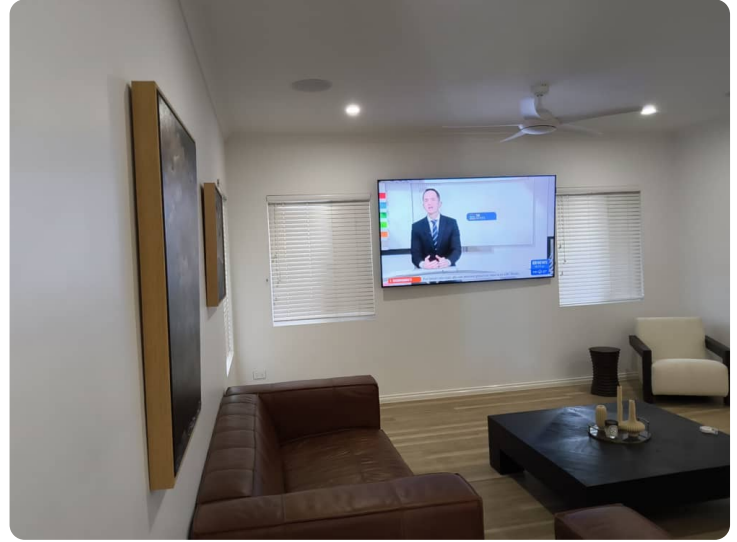
34. Internal walls

The internal walls are constructed of a frame with plaster board cladding. The condition of the internal walls is satisfactory in relation to its age and will require normal ongoing maintenance.

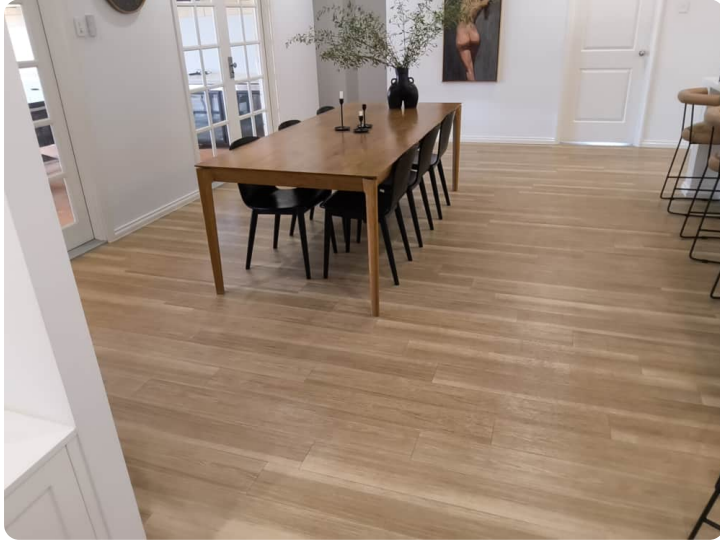
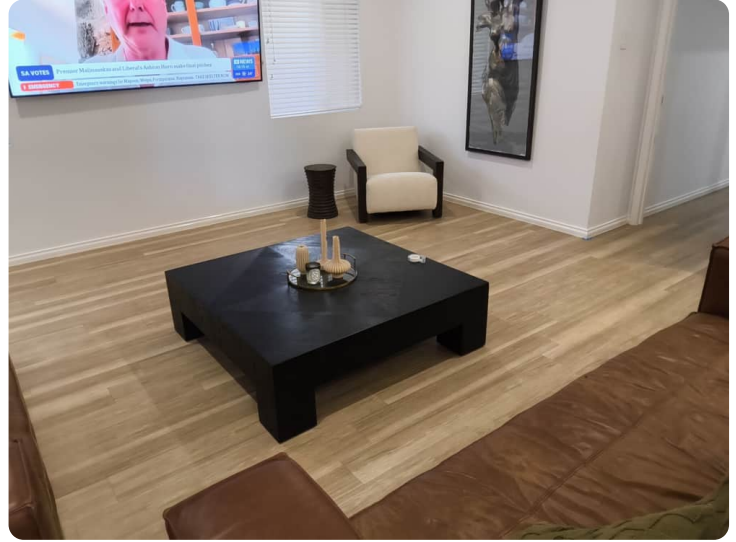
35. Internal floors

The internal floors are constructed of concrete and are covered in a variety of coverings. The condition of the internal floors is unable to be determined as they could not be seen due to coverings.

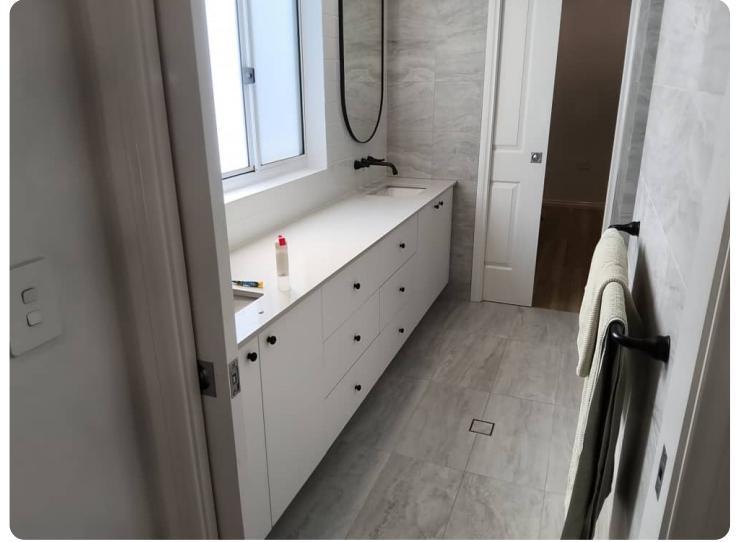
36. Tiled floors and walls

There are areas of internal floors and walls which are covered with a tile covering. The condition of the tiles is satisfactory in relation to its age and will require normal ongoing maintenance.

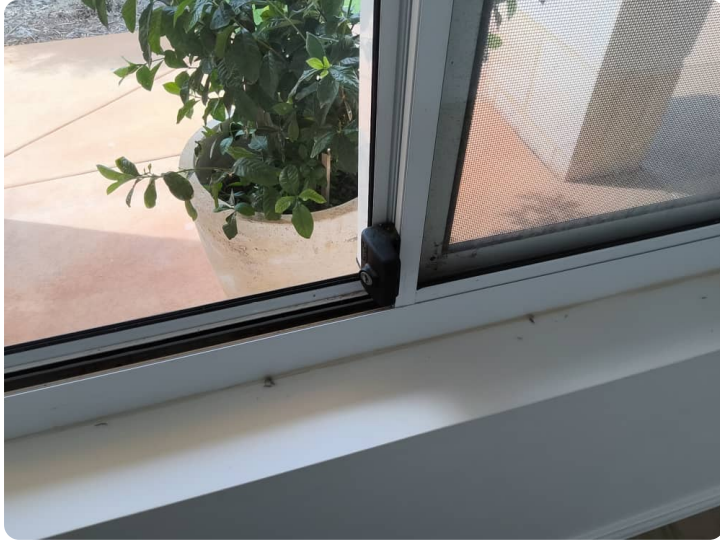
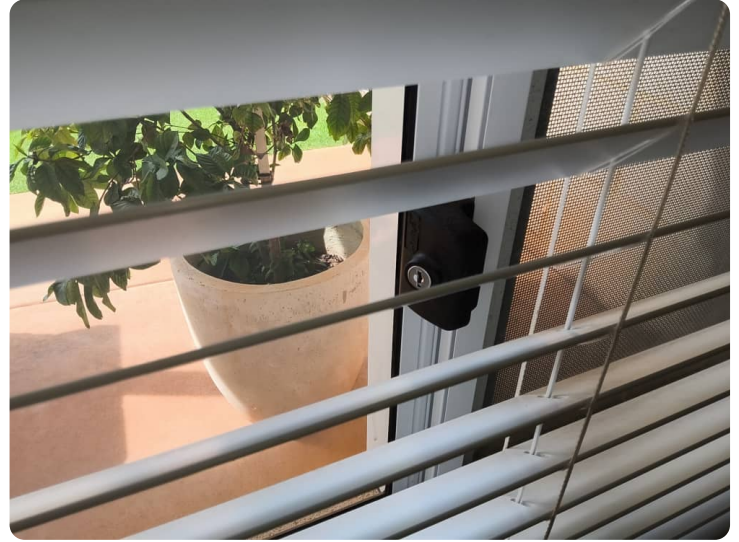
37. Windows (internal)

The condition of the windows, as viewed from within the property, is satisfactory in relation to its age and will require normal ongoing maintenance. Window locks have been installed to all of the windows.

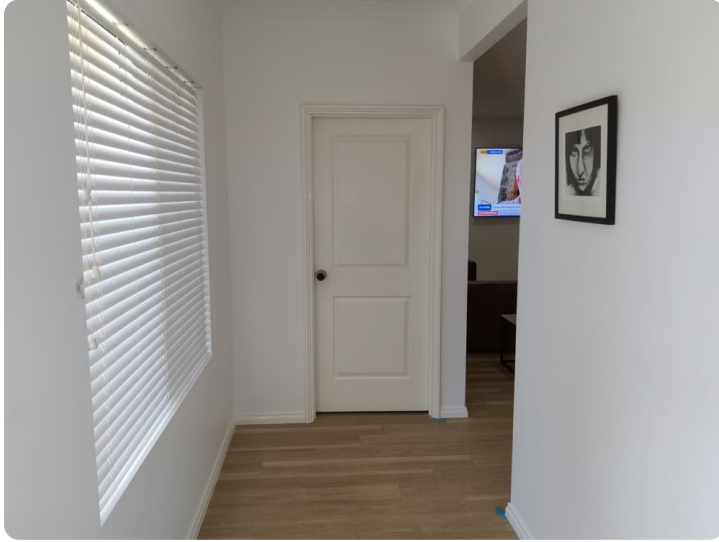
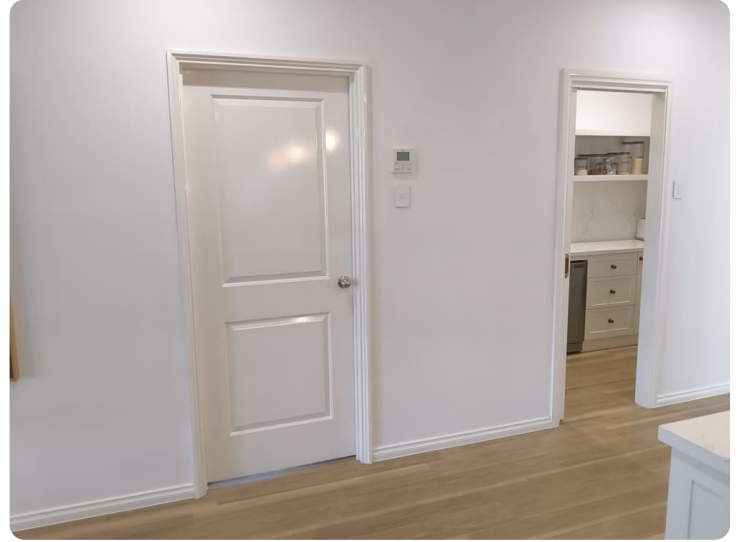
38. Internal doors

The internal doors were mainly constructed of timber hollow core. The condition of the internal doors is satisfactory in relation to its age and will require normal ongoing maintenance.

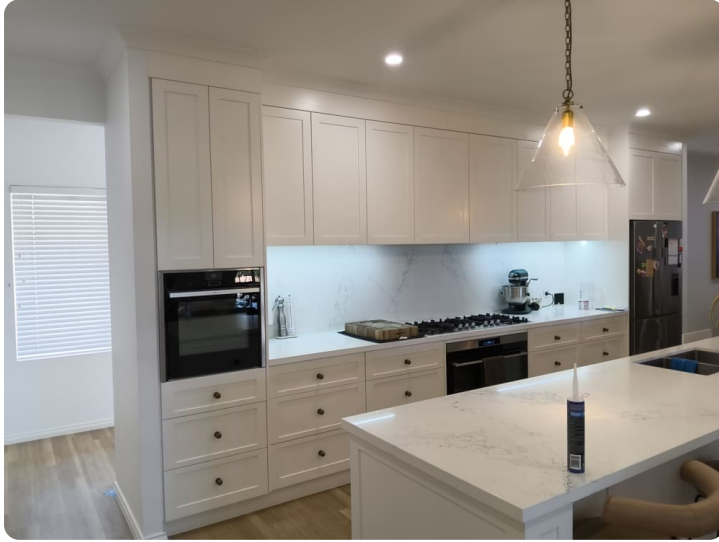
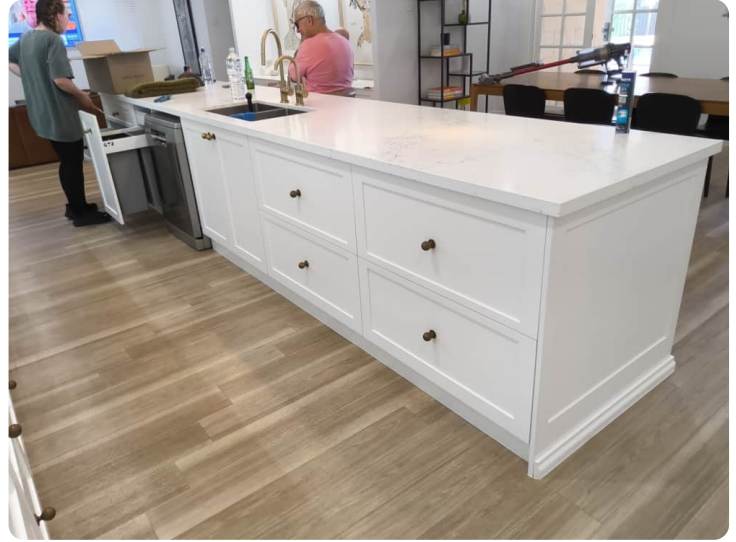
39. Kitchen cabinets

The condition of the kitchen cabinets in general is satisfactory in relation to their age and require normal maintenance.

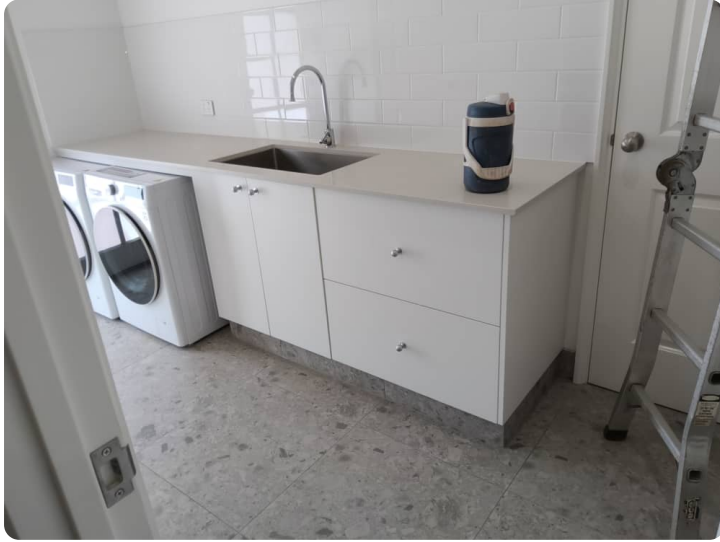
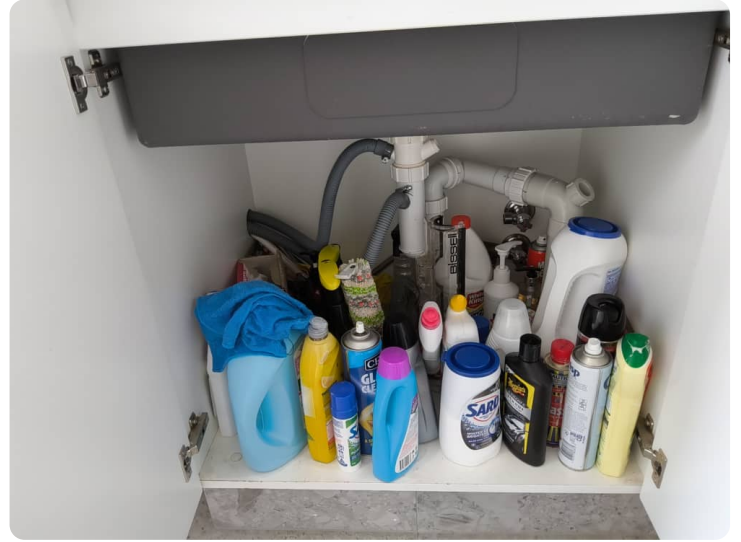
40. Laundry cabinets

The condition of the laundry cabinets is satisfactory in relation to their age and require normal maintenance.

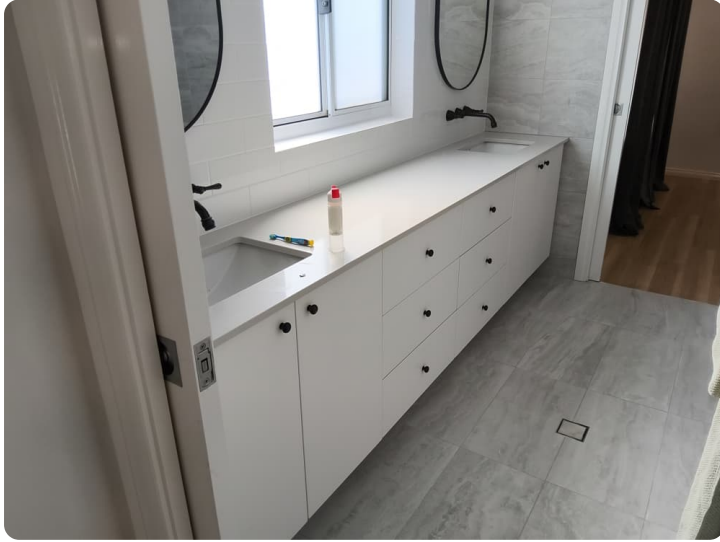
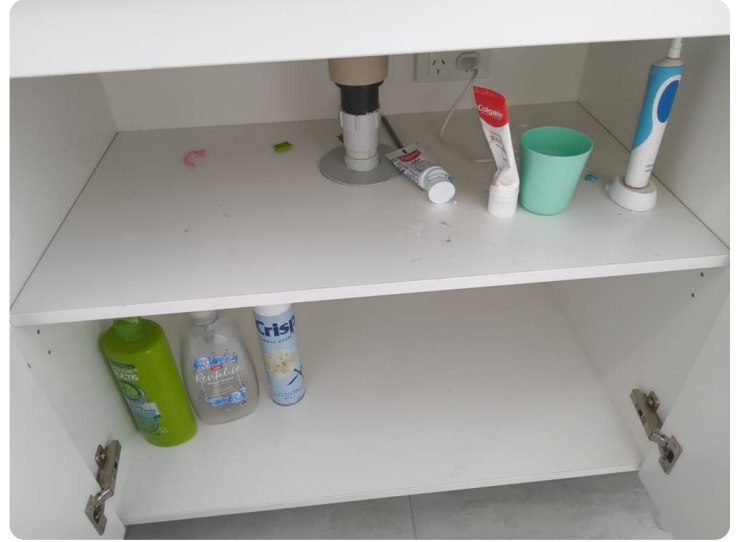
41. Bathroom cabinets

The condition of the bathroom cabinets is satisfactory in relation to their age and require normal maintenance.

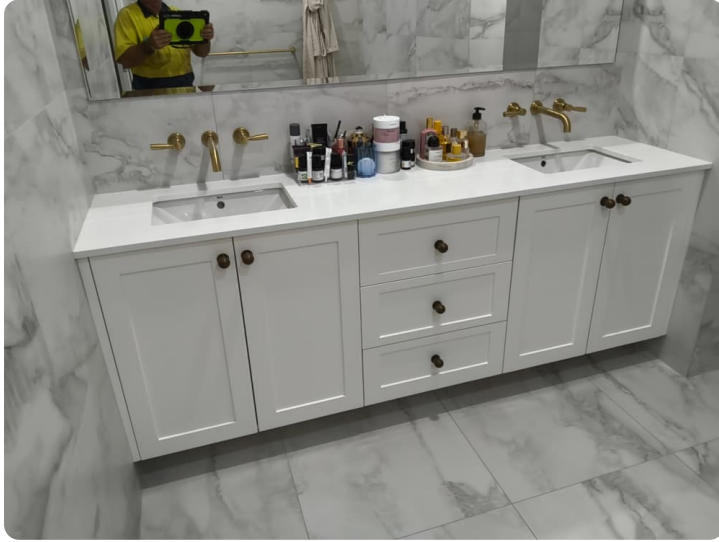
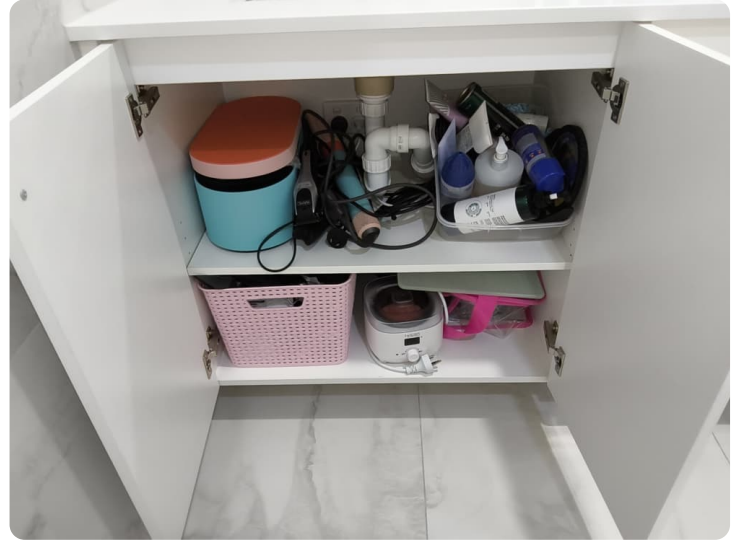
42. Ensuite cabinets

The condition of the ensuite cabinets is satisfactory in relation to their age and require normal maintenance.
