# Pre-Purchase Timber Pest Inspection Report

12 Jankurna St, Baynton WA, Australia

**Pre-Purchase Timber Pest Inspection - Pre-Purchase Timber Pest Inspection  
(AS4349.3-2010)**

17 Mar 2026

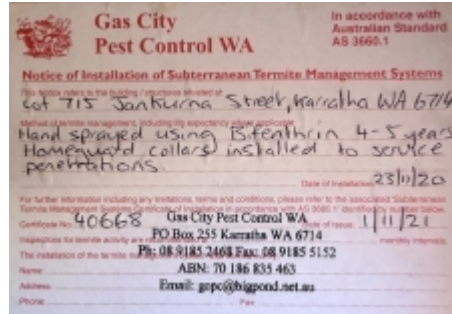
### Durable Notice Photos

Was a durable Notice found at the time of this inspection? Yes

Date of Treatment: (if known) 23 Nov 2020

The Inspection undertaken is a visual inspection only and therefore no representations can be made with regard to work historically performed. We strongly recommend that if possible, the client requests copies of any reporting related to previous activity or treatments including related warranties and dates of actions.
