# **Houspect**

**Building inspection**

**Job ID:** 91887

**Address:** 10 Matebore Street, Nickol WA

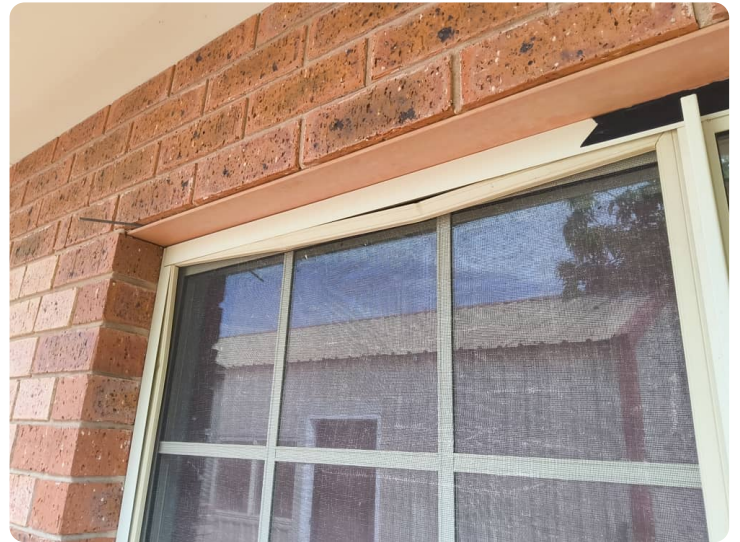
### 12.1 Screens damage - replacement

As per the images, the fly screens are damaged and require replacement.

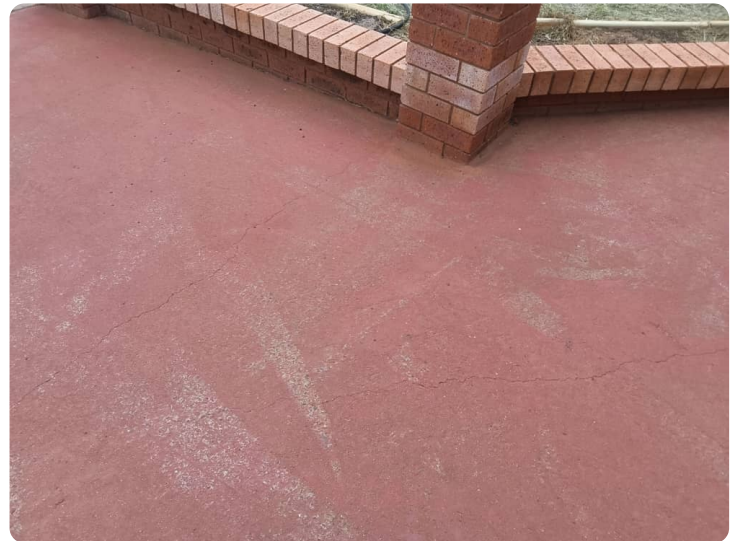
#### 23.1 Concrete cracking - minor

Cracking was noted to the concrete driveway. This is not of a structural concern. Cracks should be filled to avoid further deterioration.

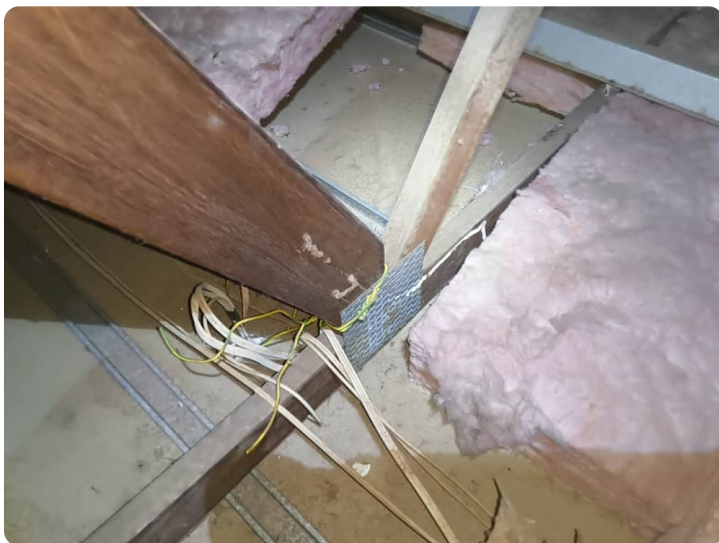
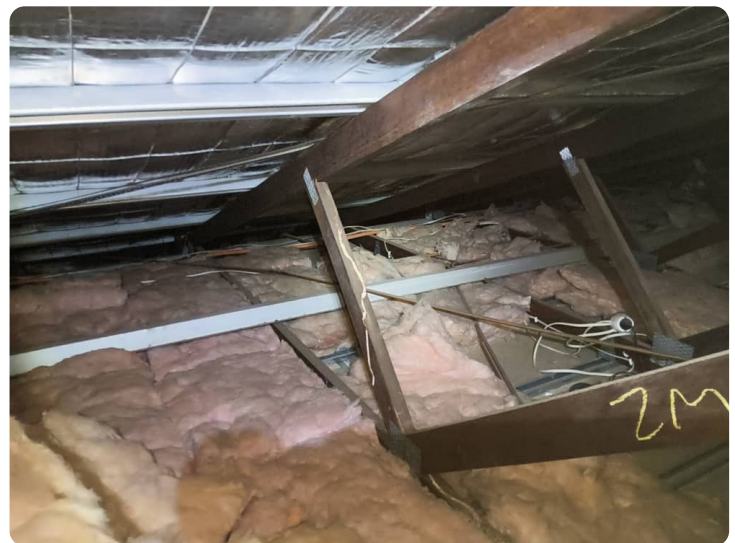
### 30.1 Termite damage - minor

During the inspection of the roof space termite mud trails were noted and or minor termite damage to roof timbers. It is recommended that consideration be given to a full invasive inspection of the entire roof frame be undertaken to determine the extent of any further damage and then repairs by a Registered Builder be undertaken as required. It is also recommend that a full termite inspection be undertaken and then ongoing termite treatment be undertaken at the required intervals.

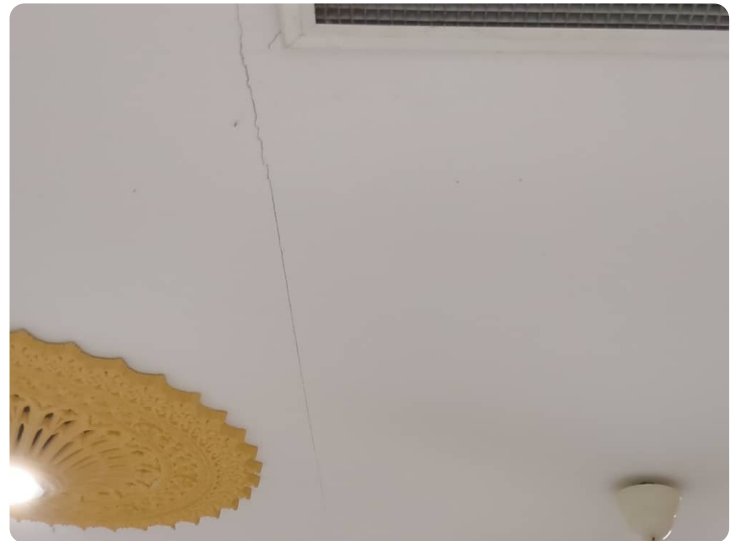
### 32.1 Cracking - minor

The ceilings in the images contain multiple cracks, likely caused by thermal expansion and contraction. This is not a structural issue but repairs are required.

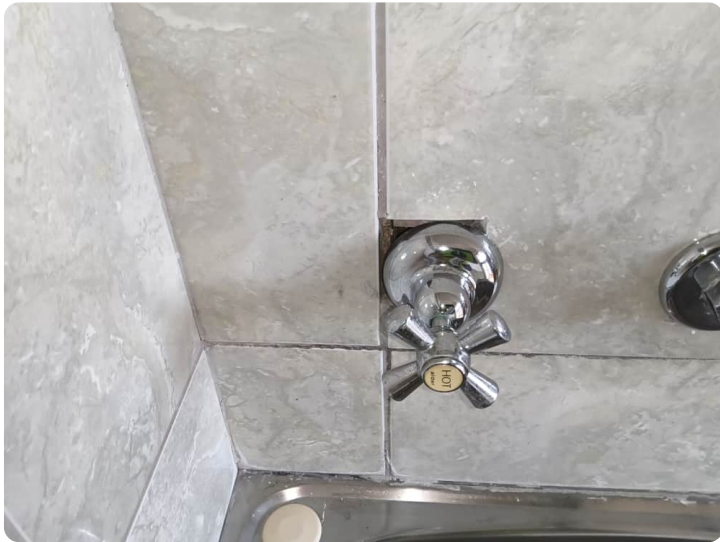
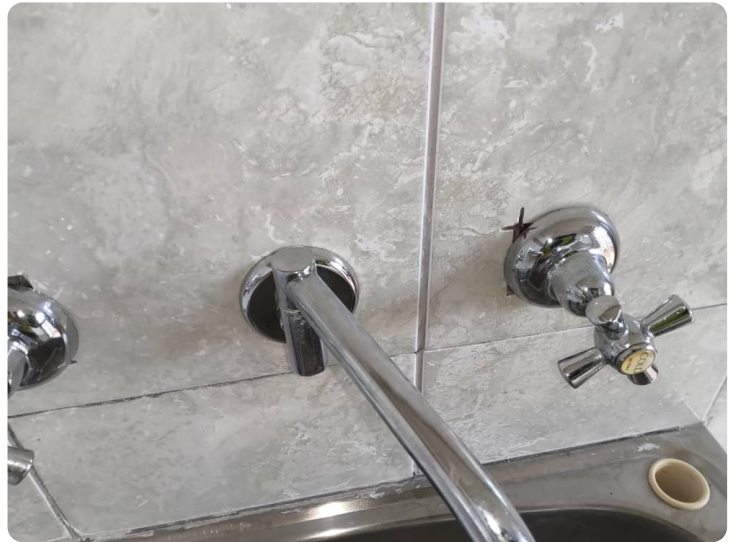
### 35.1 Tile damage - minor

As per the images provided there is damage to the wall or floor tiles requiring remediation.

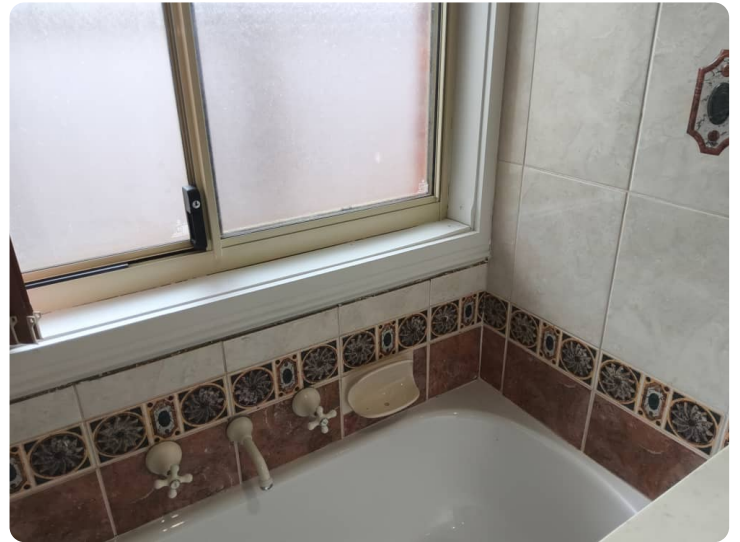
#### 36.1 Sill water damaged

The window sill is water damaged. Windows require new sill to remediate.

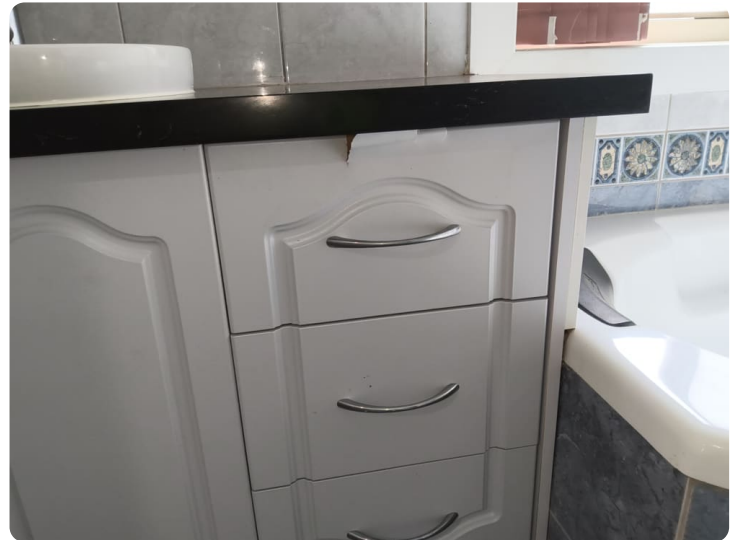
#### 41.1 Cabinet drawer vinyl damage

As per the images some cabinet drawers are damaged requiring repairs.

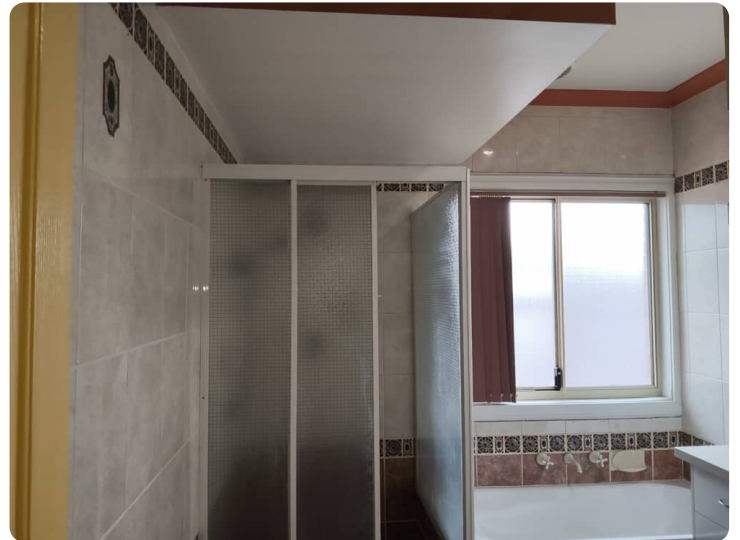
### 42.1 Bathroom shower screen door missing

As per the images the shower screen in the bathroom is missing a section of door. Screen should be replaced.
