**Building inspection**

**Job ID:** 89831

**Address:** 9 Blackwood Crescent, Dampier WA

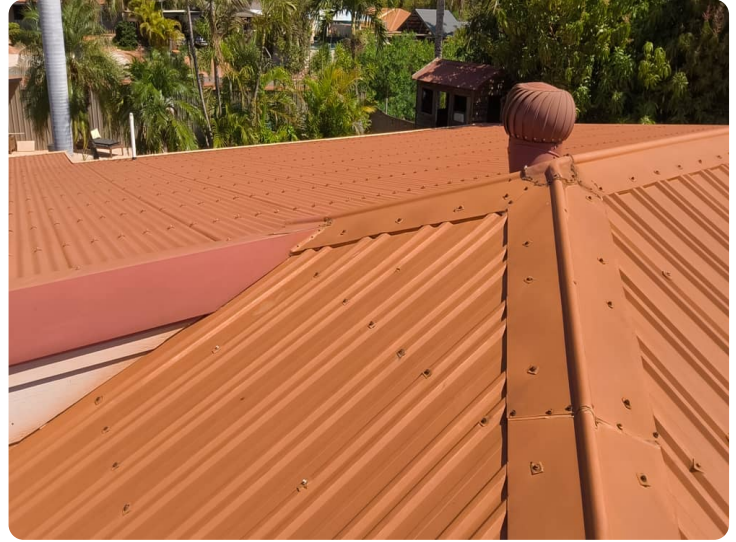
The roof covering is constructed of metal. The condition of the roof covering is fair in relation to its age and will require ongoing maintenance.

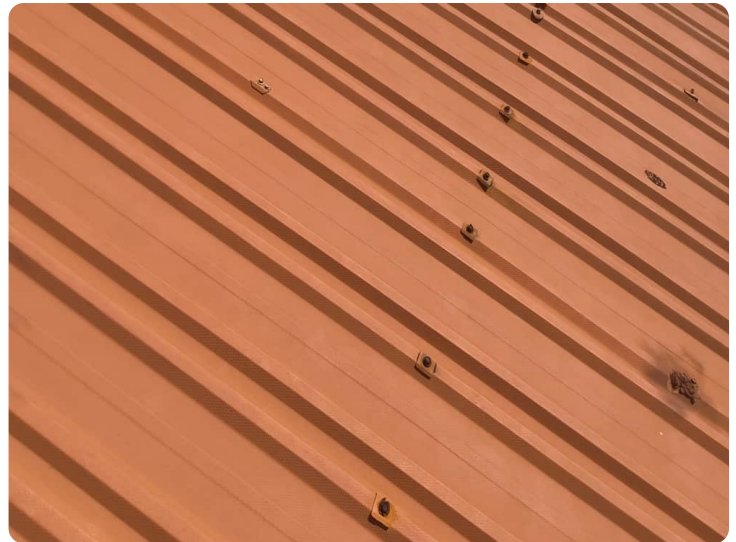
### 1.1 Metal roof rusting fixings

There are rusting fixings which need to be replaced to minimise potential rust transfer to the roof sheets and extend the life of adjacent metal sheets.

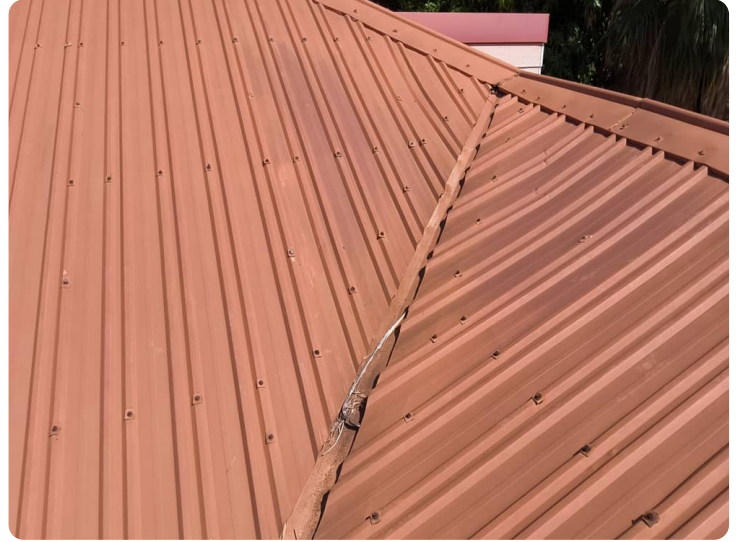
The valleys are constructed of metal and are unpainted. The condition of the valleys is satisfactory in relation to their age and will require normal ongoing maintenance. The valleys need to be cleared of debris.

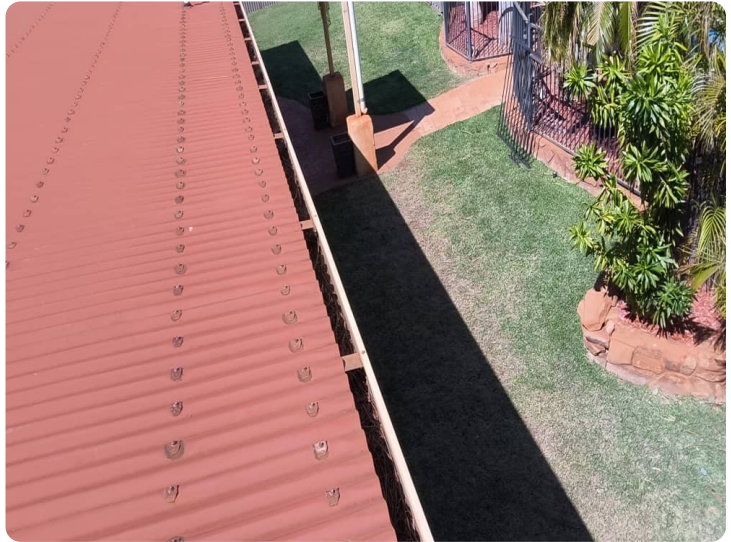
The gutters are constructed of metal and they have a colorbond covering. The condition of the gutters is satisfactory in relation to their age and will require normal ongoing maintenance. The gutters need to be cleared of debris.

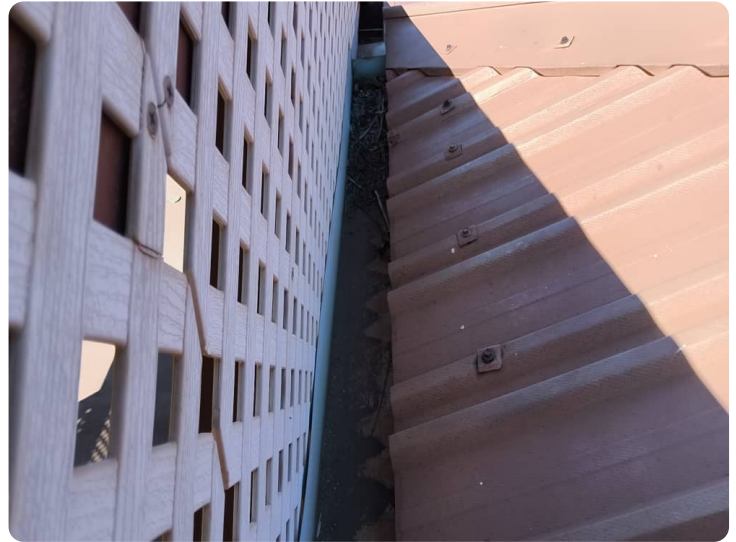
The box gutters are constructed of metal and they have a colorbond covering. The condition of the box gutters is satisfactory in relation to their age and will require normal ongoing maintenance. The box gutters need to be cleared of debris.

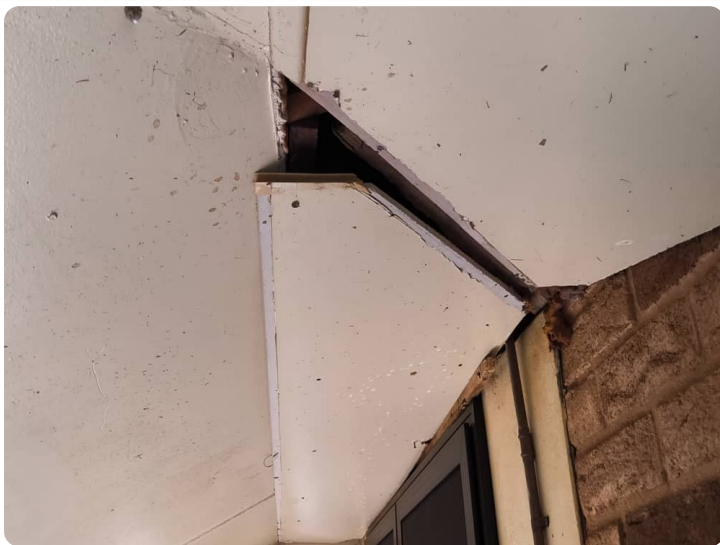
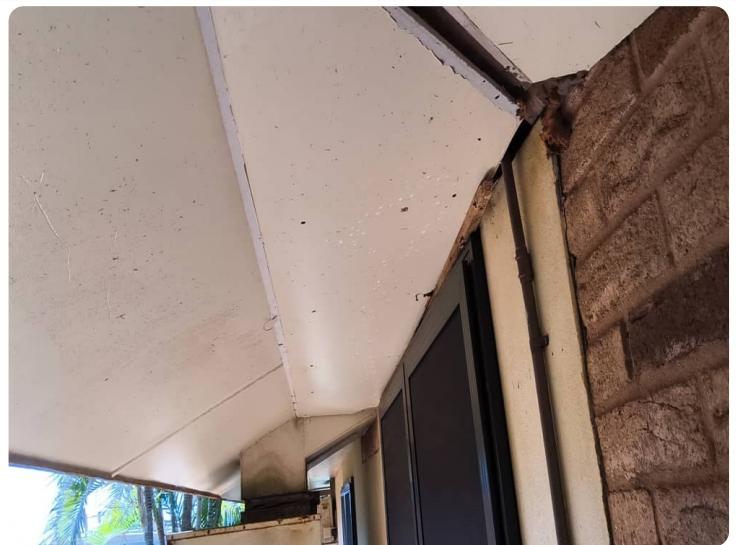
### 9.1 Eaves damaged

The eave is damaged and requires repairs or replacement. The material should be tested where required and then a remediation plan established.

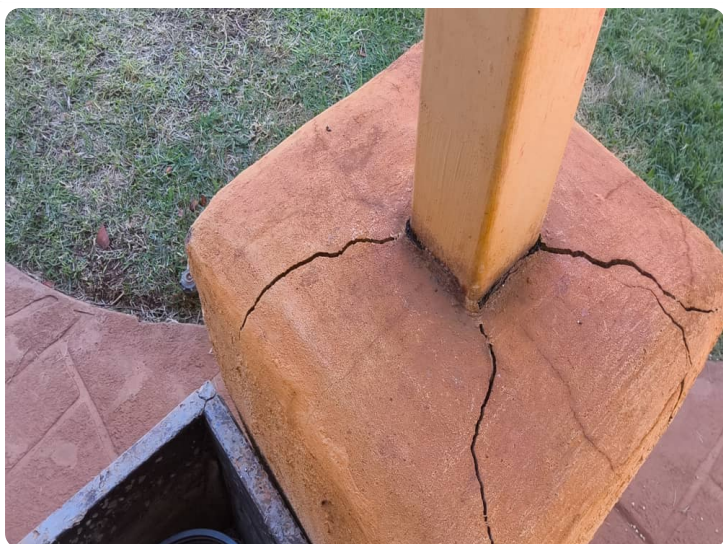
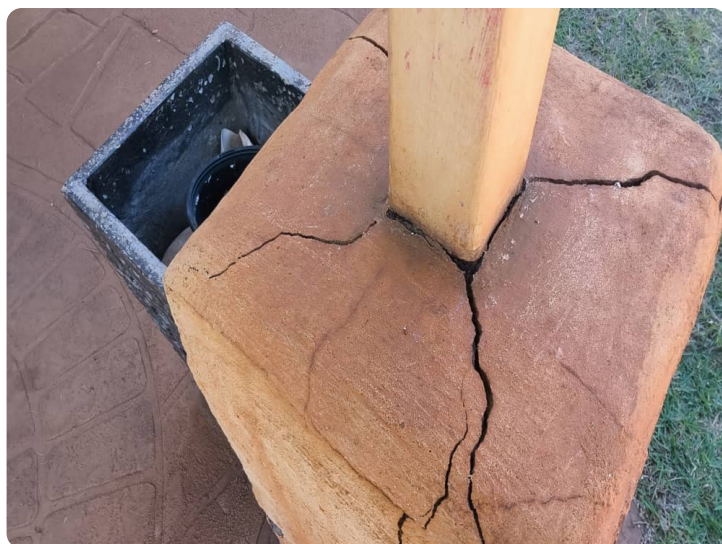
### 24.1 Metal posts rusted - minor

Metal support posts are rusted and require maintenance to prolong their life. Photos showing visible cracks, these are not of structural issues, it is only result from poor rendering job, cosmetic only.

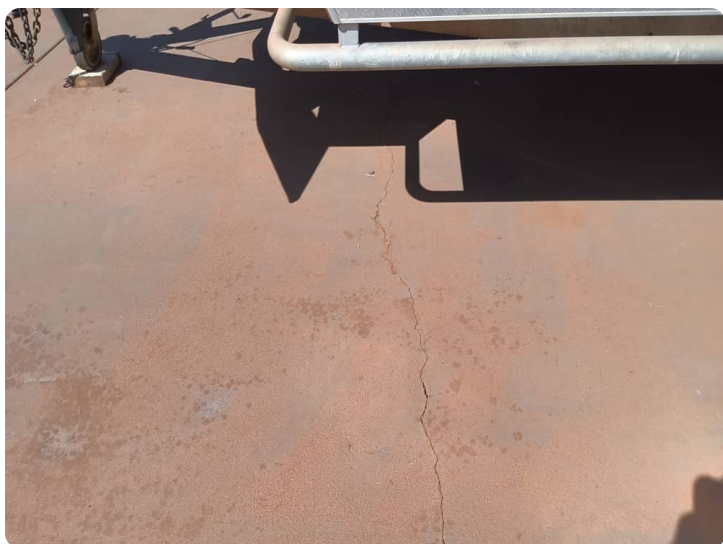
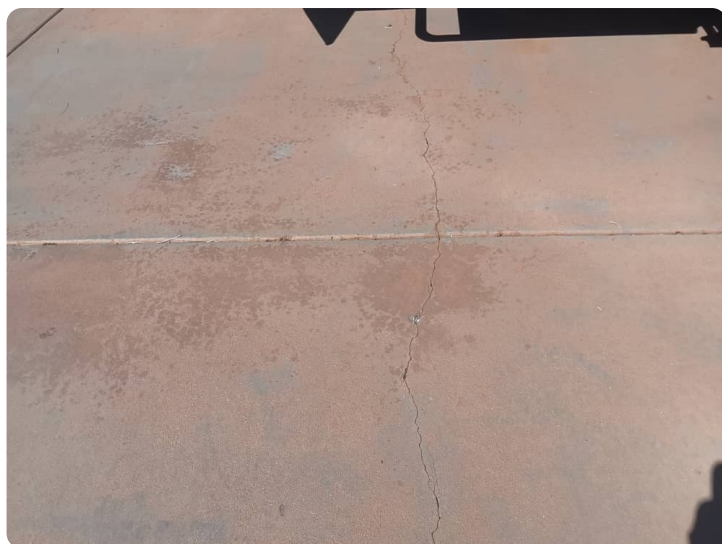
### 29.1 Concrete cracking - minor

Cracking was noted to the concrete driveway. This is not of a structural concern. Cracks should be filled to avoid further deterioration.
