Pre-Purchase Timber Pest Inspection Report

9 Blackwood Crescent, Dampier WA, Australia

**Pre-Purchase Timber Pest Inspection - Pre-Purchase Timber Pest Inspection
(AS4349.3-2010)**

02 Sep 2025

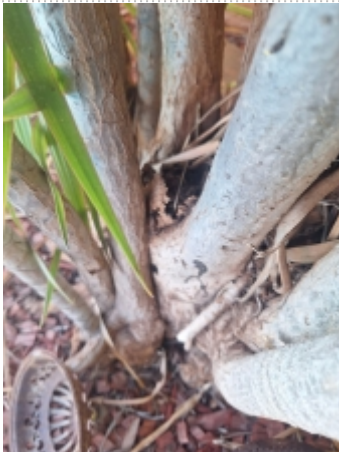
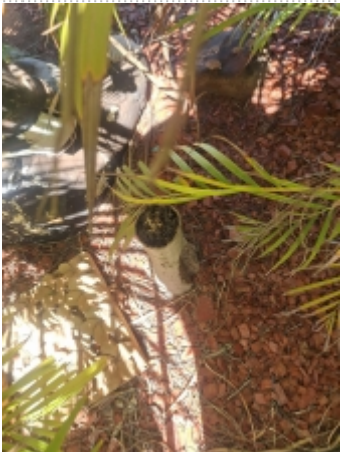
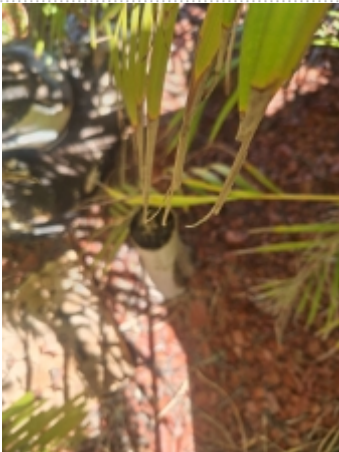
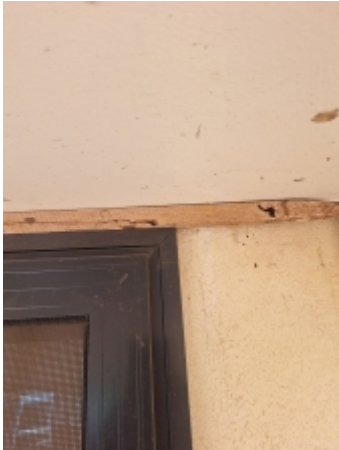
Location(s): termite damage found in trees and garden stake above window frame

Termite damage to trees and stake

Additional Comments: Due to no evidence of a previous termite management system and having termite history in yard i strongly recommend as a preventative measure that a termite management system be installed at a cost of \$2320.00inc which would be completed in fipronil.
