Building inspection

Job ID: 91652

Address: 74 Falcon Parade, Nickol WA

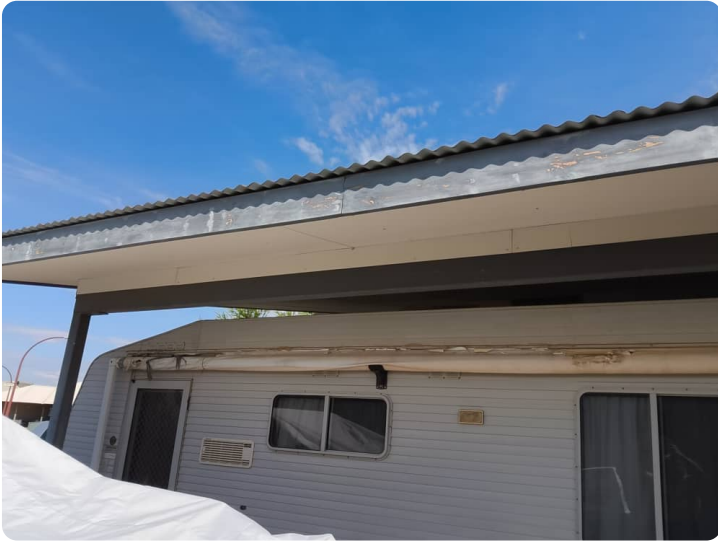
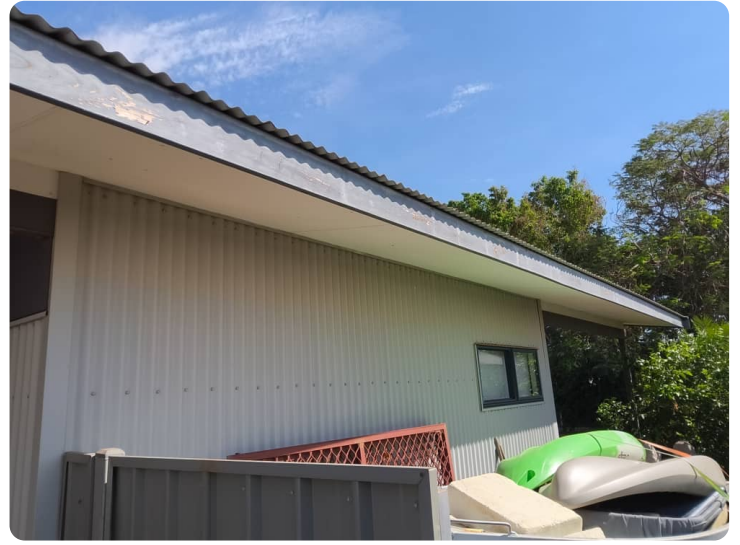
4. Fascia

The fascia are constructed of timber and they are weathered. The condition of the fascia is fair in relation to its age and will require ongoing maintenance.

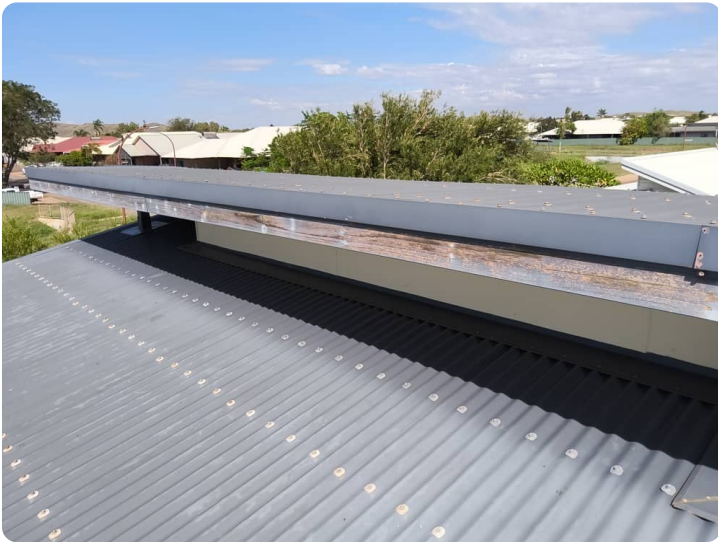
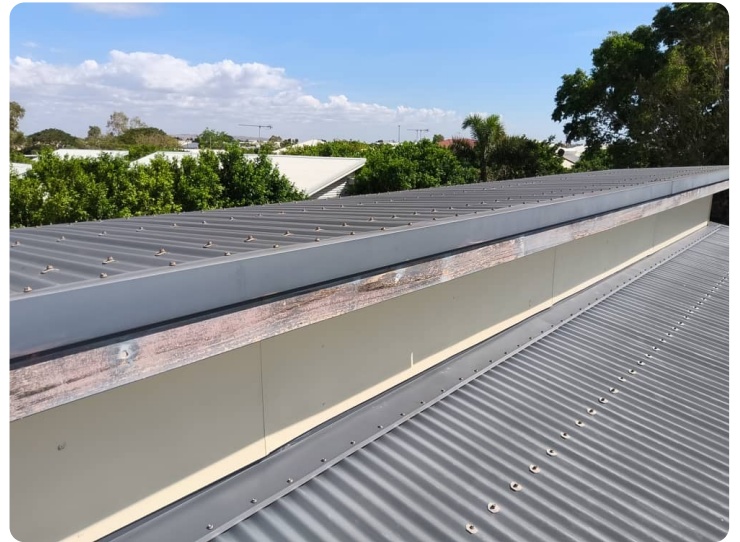
4.1 Fascia timber weathered

The timber fascia is weathered. Recommend sanding, sealing and painting to prolong lifespan.

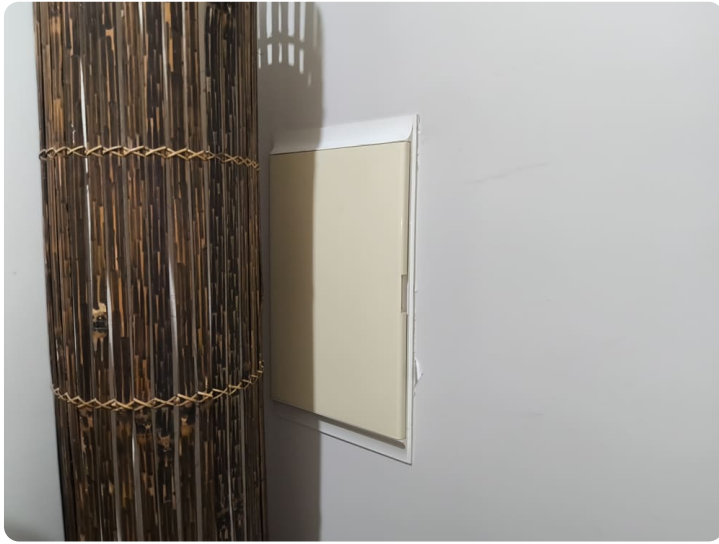
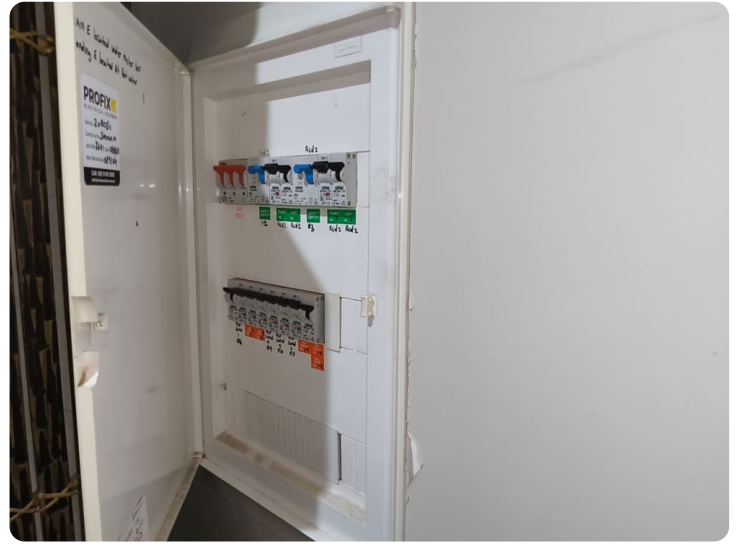
15. Residual Current Devices

There were two Residual Current Devices (RCD)(s) noted in the meter box or sub meter box. The RCD(s) were not tested. It is suggested that an Electrical Compliance Certificate be obtained in relation to the RCD(s).

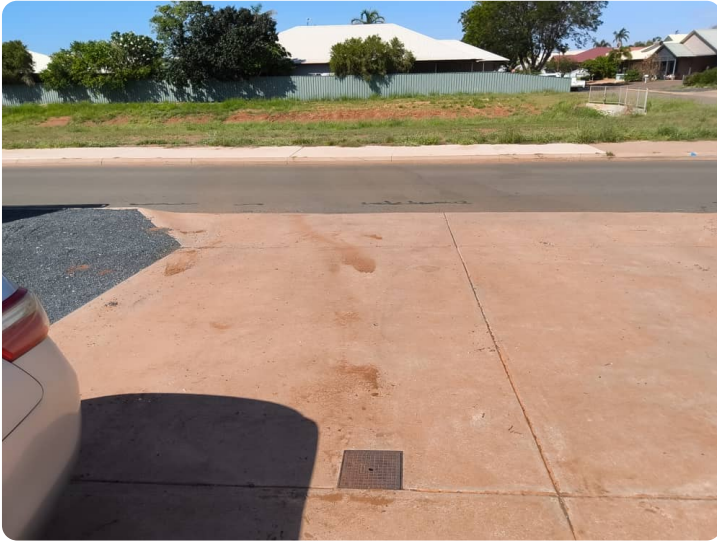
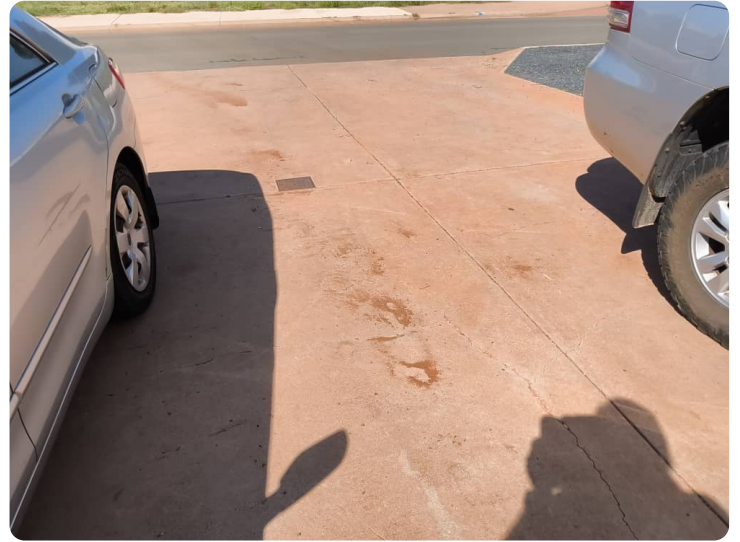
19. Driveway

The driveway and cross over is constructed of concrete. The condition of the driveway is fair in relation to its age and will require ongoing maintenance.

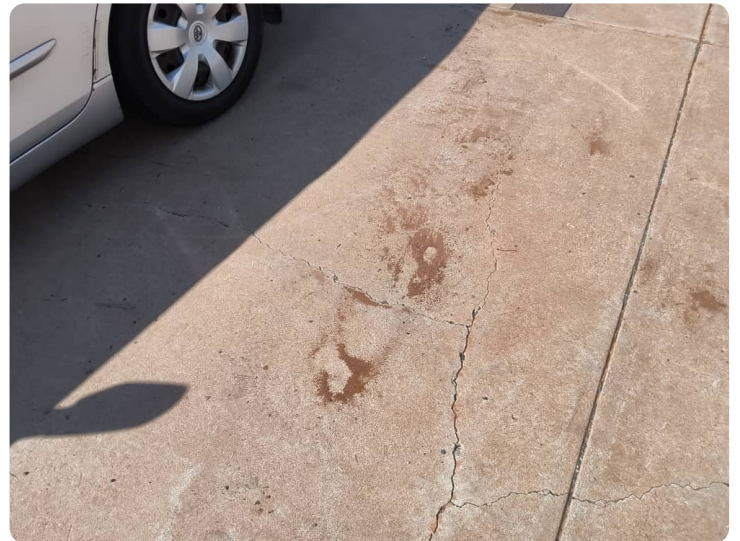
19.1 Concrete cracking - minor

Cracking was noted to the concrete driveway. This is not of a structural concern. Cracks should be filled to avoid further deterioration.

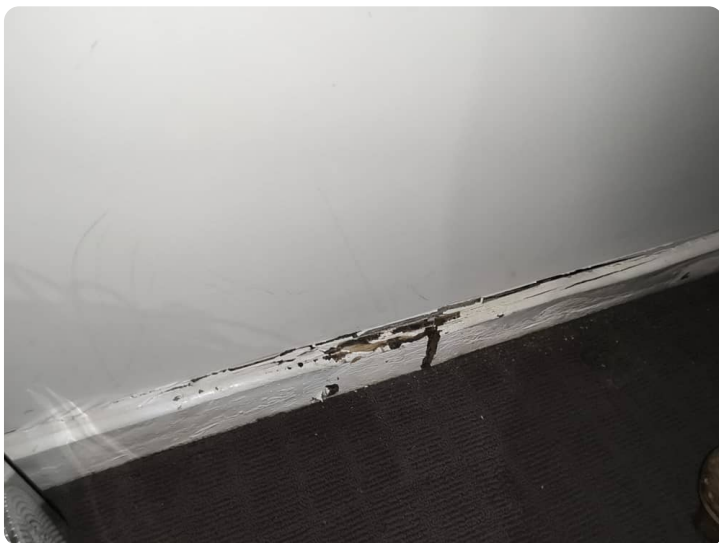
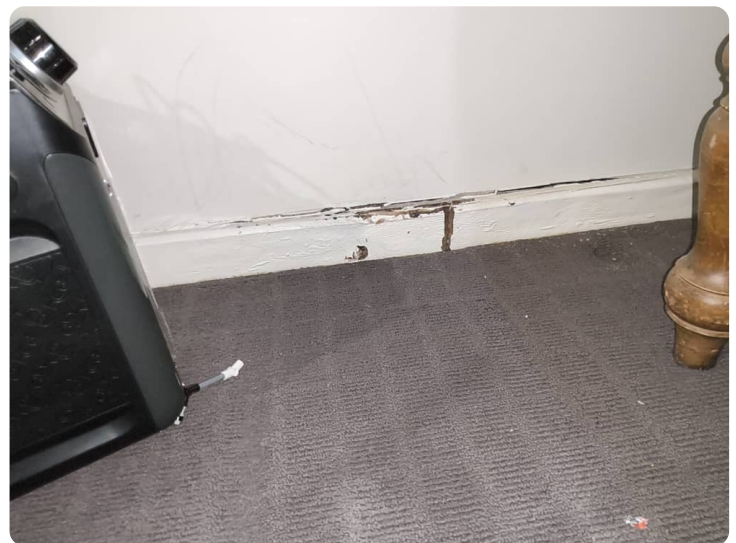
27.1 Ensuite water egress

As per the images provided the internal wall broadly adjacent to the shower recess on the main bathroom has water damage. In the majority of cases this relates to a break down in the grout or silicone seals allowing water to escape into the wall and spread via capillary action. Often this can be resolved by regrouting and sealing the shower. On occasions the issues relates to a plumbing failure or a failure of the waterproofing system. This can only be checked via pressure test conducted by a Plumbing Contractor or an invasive inspection of the waterproofing membrane both of which are outside the scope of our inspection.

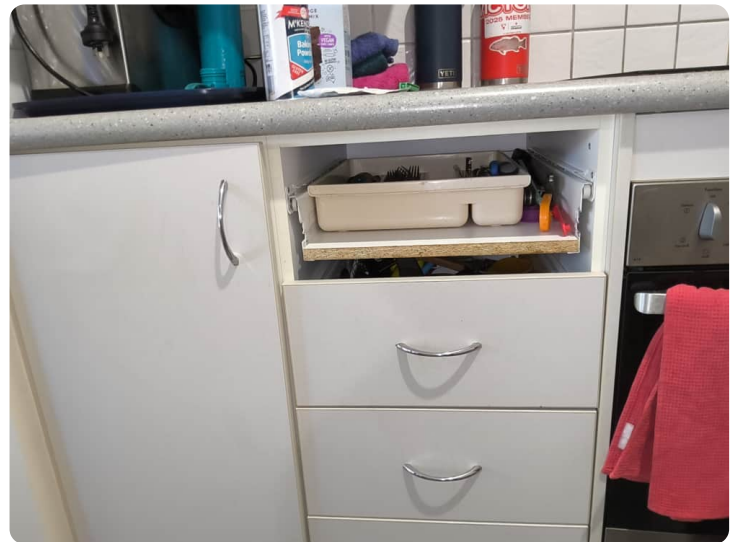
32.1 Cabinet draw front missing

As per the images the cabinet draw front was missing at the time of the inspection.
