Pre-Purchase Timber Pest Inspection Report

In Accordance with AS 4349.3

74 Falcon Parade, Nickol WA, Australia

24 Apr 2026

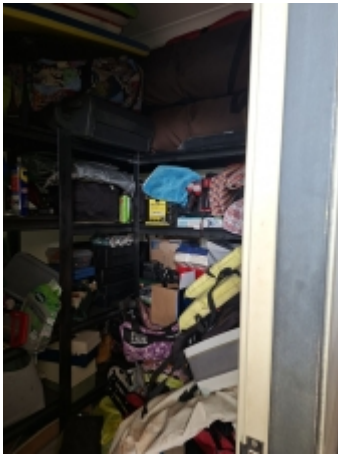
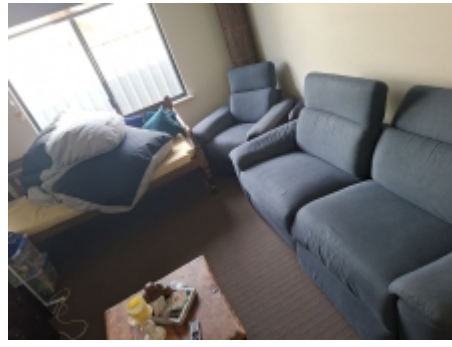
Stored items and furniture significantly hindered visual inspection particularly to carpet smooth edge.

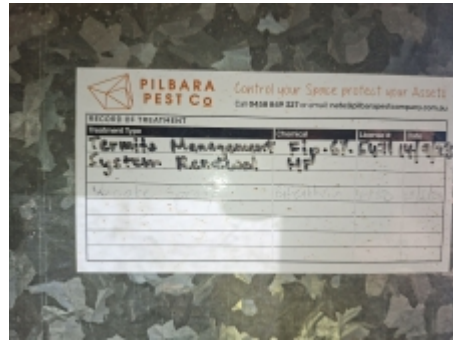
Description of the evidence found: Treatment sticker in meter box

Was a durable Notice found at the time of this inspection? Yes

Date of Treatment: (if known) 14 Sep 2023

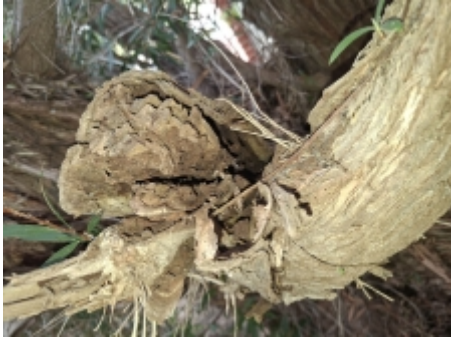
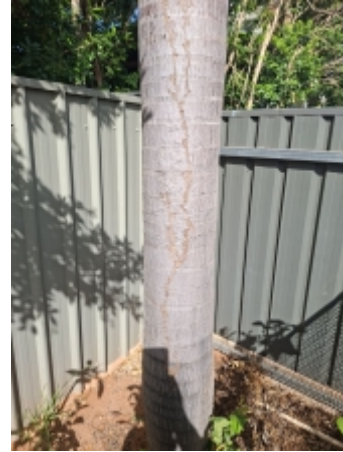
Location(s): Old evidence of termite damage found in the trees

Old evidence of termite damage found in the trees

A more invasive inspection is highly recommended to be carried out. This is outside the Scope of our Agreement for this Inspection.

It is strongly recommended that the full extent of any such activity and damage be fully understood through the engagement of a Licenced Builder, Structural Engineer or appropriately qualified expert.
