# **Houspect**

### **Pre purchase inspection**

**Job ID:** 93039

**Address:** 44 Hunt Way, Bulgarra WA 6714

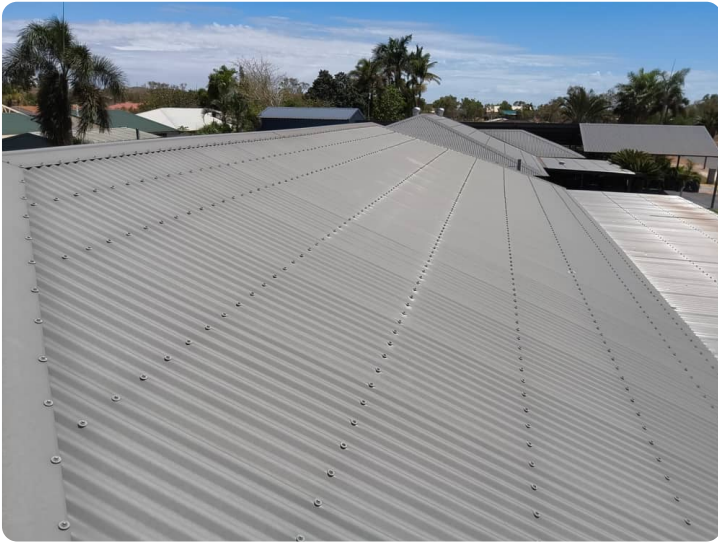
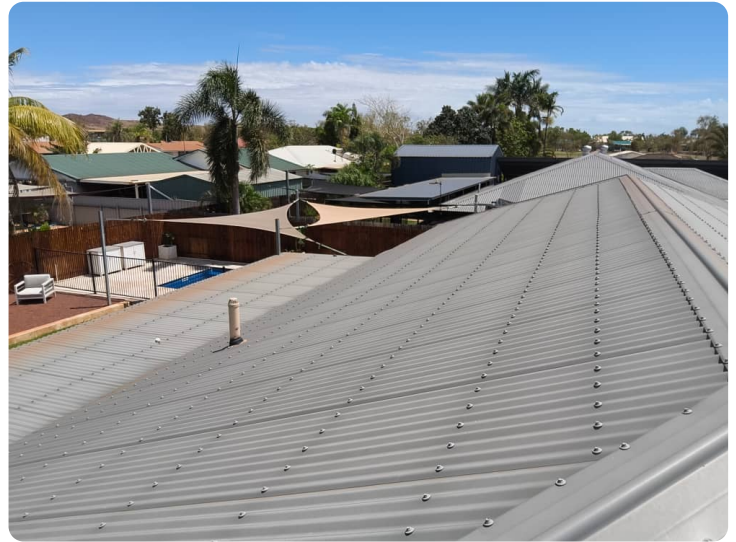
## 1. Roof covering

The roof covering is constructed of colorbond. The condition of the roof covering is satisfactory in relation to its age and will require normal ongoing maintenance.

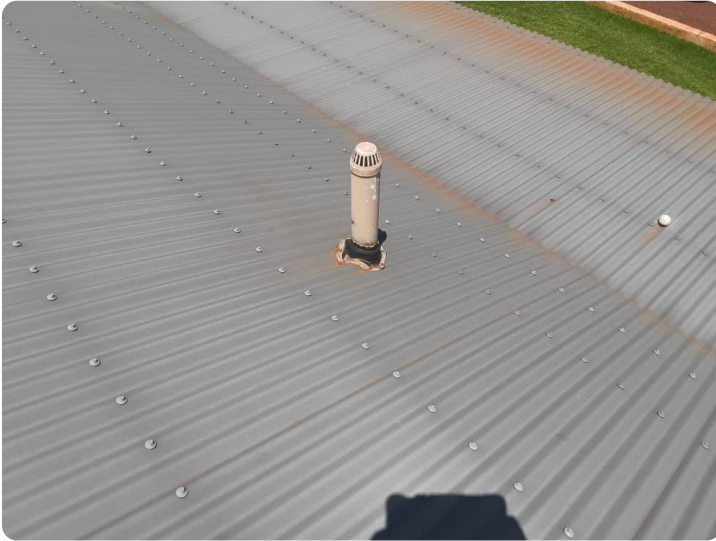
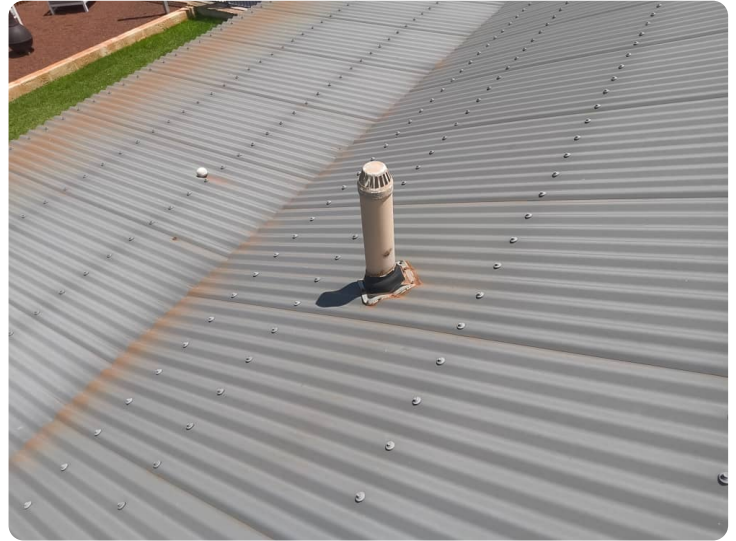
### 3. Flashings

The flashings are covered with a variety of finishes and are constructed of a mixture of materials. The condition of the flashings is satisfactory in relation to their age and will require normal ongoing maintenance.

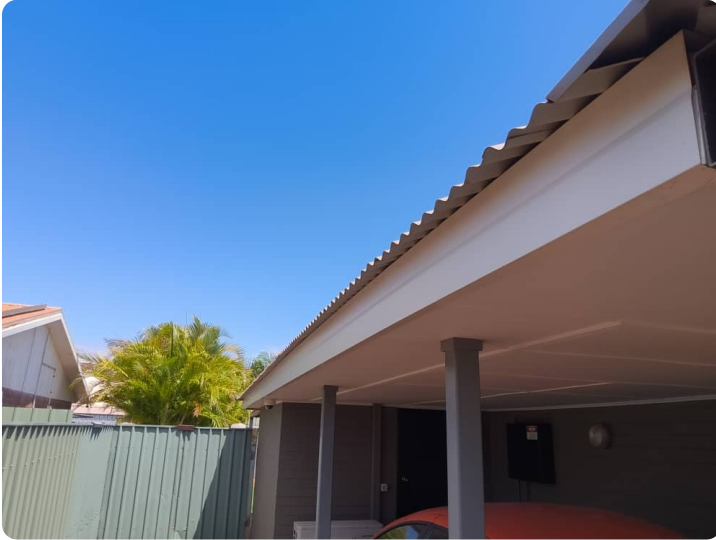
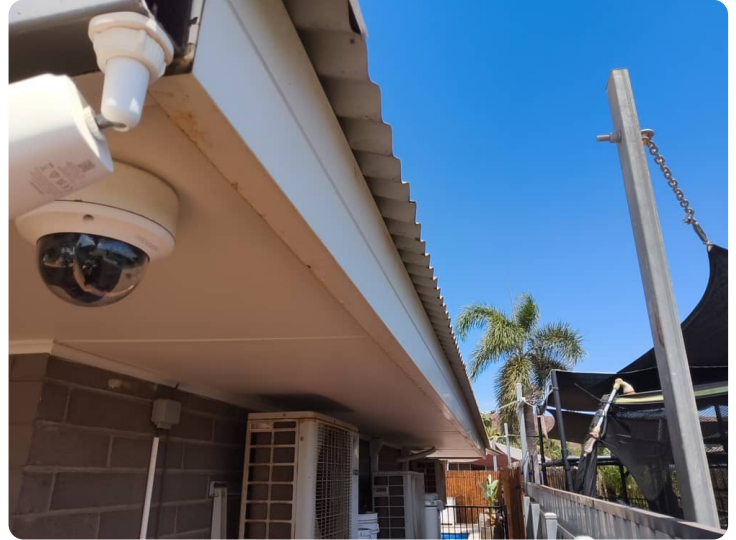
#### 4. Fascia

The fascia are constructed of metal and they are painted. The condition of the fascia is satisfactory in relation to their age and will require normal ongoing maintenance.

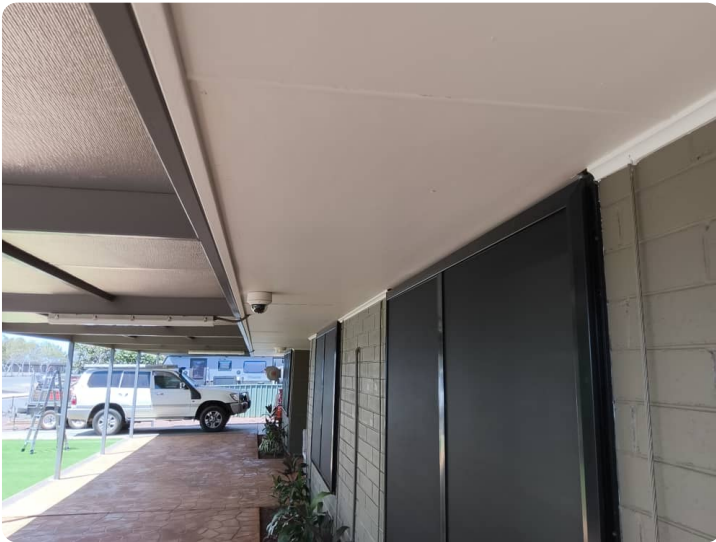
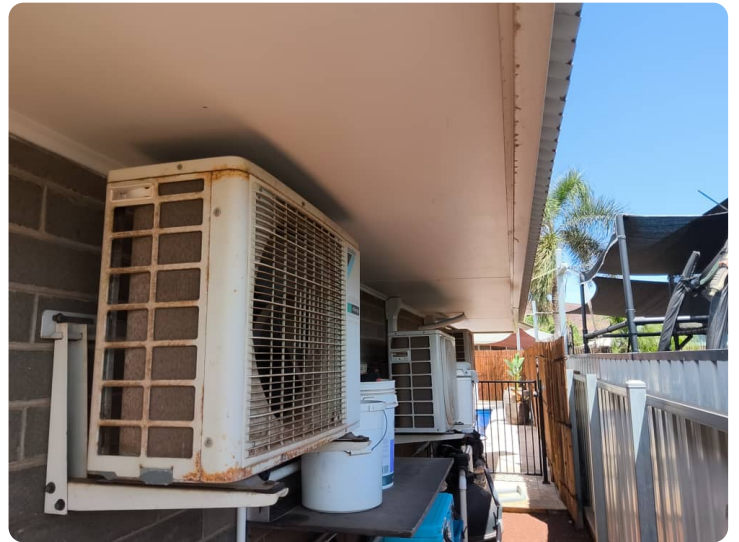
## 5. Eaves

The eaves are boxed and constructed of painted fibre cement. The condition of the eaves is satisfactory in relation to their age and will require normal ongoing maintenance. Please note that some of the building material utilised on or within the building may or may not contain asbestos. The Australian Government has indicated that asbestos can only be correctly identified through laboratory testing. The material on this building site may not pose a concern in the current static state if maintained but for any future works the material should be tested and appropriate measures used for asbestos handling if the material is subsequently found to contain asbestos.

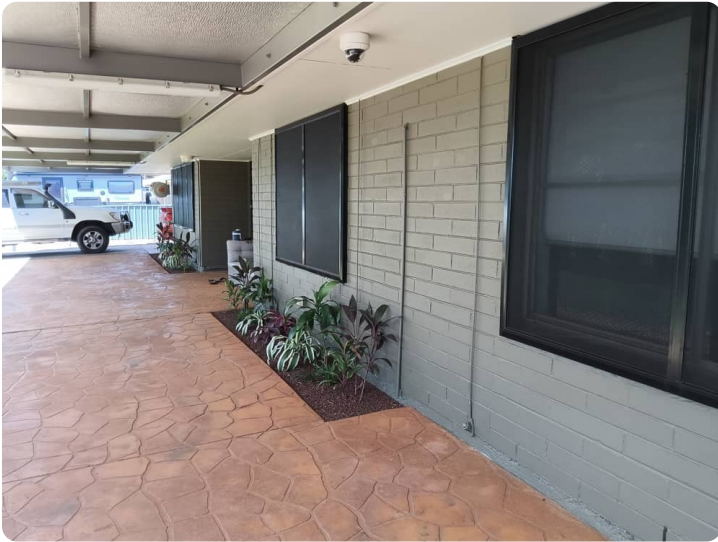
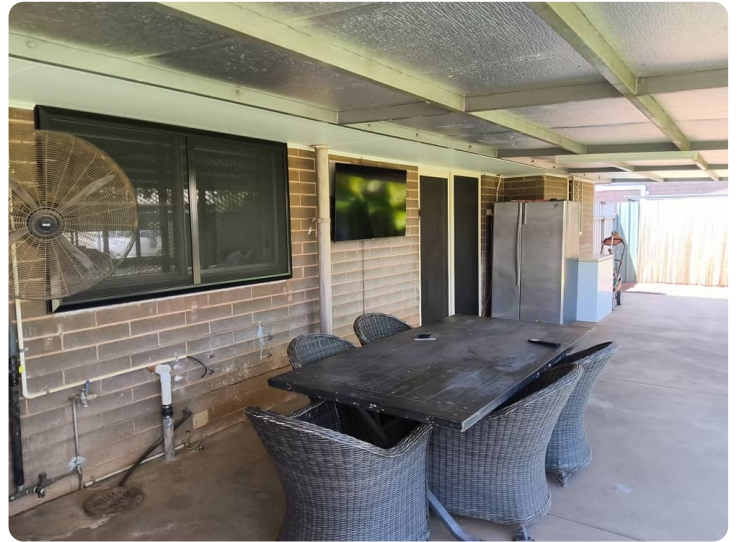
## 6. External walls

The external walls are constructed of painted brick. The condition of the walls generally is satisfactory in relation to their age and will require normal ongoing maintenance.

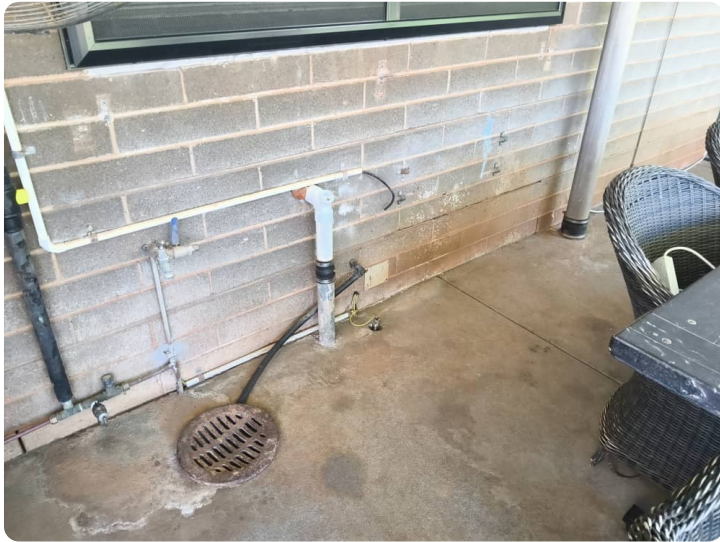
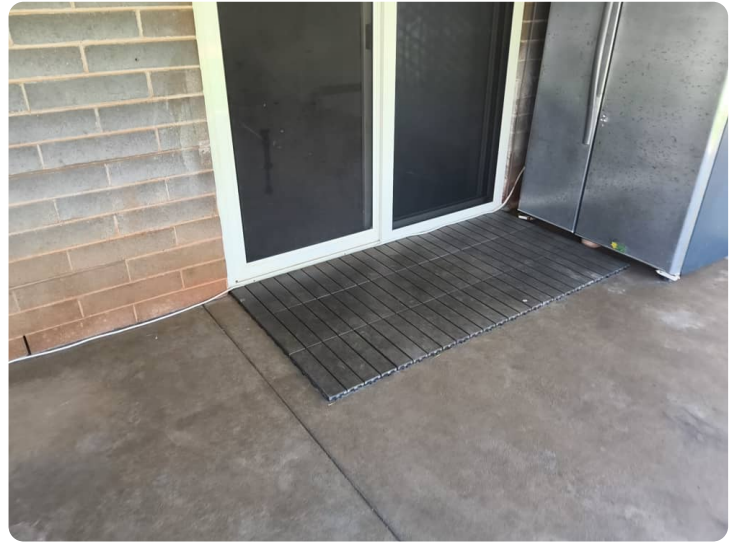
## 7. Footings

The footings are below ground and cannot be seen. The condition of the footings cannot be determined.

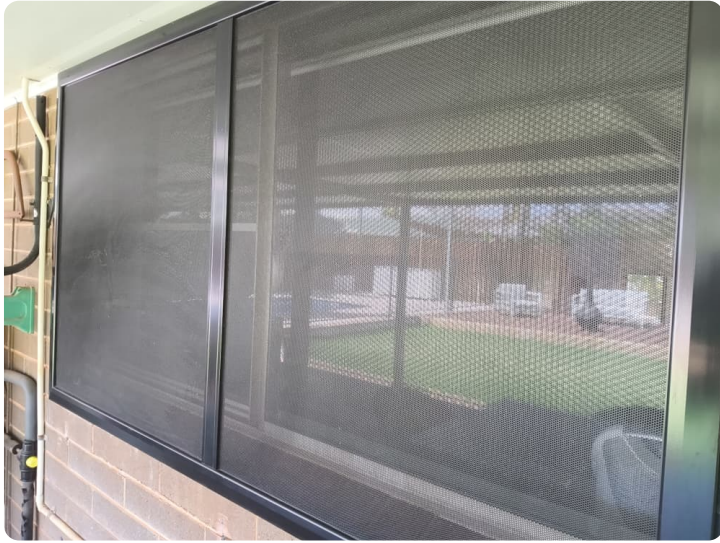
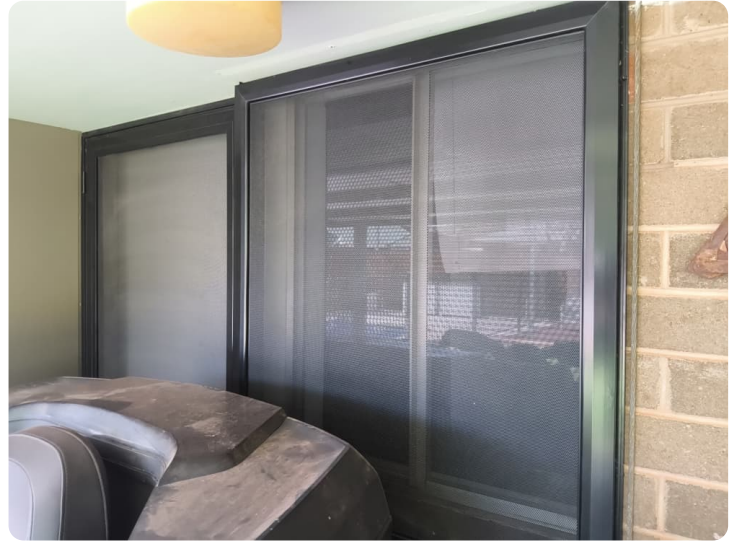
## 8. Windows and window frames

The window and window frames are primarily constructed of aluminium. The condition of the window and window frames is generally satisfactory in relation to its age and will require normal ongoing maintenance.

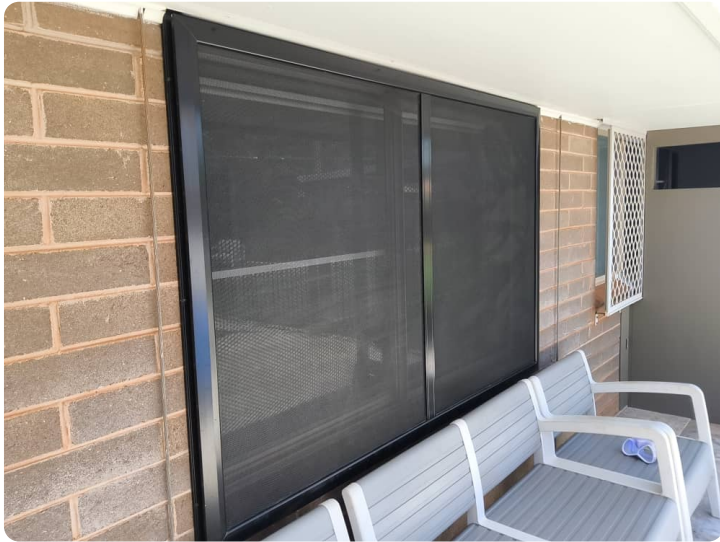
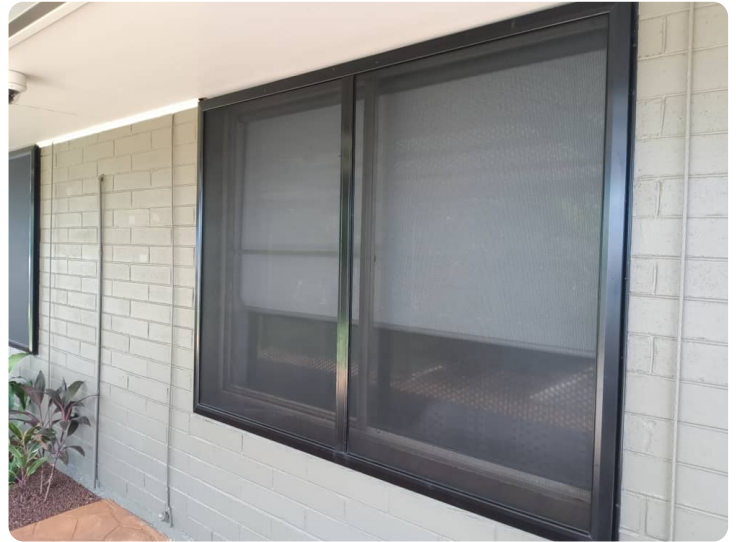
## 9. Window fly screens

Fly screens have been installed to all of the windows. The condition of the window fly screens is generally satisfactory in relation to its age and will require normal ongoing maintenance.

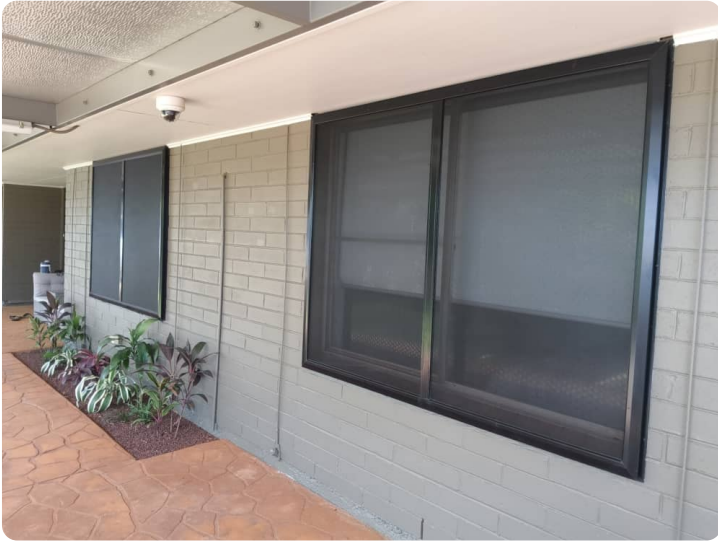
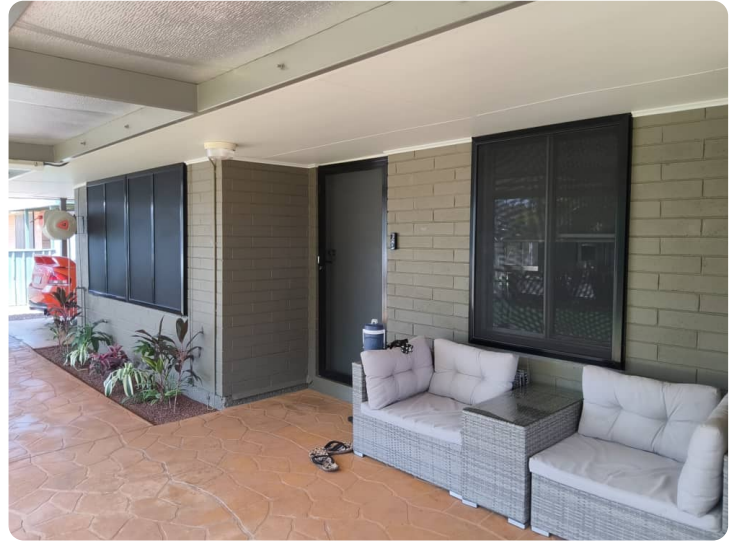
## 10. Cyclone screens

Cyclone screens have been installed to all of the windows. The condition of the cyclone screens is satisfactory in relation to its age and will require normal ongoing maintenance. The cyclone screens appear to be compliant with local requirements.

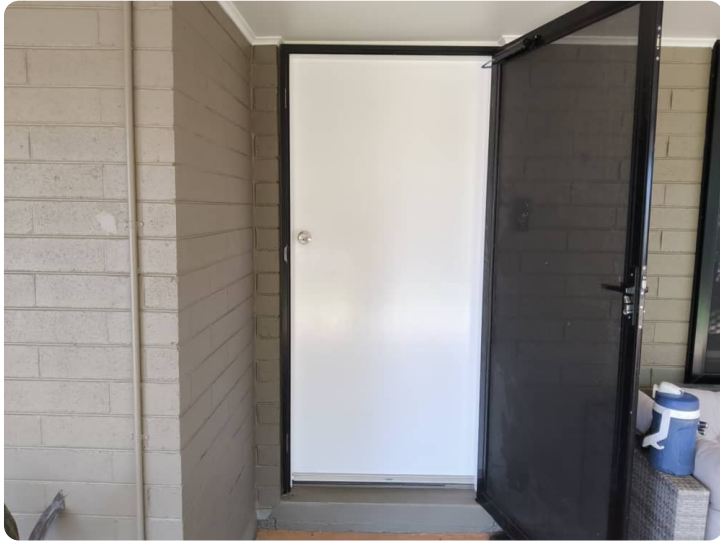
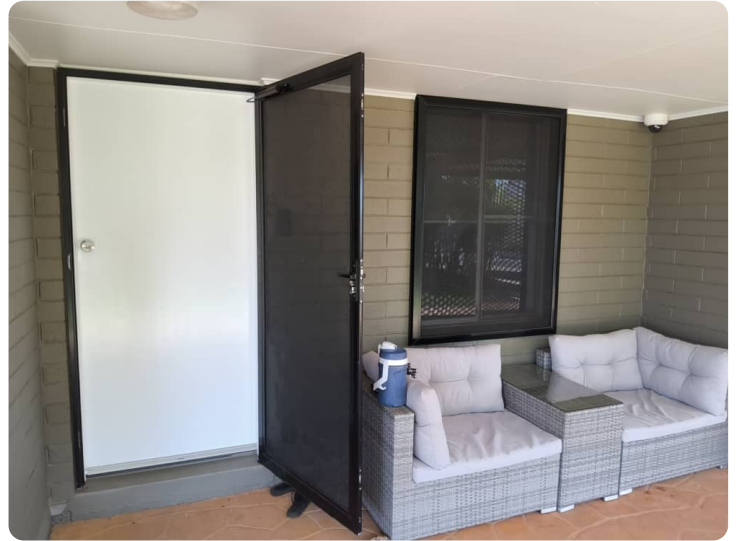
## 11. Front door

The front door is constructed of solid timber. The condition of the front door is satisfactory in relation to its age and will require normal ongoing maintenance. Deadlocks have not been installed. A security screen door has been fitted.

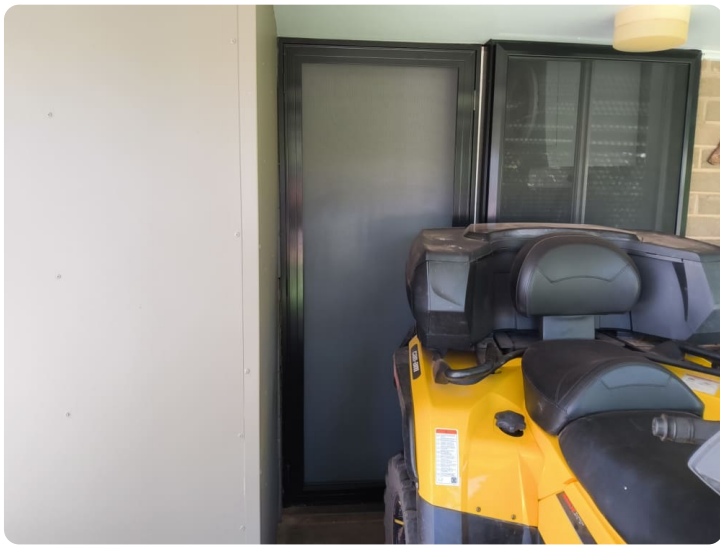
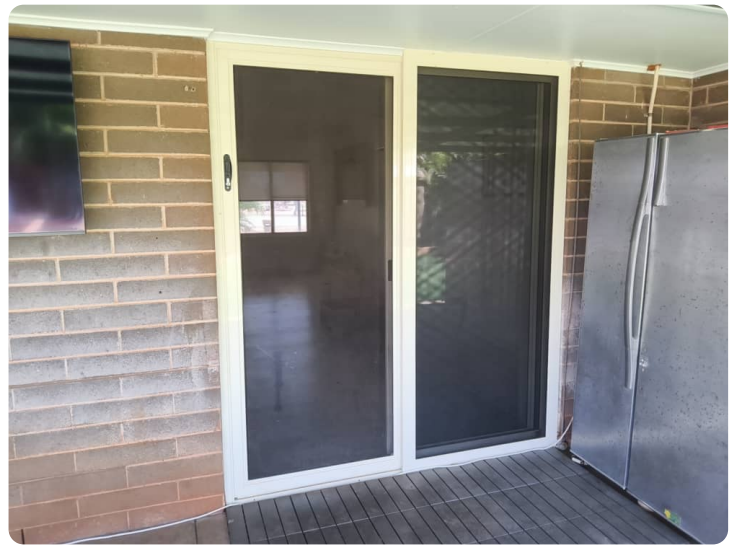
## 12. Other external doors

Other external doors are constructed of a variety of materials. The condition of the other external doors is satisfactory in relation to its age and will require normal ongoing maintenance. Current Building Codes require that glass in windows and doors in close proximity to the floor must be safety glass to minimise personal injury in the case of breakage. Houses built prior to the 1980(s) did not have this requirement. There is no current requirement to retrospectively remediate however it is suggested that consideration be given to upgrading where applicable.

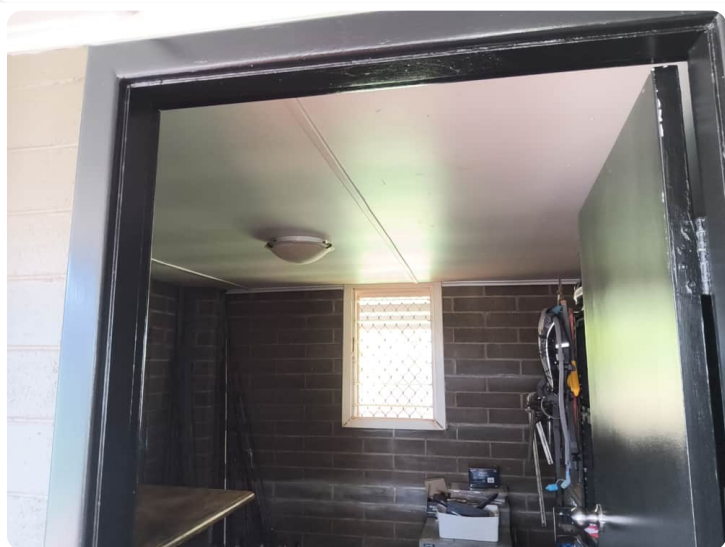
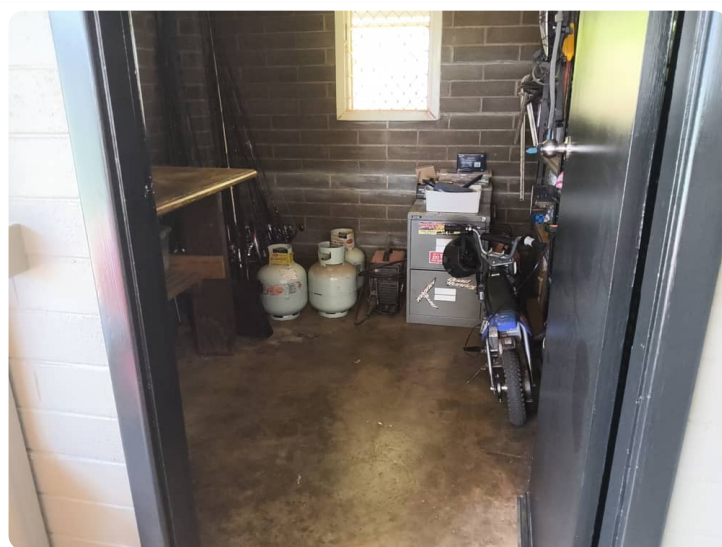
### 13. Storeroom 1

An external storeroom for the property is located adjacent and under the main roof of the building. The condition of the storeroom is satisfactory in relation to its age and will require normal ongoing maintenance. Access and visibility of the area was restricted by stored items. Please note that some of the building material utilised on or within the building may or may not contain asbestos. The Australian Government has indicated that asbestos can only be correctly identified through laboratory testing. The material on this building site may not pose a concern in the current static state if maintained but for any future works the material should be tested and appropriate measures used for asbestos handling if the material is subsequently found to contain asbestos.

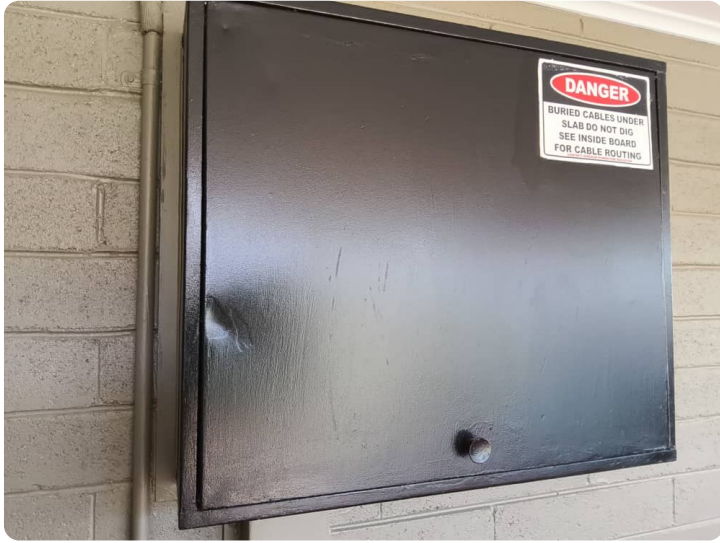
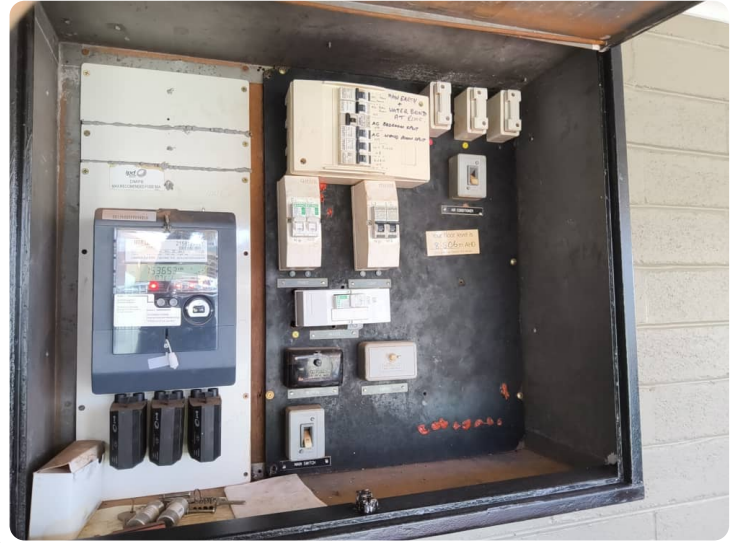
### 15. Residual Current Devices

There were multiple Residual Current Devices (RCD)(s) noted in the meter box or sub meter box. The RCD(s) were not tested. It is suggested that an Electrical Compliance Certificate be obtained in relation to the RCD(s).

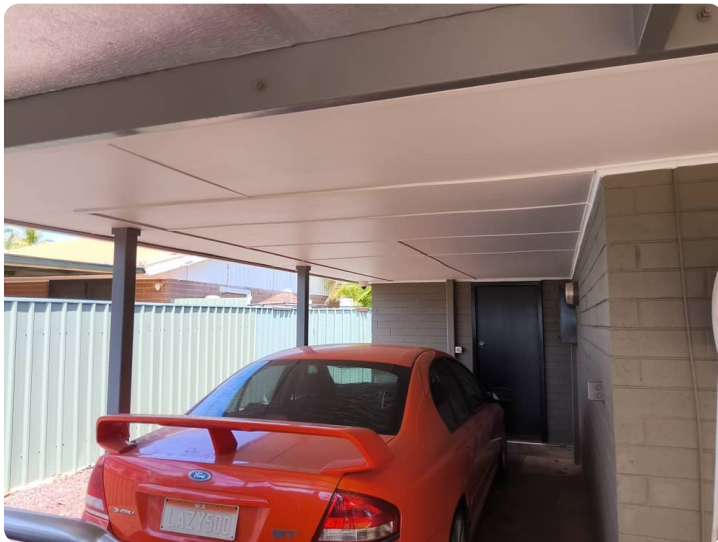
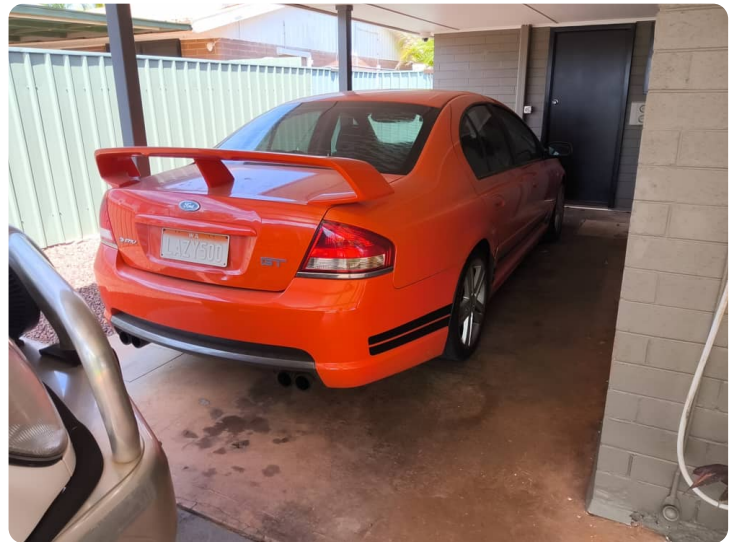
## 16. Carport or Garage (Primary)

There is a primary carport on the property constructed of same materials as the primary structure. The condition of the carport or garage is satisfactory in relation to its age and will require normal ongoing maintenance. Please note that some of the building material utilised on or within the building may or may not contain asbestos. The Australian Government has indicated that asbestos can only be correctly identified through laboratory testing. The material on this building site may not pose a concern in the current static state if maintained but for any future works the material should be tested and appropriate measures used for asbestos handling if the material is subsequently found to contain asbestos.

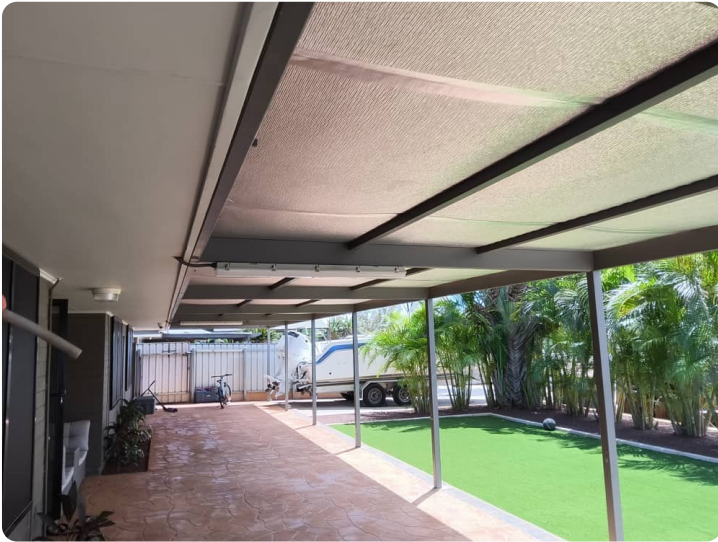
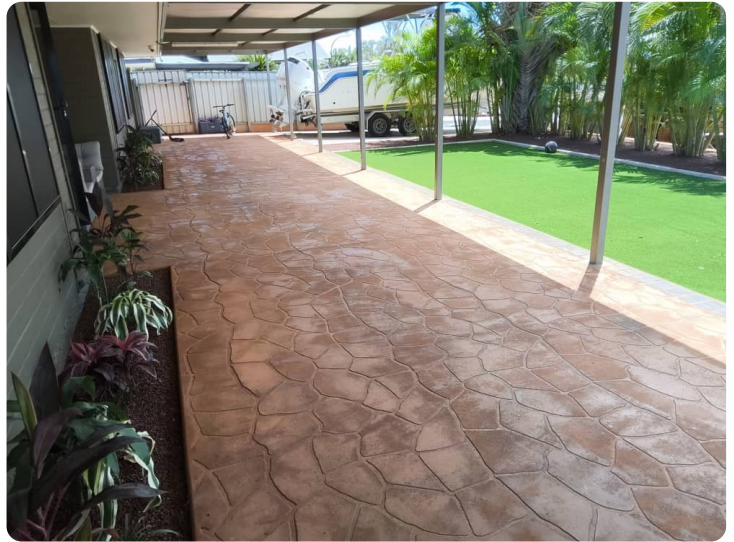
### 17. Veranda (Primary)

The primary veranda is constructed of metal. The condition of the veranda is satisfactory in relation to its age and will require normal ongoing maintenance.

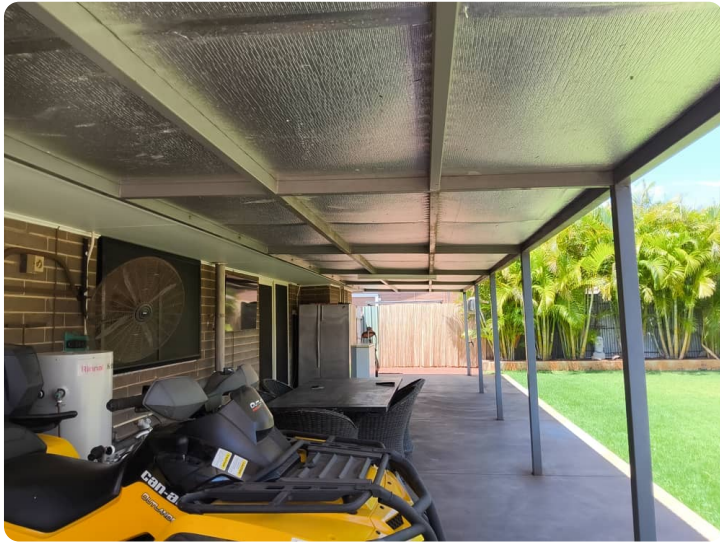
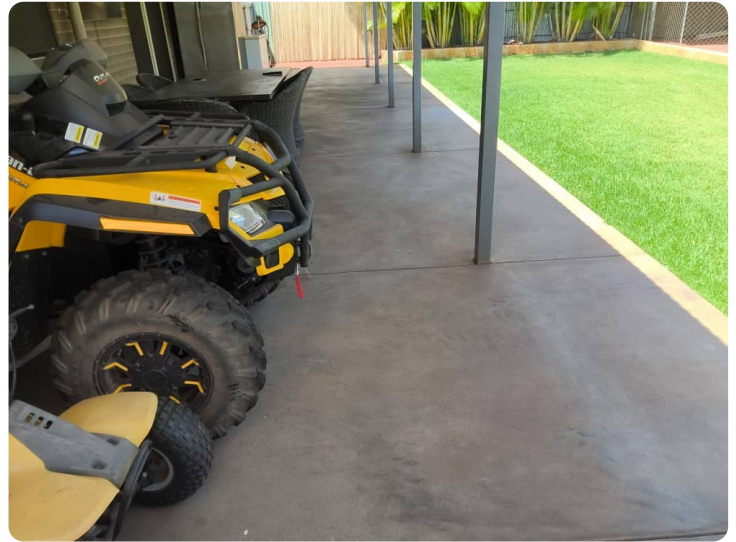
## 18. Patio

The primary patio is constructed of metal. The condition of the patio is satisfactory in relation to its age and will require normal ongoing maintenance.

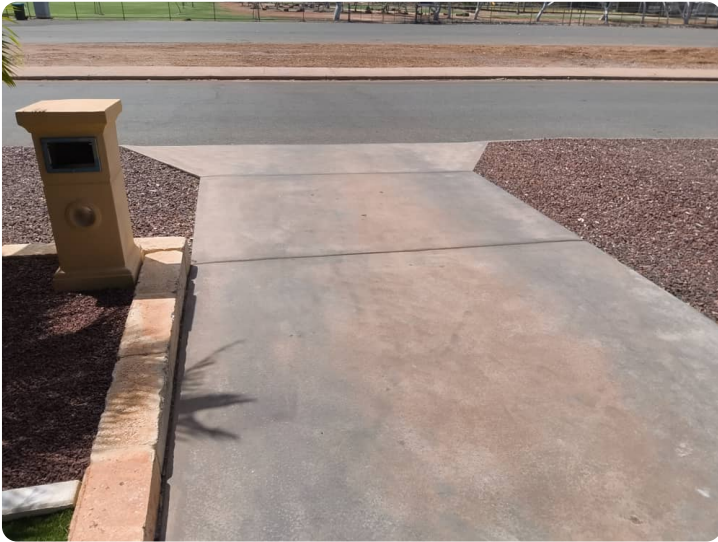
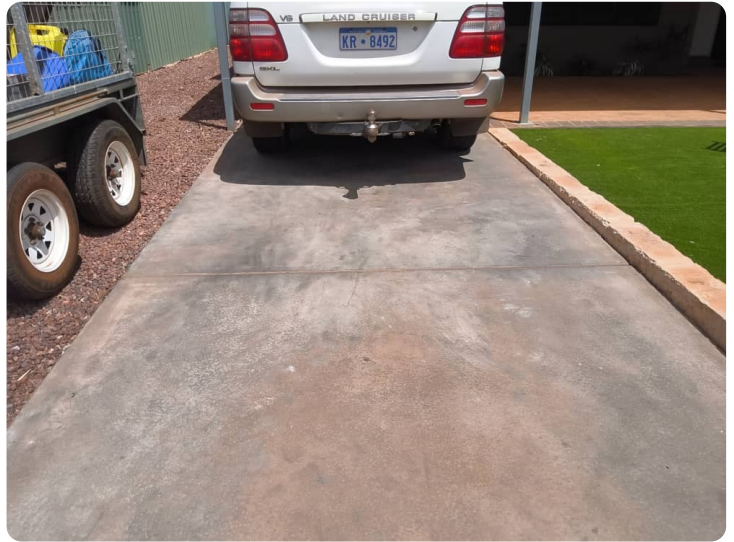
## 19. Driveway

The driveway and cross over is constructed of concrete. The condition of the driveway is satisfactory in relation to its age and will require normal ongoing maintenance.

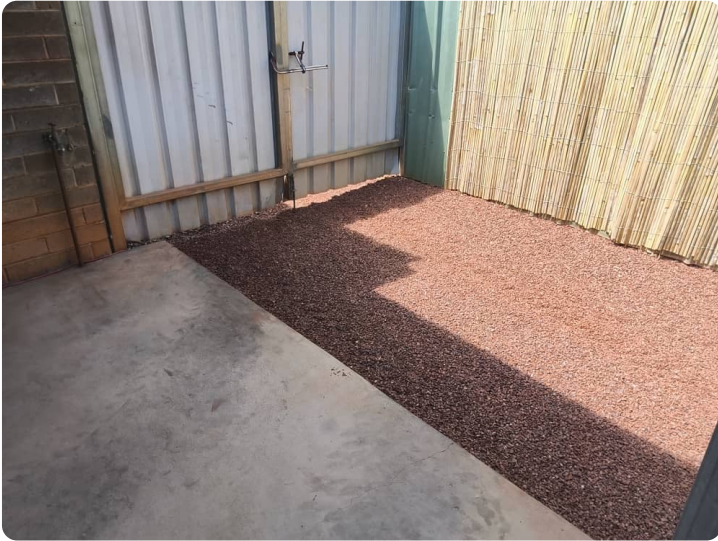
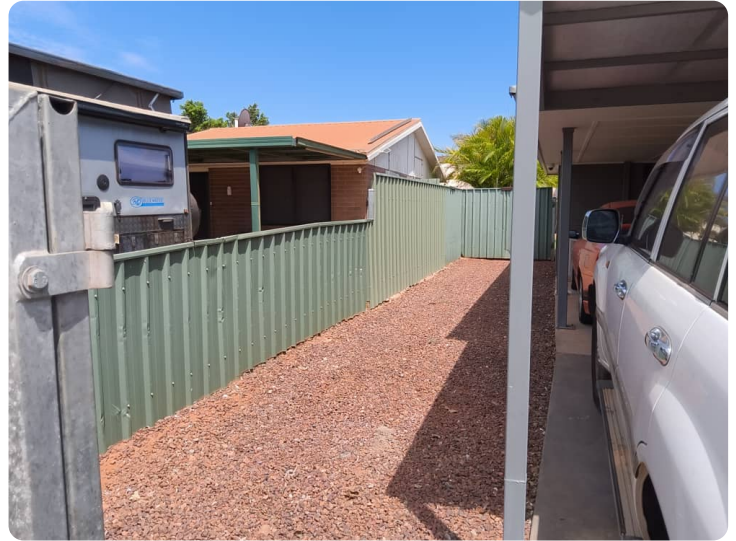
## 20. External walkways and paved areas

The external walkways and paved areas are constructed of a variety of materials. The condition of the external walkways and paved areas is satisfactory in relation to its age and will require normal ongoing maintenance.

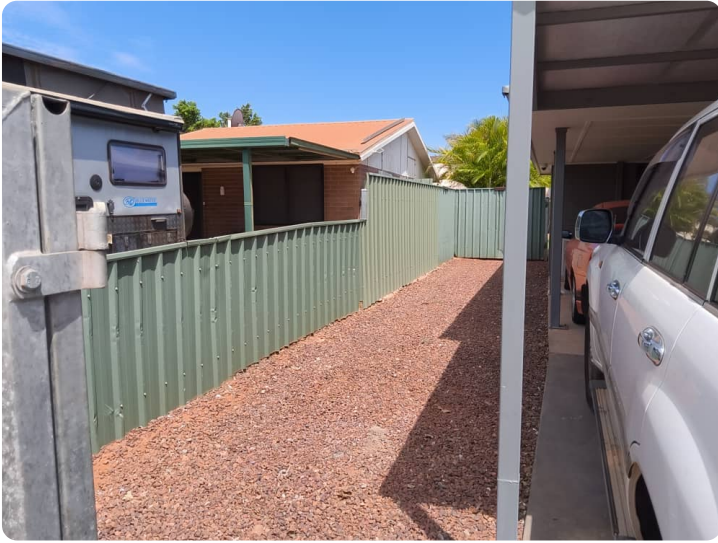
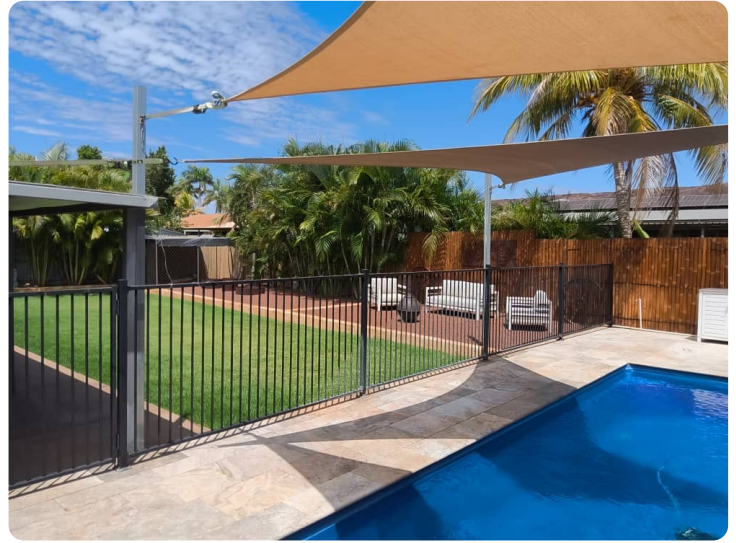
## 21. Fences - boundary

The boundary fences are constructed of metal. The condition of the boundary fence is satisfactory in relation to its age and will require normal ongoing maintenance. Some of the fences could not be viewed due to vegetation, stored items or secondary structures.

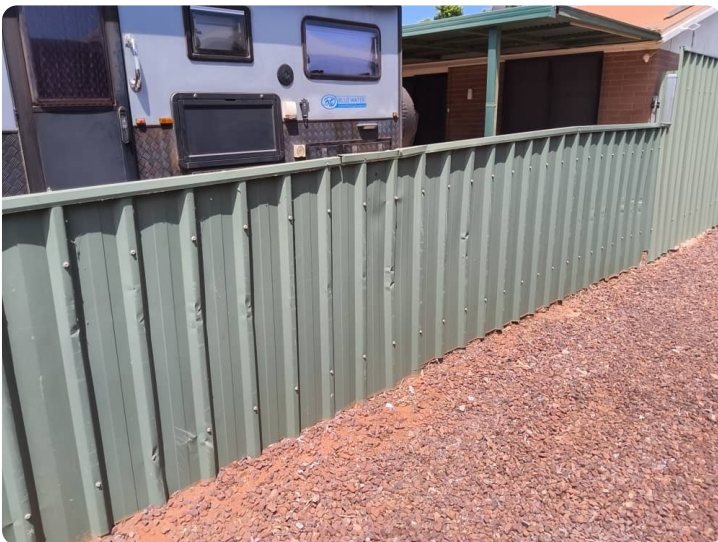
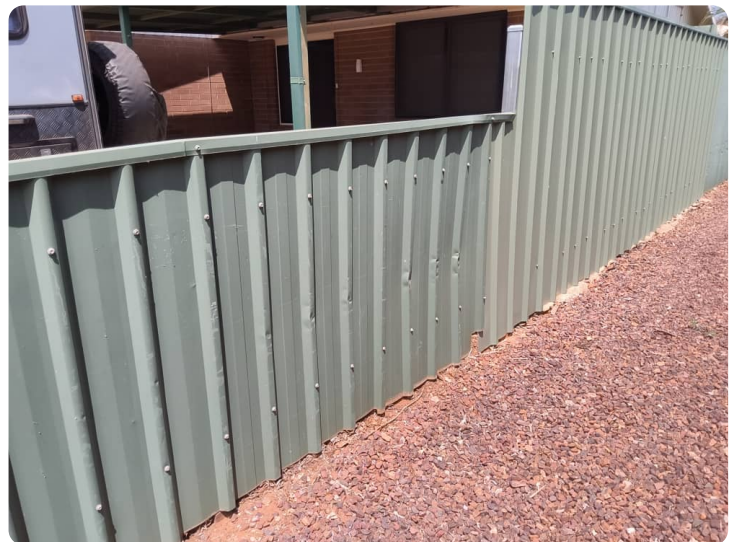
### 21.1 Metal cladding damage

There was loose, missing or damaged metal fence components that requires remediation.

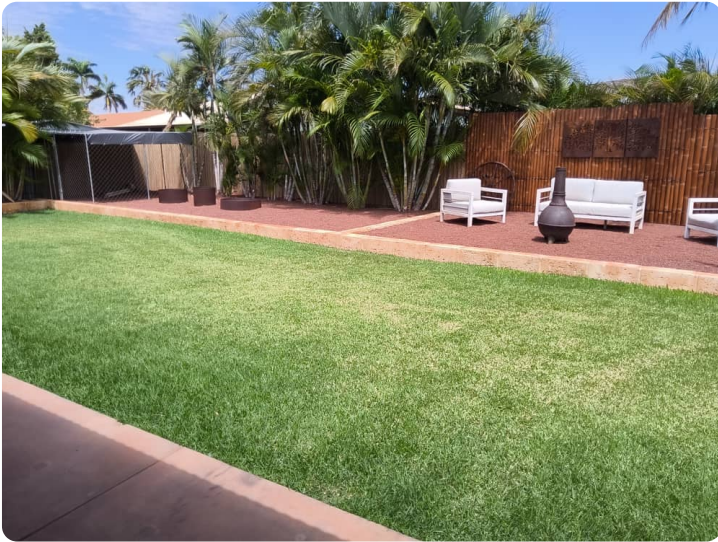
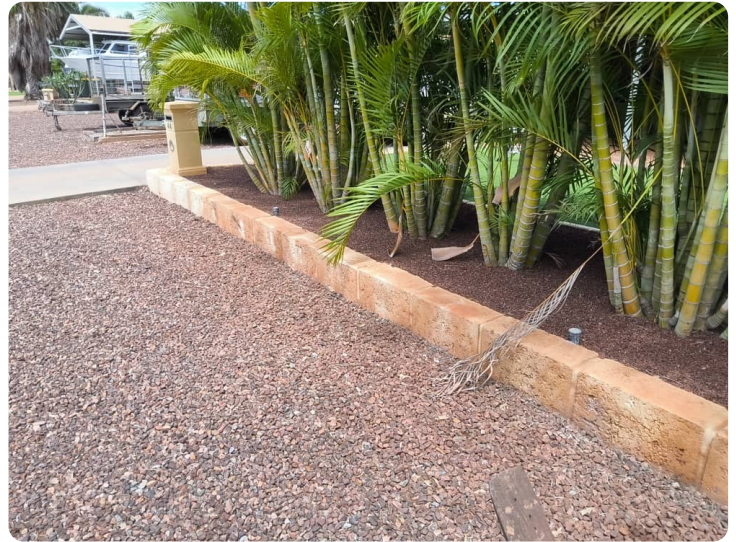
## 22. Retaining walls

The retaining walls are constructed of limestone or concrete blocks. The condition of the retaining wall is satisfactory in relation to its age and will require normal ongoing maintenance.

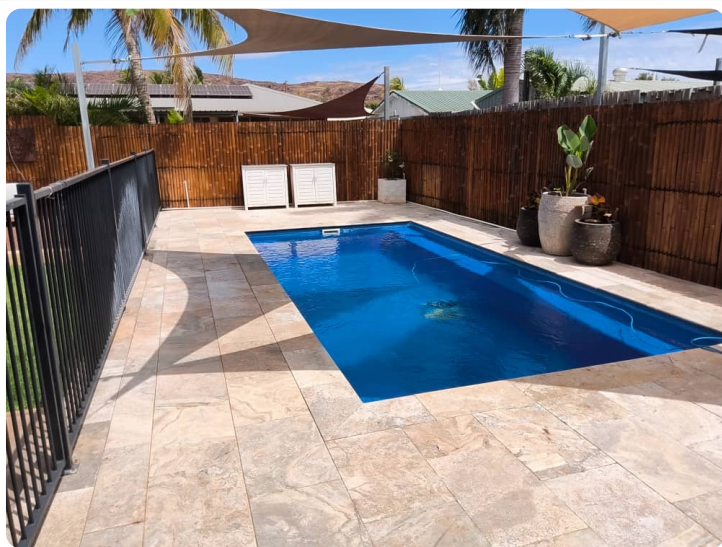
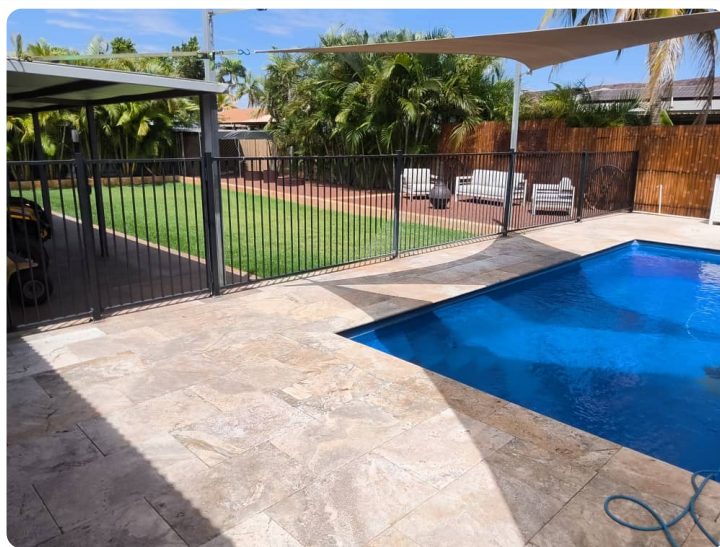
### 23. Pool (isolation fencing)

The pool is situated below ground. The external pool on the property is constructed of fibreglass. In relation to subsidence to the ground immediately adjacent to the pool, no significant subsidence was noted. There is isolation fencing installed around the pool. The isolation fencing and gates appear to be inconsistent with current pool fencing requirements. It is recommended that a copy of the previous Council Pool Safety Compliance Certificate is obtained. It is recommended that a pool maintenance contractor review and confirm the operation of all pool equipment.

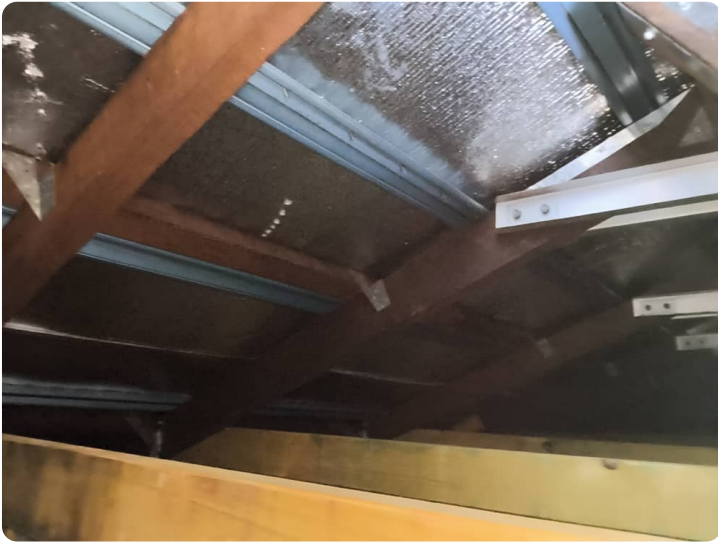
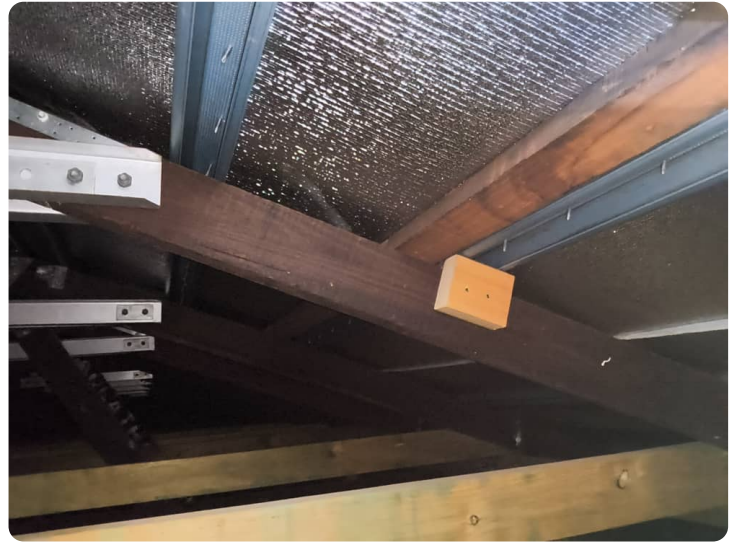
#### 24. Under side of roof cover

The condition of the underside of the roof cover could not be determined as sarking had been installed.

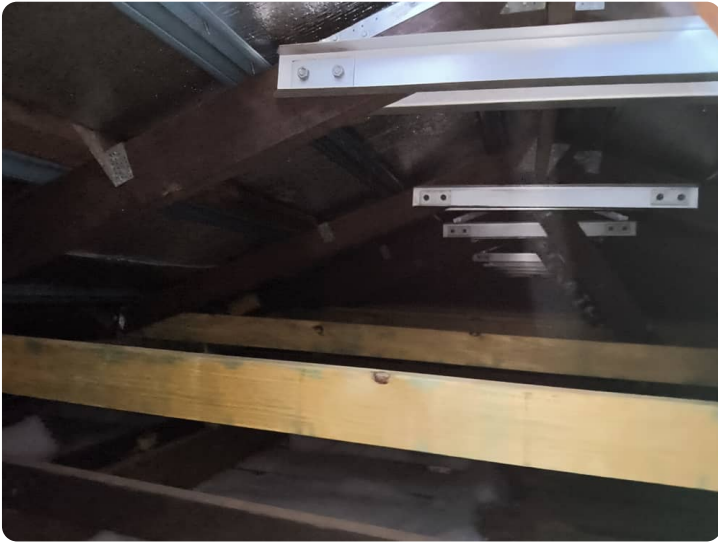
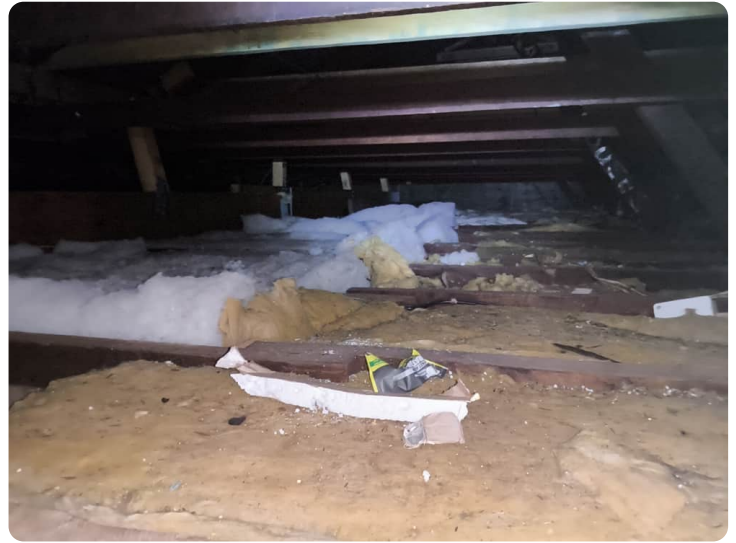
## 26. Roof frame

The roof frame type is a traditional timber stick frame. The condition of the roof frame is satisfactory in relation to its age and will require normal ongoing maintenance. Access to the roof space was restricted by the pitch of the roof, insulation, ducting or other items. The inspector estimates that visibility was available to more than 75% of the area.

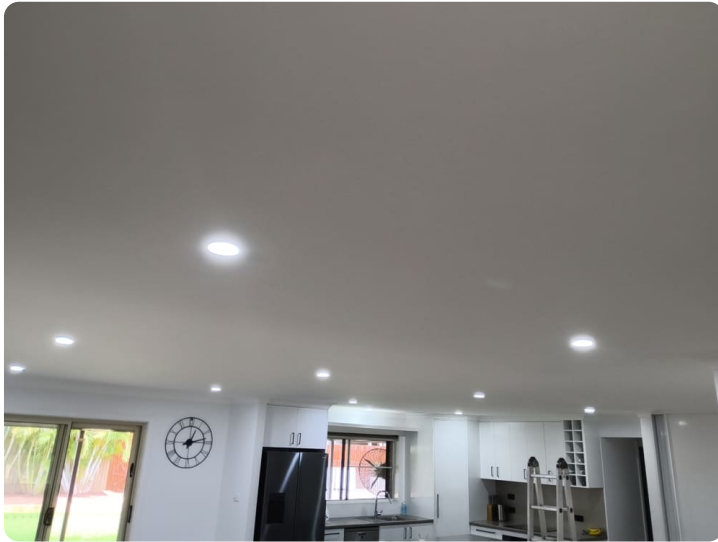
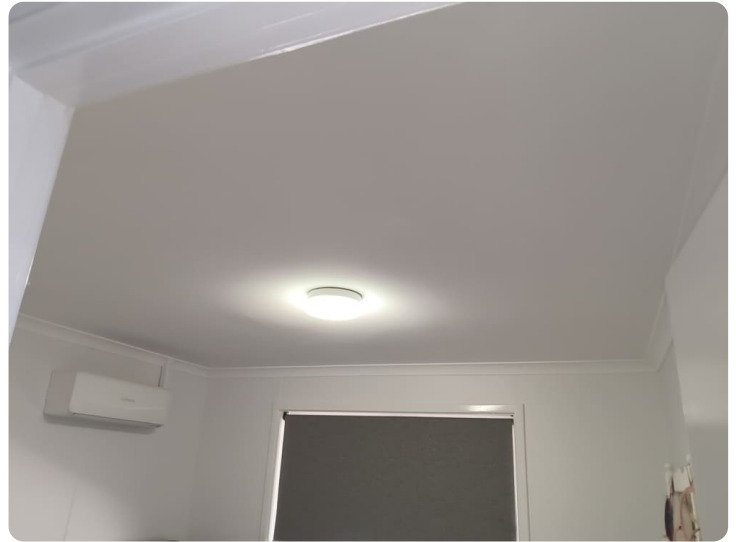
## 28. Ceilings

The ceilings are constructed of plasterboard with cornices constructed of plasterboard. The condition of the ceilings is satisfactory in relation to its age and will require normal ongoing maintenance.

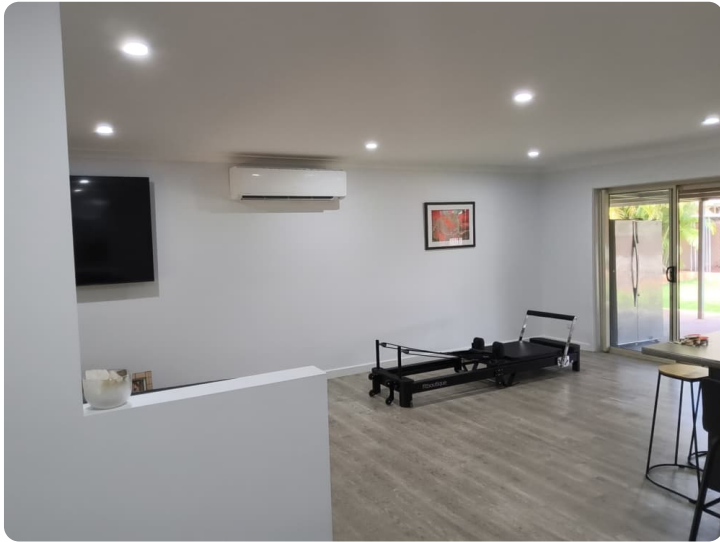
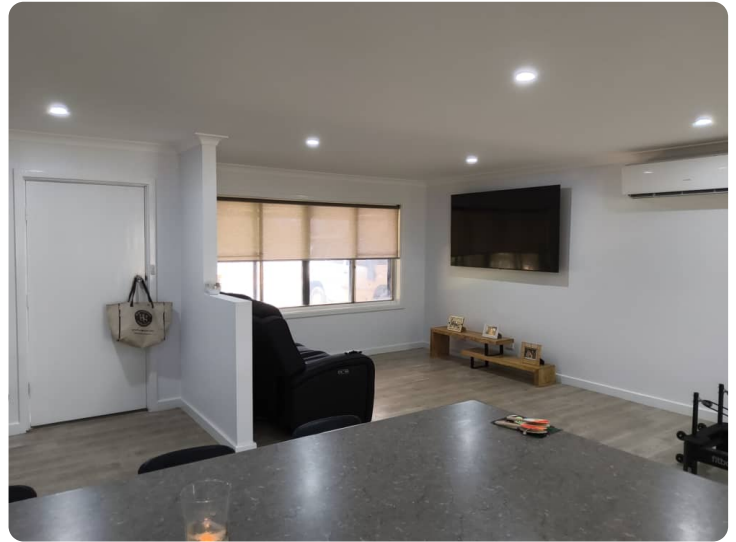
## 29. Internal walls

The internal walls are constructed of a frame with plaster board cladding. The condition of the internal walls is satisfactory in relation to its age and will require normal ongoing maintenance.
