# **Houspect**

### **Pre purchase inspection**

**Job ID:** 93039

**Address:** 44 Hunt Way, Bulgarra WA 6714

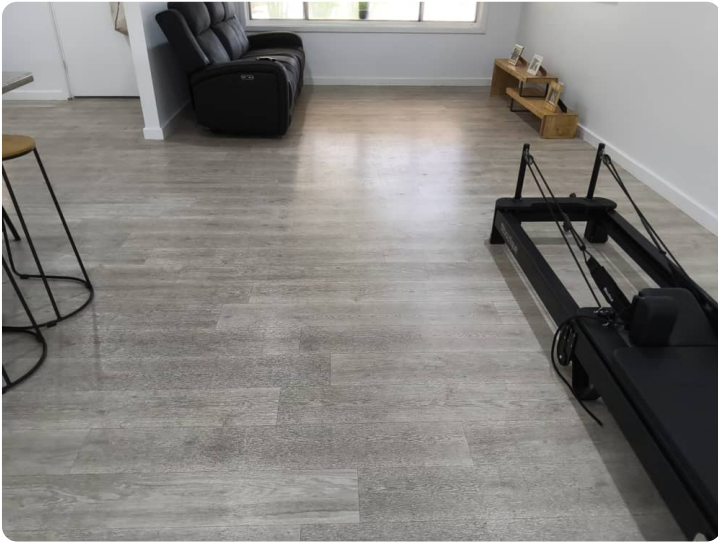
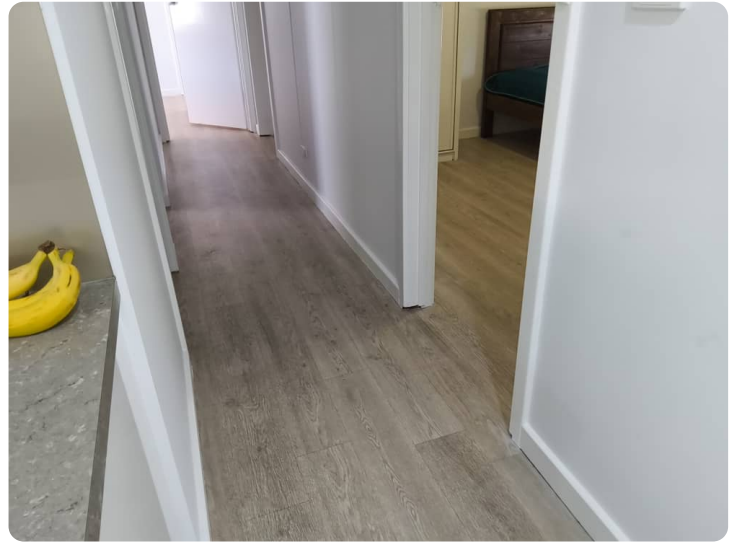
### 30. Internal floors

The internal floors are constructed of concrete and are covered in vinyl planks. The condition of the internal floors is unable to be determined as they could not be seen due to coverings.

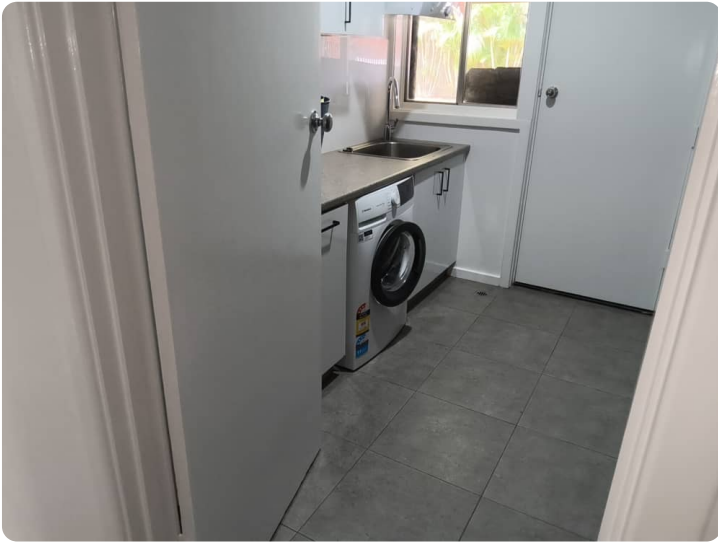
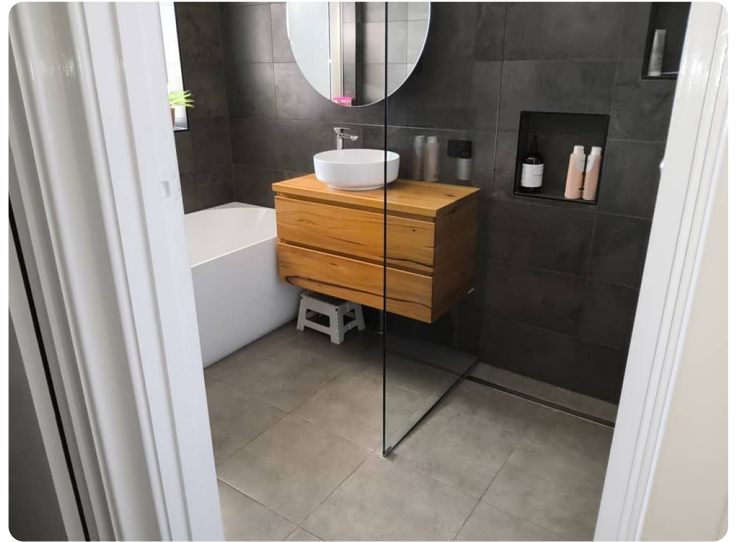
### 31. Tiled floors and walls

There are areas of internal floors and walls which are covered with a tile covering. The condition of the tiles is satisfactory in relation to its age and will require normal ongoing maintenance.

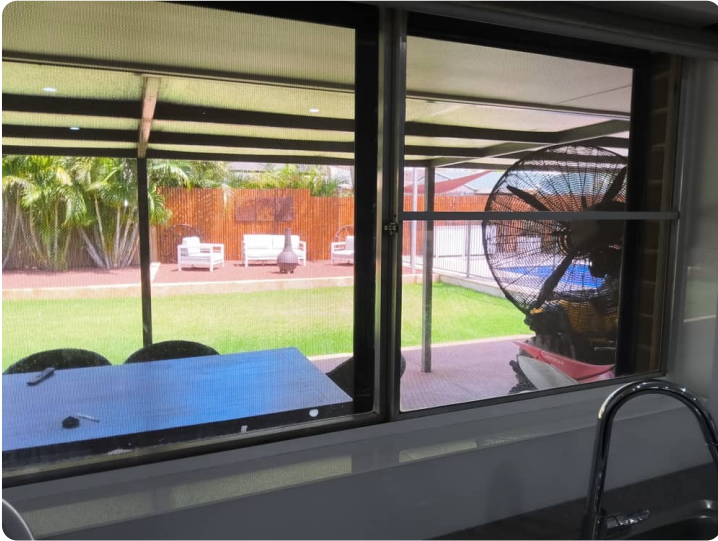
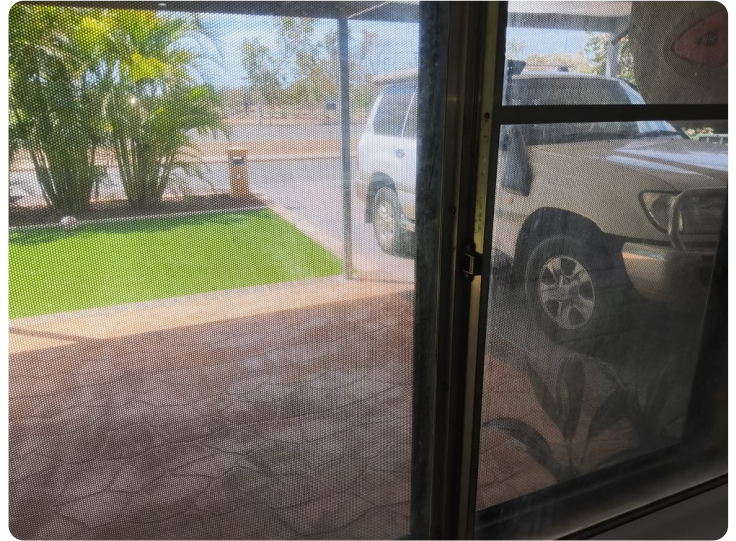
### 32. Windows (internal)

The condition of the windows, as viewed from within the property, is satisfactory in relation to its age and will require normal ongoing maintenance. Window locks have been installed to none of the windows.

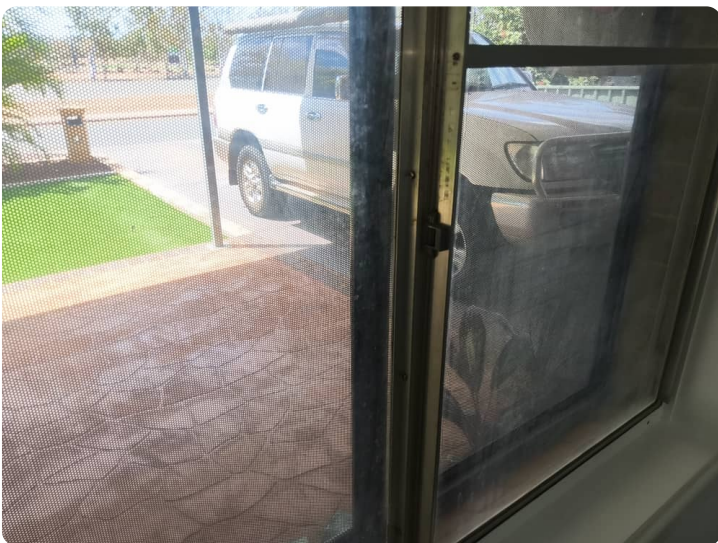
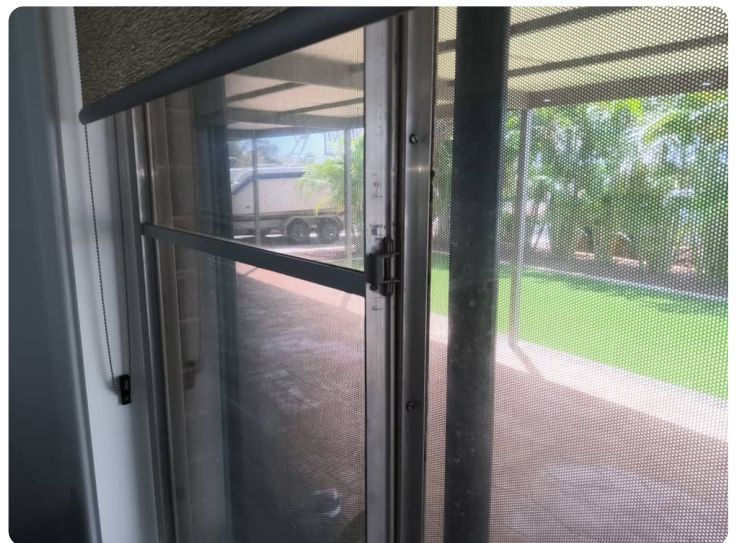
#### 32.1 Window latches, catches or opening mechanism, damaged, broken or missing

As per the images the window latches, catches or opening mechanism is missing damaged or requires repairs or replacement.

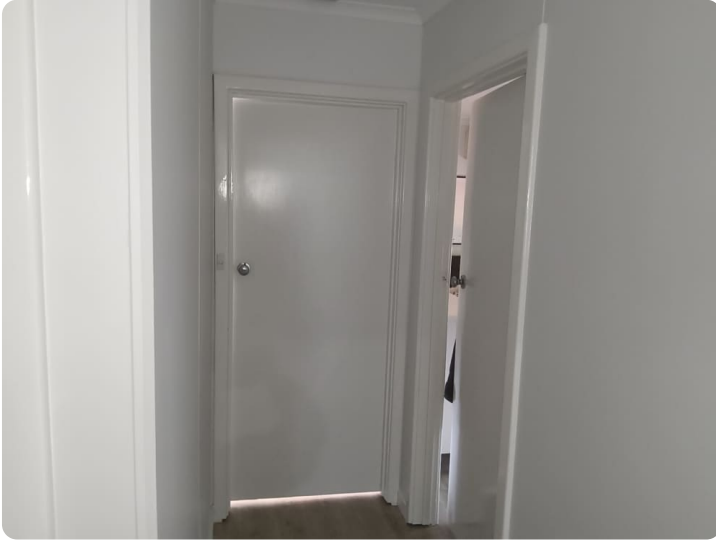
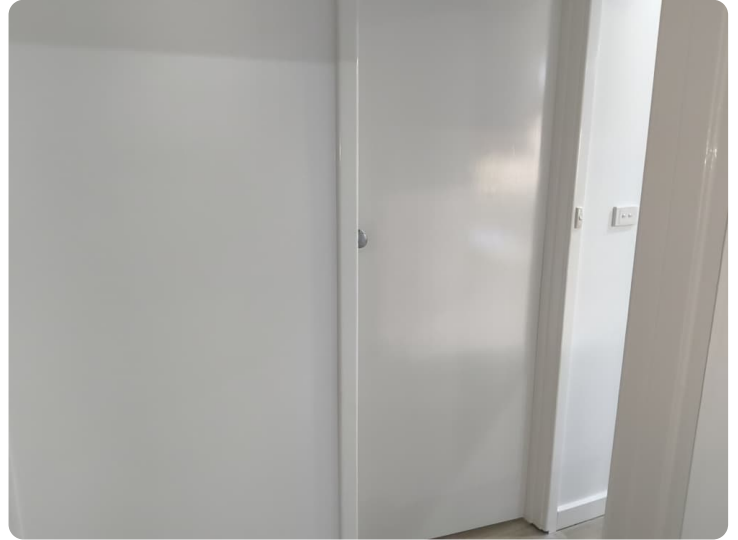
### 33. Internal doors

The internal doors were mainly constructed of timber hollow core. The condition of the internal doors is satisfactory in relation to its age and will require normal ongoing maintenance.

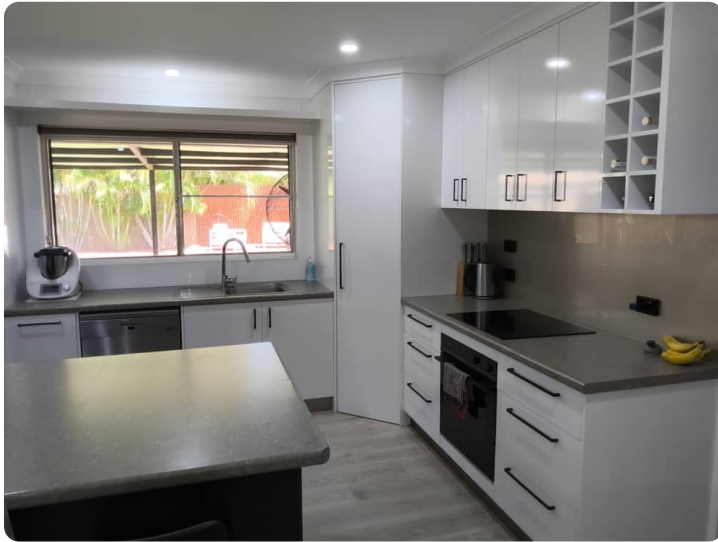
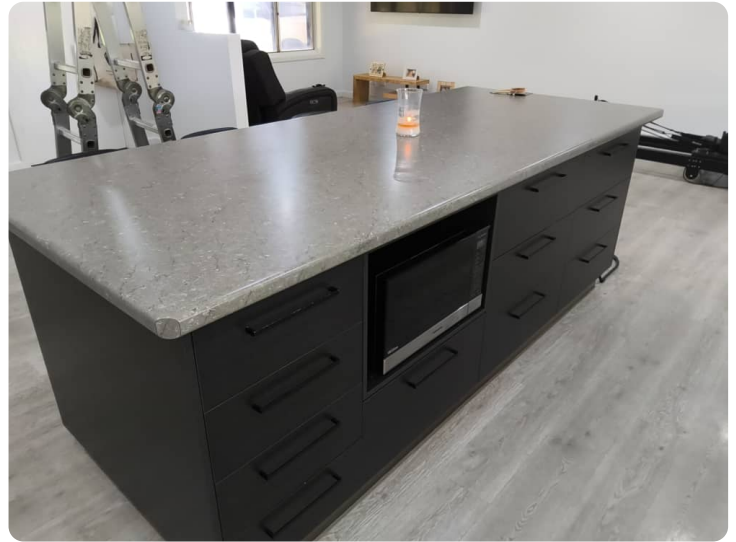
#### 34. Kitchen cabinets

The condition of the kitchen cabinets in general is satisfactory in relation to their age and require normal maintenance.

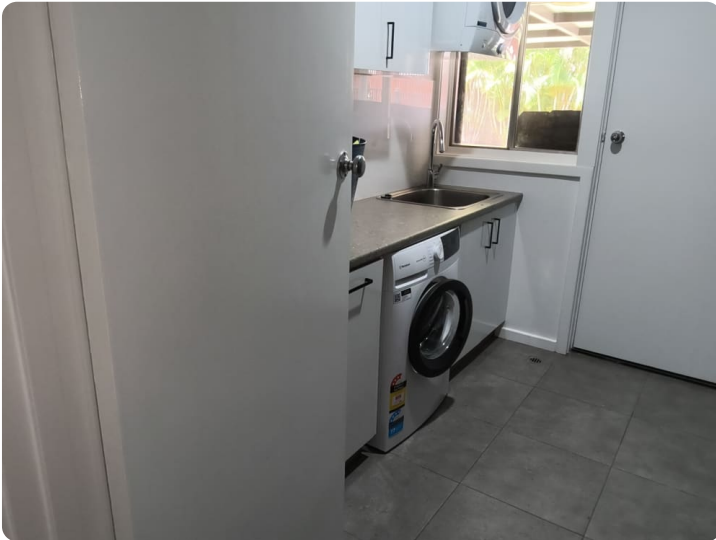
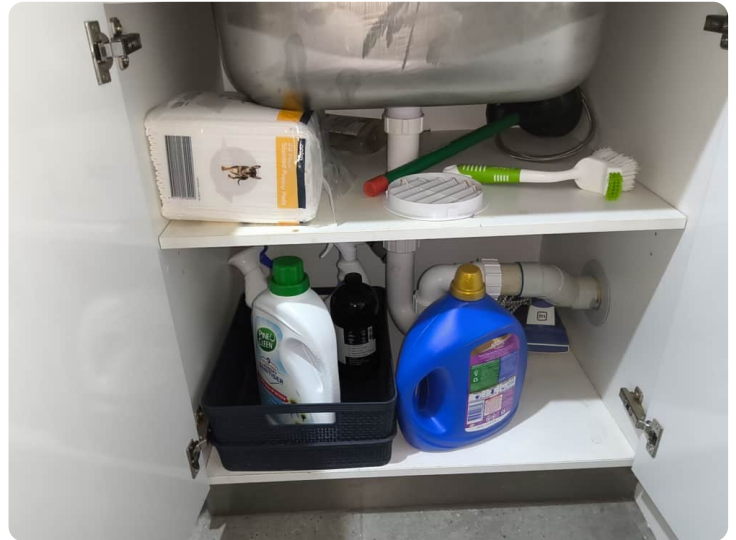
### 35. Laundry cabinets

The condition of the laundry cabinets is satisfactory in relation to their age and require normal maintenance.

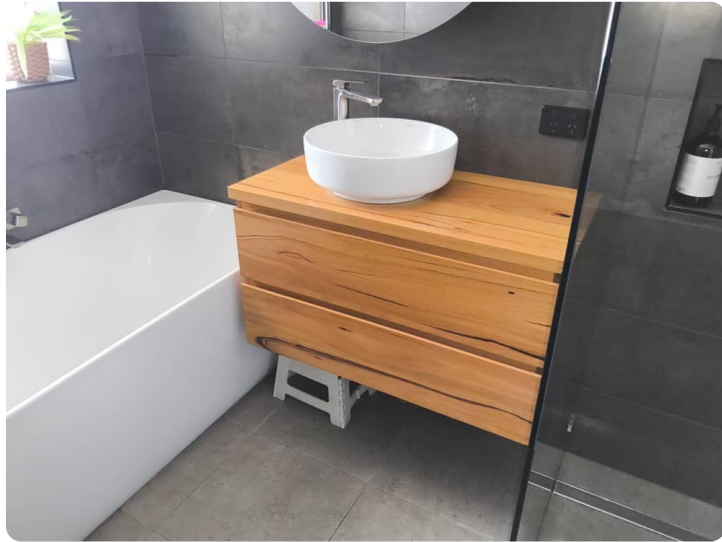
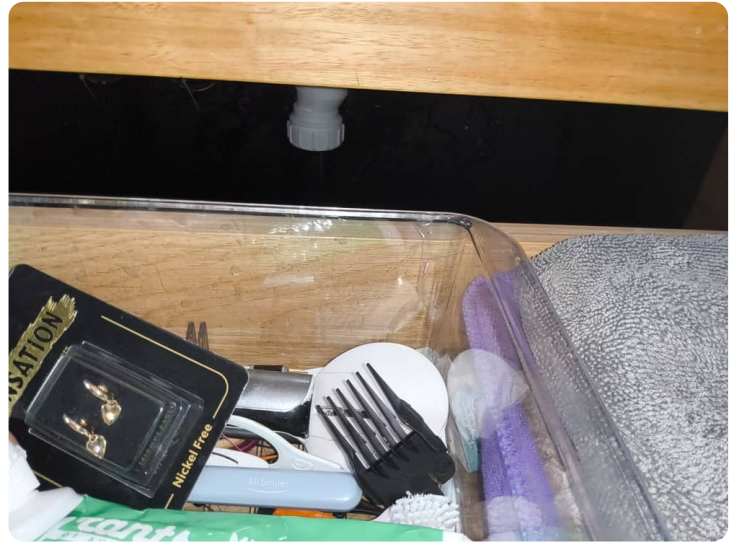
### 36. Bathroom cabinets

The condition of the bathroom cabinets is satisfactory in relation to their age and require normal maintenance.

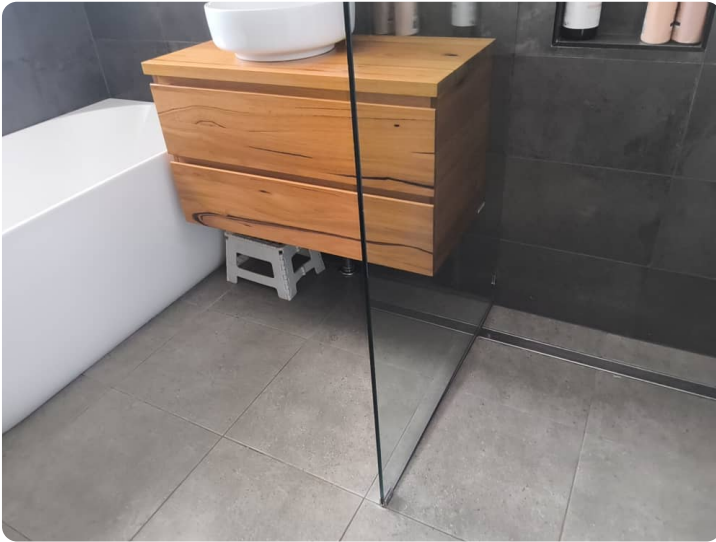
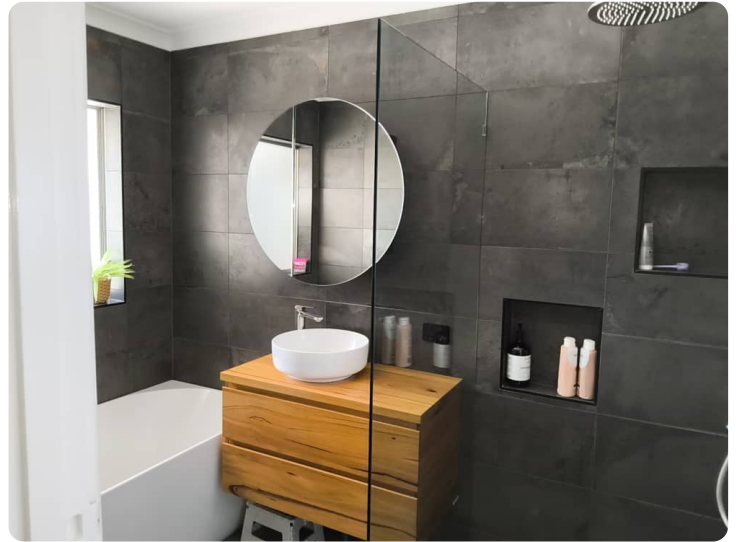
### 37. Shower screens

The condition of the shower screens is satisfactory in relation to their age and require normal maintenance.
