# Pre-Purchase Timber Pest Inspection Report

**In Accordance with AS 4349.3**

44 Hunt Way, Bulgarra WA, Australia

08 Oct 2026

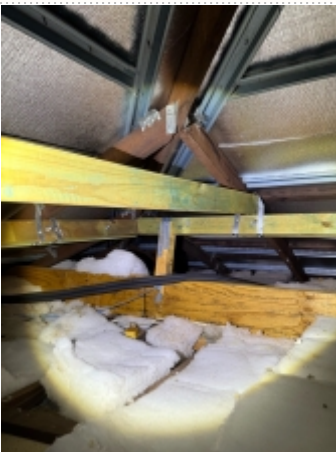
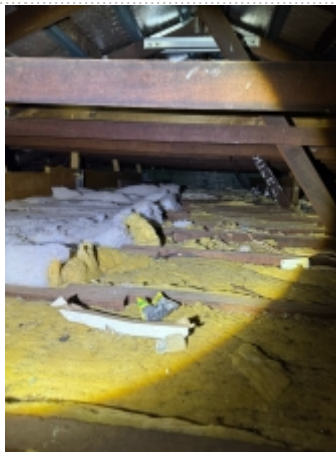
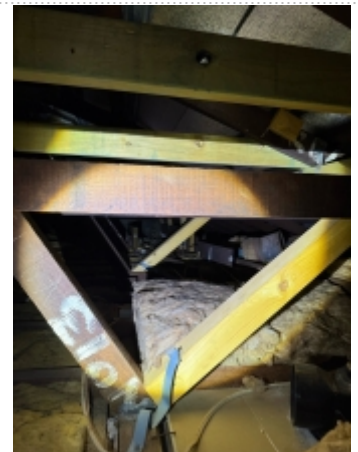
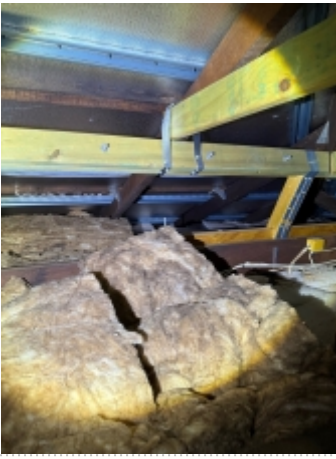
New timber reinforcements installed in roof void where difficult to access

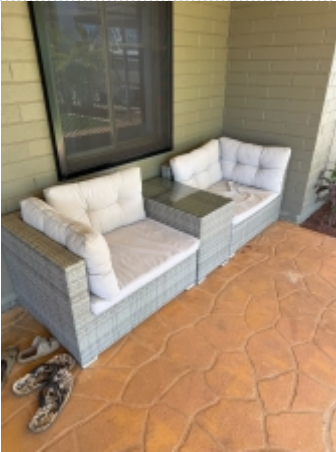
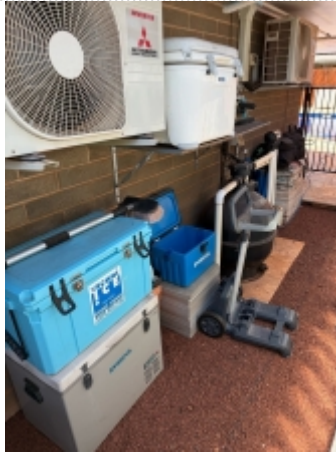
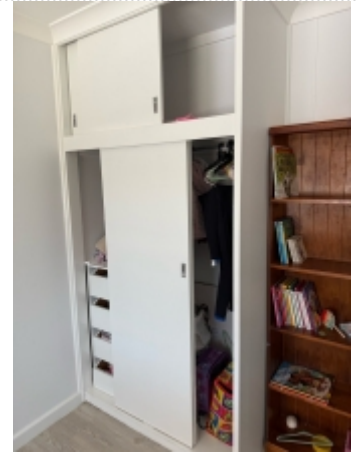
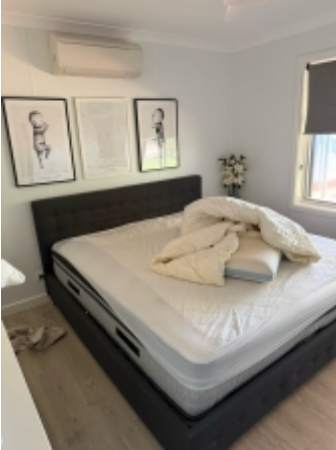
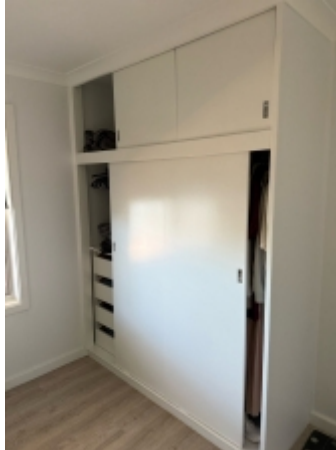
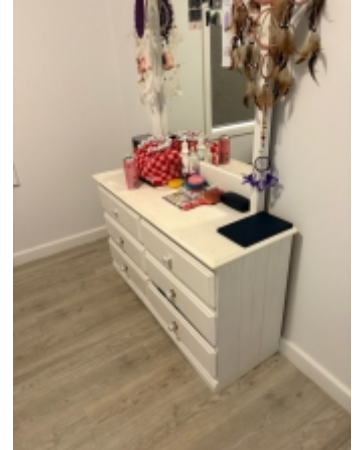
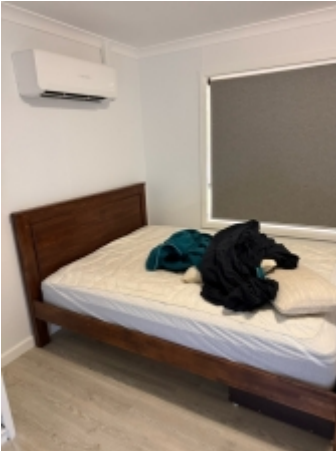
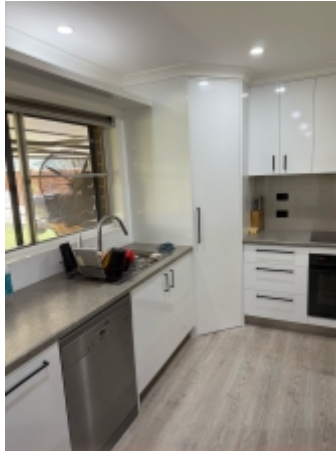
Items, furniture, fixtures etc hinder view for inspection

It is important to note that as an inspection of the above areas was not possible at the time of the inspection, timber pest activity or damage may therefore exist in these areas.

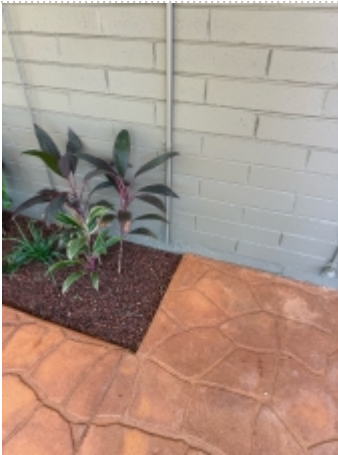
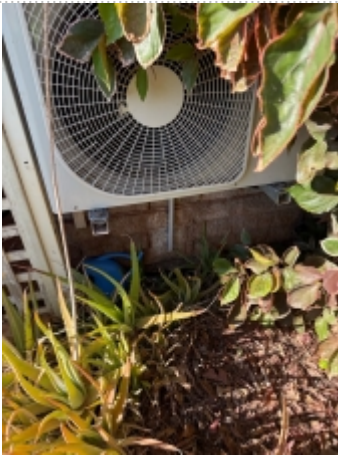
Visible leaks were located in the following areas: Air conditioning overflow

AC downpipes recommended to be redirected into drainage into where possible

Details & Recommendations: Piping expelling water at building edge is always recommended to be redirected into drainage to reduce moisture

If leaks are detected, it is recommended that a suitably qualified plumber or builder is engaged to rectify as soon as possible.
