Building inspection

Job ID: 91579

Address: 68 Hunt Way, Bulgarra WA

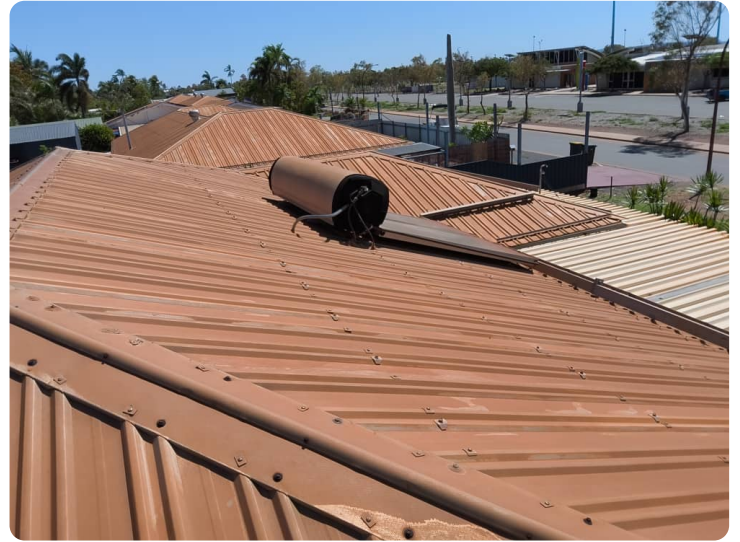
1. Roof covering

The roof covering is constructed of metal. The condition of the roof covering is fair in relation to its age and will require ongoing maintenance.

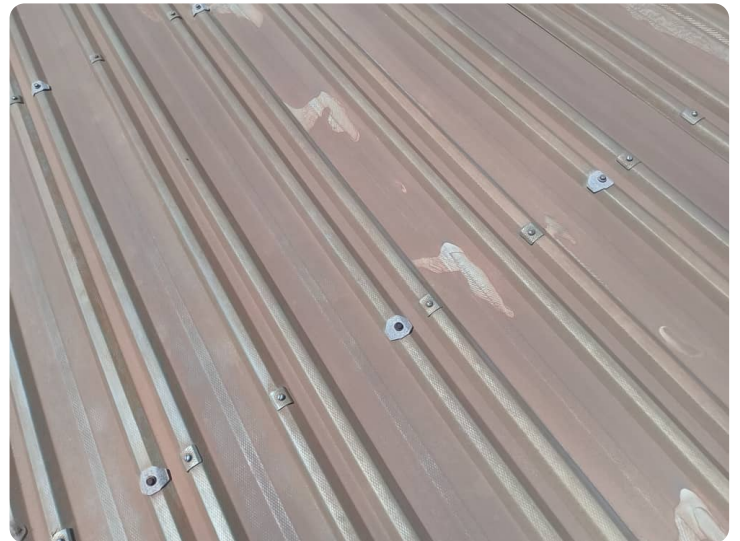
1.1 Metal roof rusting fixings

There are rusting fixings which need to be replaced to minimise potential rust transfer to the roof sheets and extend the life of adjacent metal sheets.

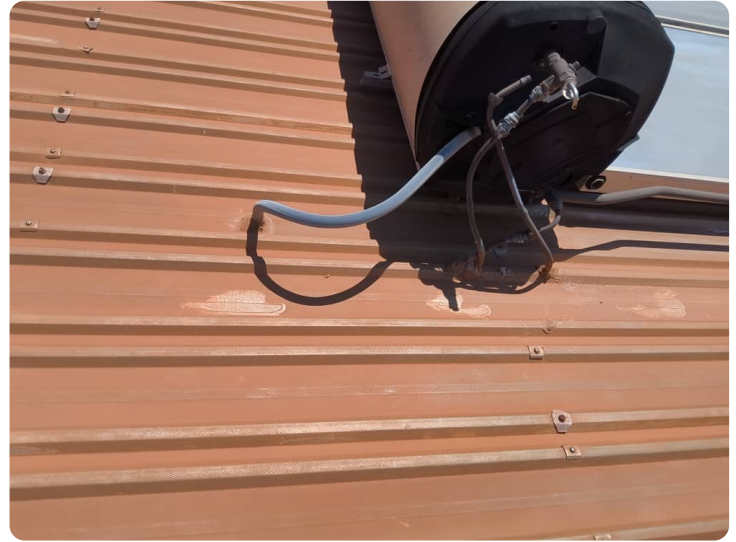
3. Flashings

The flashings are covered with a variety of finishes and are constructed of a mixture of materials. The condition of the flashings is fair in relation to its age and will require ongoing maintenance.

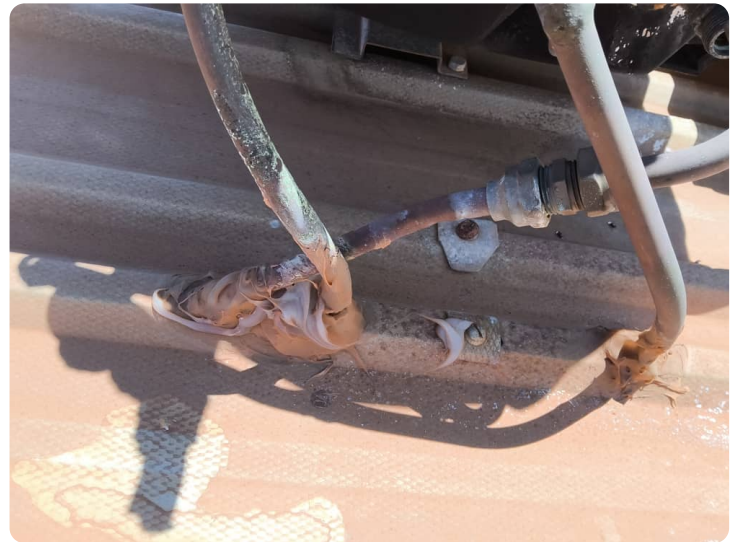
3.1 Flashings general - only silicone

There is insufficient or no flashing installed around the roof penetrations which have only been silicone sealed. Installing flashing around these penetrations is recommended to prevent water ingress into the roof space.

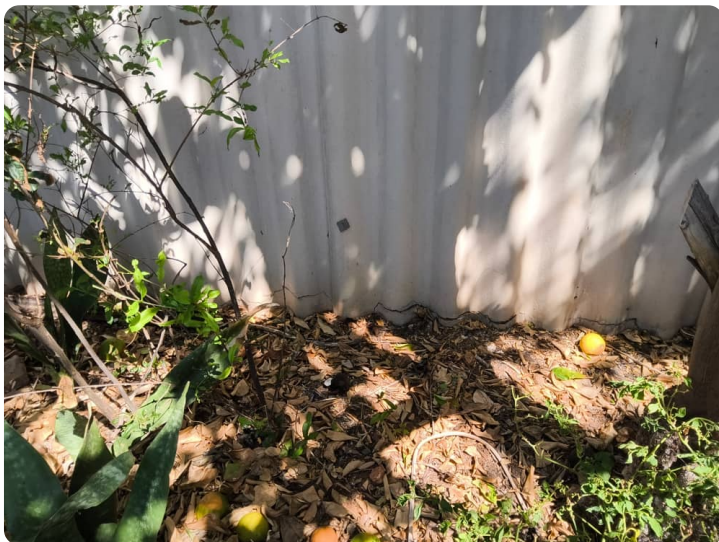
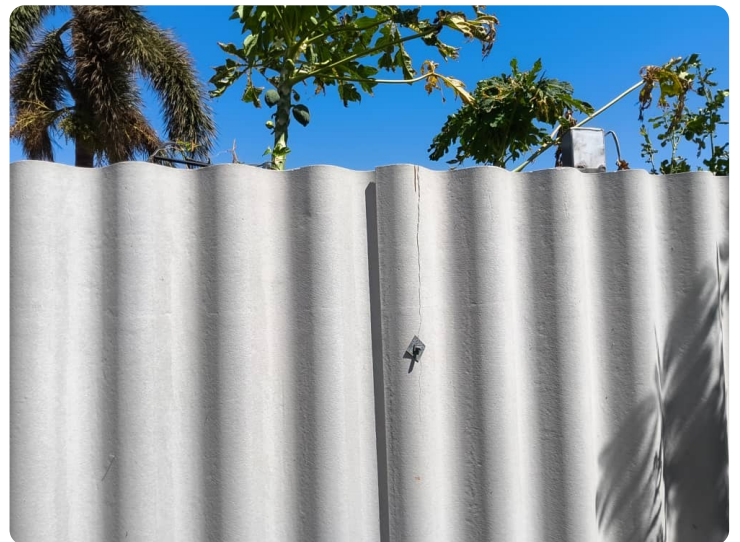
24.1 Fibre cement damage

There was loose, missing or damaged fibre cement fence components that requires remediation. The material should be tested, where required, and then a remediation plan established.

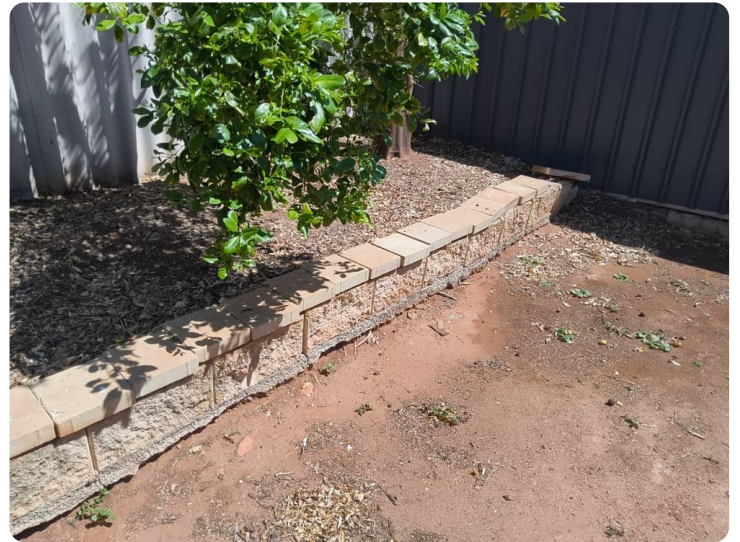
25.1 Header bricks loose

The header bricks are loose and require re-fixing.

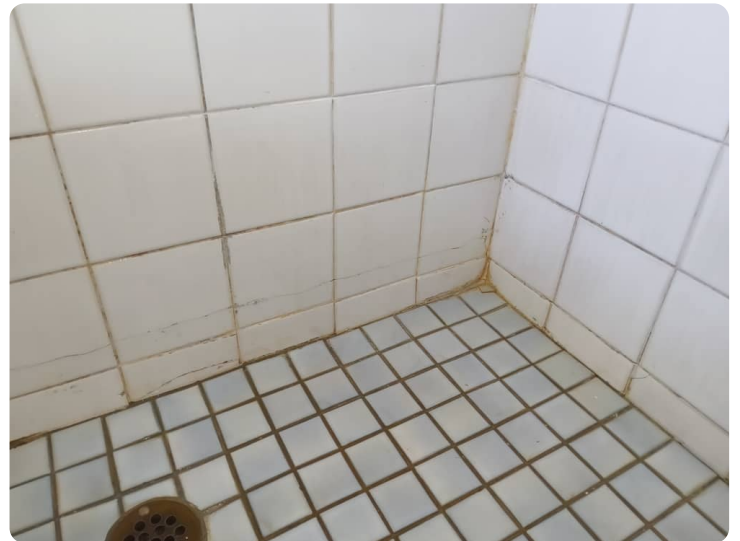
33.1 Tile damage - major

Based on the images provided, there is significant damage to the wall and/or floor tiles, requiring repair or replacement. This damage may have compromised the waterproofing.
