**PILBARA
PEST Co**

Pre-Purchase Timber Pest Inspection Report

68 Hunt Way, Bulgarra WA, Australia

17 Apr 2026

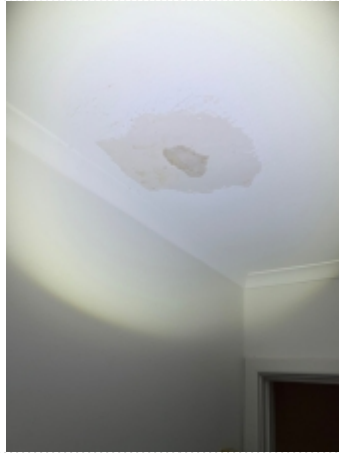
Evidence of water damage to master bedroom ceiling

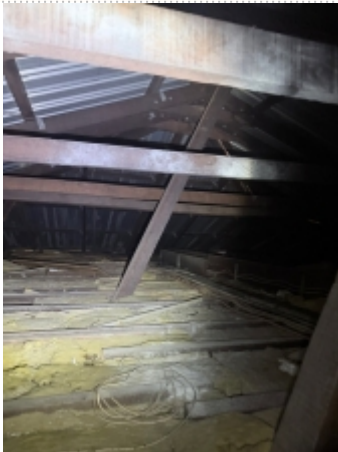
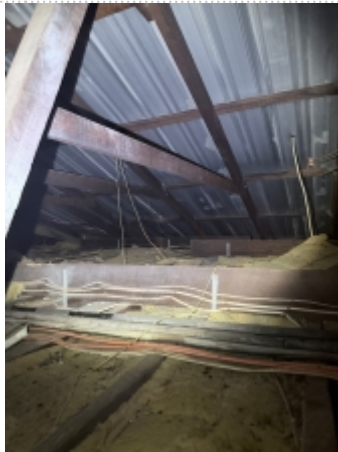
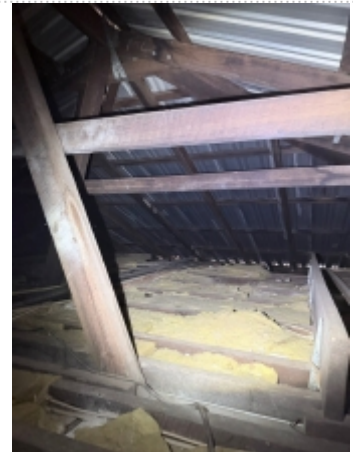
No visible evidence of termites
