# Pre-Purchase Timber Pest Inspection Report

**In Accordance with AS 4349.3**

1 Straker Road, Millars Well WA, Australia

03 Sep 2026

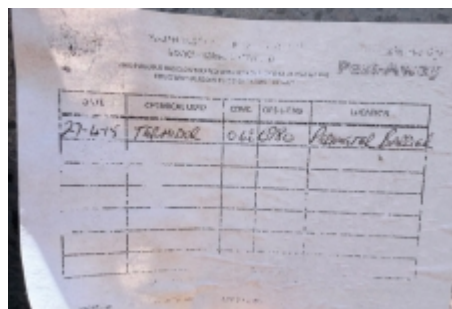
#### Durable Notice Photos

| Description of the evidence found: | Treatment sticker in meter box<br>Evidence of drilled holes in ground |

Was a durable Notice found at the time of this inspection? Yes

Date of Treatment: (if known) 27 Apr 2015

| Additional Comments: | Recommend renewal of the existing termite management system and reinstallation to the rear of the property where New concrete has been poured |
