# **Houspect**

### **Pre purchase inspection**

**Job ID:** 93044

**Address:** 17 Lady Douglas Way, Pegs Creek WA 6714

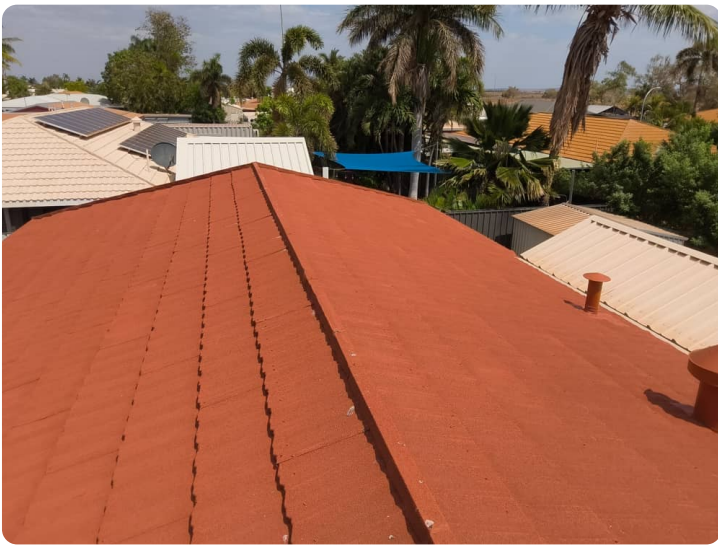
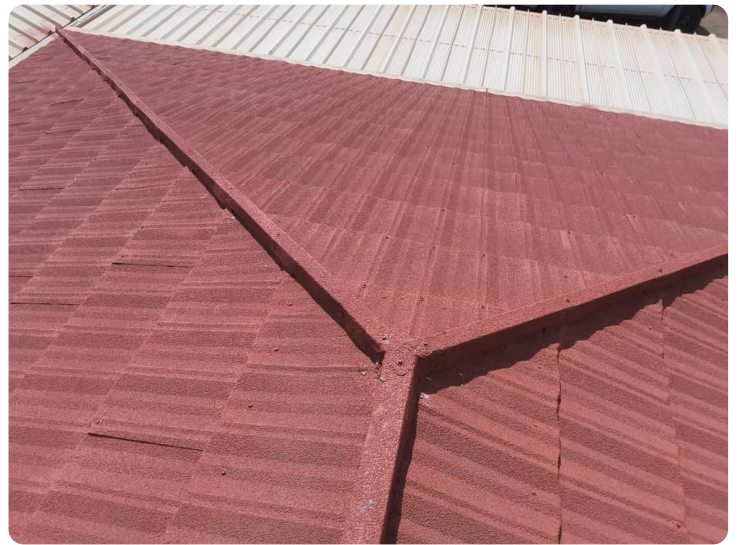
## 2. Ridges

The ridges and capping are fair in relation to its age and will require ongoing maintenance. Please note that some of the building material utilised on or within the building may or may not contain asbestos. The Australian Government has indicated that asbestos can only be correctly identified through laboratory testing. The material on this building site may not pose a concern in the current static state if maintained but for any future works the material should be tested and appropriate measures used for asbestos handling if the material is subsequently found to contain asbestos.

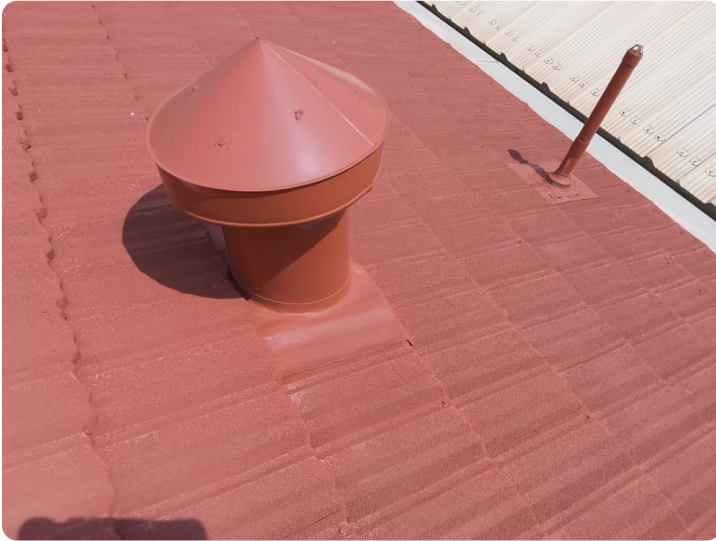
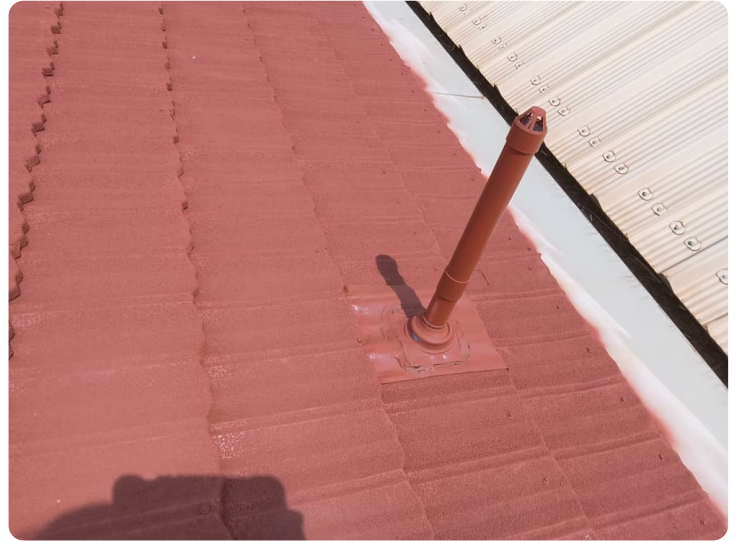
### 3. Flashings

The flashings are covered with a variety of finishes and are constructed of a mixture of materials. The condition of the flashings is satisfactory in relation to their age and will require normal ongoing maintenance.

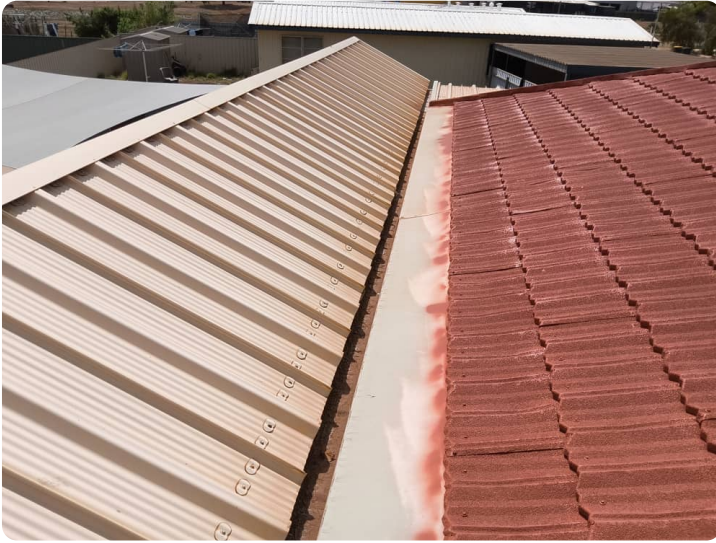
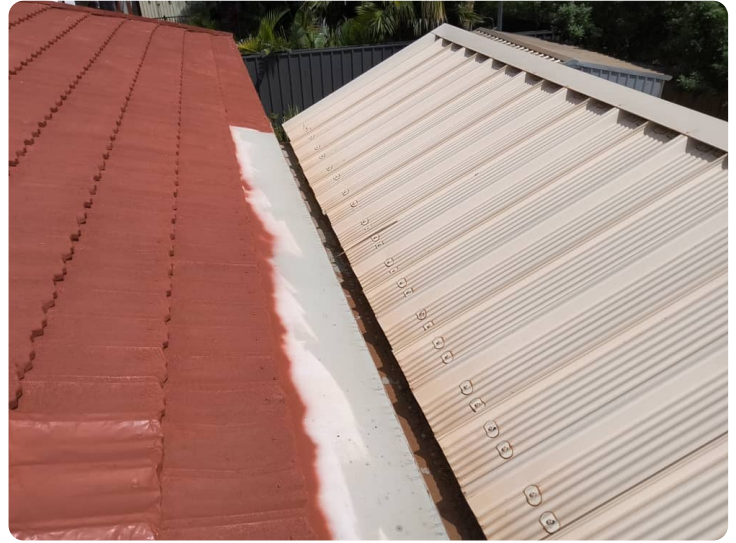
#### 4. Box gutters

The box gutters are constructed of metal and they have a colorbond covering. The condition of the box gutters is satisfactory in relation to their age and will require normal ongoing maintenance. The box gutters appear to be relatively free of debris.

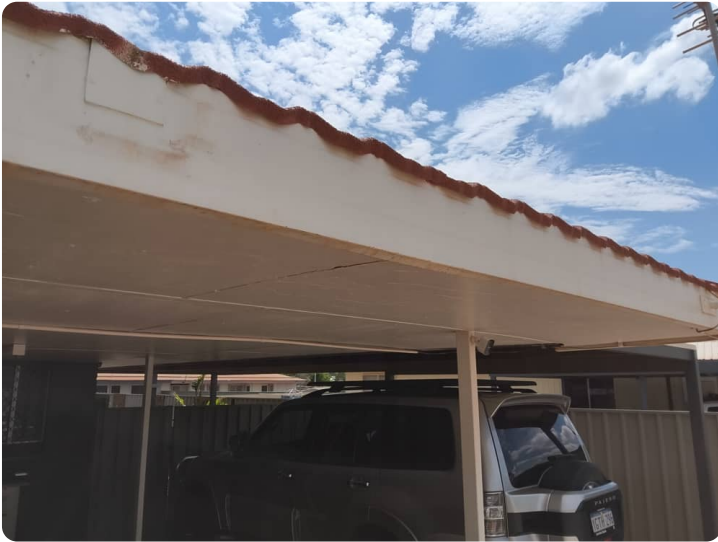
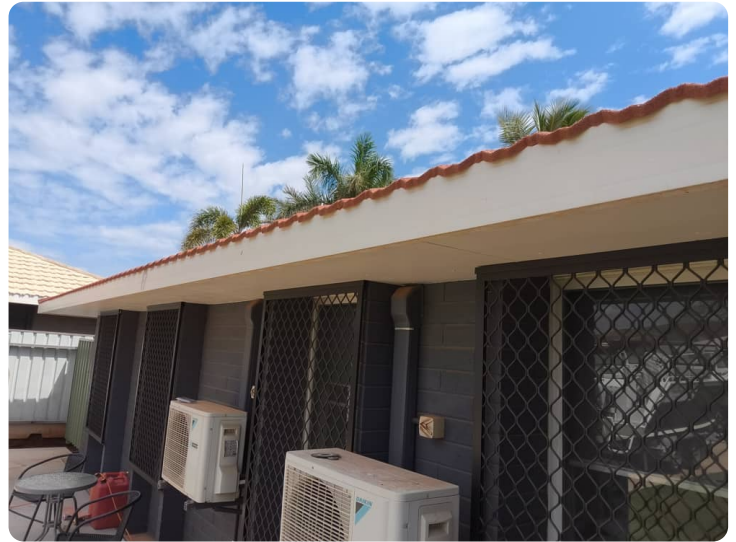
## 5. Fascia

The fascia are constructed of metal and they are painted. The condition of the fascia is satisfactory in relation to their age and will require normal ongoing maintenance.

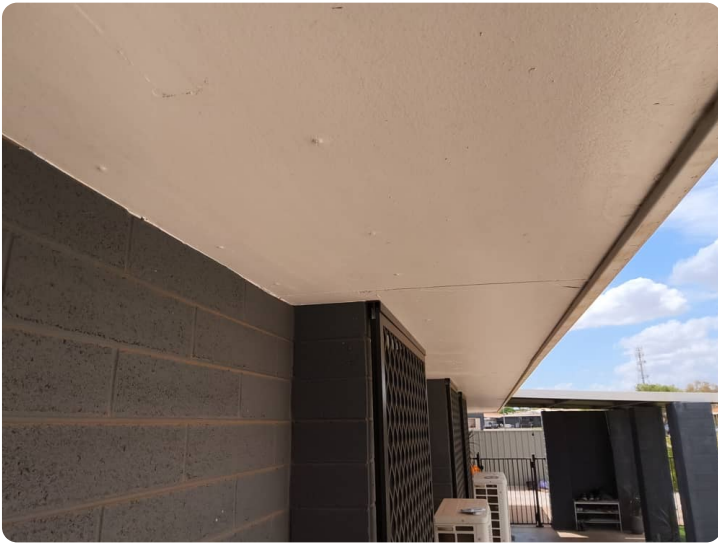
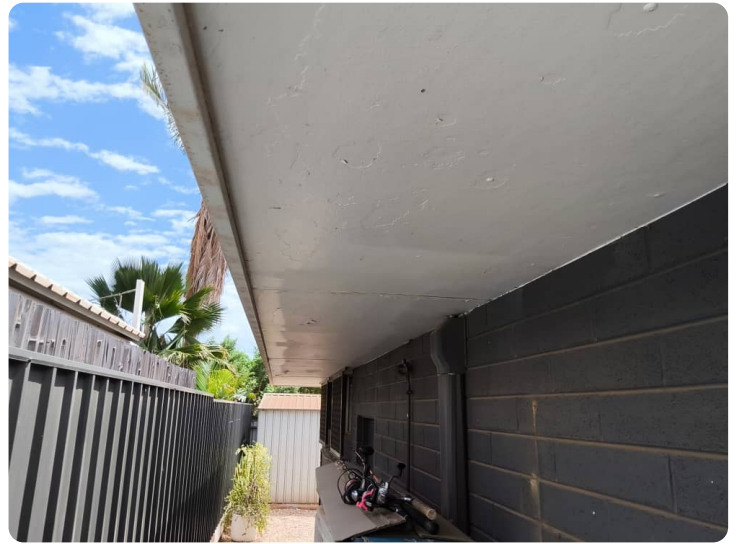
## 6. Eaves

The eaves are boxed and constructed of painted fibre cement. The condition of the eaves is fair in relation to its age and will require ongoing maintenance. Please note that some of the building material utilised on or within the building may or may not contain asbestos. The Australian Government has indicated that asbestos can only be correctly identified through laboratory testing. The material on this building site may not pose a concern in the current static state if maintained but for any future works the material should be tested and appropriate measures used for asbestos handling if the material is subsequently found to contain asbestos.

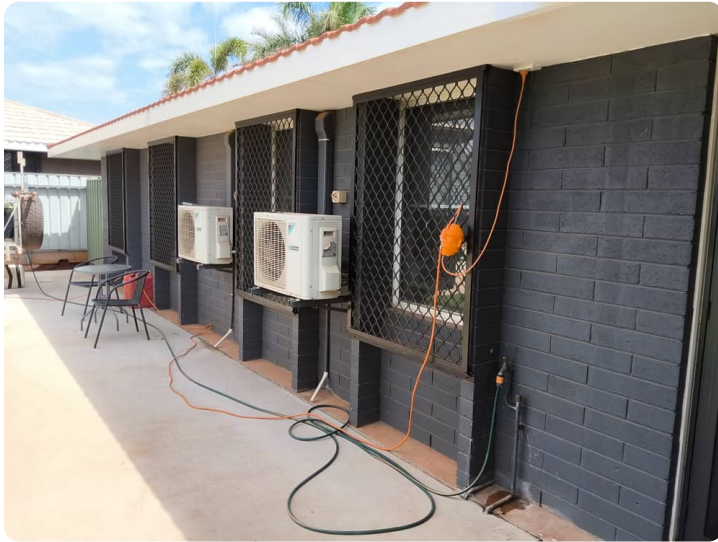
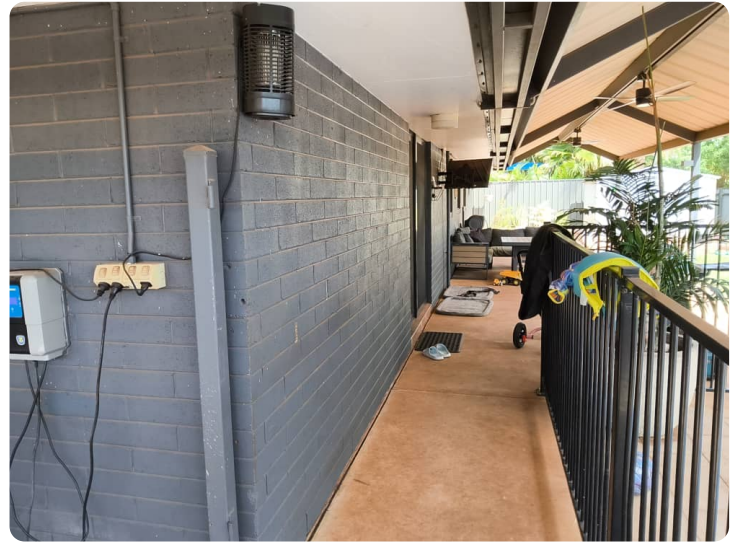
## 7. External walls

The external walls are constructed of painted brick. The condition of the walls generally is satisfactory in relation to their age and will require normal ongoing maintenance.

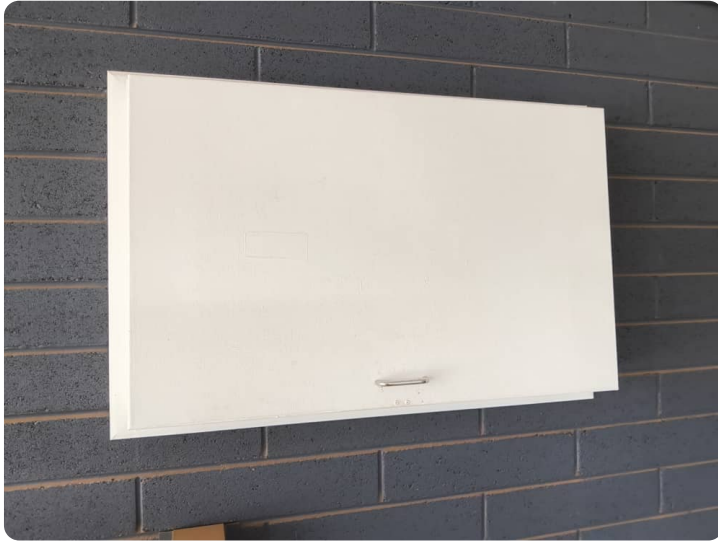
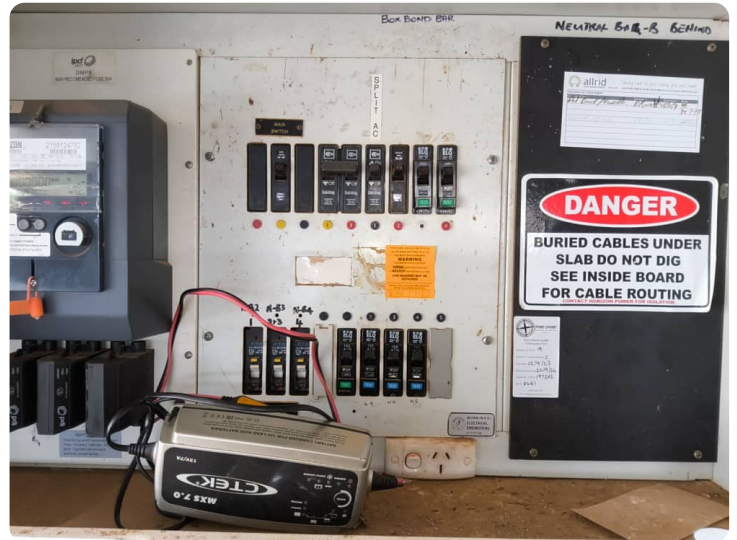
## 15. Residual Current Devices

There were multiple Residual Current Devices (RCD)(s) noted in the meter box or sub meter box. The RCD(s) were not tested. It is suggested that an Electrical Compliance Certificate be obtained in relation to the RCD(s).

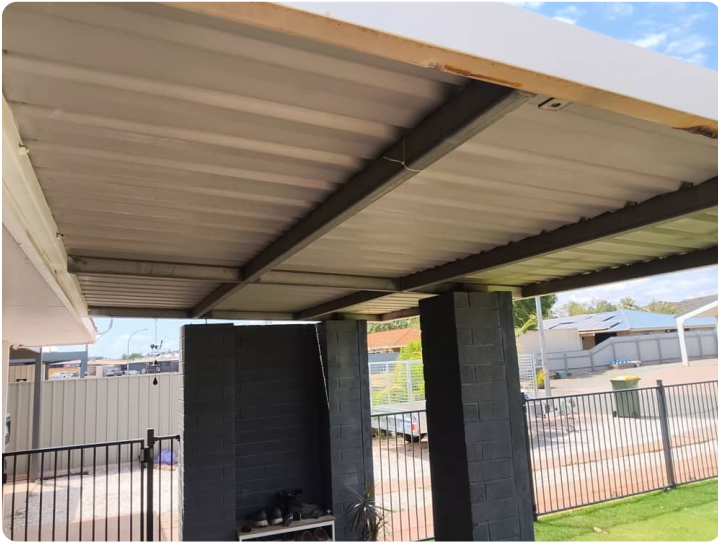
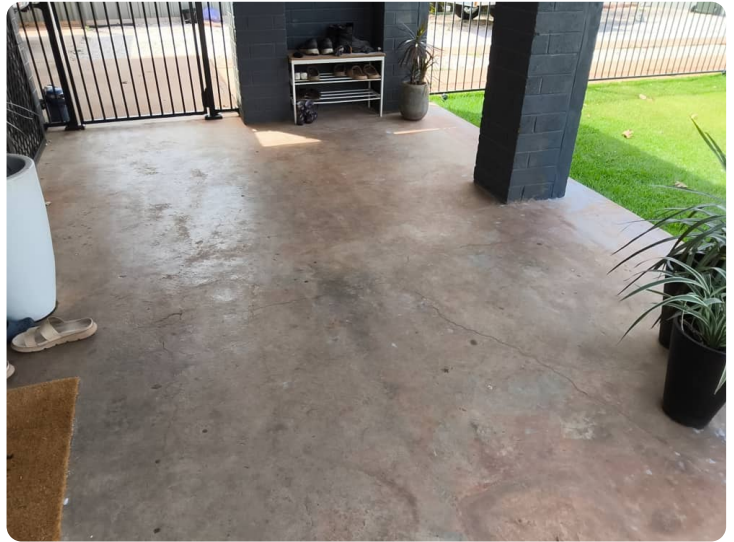
## 18. Veranda (Primary)

The primary veranda is constructed of metal. The condition of the veranda is satisfactory in relation to its age and will require normal ongoing maintenance.

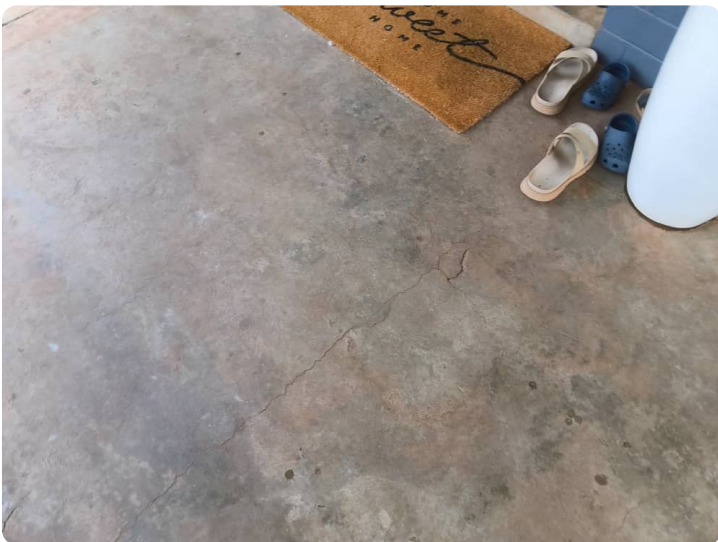
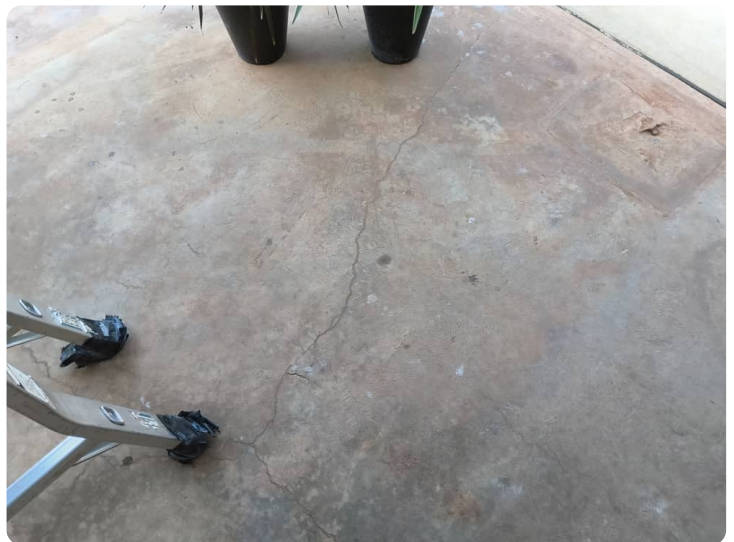
### 18.1 Concrete cracking - minor

Cracking was noted to the concrete paving. This is not of a structural concern. Cracks should be filled to avoid further deterioration.

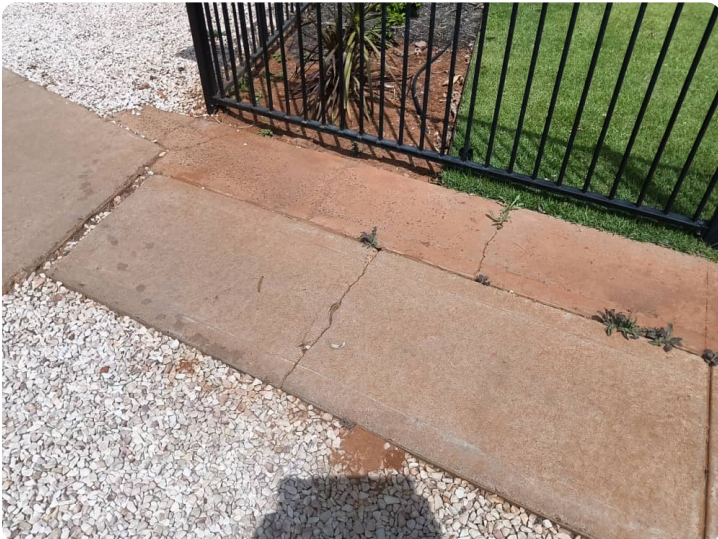
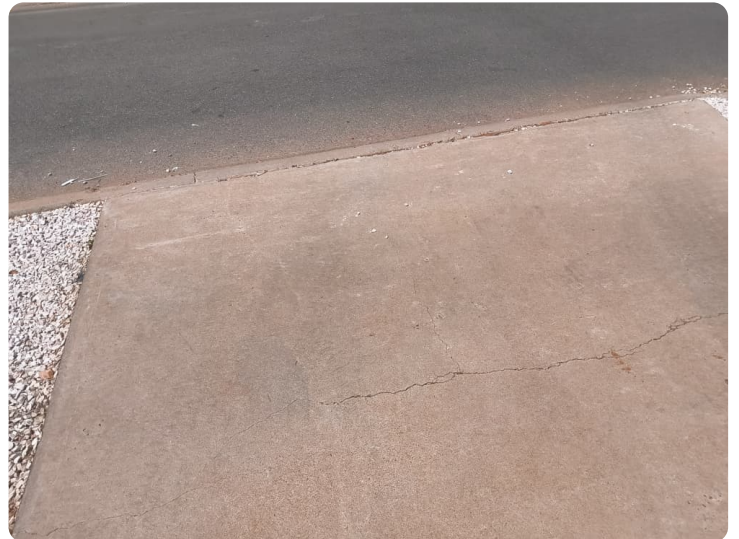
### 21.1 Concrete cracking - minor

Cracking was noted to the concrete driveway. This is not of a structural concern. Cracks should be filled to avoid further deterioration.

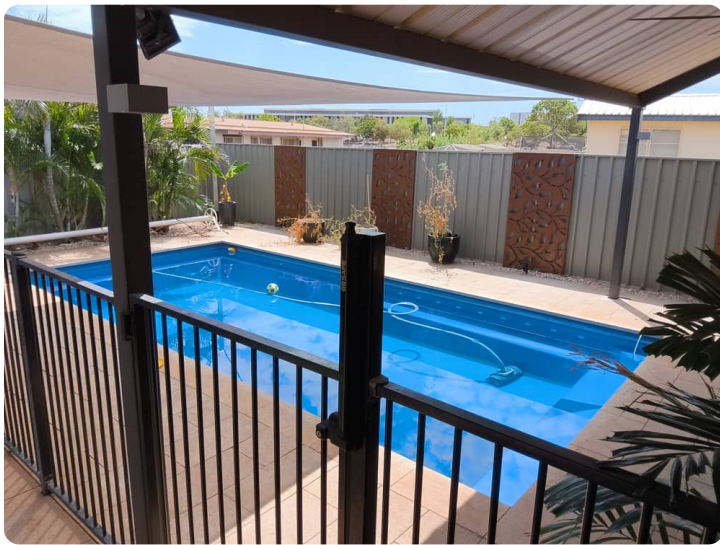
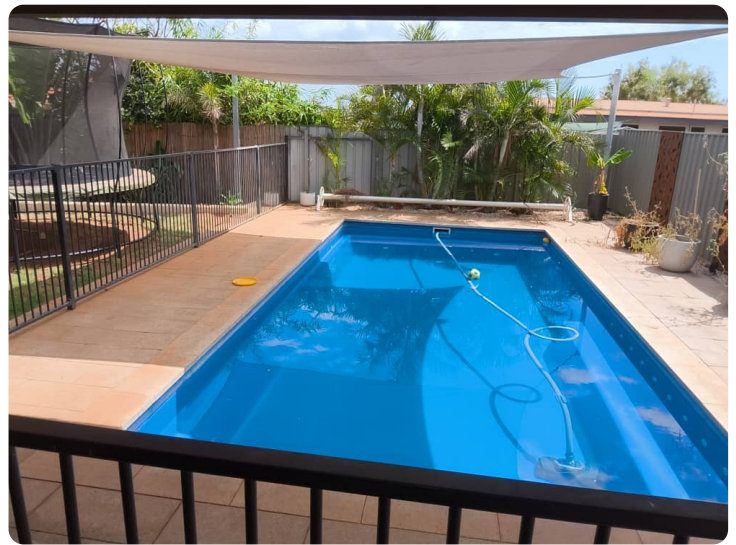
## 24. Pool (isolation fencing)

The pool is situated below ground. The external pool on the property is constructed of fibreglass. In relation to subsidence to the ground immediately adjacent to the pool, no significant subsidence was noted. There is isolation fencing installed around the pool. The isolation fencing and gates appear to be consistent with current pool fencing requirements. It is recommended that a copy of the previous Council Pool Safety Compliance Certificate is obtained. It is recommended that a pool maintenance contractor review and confirm the operation of all pool equipment.

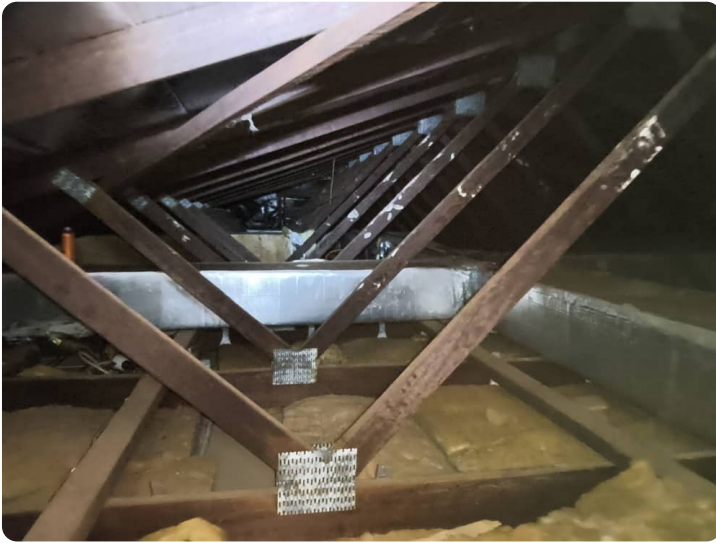
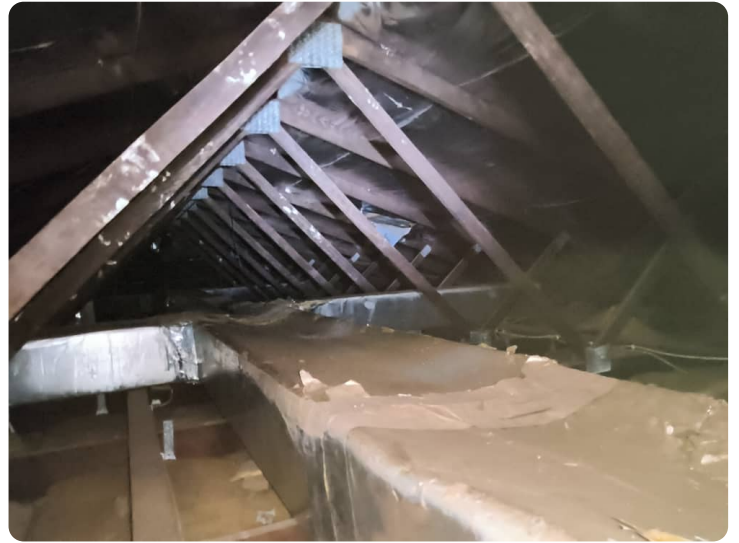
## 27. Roof frame

The roof frame type is a timber truss. The condition of the roof frame is satisfactory in relation to its age and will require normal ongoing maintenance. Access to the roof space was restricted by the pitch of the roof, insulation, ducting or other items. The inspector estimates that visibility was available to more than 75% of the area.
