Building inspection

Job ID: 91855

Address: 35 Hunt Way, Bulgarra WA

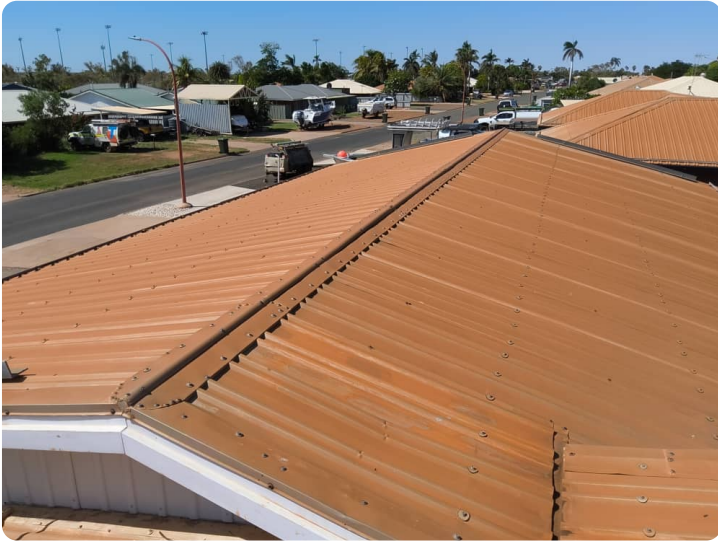
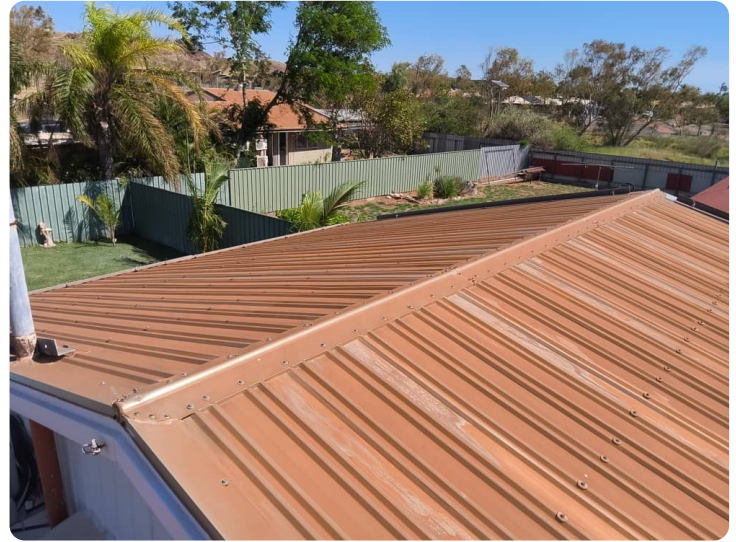
1. Roof covering

The roof covering is constructed of metal. The condition of the roof covering is fair in relation to its age and will require ongoing maintenance.

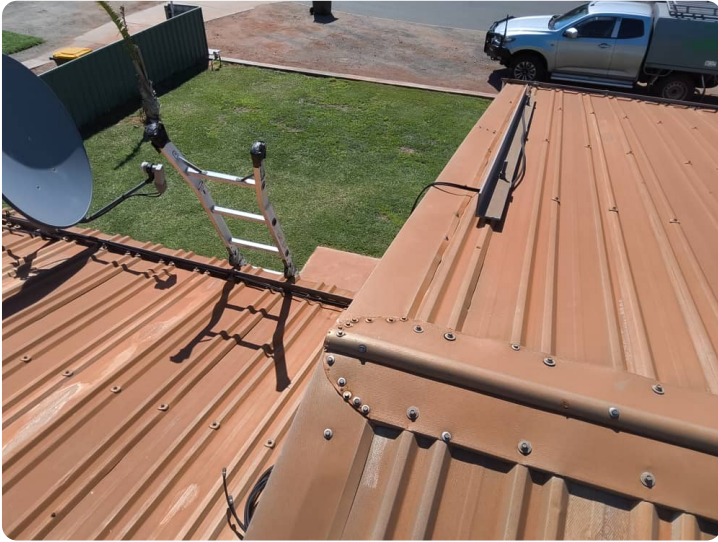
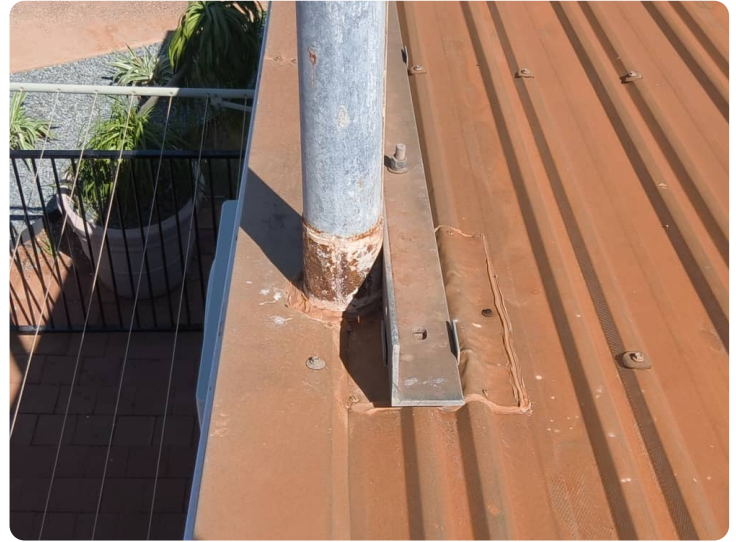
3. Flashings

The flashings are covered with a variety of finishes and are constructed of a mixture of materials. The condition of the flashings is fair in relation to its age and will require ongoing maintenance.

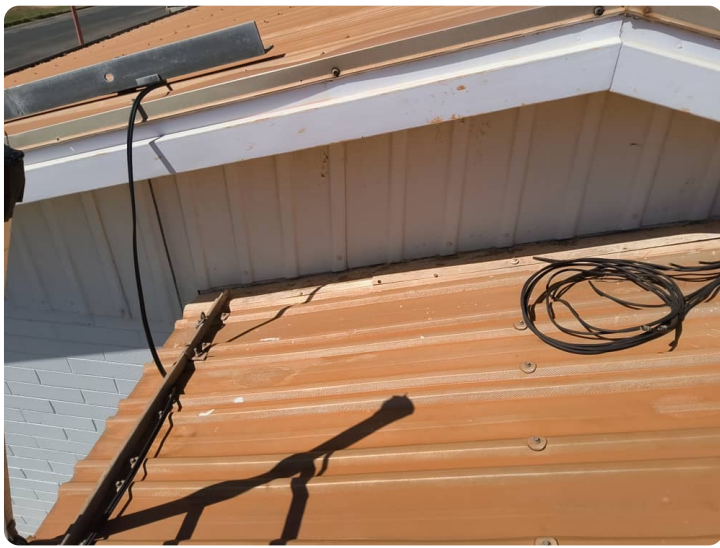
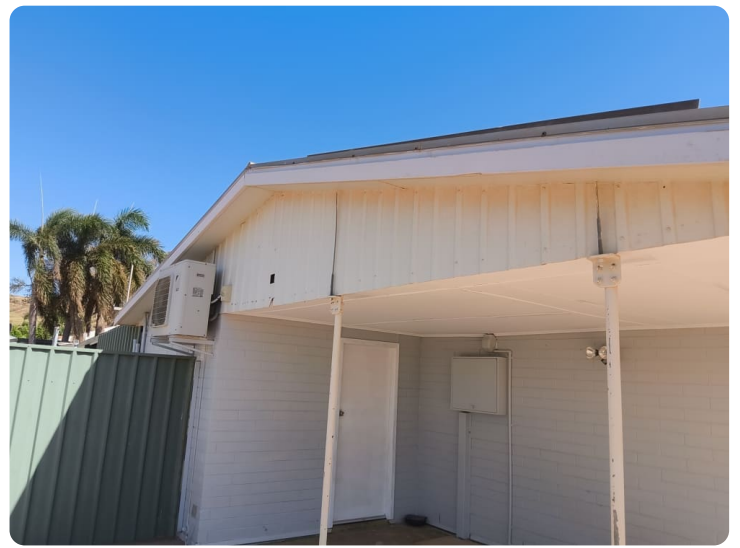
4. Gables

The gables are painted and constructed of fibre cement. The condition of the gables is fair in relation to its age and will require ongoing maintenance. Please note that some of the building material utilised on or within the building may or may not contain asbestos. The Australian Government has indicated that asbestos can only be correctly identified through laboratory testing. The material on this building site may not pose a concern in the current static state if maintained but for any future works the material should be tested and appropriate measures used for asbestos handling if the material is subsequently found to contain asbestos.

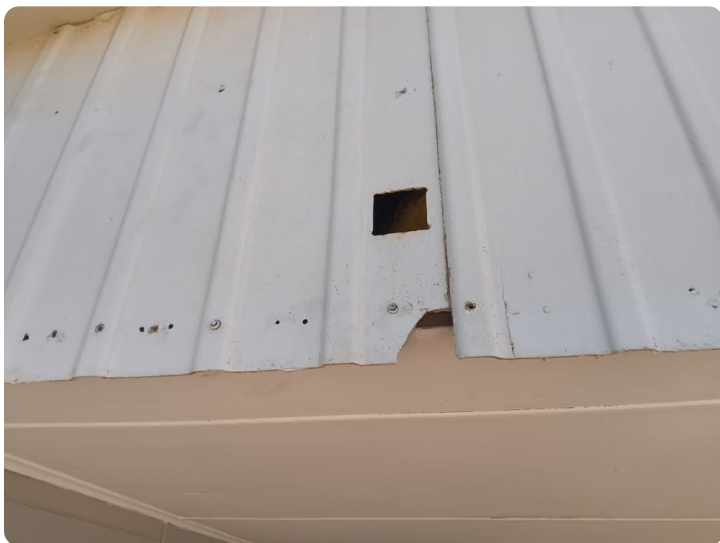
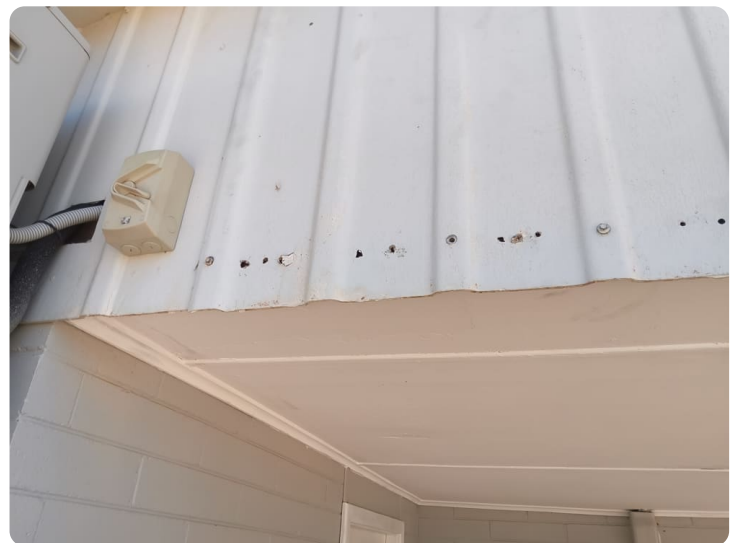
4.1 Gable fibre cement missing or damage

The fibre cement on the gable is missing or damaged. Repairs or replacement is recommended. The material should be tested, where required, and then a remediation plan established.

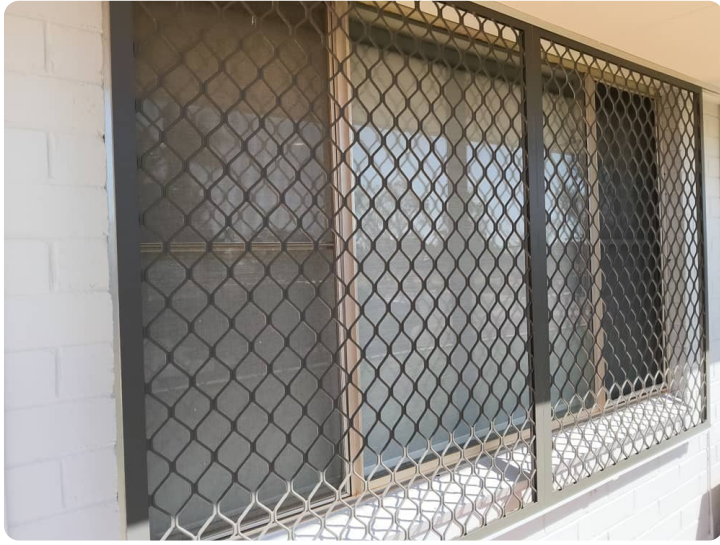
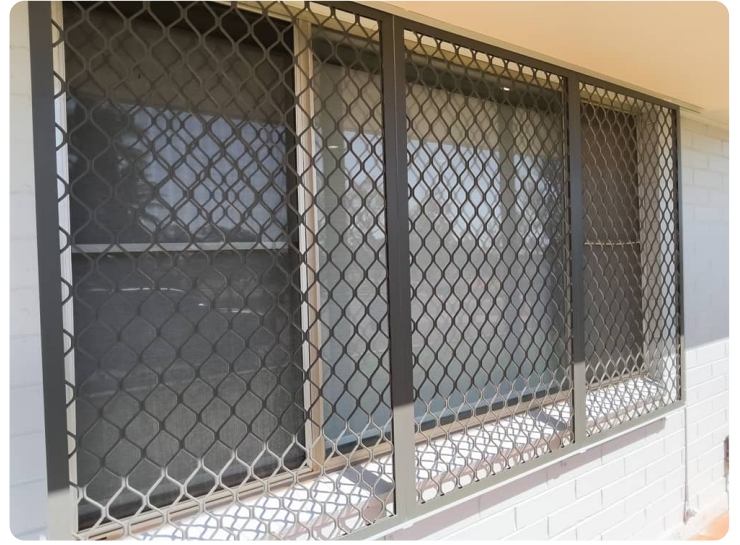
9. Windows and window frames

The window and window frames are primarily constructed of aluminium. The condition of the window and window frames is generally fair in relation to its age and will require ongoing maintenance.

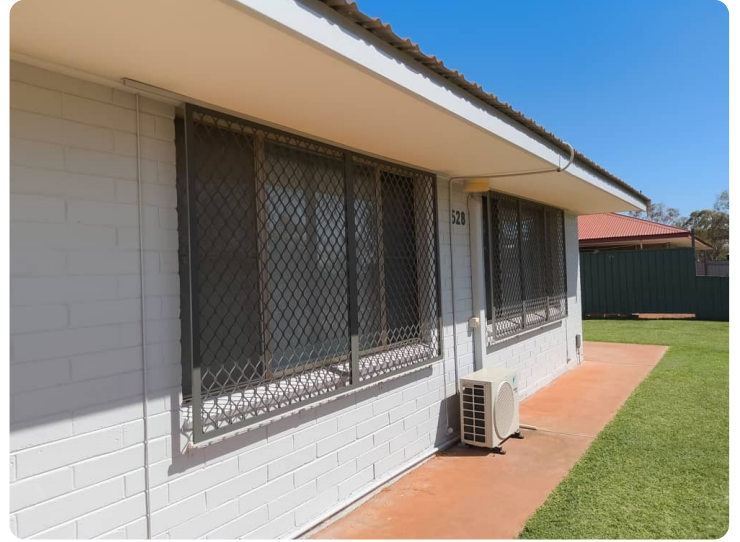
11. Cyclone screens

Cyclone screens have been installed to most of the windows. The condition of the cyclone screens is satisfactory in relation to its age and will require normal ongoing maintenance. The cyclone screens appear to be non compliant with local requirements.

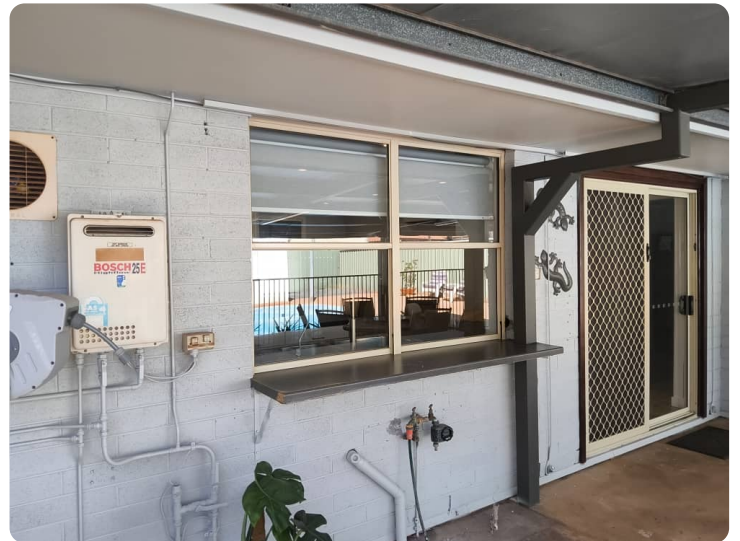
11.1 Cyclone screen missing

The cyclone screen is missing and requires replacement to meet local requirements.

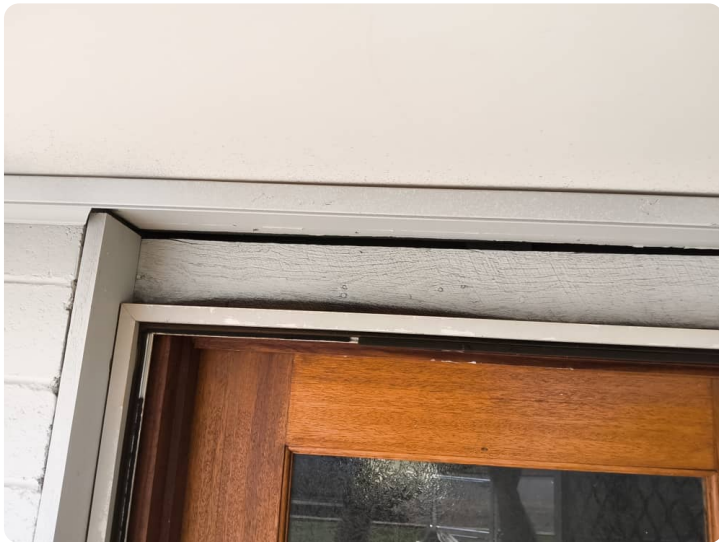
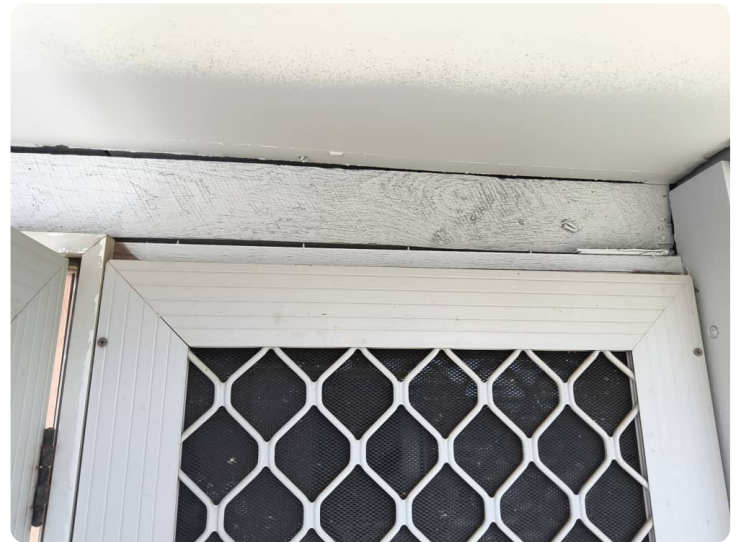
12.1 Door frame not sealed to eaves

The top section above the door frame is not sealed to the elements and water may egress into the wall. Repairs are required.

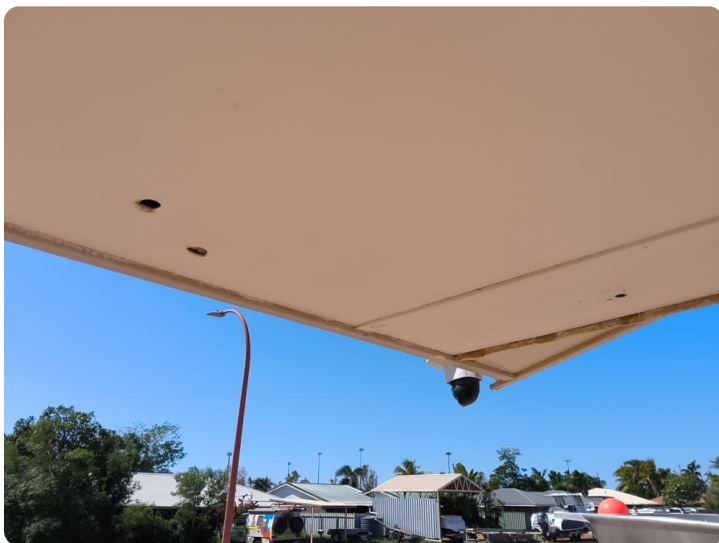
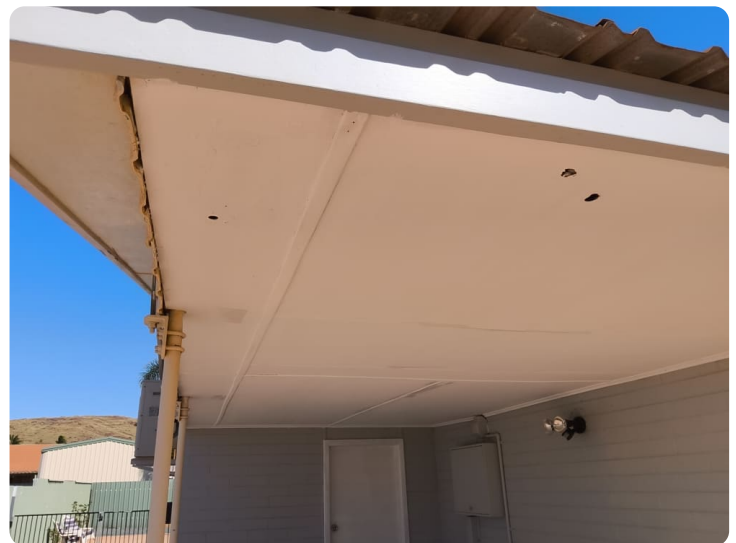
17.1 Fiber cement damage

There were hole in the fibre cement sheeting that should be patched and painted. The material should be tested, where required, and then a remediation plan established.

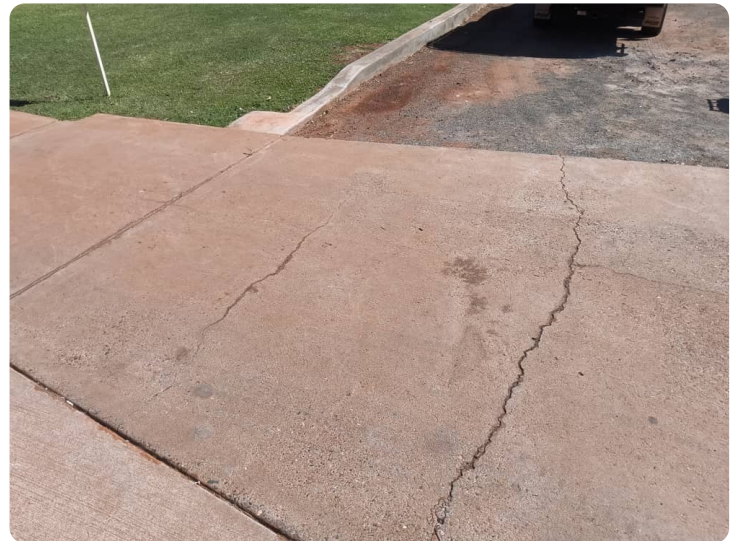
20.1 Concrete cracking - minor

Cracking was noted to the concrete driveway. This is not of a structural concern. Cracks should be filled to avoid further deterioration.

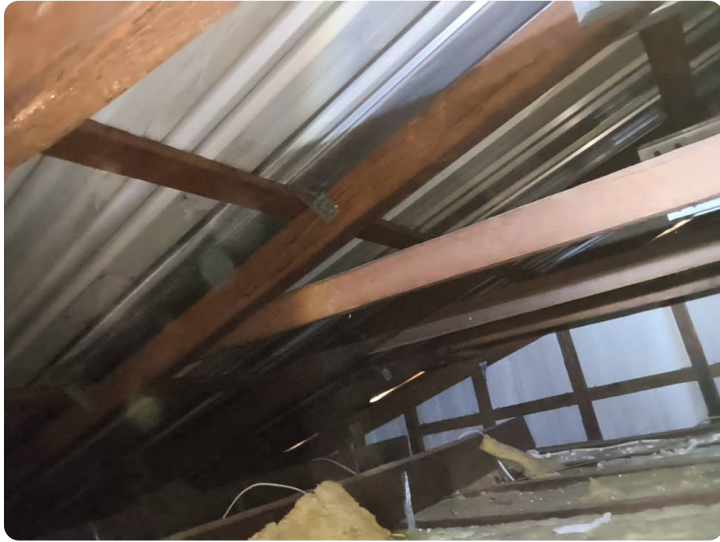
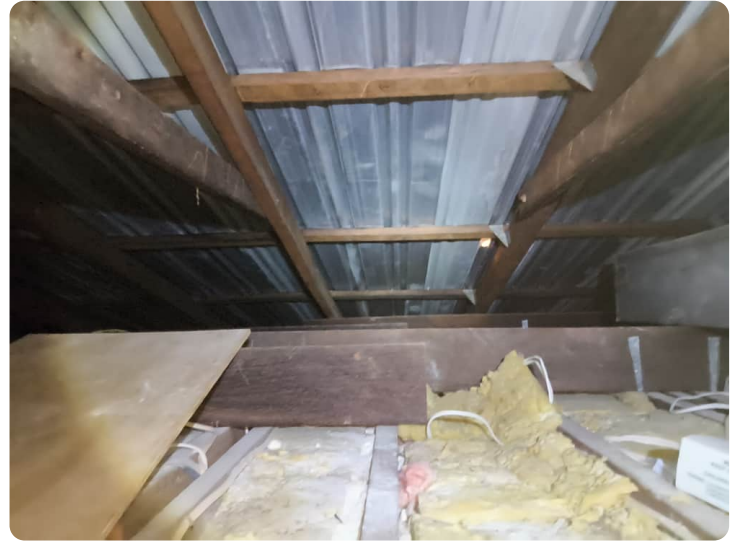
25. Under side of roof cover

The condition of the underside of the roof cover is fair in relation to its age and will require ongoing maintenance.

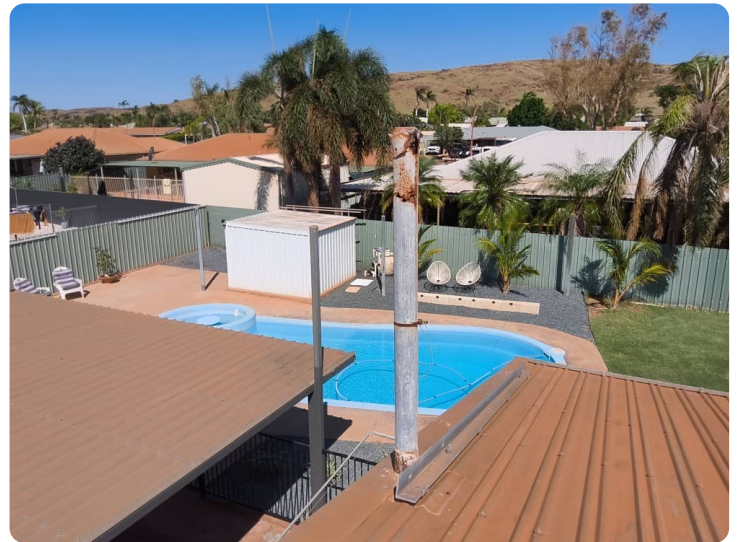
40.1 Sewer vent pipe damage

As per the images the sewer vent pipe is damaged and requires repairs or replacement by a plumber.
