**PILBARA  
PEST Co**

# Pre-Purchase Timber Pest Inspection Report

8 Leonard Way, Nickol WA, Australia

## Pre-Purchase Timber Pest Inspection (AS4349.3-2010)

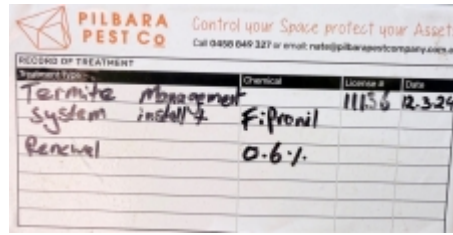
**Durable Notice Photos**

Description of the evidence found: Treatment sticker in meter box

Evidence of drilled holes in ground

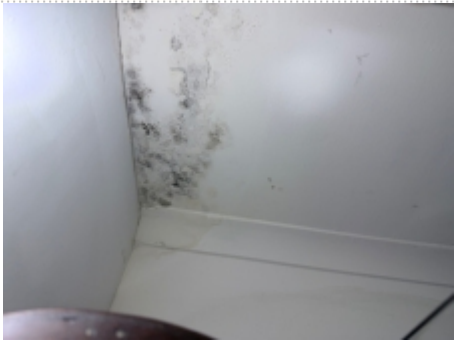
Mould found in dining room cupboard at the top on the ceiling. Buyer is aware and has had leak repaired that caused it to begin with.

Photo Comments      Mould found in dining room cupboard at the top on the ceiling buyer is aware and has had the leak repaired that caused the initial damage.
