# **Houspect**

**Building inspection**

**Job ID:** 92397

**Address:** 5 Edney Way, Pegs Creek WA

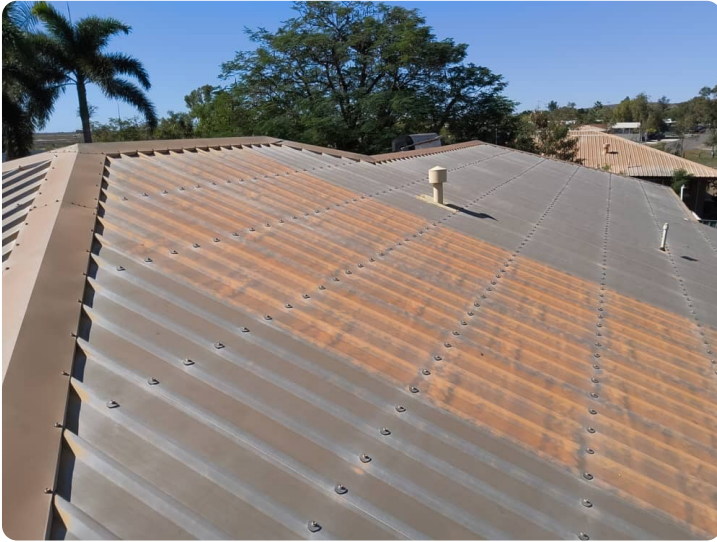
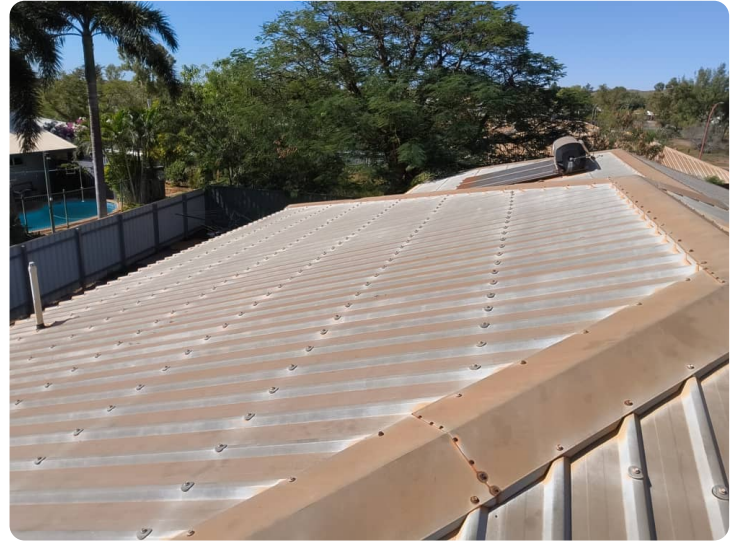
The roof covering is constructed of colorbond. The condition of the roof covering is satisfactory in relation to its age and will require normal ongoing maintenance.

### 1.1 Metal (colorbond) roof colour faded

As per the images the colorbond roof sheeting has or is losing its colour on most of the roof, leaving the zincalume finish. This is a cosmetic issue and does not diminish the sheets performance broader performance.

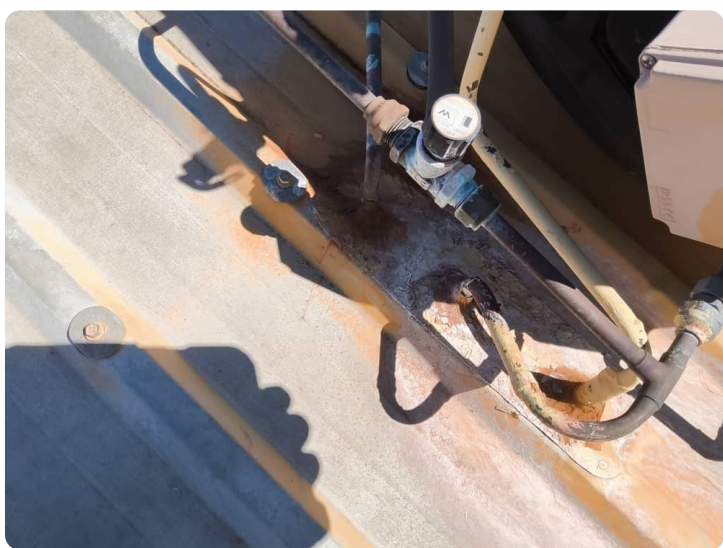
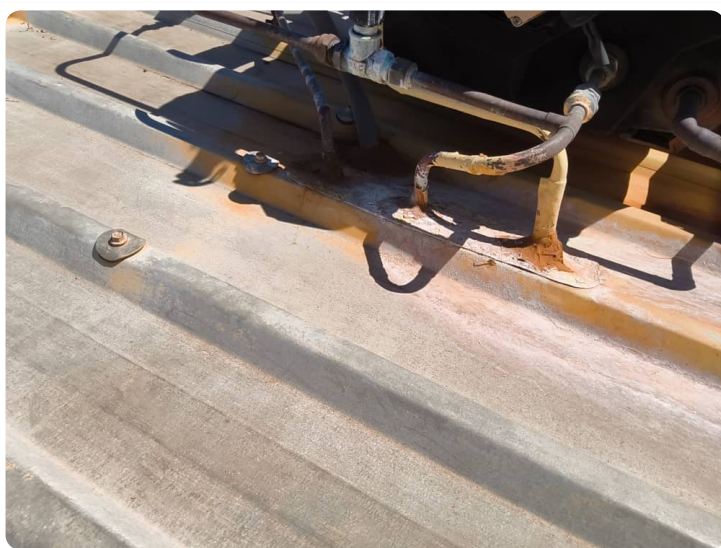
#### 3.1 Flashings general - only silicone

There is insufficient or no flashing installed around the roof penetrations which have only been silicone sealed. Installing flashing around these penetrations is recommended to prevent water ingress into the roof space.

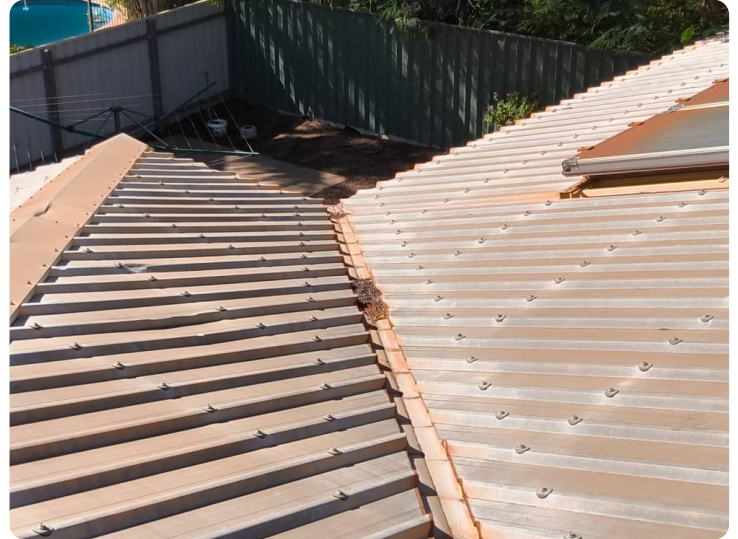
The valleys are constructed of metal and have a colorbond covering. The condition of the valleys is satisfactory in relation to their age and will require normal ongoing maintenance. The valleys need to be cleared of debris.

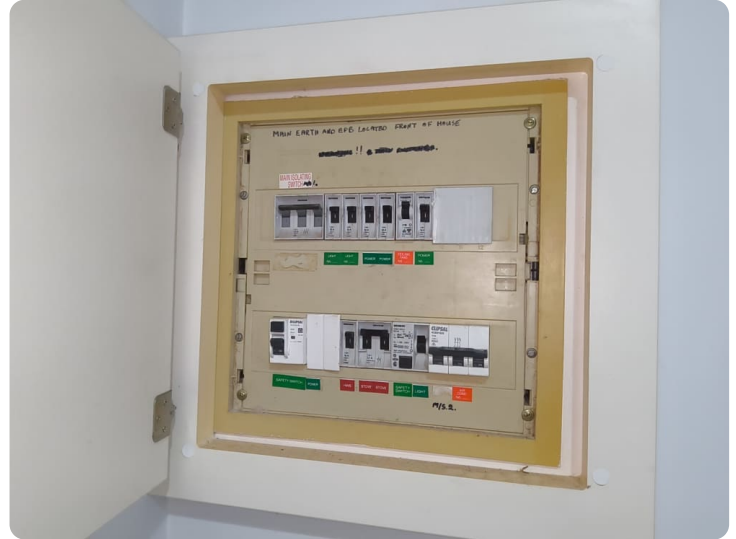
There were two Residual Current Devices (RCD)(s) noted in the meter box or sub meter box. The RCD(s) were not tested. It is suggested that an Electrical Compliance Certificate be obtained in relation to the RCD(s).

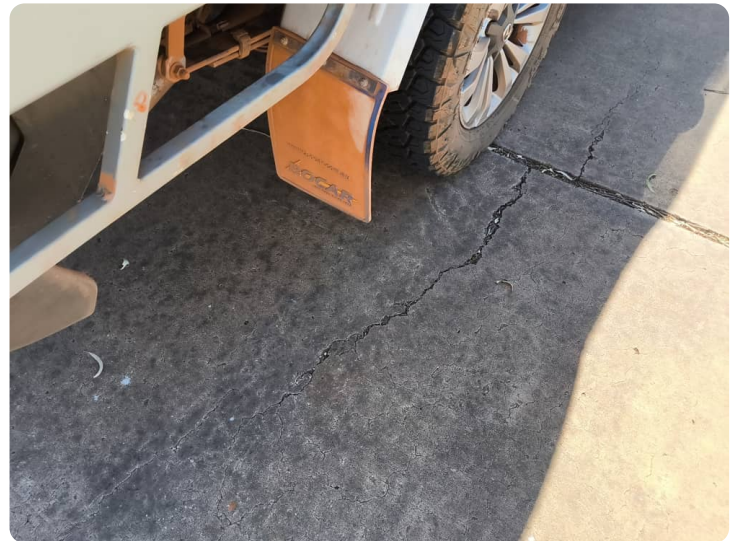
#### 23.1 Concrete cracking - minor

Cracking was noted to the concrete driveway. This is not of a structural concern. Cracks should be filled to avoid further deterioration.

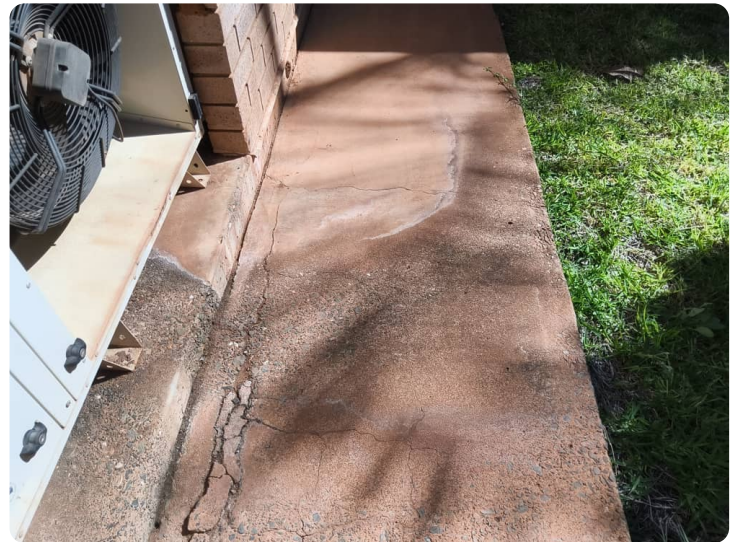
### 24.1 Cracking - major

Cracking was noted to the walkways. Repairs should be carried out to ensure the cracks do not become a trip hazard or cause further damage.

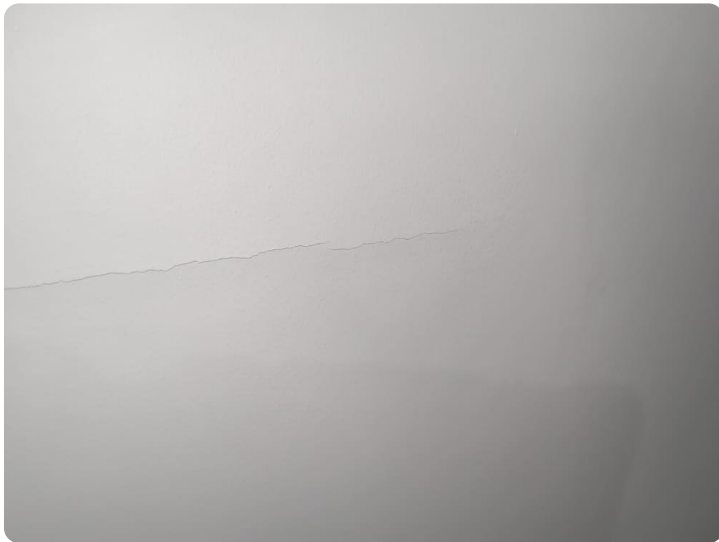
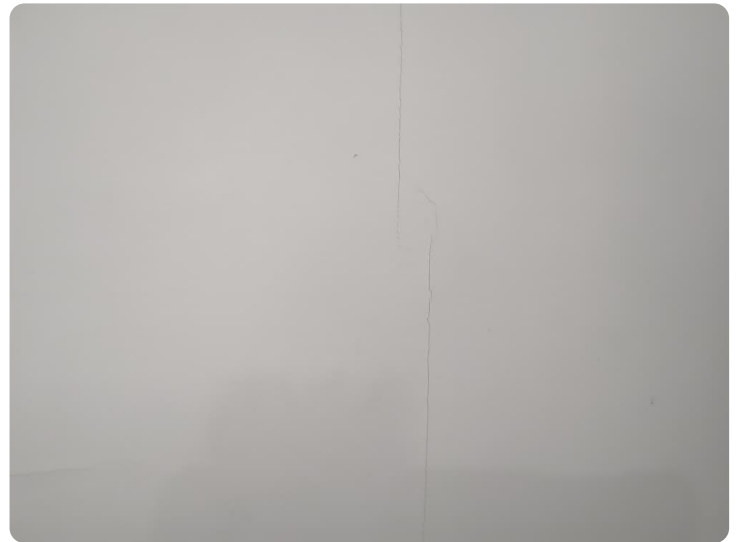
#### 31.1 Cracking - minor

There was some cracking visible that is consistent with the age and type of construction. The cracking is not of a structural nature. Patch and paint. Cracks should be monitored to ensure that they do not deteriorate. If deterioration occurs professional advice should be sought.

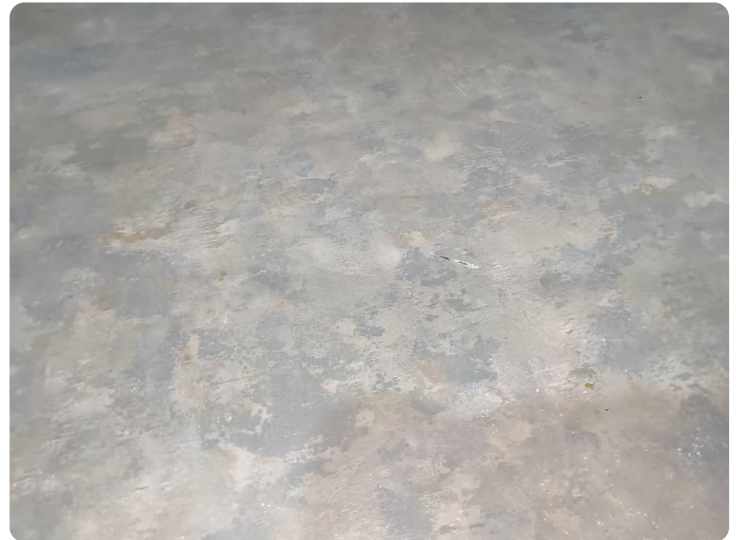
#### 36.1 Bench top damage

As per the images the kitchen benchtop is damage requiring repairs or replacement.

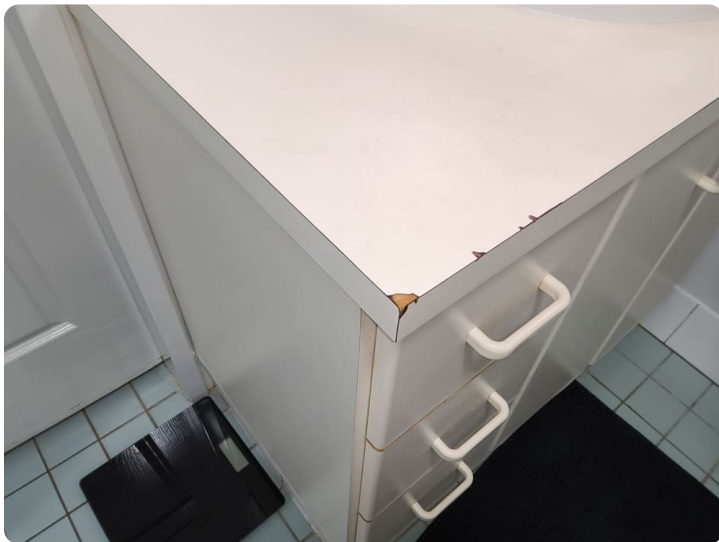
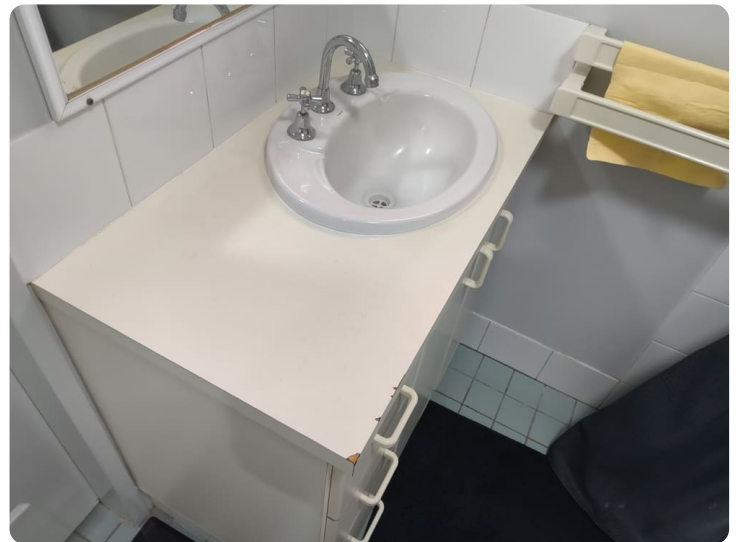
#### 38.1 Top damaged

As per the images the vanity benchtop is damage requiring repairs or replacement.
