**PILBARA  
PEST Co**

# Pre-Purchase Timber Pest Inspection Report

5 Edney Way, Pegs Creek WA, Australia

**AS 4349.3-2010: Inspection of Buildings - Timber Pest Inspections**

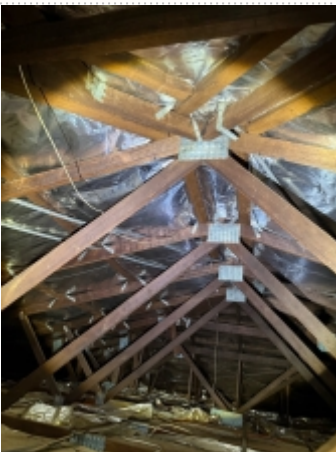
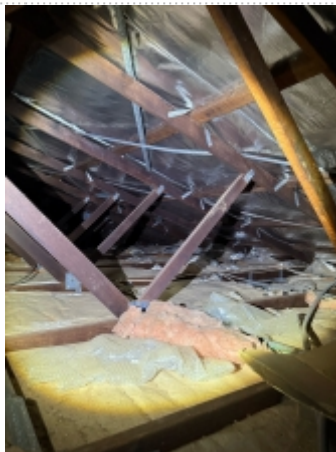
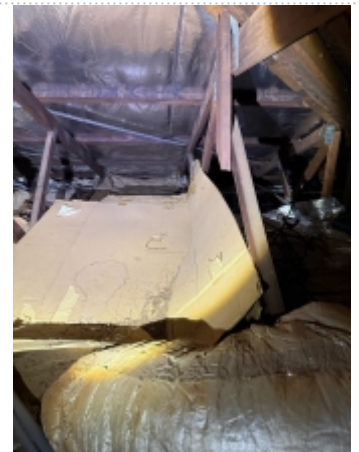
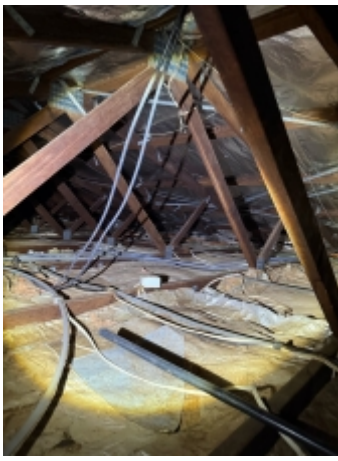
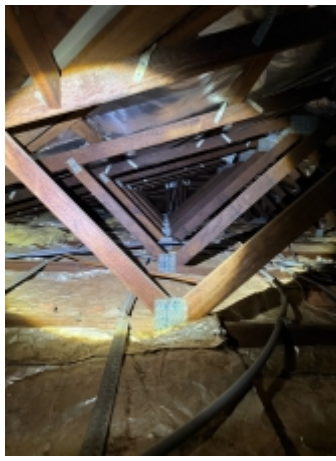
Fixtures, furniture and stored articles hinder access for inspection

It is important to note that as an inspection of the above areas was not possible at the time of the inspection, timber pest activity or damage may therefore exist in these areas.

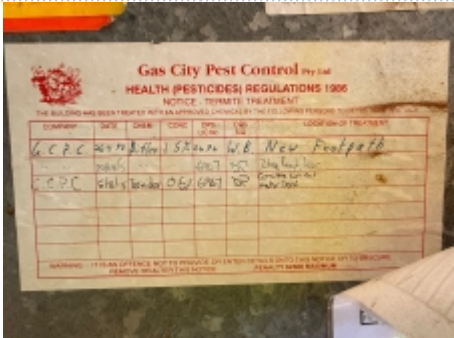
Description of the evidence found: Treatment sticker in meter box  
Evidence of drilled holes in ground

Photo Comments: Meterbox cut out treatment. No treatment to whole house only isolated treatment in 2015

Additional Comments: A termite management system is recommended to be installed

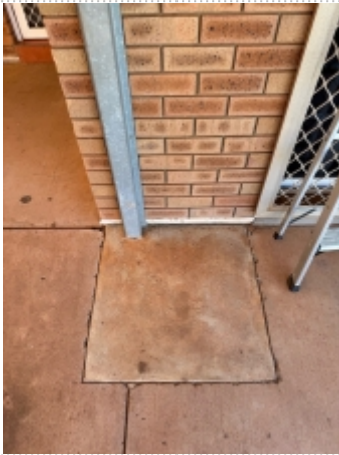
Photo Comments Previous termite treatment to cutout of front of house (2015)

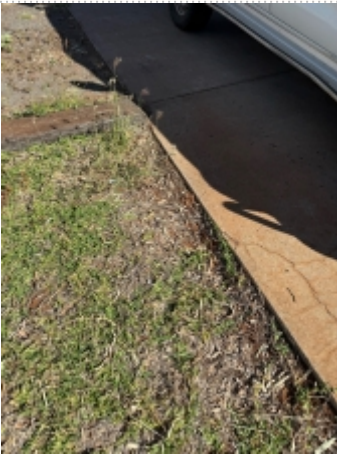
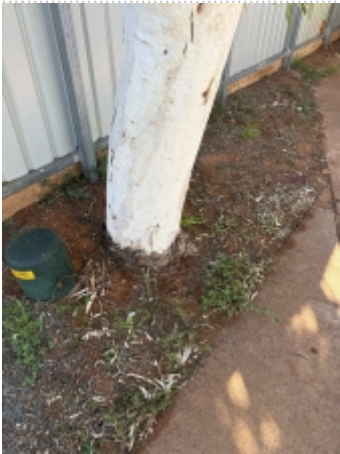
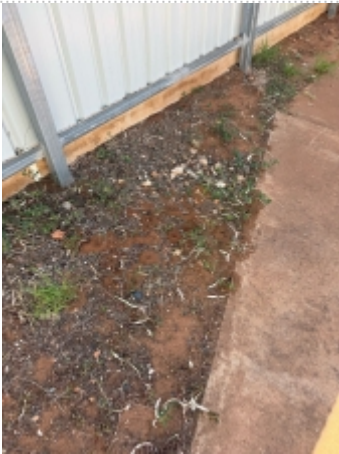
Photo Comments Ant mounds noticed at time of inspection
