# **Houspect**

### **Pre purchase inspection**

**Job ID:** 92886

**Address:** 3/31 Withnell Way, Bulgarra WA 6714

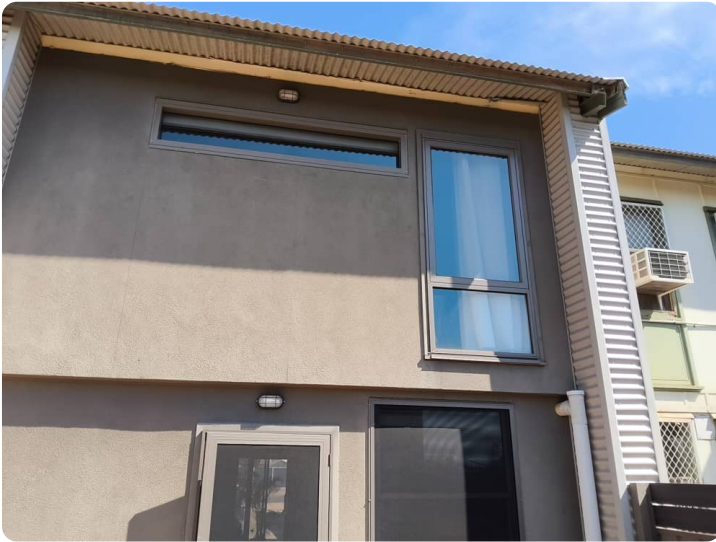
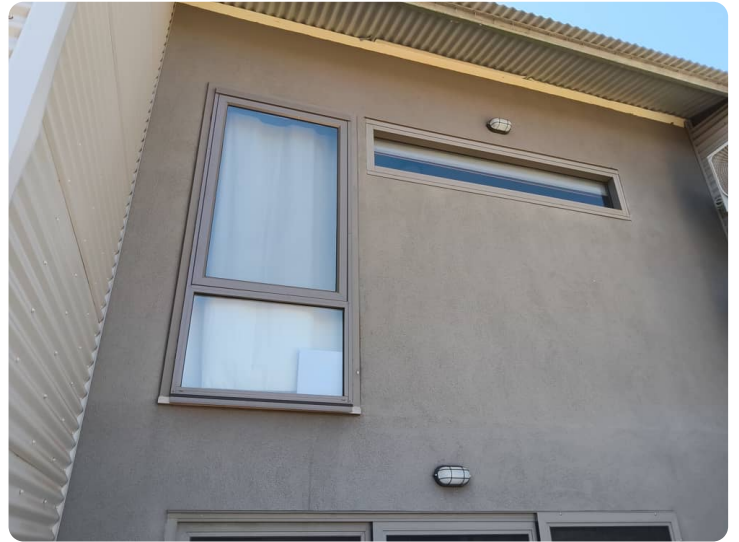
## 9. Cyclone screens

Cyclone screens have been installed to none of the windows. The condition of the cyclone screens is poor in relation to its age. The cyclone screens appear to be non compliant with local requirements.

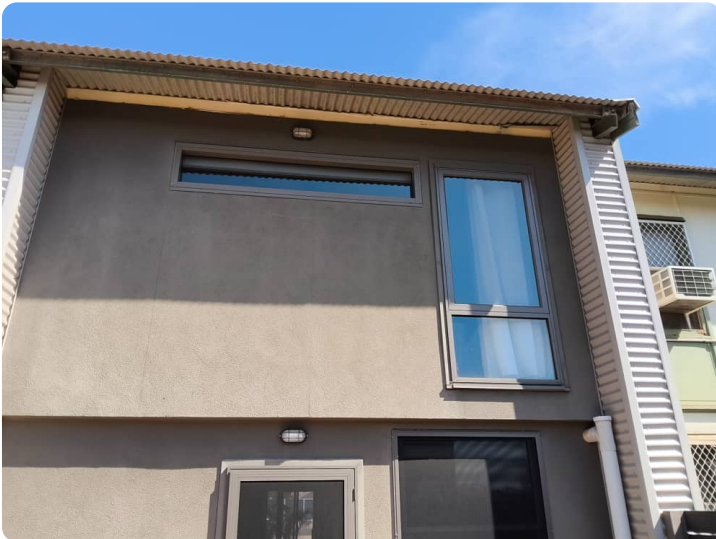
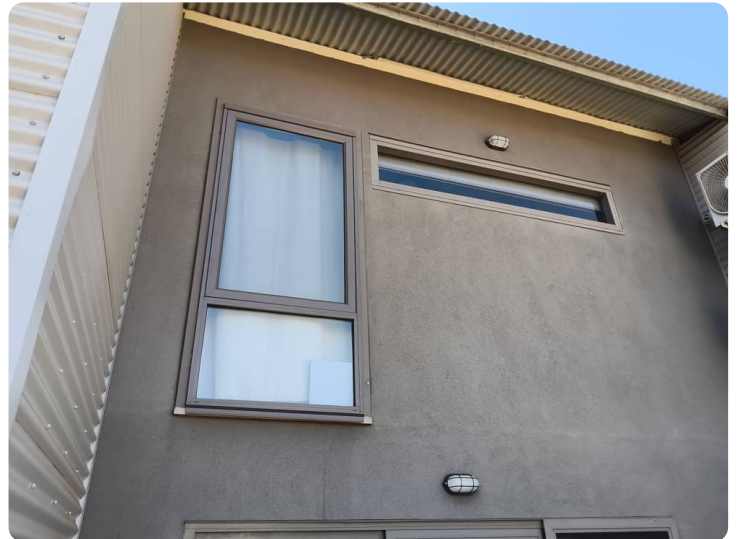
### 9.1 Cyclone screen missing

**Issue flag:** Safety Item

The cyclone screen is missing and requires replacement to meet local requirements.

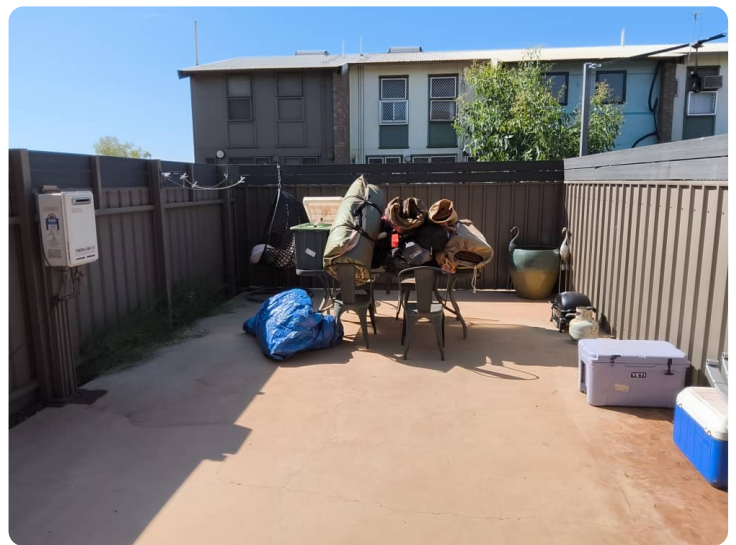
### 12.1 Store room not available

#### Issue flag: Safety Item

There is no external storeroom on site. Under local building requirements a storeroom is required for all properties.

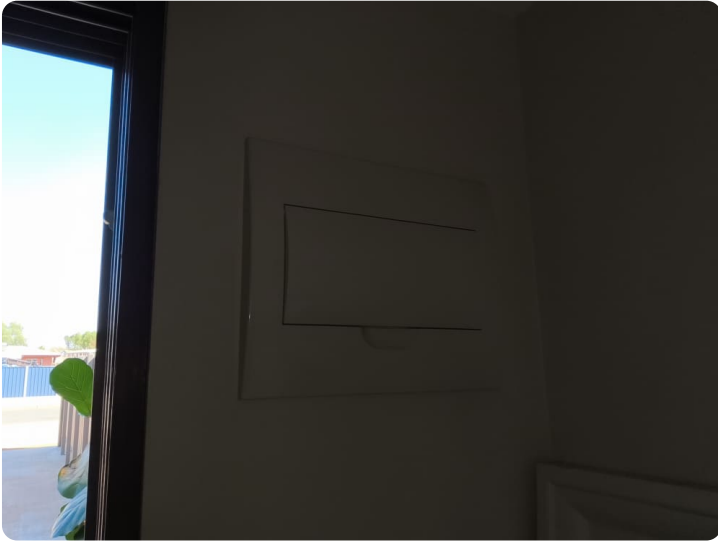
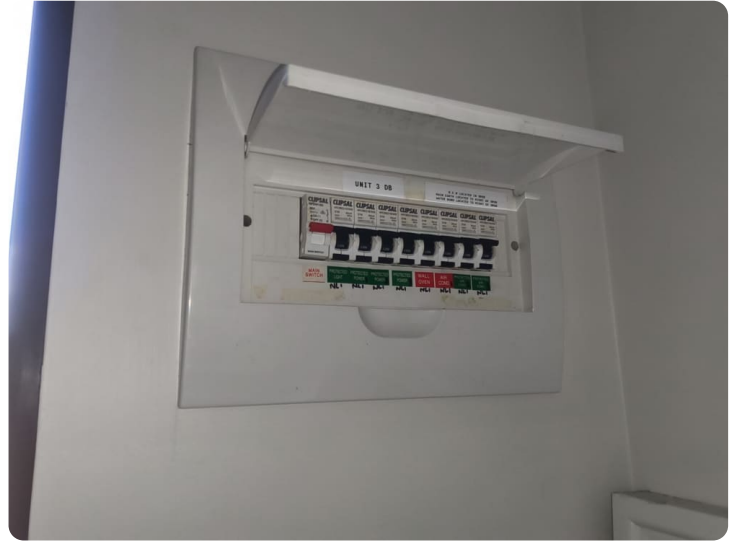
#### 14. Residual Current Devices

There were multiple Residual Current Devices (RCD)(s) noted in the meter box or sub meter box. The RCD(s) were not tested. It is suggested that an Electrical Compliance Certificate be obtained in relation to the RCD(s).

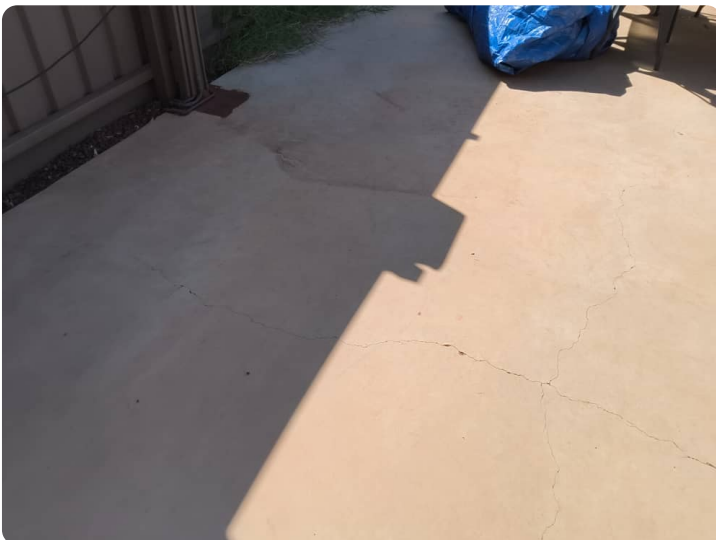
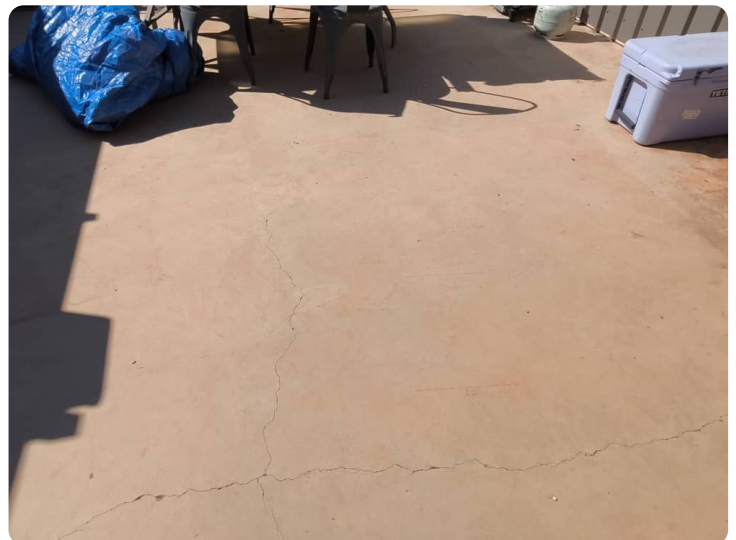
### 17.1 Cracking - minor

There was some cracking visible that is consistent with the age and type of construction. The cracking is not of a structural nature but the cracks should be sealed to stop water from entering the structure and causing further damage. Cracks should be monitored to ensure that they do not deteriorate. If deterioration occurs professional advice should be sought.

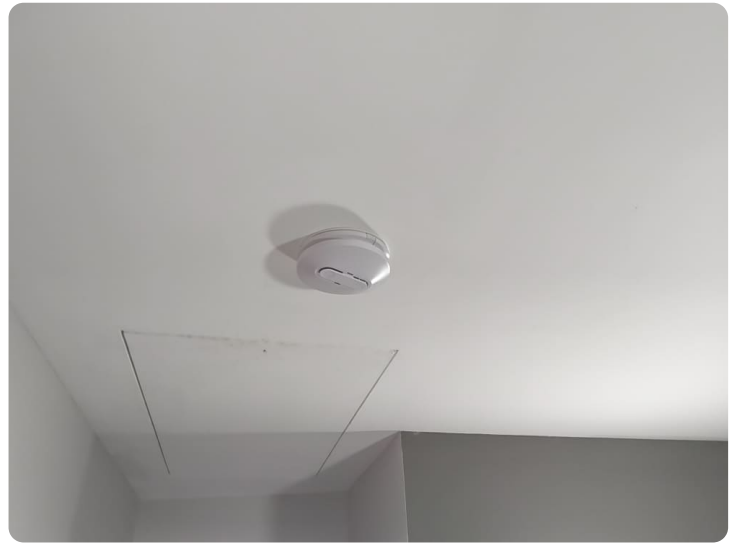
### 35. Smoke Alarms

There was one hardwired smoke alarms on site. There were no battery smoke alarms on site. The location, number and type of smoke alarms appeared to be consistent with Legislative requirements. It is suggested that an Electrical Compliance Certificate be obtained in relation to the smoke alarms.
