# **Houspect**

**Building inspection**

**Job ID:** 92365

**Address:** 2 Cowan Way, Pegs Creek WA

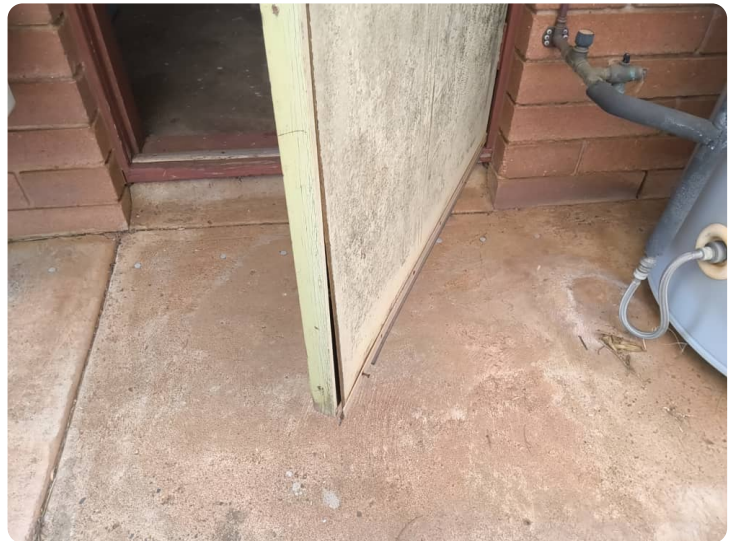
### 16.1 Door weathered

The door in the images is weathered and needs repairs or replacing.

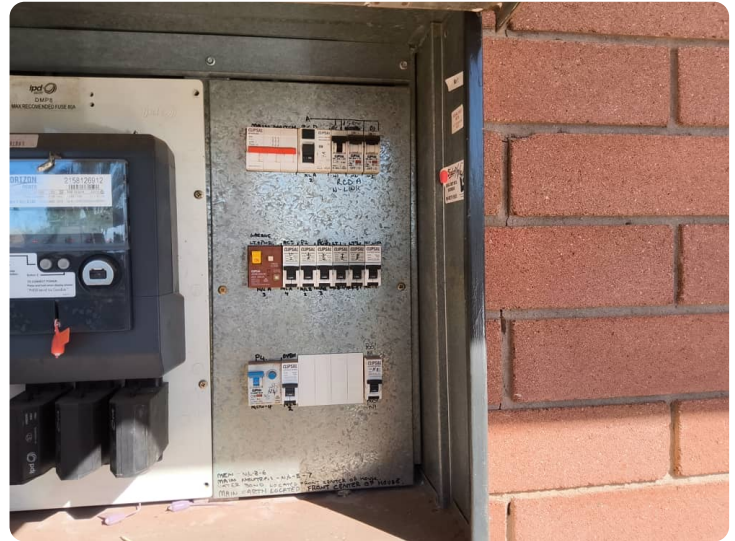
## 18. Residual Current Devices

There were multiple Residual Current Devices (RCD)(s) noted in the meter box or sub meter box. The RCD(s) were not tested. It is suggested that an Electrical Compliance Certificate be obtained in relation to the RCD(s).

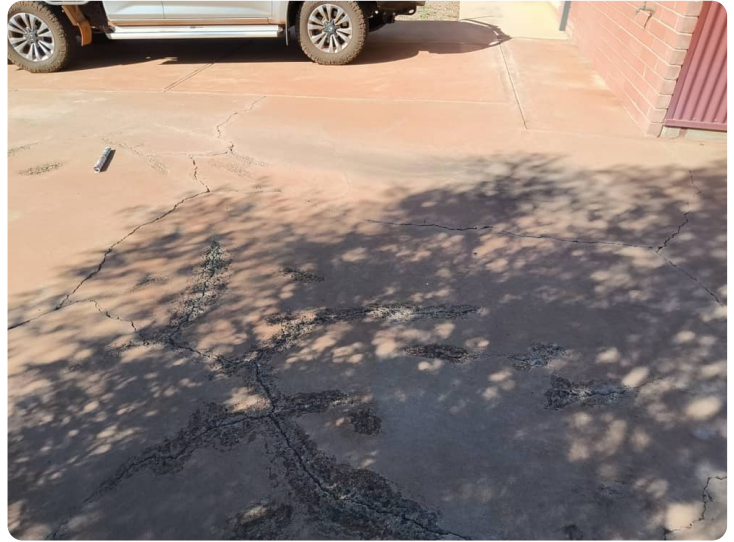
## 24. Driveway

The driveway and cross over is constructed of concrete. The condition of the driveway is fair in relation to its age and will require ongoing maintenance.

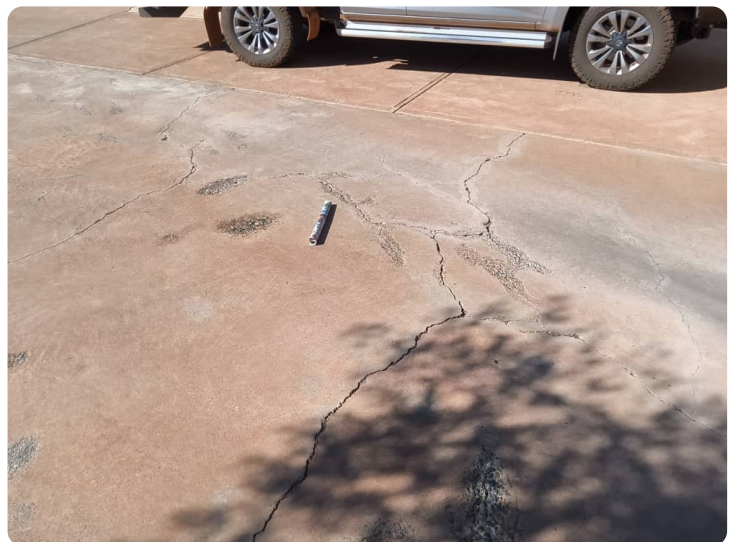
### 24.1 Concrete cracking - major

Significant cracking was noted to the concrete paving. This is not of a structural concern however repairs are required.

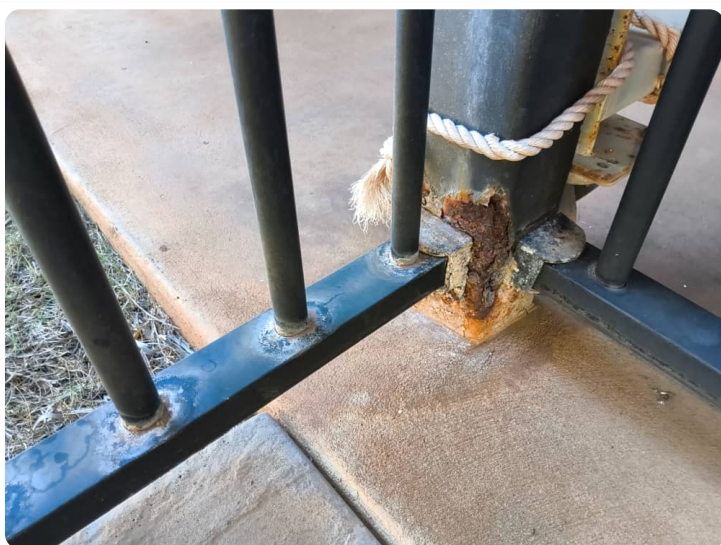
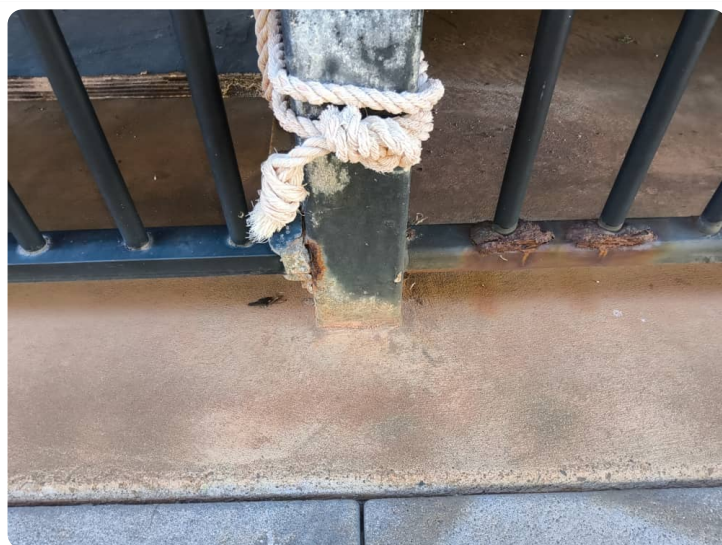
### 28.1 Pool fence rusting minor

The pool fence is rusting action should be taken to prolong it life. Remediation work should be undertaken as required.

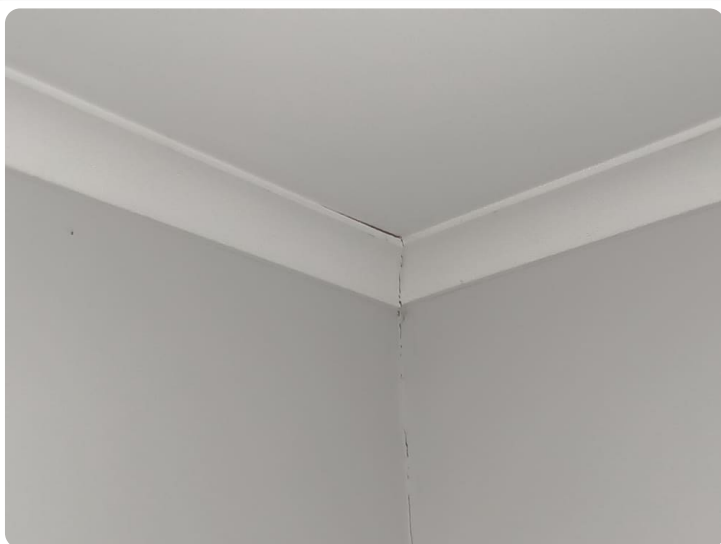
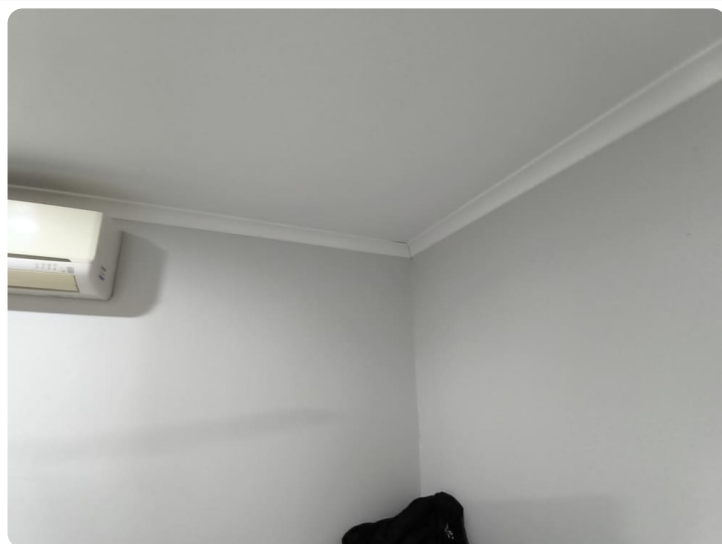
#### 33.1 Cornice cracking - minor

Cornice cracking noted likely due to thermal contraction and expansion and or settlement and is not a structural issue. Patch and paint as required.
