# Pre-Purchase Timber Pest Inspection Report

**In Accordance with AS 4349.3**

2 Cowan Way, Pegs Creek WA, Australia

08 Jul 2026

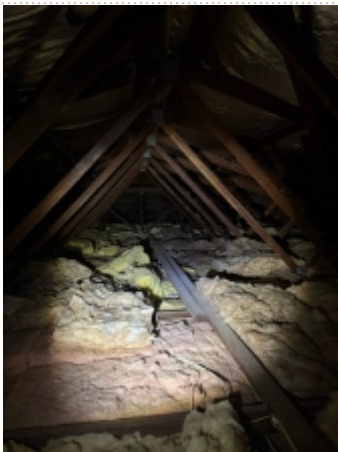
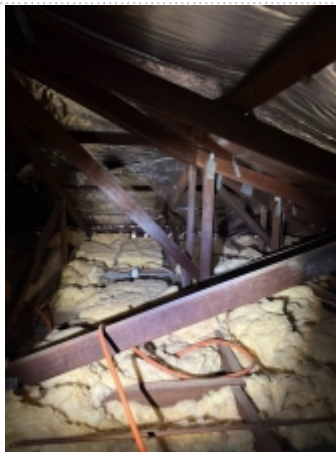
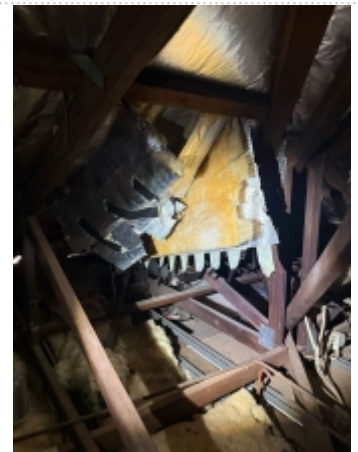
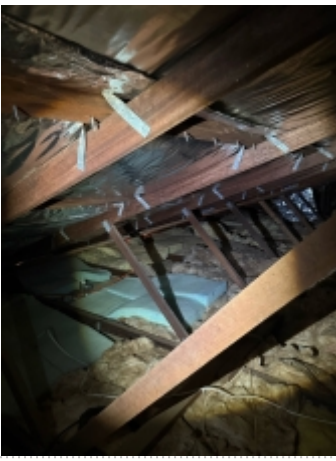
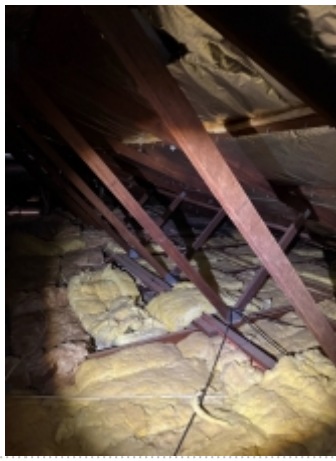
Sarking, insulation hinder inspection view

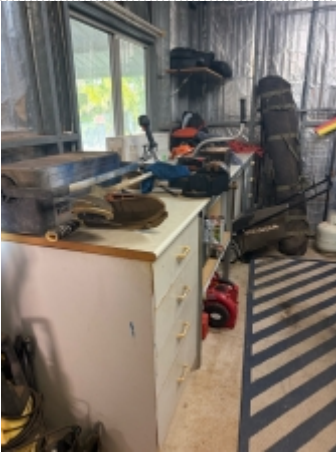
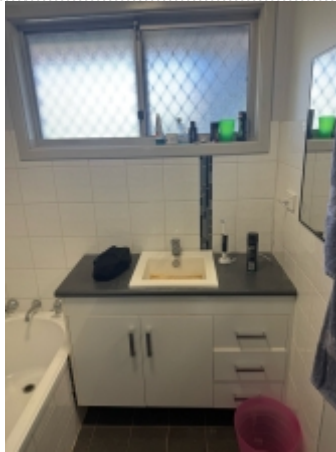
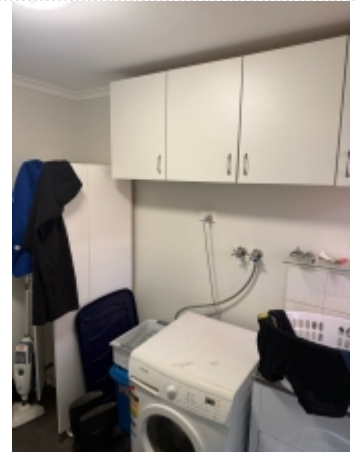
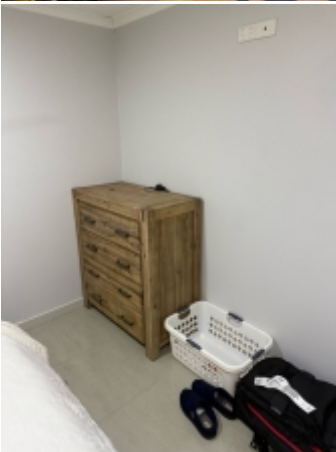
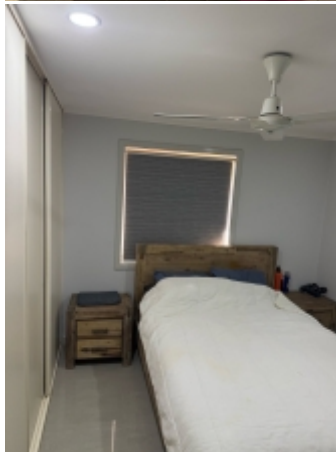
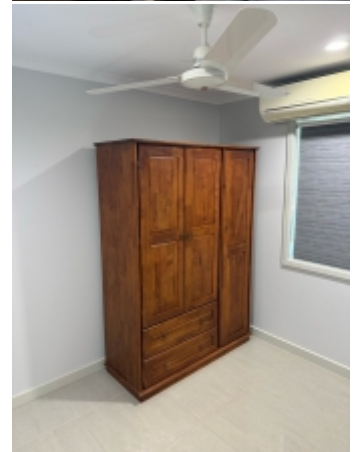
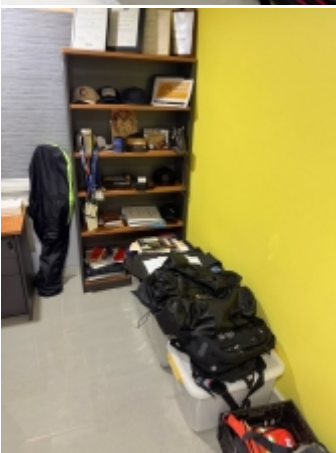
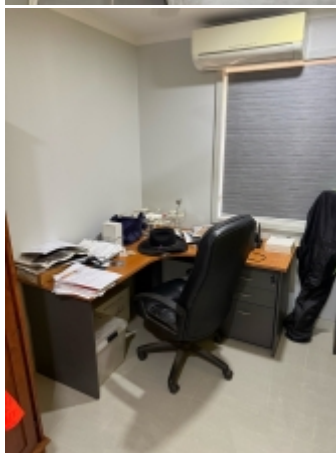
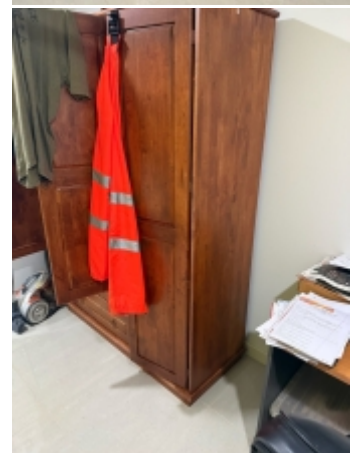
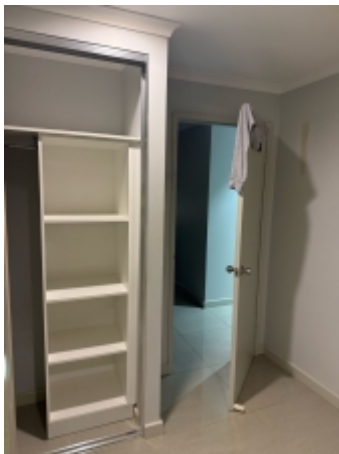
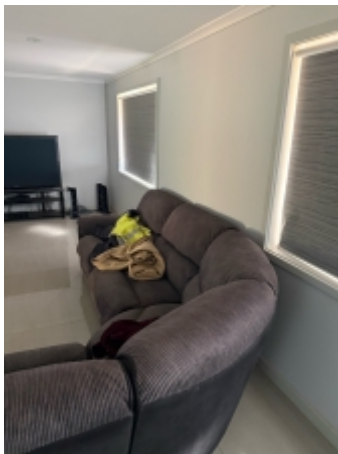
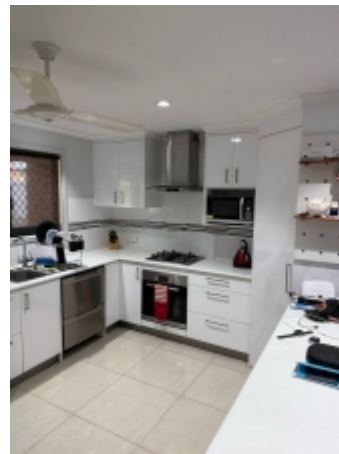
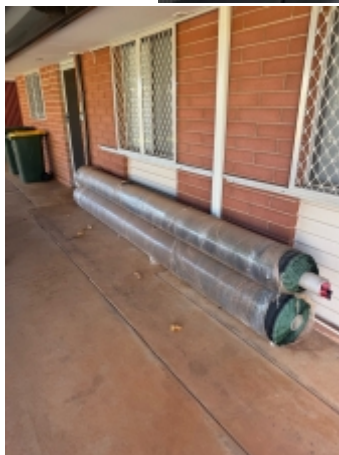
Internal areas with furniture, fixtures and stored goods hinder view for inspection

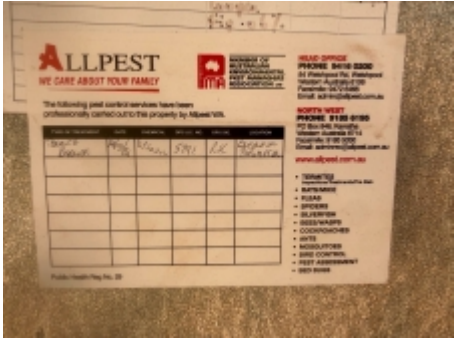
Durable Notice Photos

Was a durable Notice found at the time of this inspection? Yes

Date of Treatment: (if known) 26 Mar 2021

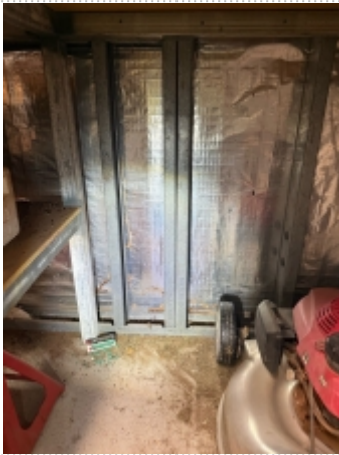
Pre-existing termite workings in shed. No live termites at time of inspection.

Is a termite treatment recommended? Yes

Additional Comments: The termite management system is recommended to be renewed

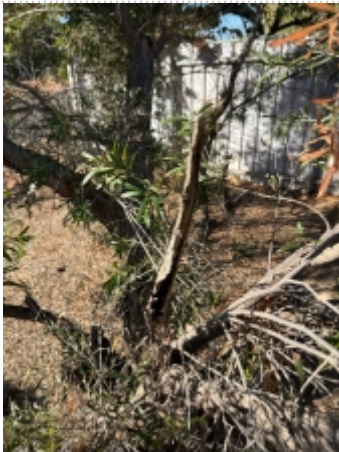
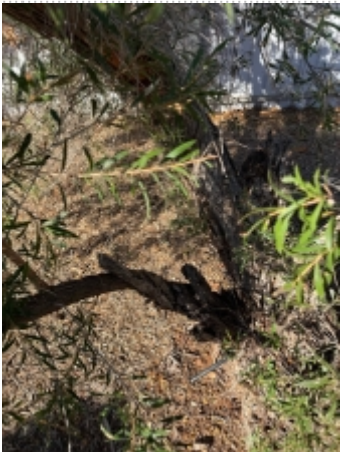
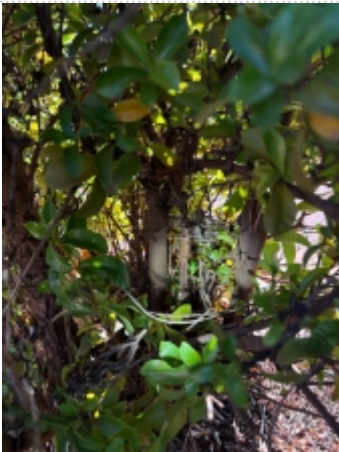
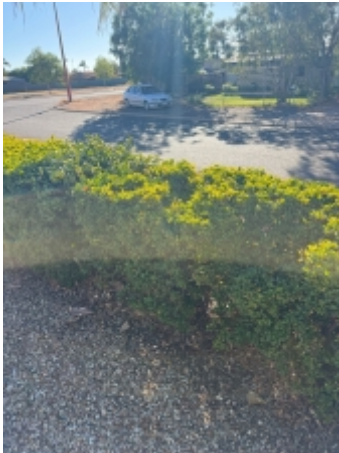
Pre-existing termite workings in shrub and tree at front of yard

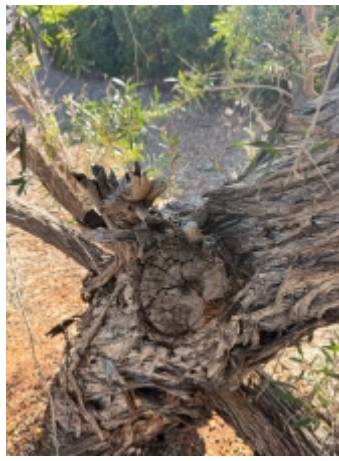
The borers found at the time of inspection appear to be: Undetermined

Borer holes at front of yard tree
