Building inspection

Job ID: 90916

Address: 13 Pymn Court, Pegs Creek WA

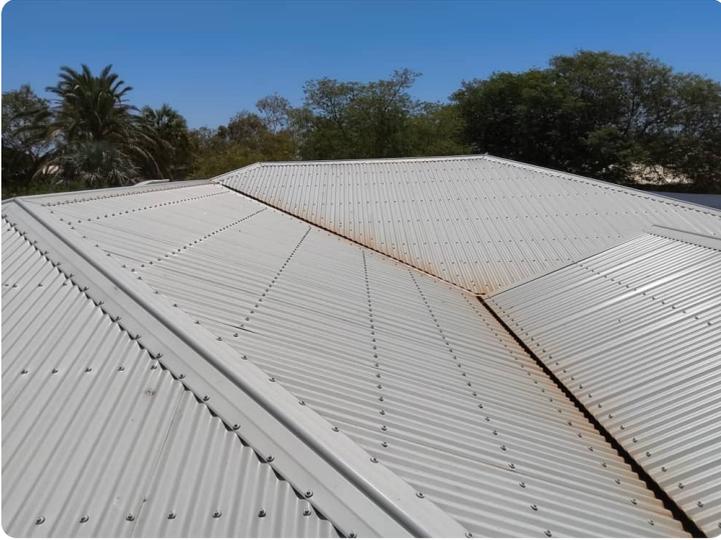
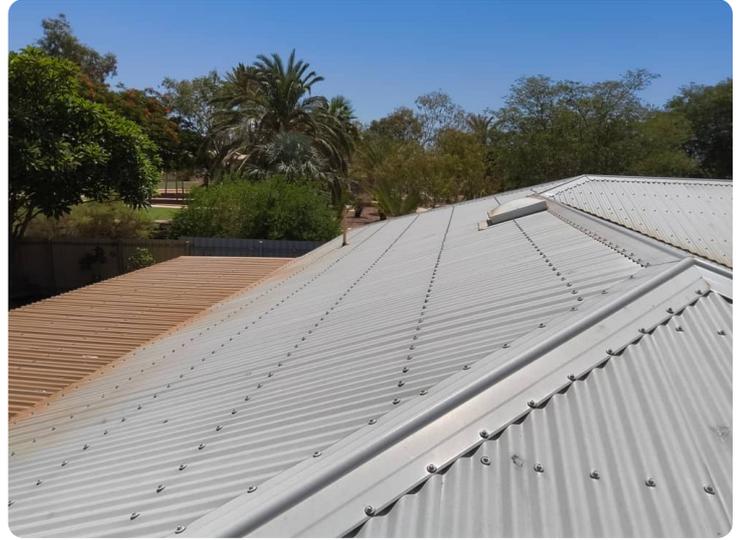
1. Roof covering

The roof covering is constructed of colorbond. The condition of the roof covering is satisfactory in relation to its age and will require normal ongoing maintenance.

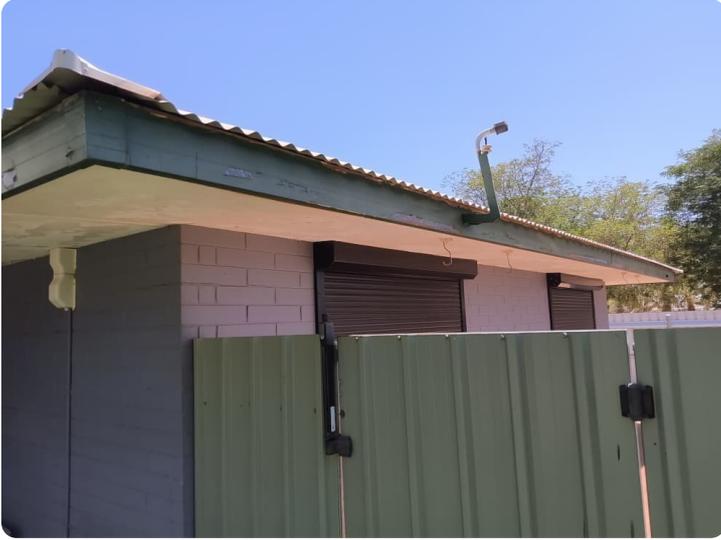
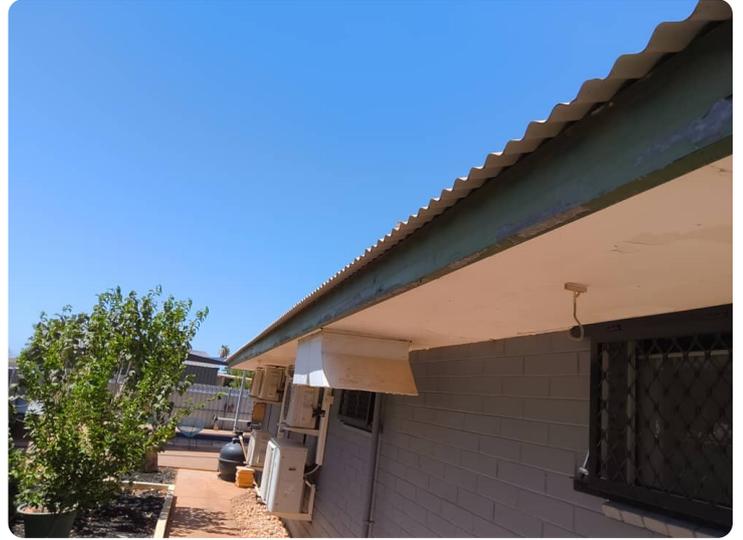
6. Fascia

The fascia are constructed of metal and they are weathered. The condition of the fascia is fair in relation to its age and will require ongoing maintenance.

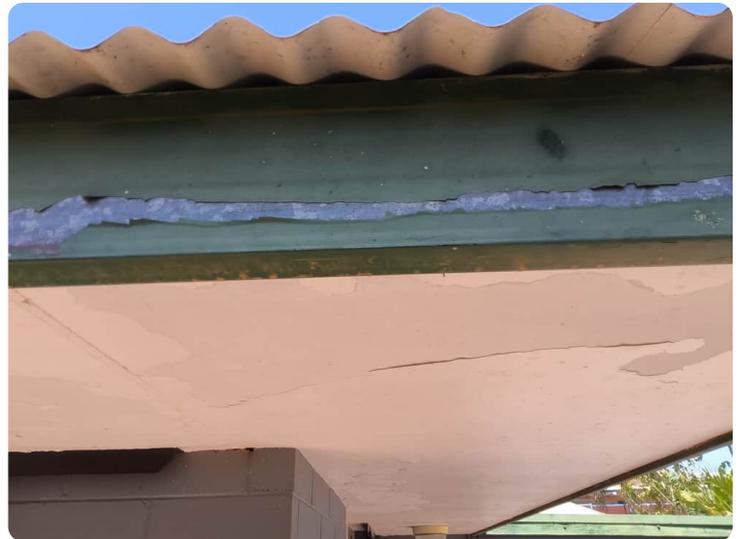
6.1 Fascia general peeling paint

There was peeling paint noted to the fascia. Recommended fascia is repainted.

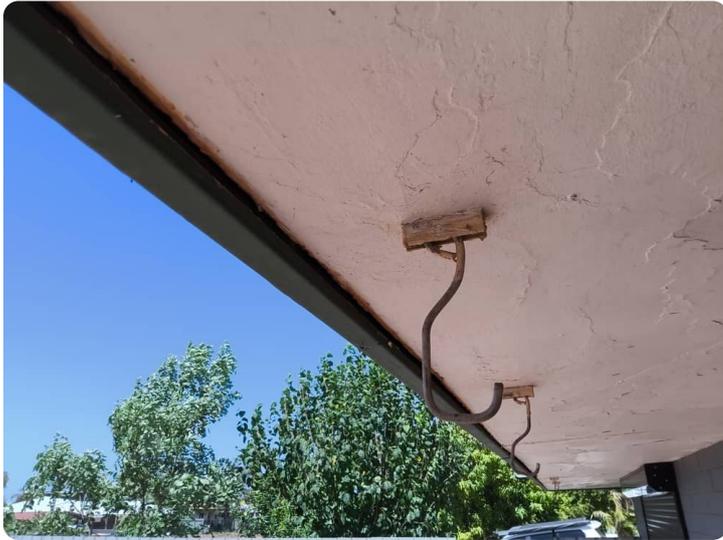
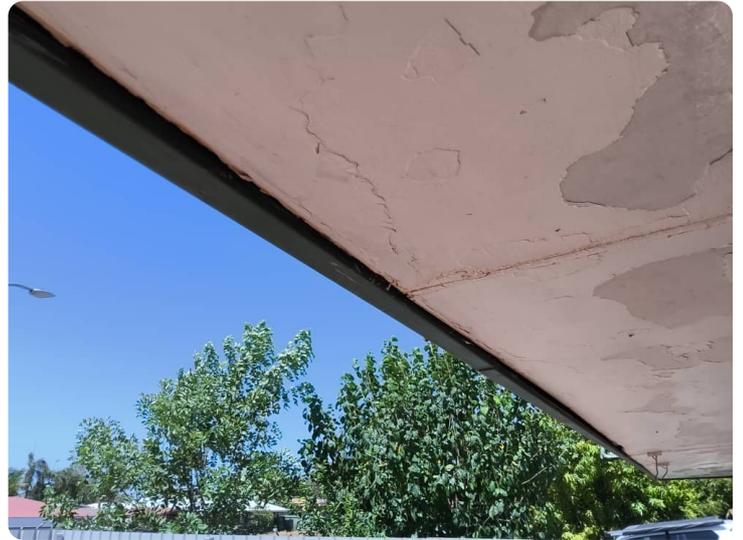
6.2 Fascia movement and roof sagged

As per the images a section of the fascia has moved and requires to be repositioned and secured. Sections of the roof frame have sagged and affect the levels of the fascia, requiring additional support and to rectify levels. Variations affect drainage to gutters and are a visible defect.

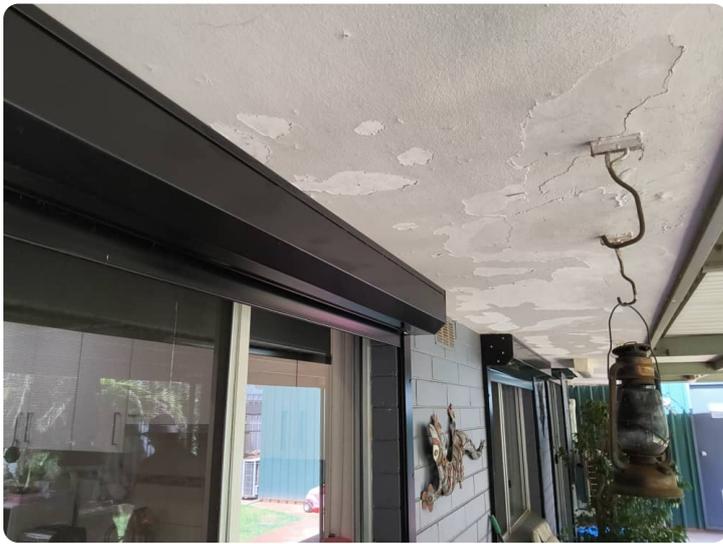
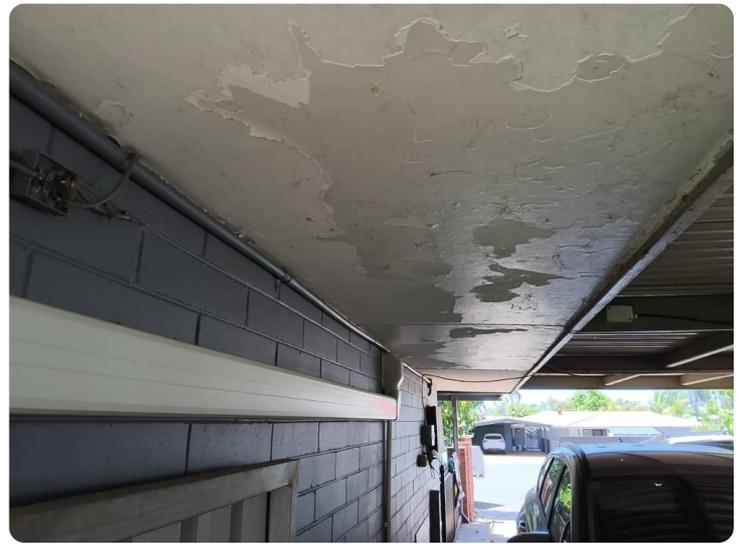
7. Eaves

The eaves are boxed and constructed of painted fibre cement. The condition of the eaves is fair in relation to its age and will require ongoing maintenance. Please note that some of the building material utilised on or within the building may or may not contain asbestos. The Australian Government has indicated that asbestos can only be correctly identified through laboratory testing. The material on this building site may not pose a concern in the current static state if maintained but for any future works the material should be tested and appropriate measures used for asbestos handling if the material is subsequently found to contain asbestos.

The eaves are weathered and need to be repainted. The material should be tested where required and then a remediation plan established.

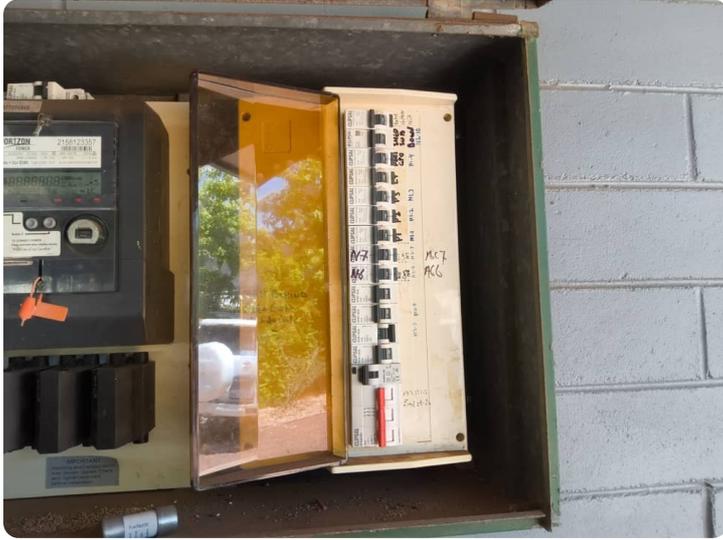
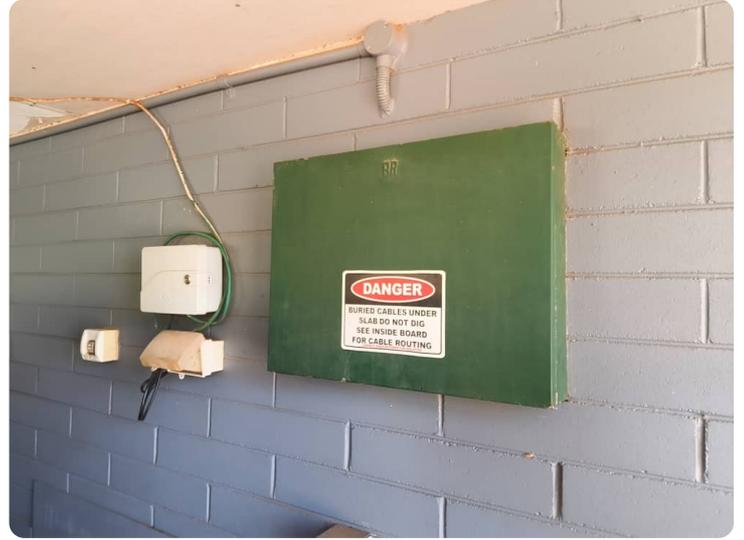
16. Residual Current Devices

There were multiple Residual Current Devices (RCD)(s) noted in the meter box or sub meter box. The RCD(s) were not tested. It is suggested that an Electrical Compliance Certificate be obtained in relation to the RCD(s).

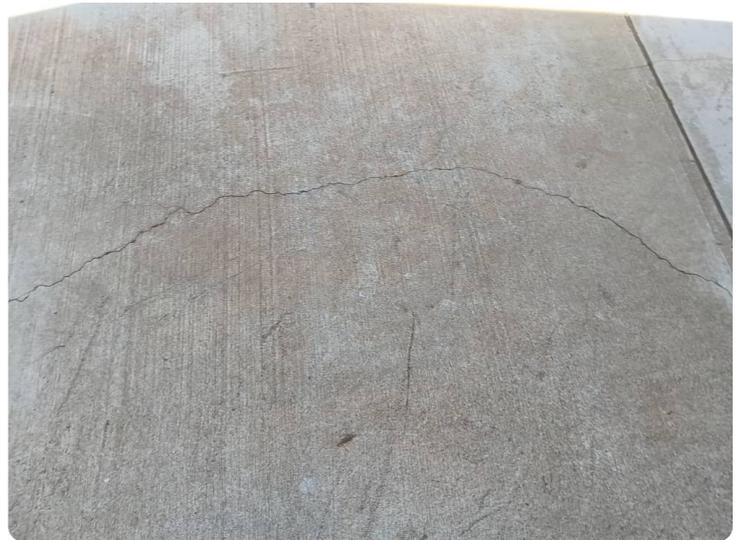
21.1 Concrete cracking - minor

Cracking was noted to the concrete driveway. This is not of a structural concern. Cracks should be filled to avoid further deterioration.

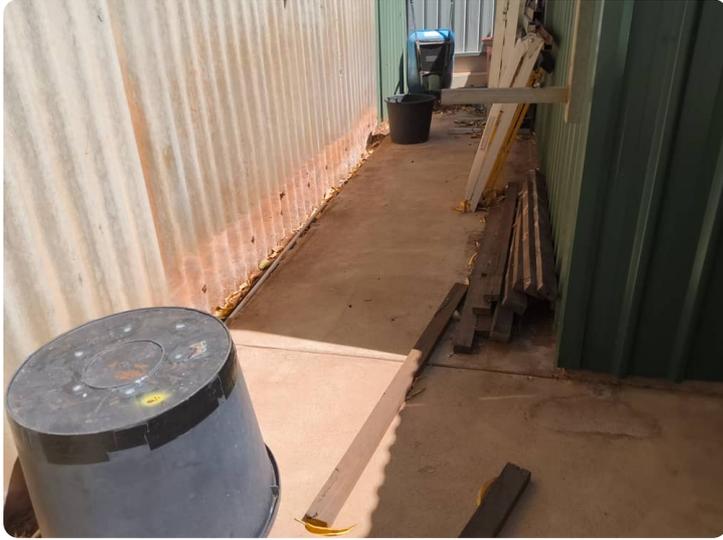
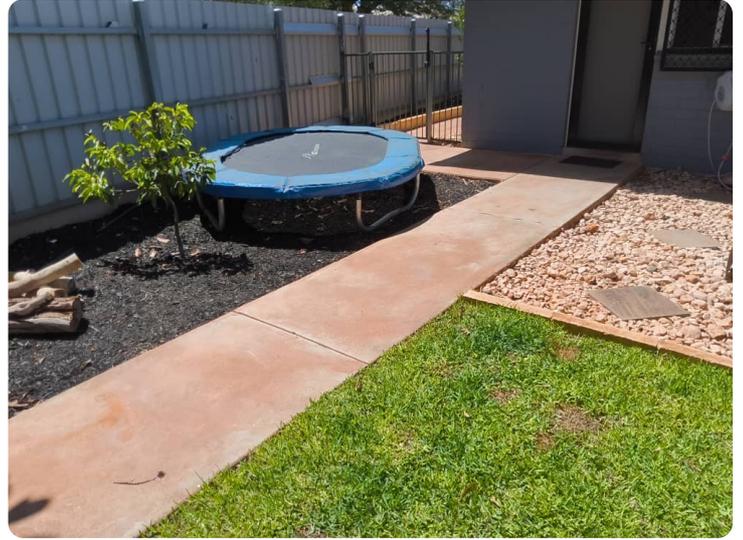
22. External walkways and paved areas

The external walkways and paved areas are constructed of concrete. The condition of the external walkways and paved areas is fair in relation to its age and will require ongoing maintenance.
