**PILBARA  
PEST Co**

# Pre-Purchase Timber Pest Inspection Report

13 Prymn Court, Pegs Creek WA 6714, Australia

21 Jan 2026

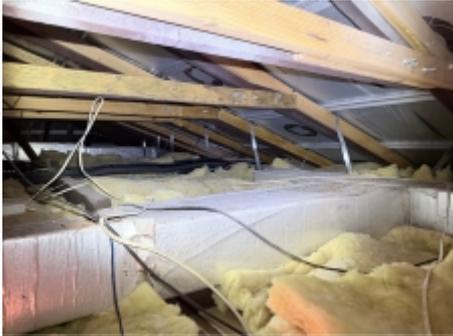
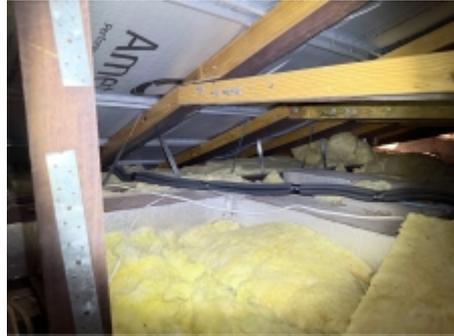
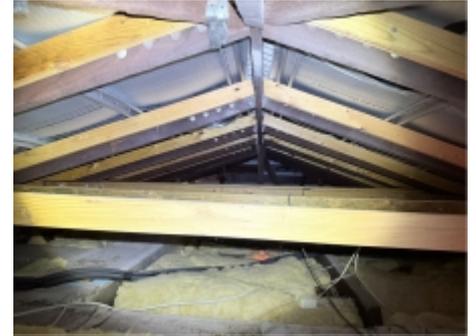
No visible evidence of termites was found internally of the ceiling at the time of the inspection
