# **Houspect**

### **Pre purchase inspection**

**Job ID:** 92957

**Address:** 44 Campbell Cres, Baynton WA 6714

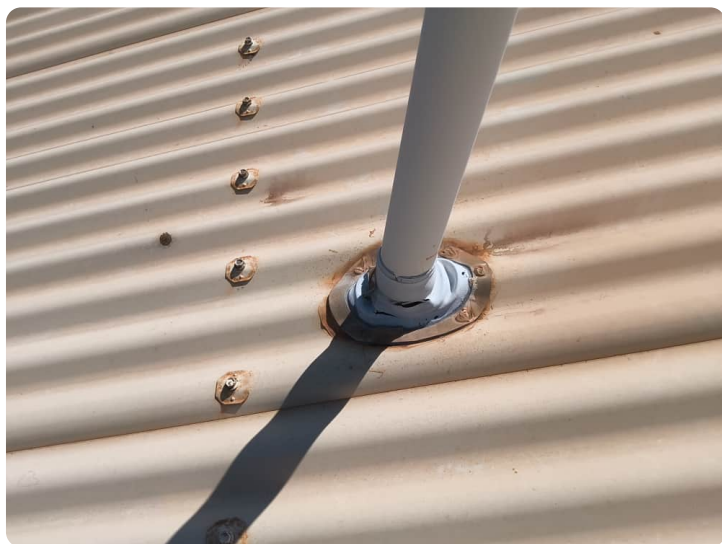
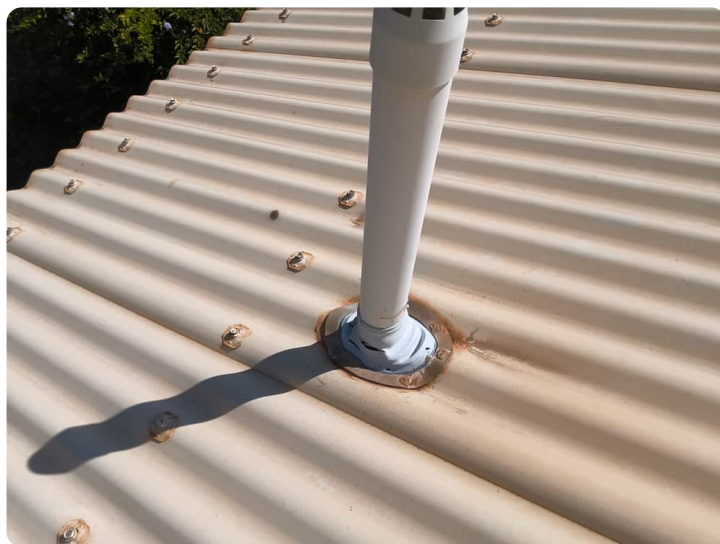
#### 3.1 Dektite damaged or perished

The dektite has been damaged or has perished and needs to be replaced.

**Issue:** Dektite damaged or  
perished

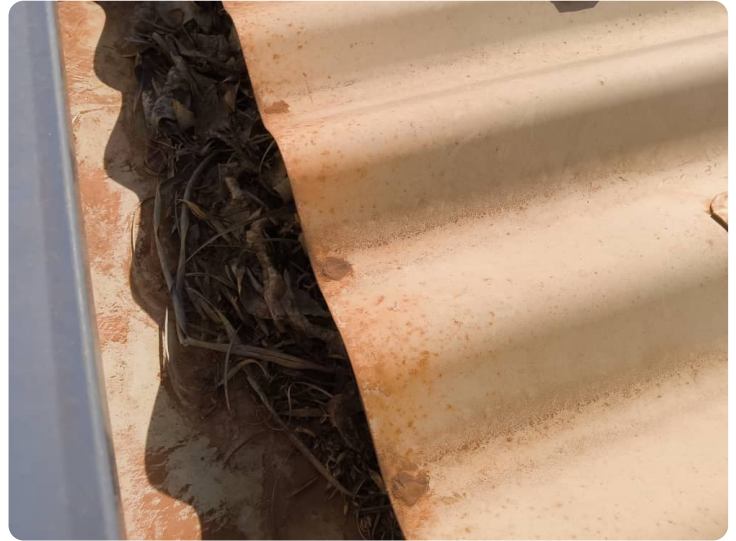
## 5. Gutters

The gutters are constructed of metal and they have a colorbond covering. The condition of the gutters is satisfactory in relation to their age and will require normal ongoing maintenance. The gutters need to be cleared of debris.

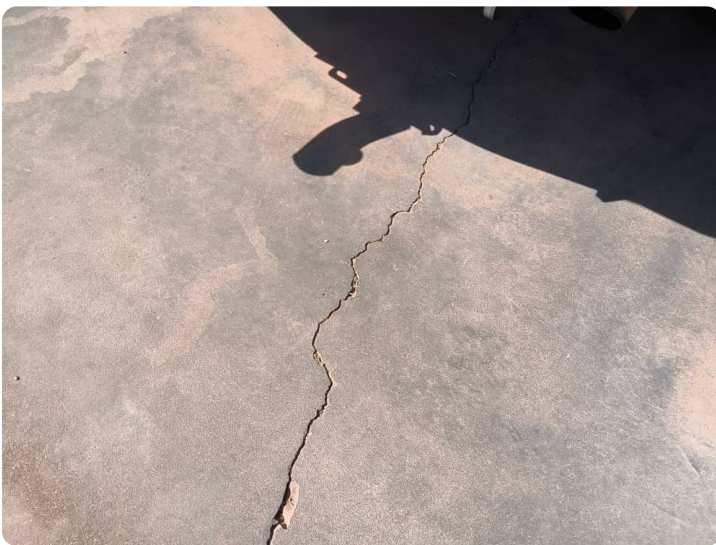
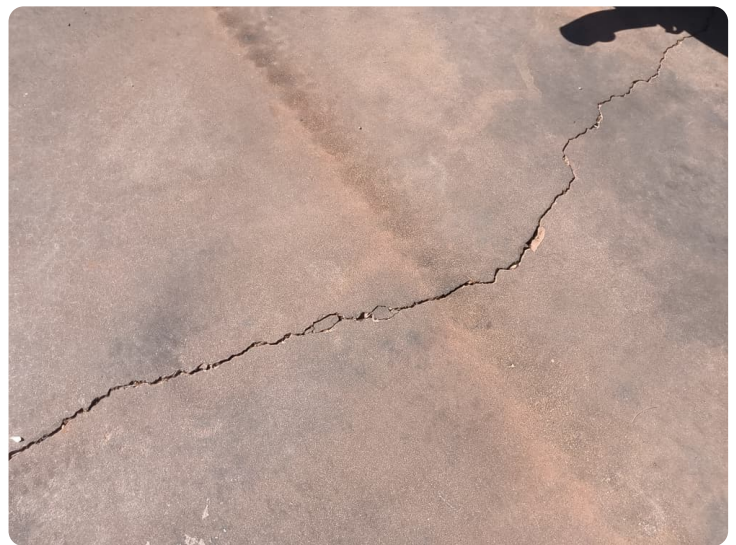
### 20.1 Concrete cracking - minor

Cracking was noted to the concrete paving. This is not of a structural concern. Cracks should be filled to avoid further deterioration.

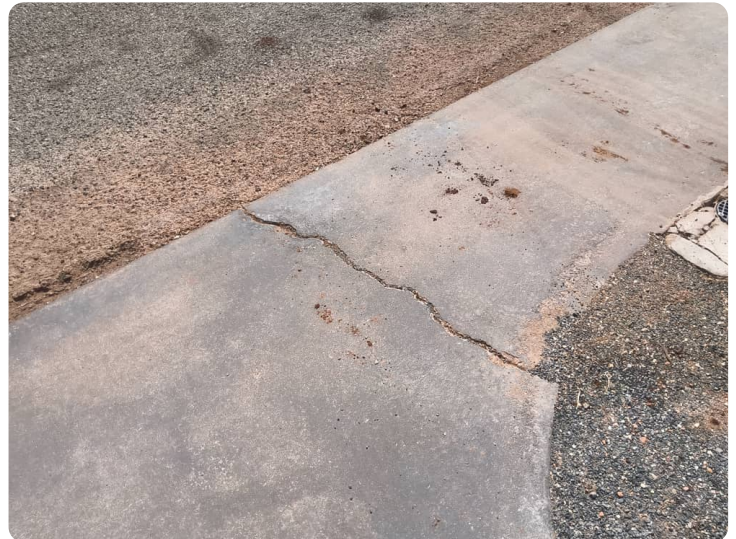
### 25.1 Concrete cracking - major

Significant cracking was noted to the concrete paving. This is not of a structural concern however repairs are required.

**Issue:** Concrete cracking - major

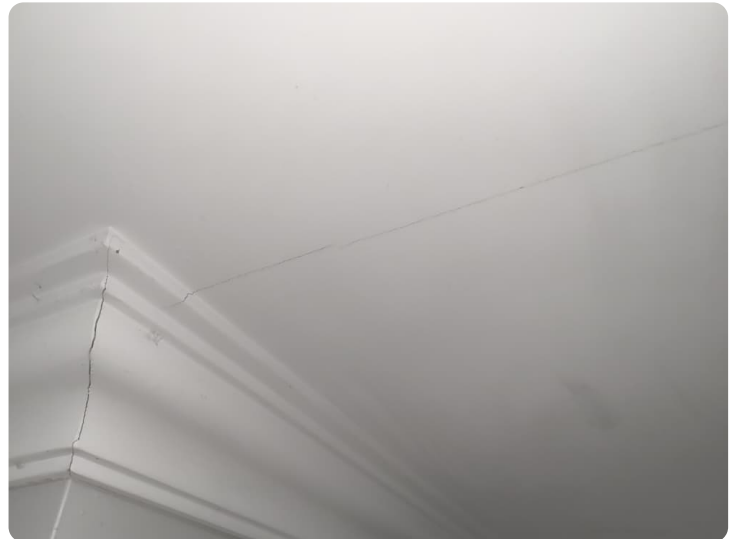
#### 35.1 Cracking - minor

The ceilings in the images contain multiple cracks, likely caused by thermal expansion and contraction. This is not a structural issue but repairs are required.

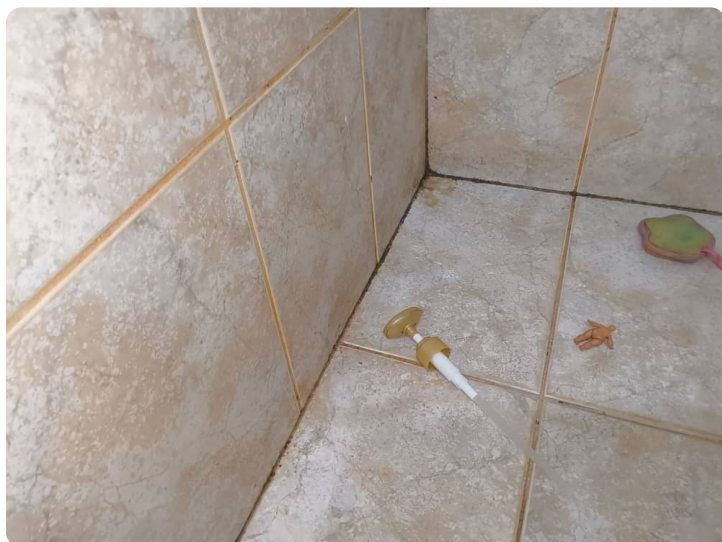
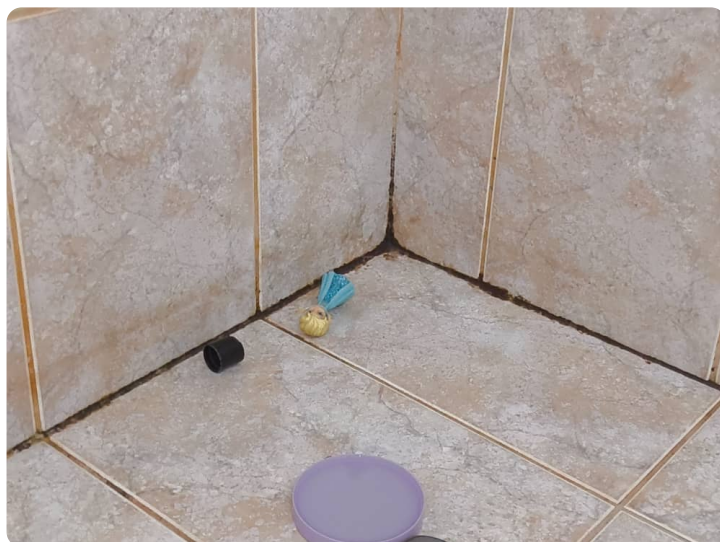
#### 38.1 Silicon seal damaged and mouldy

As per the images provided the silicone seal is damaged and mouldy. Recommend the silicon seal is replaced.

**Issue:** Silicon seal damaged and  
mouldy

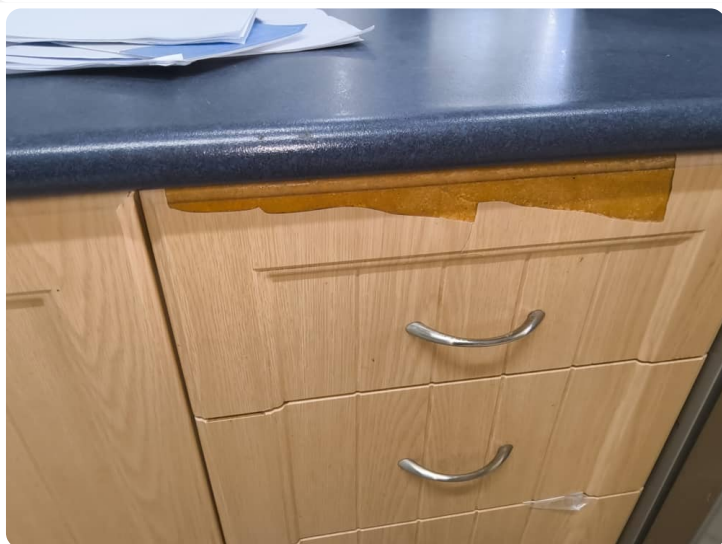
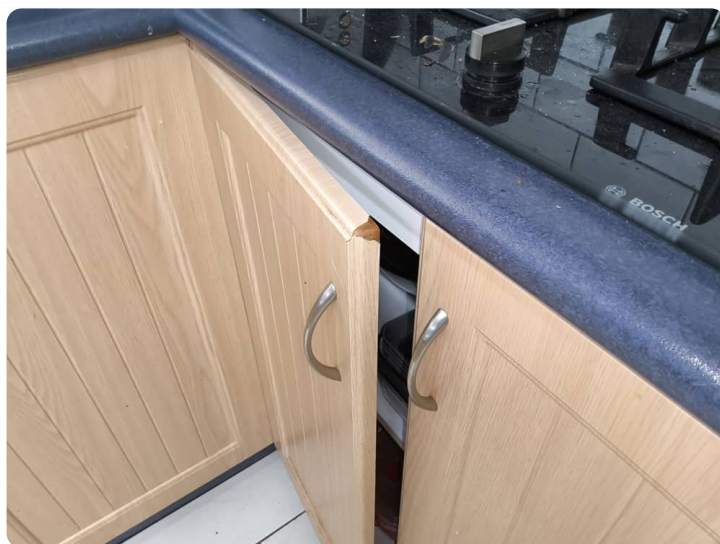
##### 41.1 Cabinet door damage

As per the images some cabinet doors drawers damaged requiring repairs or replacement.

**Issue:** Cabinet door damage

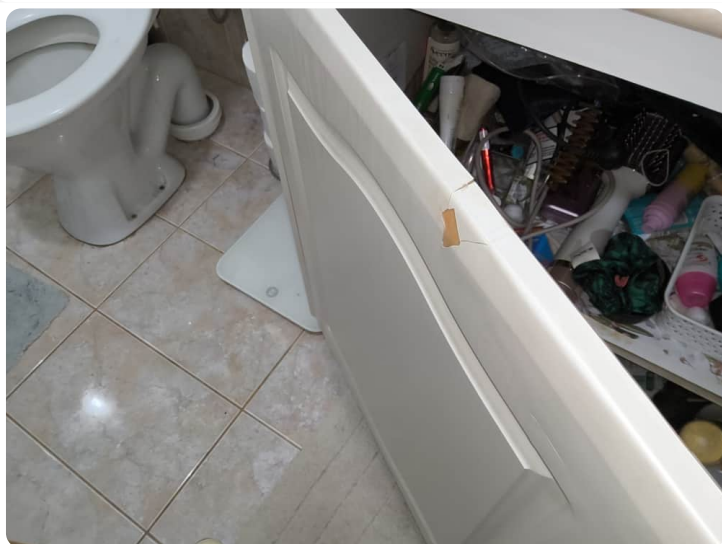
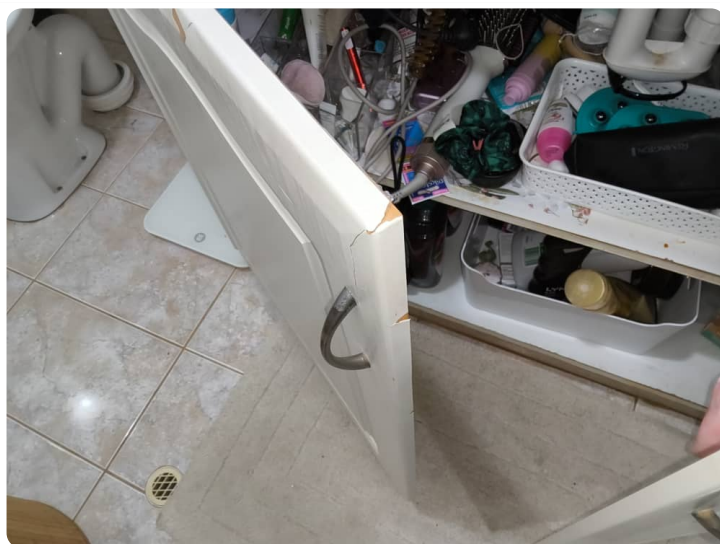
##### 44.1 Cabinet door damage

As per the images some cabinet doors are damaged requiring repairs or replacement.

**Issue:** Cabinet door damage
