Pre-Purchase Inspection - Residential Building Report

95 Steerforth Drive
Coodanup WA 6210

1.1 Residence

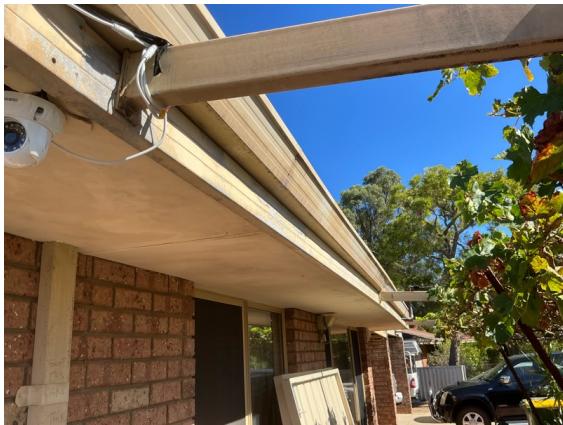
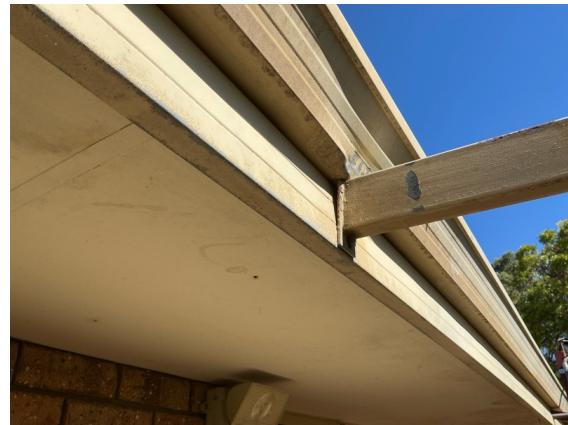
Defect 1. - Exterior

Defect Location: North Side
Defect Summary: Patio
Type of Defect: Installation
Description: Inadequate Patio connection to residence
Ongoing Consequence: Possible damage to surrounding elements.
Opinion of Cracking: Not Applicable
Building Professional: **Note: This defect should be referred to a qualified building professional for the repairs/scope of work required.**
Building Professional Required: Builder

The North elevation Patio structure is connected to the metal fascia of the main residence which is not designed to take load. This may have a negative effect and cause damage to the home.

North elevation Patio - Recommend having a Builder review the Patio connection to the residence for modification and installation of appropriate connections.

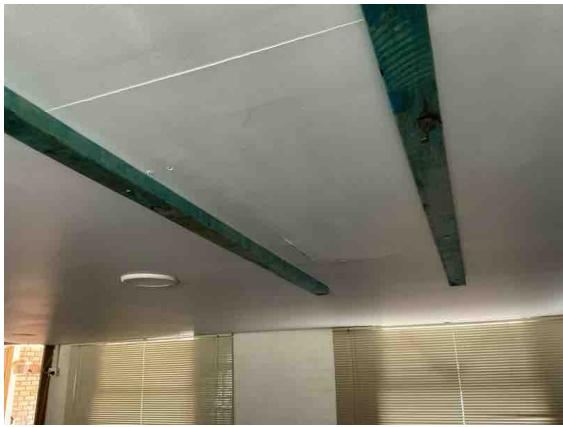
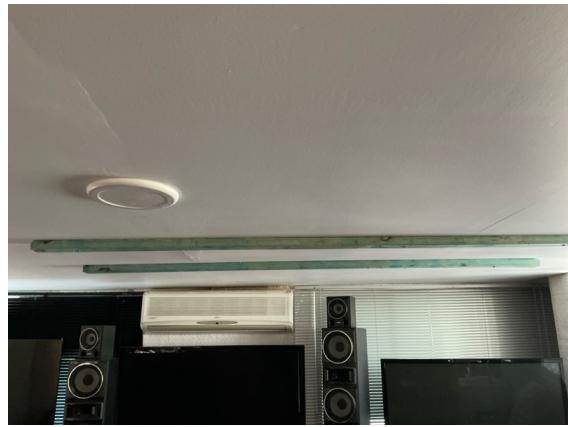
Defect 2. - Interior

Ceiling Sagging

Separation from framing

Further sagging or possible collapse

Ceiling is sagging and has been temporarily supported. Evidence of moisture ingress and staining noted to the ceiling lining.
Recommend repairs and a roof cover inspection to check above this area for repairs that may be required.

Ceiling is sagging and has been temporarily supported.

Information provided: Roof is leaking in enclosed patio area.

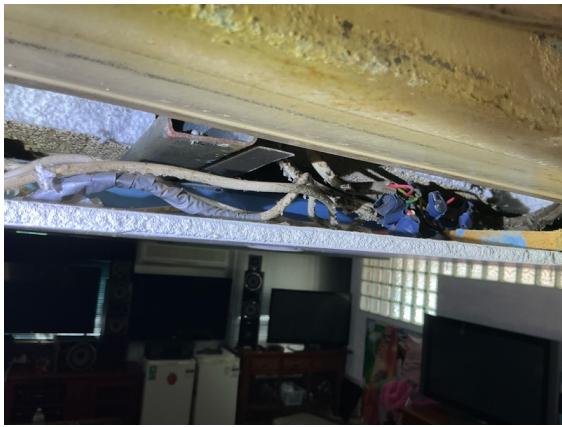
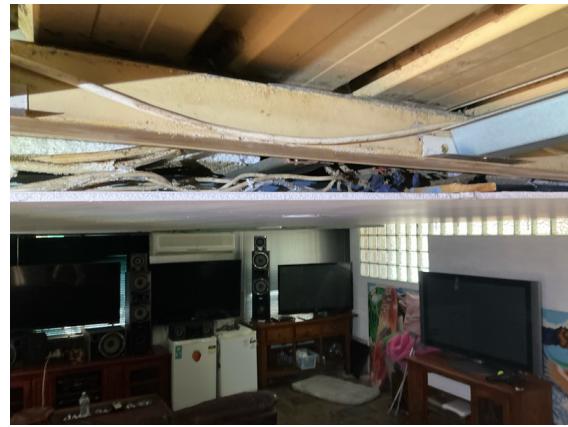
Defect 3. - Interior

Electrical hazard.

Exposed wire connections.

Exposed wiring junctions observed in the roof void above the patio area. Recommend having an Electrician install junction box's at all connections to make safe.

Exposed wiring junctions observed in the roof void above the patio area.

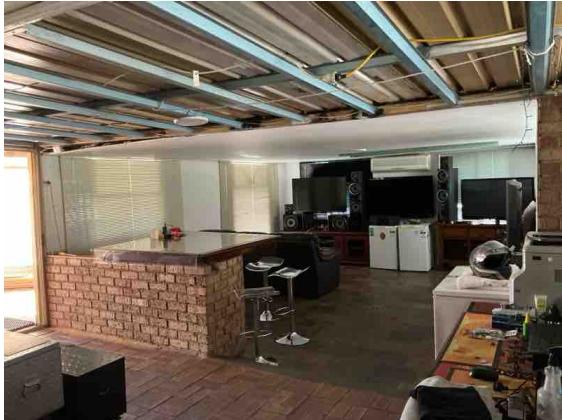
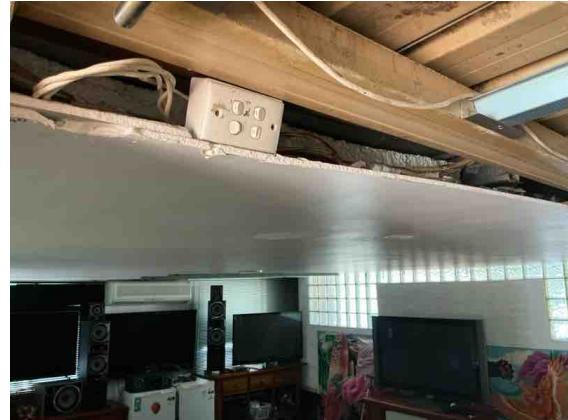
Defect 4. - Interior

Opening to the roof void.

Exposed electrical cables

There is an opening to the roof void of the patio on the south side and exposed wiring is visible. Recommend repairs to enclose roof void.

Opening to the roof void of the patio on the south side and exposed wiring is visible.

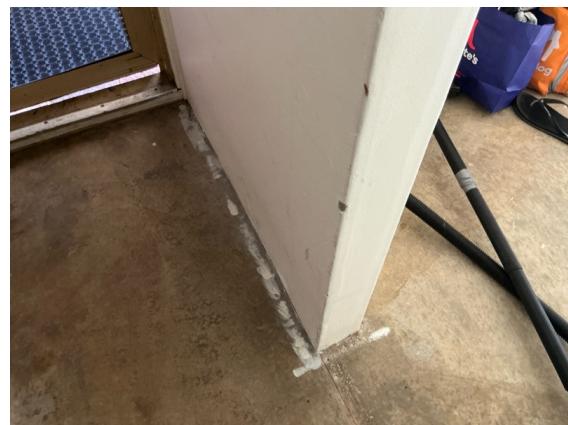
Entry - Minor damage noted to wall linings at some isolated areas throughout the home. Recommend maintenance/repair.

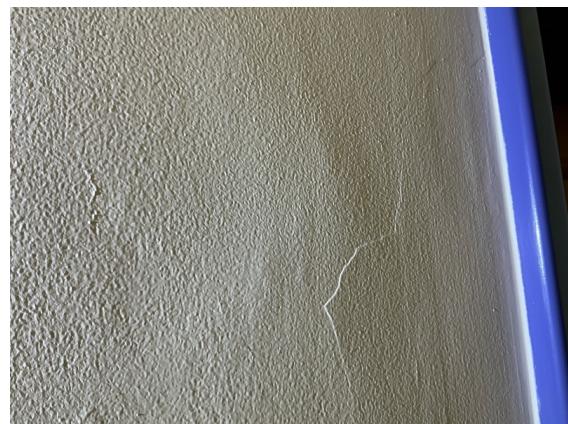
Lounge - Typical appearance cracking noted to wall linings at some isolated areas throughout the home. Recommend maintenance/repairs and to monitor over time.

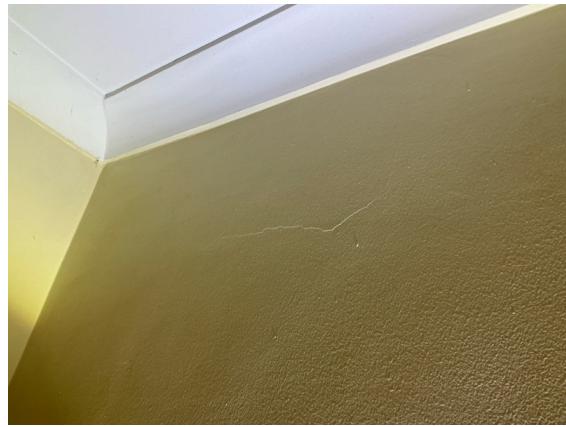
Bed 1 - Typical appearance cracking noted to wall linings at some isolated areas throughout the home. Recommend maintenance/repairs and to monitor over time.

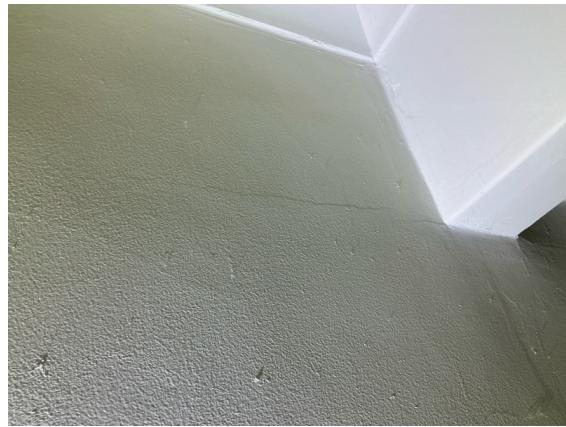
Ensuite - Typical appearance cracking noted to wall linings at some isolated areas throughout the home. Recommend maintenance/repairs and to monitor over time.

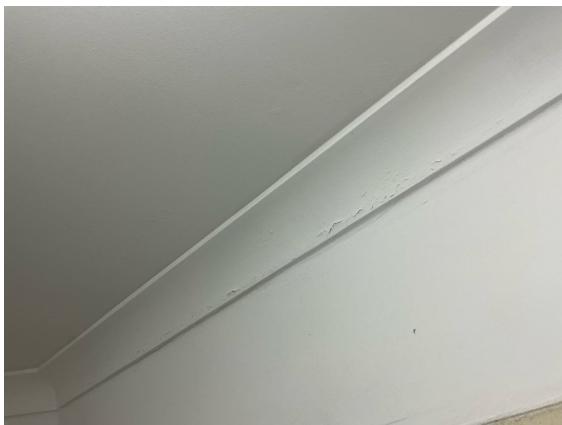
Ensuite - Flaky paint noted to cornice.
Recommend maintenance/repair and paint.

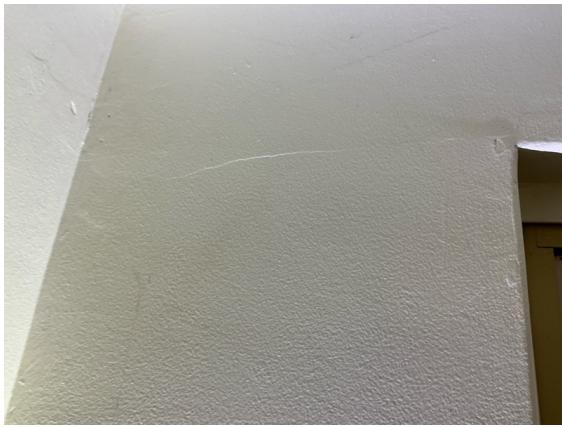
Meals - Typical appearance cracking noted to wall linings at some isolated areas throughout the home. Recommend maintenance/repairs and to monitor over time.

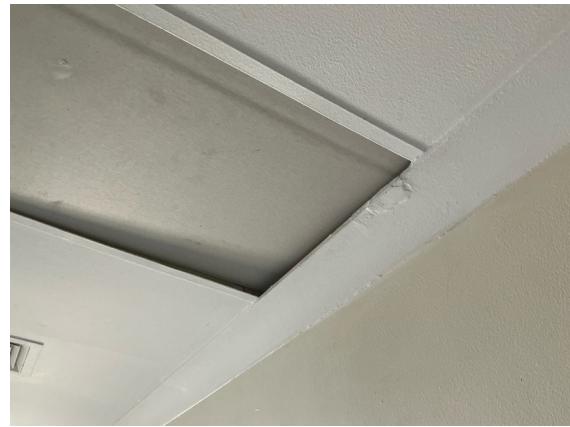
Hallway - Minor damage noted to ceiling cornice. Recommend maintenance/repair.

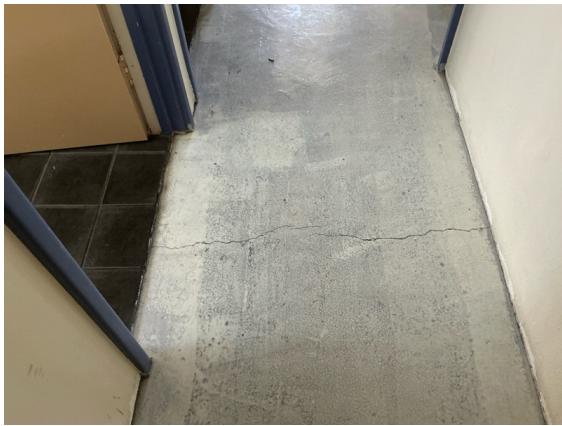
Hallway - Minor and typical appearance cracking was observed to various concrete floor finishes at some isolated areas throughout the home.

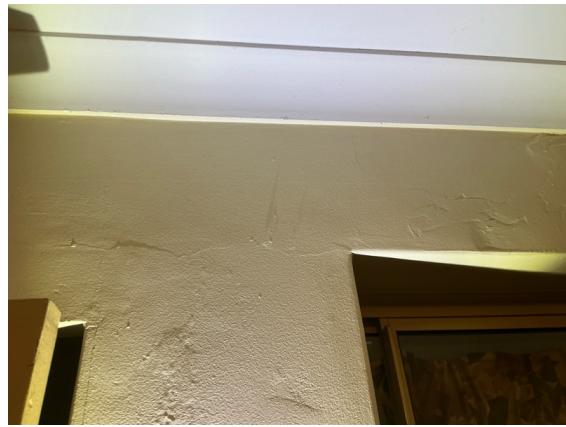
Bed 3 - Appearance cracking and patching noted to wall linings at some isolated areas throughout the home. Recommend maintenance/repairs and to monitor over time.

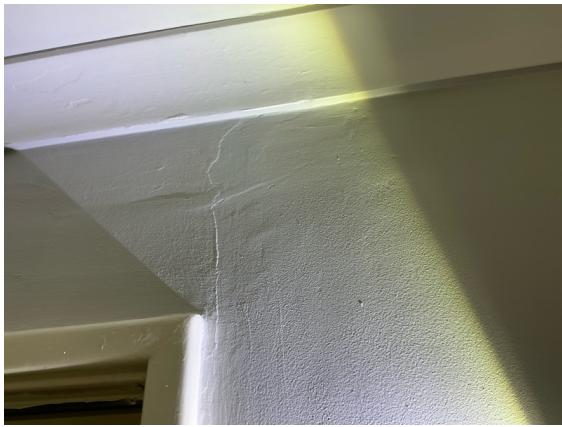
Bathroom - Typical appearance cracking noted to wall linings at some isolated areas throughout the home. Recommend maintenance/repairs and to monitor over time.

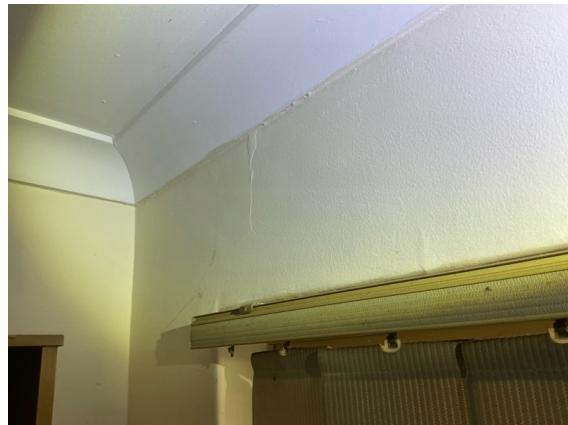
Laundry - Typical appearance cracking noted to wall linings at some isolated areas throughout the home. Recommend maintenance/repairs and to monitor over time.

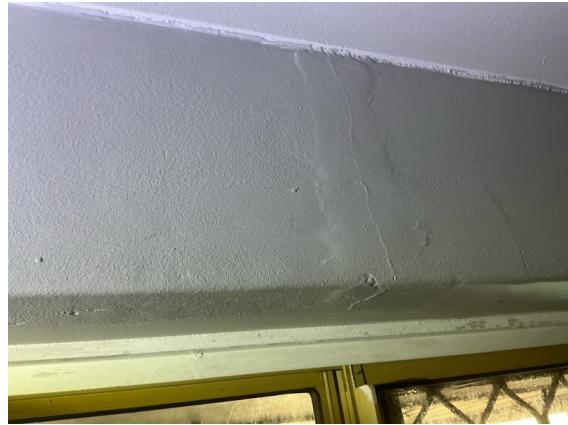
Bed 5 - Appearance cracking and patching noted to wall linings at some isolated areas throughout the home. Recommend maintenance/repairs and to monitor over time.

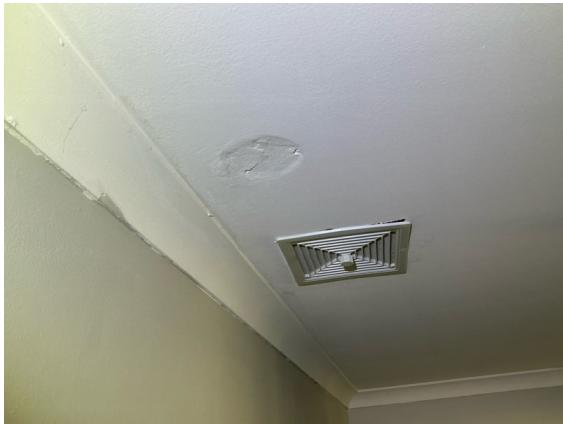
Bed 5 - Minor damage noted to ceiling lining at isolated areas throughout the home. Recommend maintenance/repair.

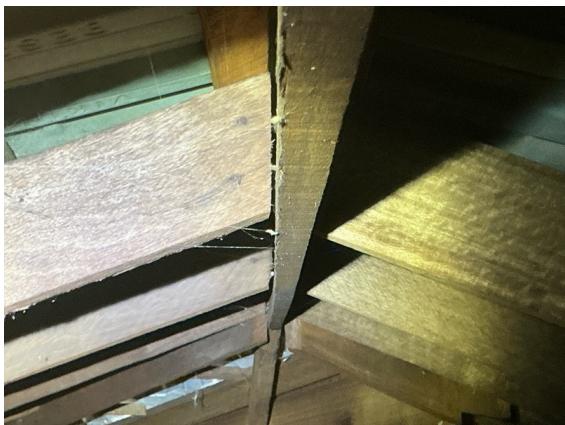
There is a minor gap between ridge board and 2 x rafters above Hallway area. No loss of strength or serviceability was observed, and the roof frame is performing as expected.

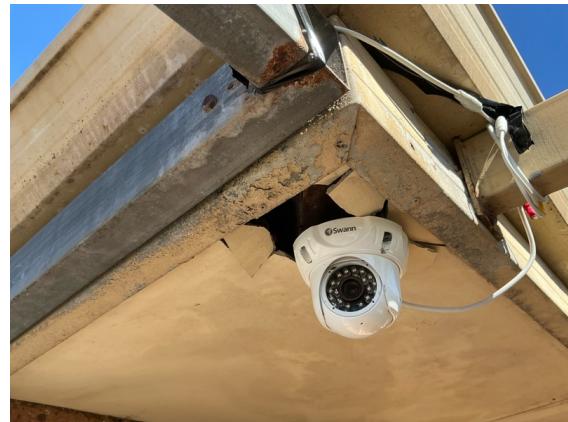
North Elevation - Minor damage noted to eaves lining at isolated areas throughout the home. Recommend maintenance/repair.

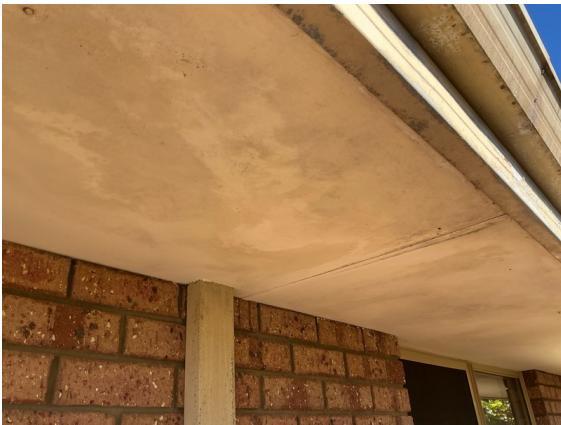
North Elevation - Evidence of moisture ingress to the exterior eaves lining in some areas. Eaves can be highly susceptible to moisture, often as a result of blocked and/or leaking gutters or down pipe connections. Recommend roof cover inspection, repairs and/or routine clearing of overflow provisions to gutters and down pipes as required.

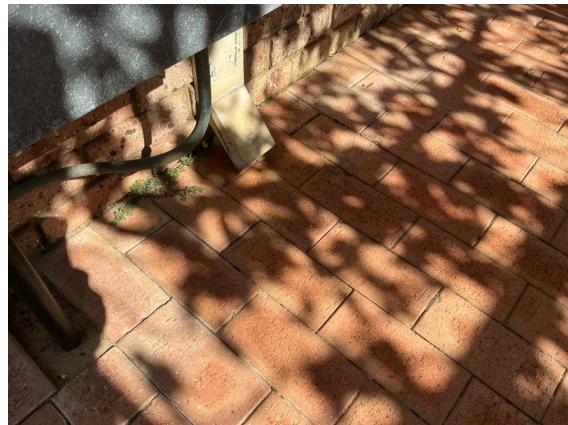
North Elevation - Some down pipes discharge next to the home. Recommend connecting all down pipes to stormwater system.

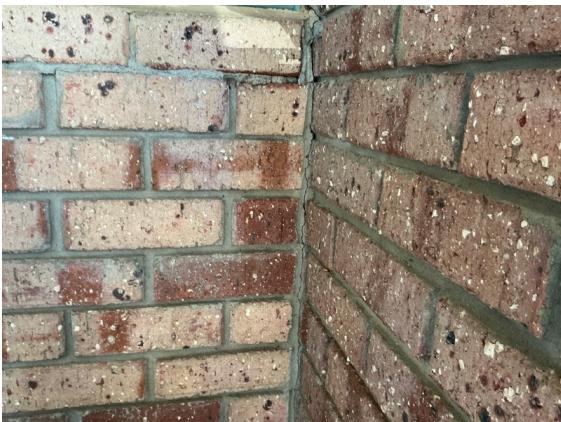
Carport - Appearance wall cracking to some external brickwork. Recommend maintenance / Repair and monitor over time.

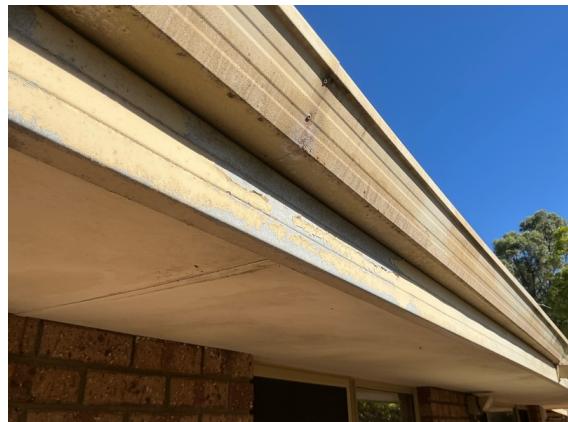
Rust damaged fascia, gutters and down pipes were observed to various areas around the home. Recommend repairs/replacement.

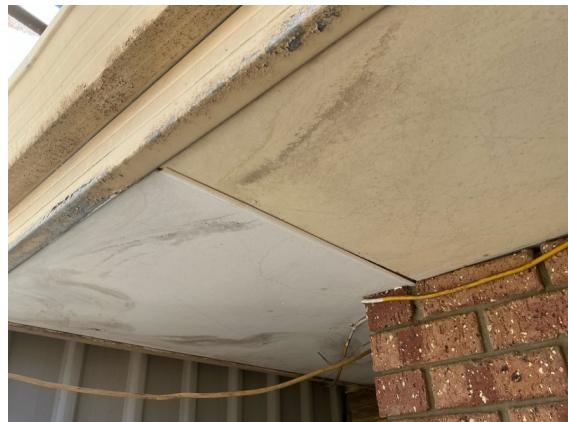
East Elevation - Joining strip disengaged from eaves lining. Recommend maintenance/repair.

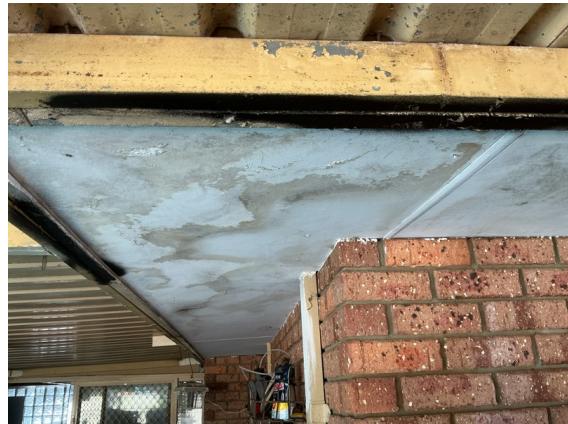
South Elevation - Evidence of moisture ingress to the exterior eaves lining in some areas. Eaves can be highly susceptible to moisture, often as a result of blocked and/or leaking gutters or down pipe connections. Recommend roof cover inspection, repairs and/or routine clearing of overflow provisions to gutters and down pipes as required.

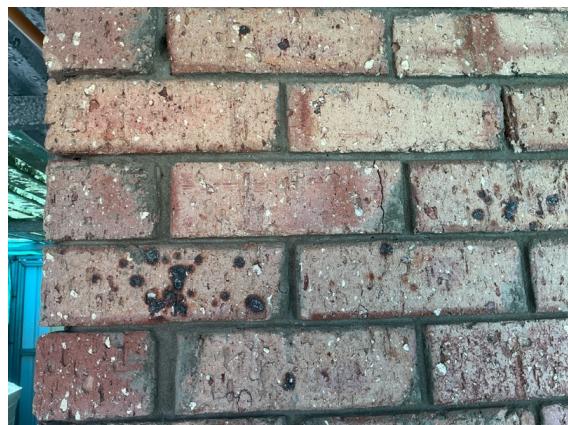
Appearance wall cracking to some external brickwork. Recommend maintenance / Repair and monitor over time.

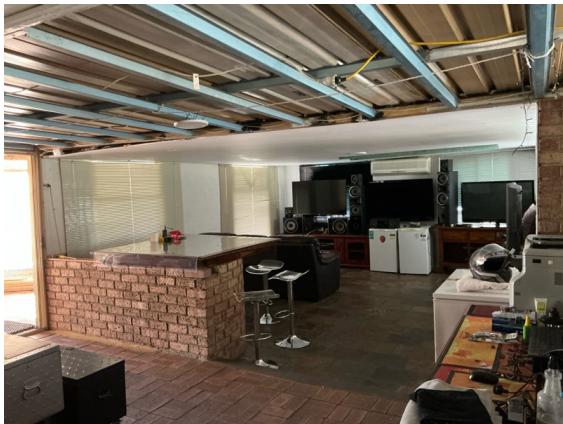
Enclosed patio - Recommend council record search to verify patio is an approved living area.

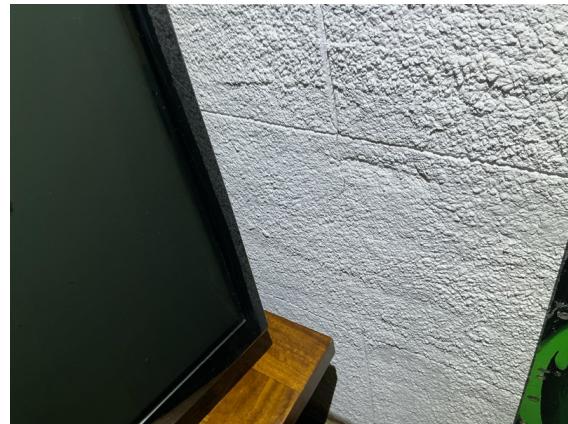
Enclosed patio area -Appearance cracking noted to some internal rendered wall areas. Recommend maintenance/repair and monitor over time.

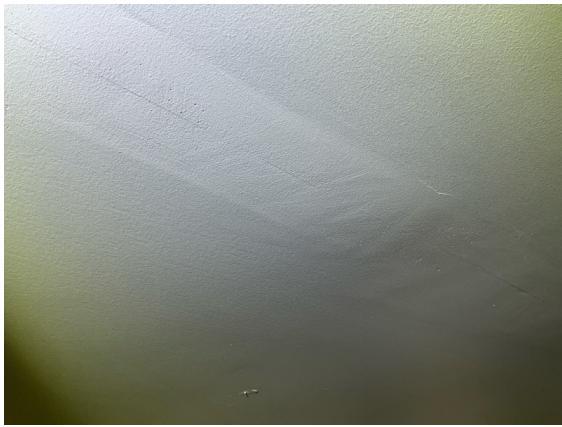
Appearance cracking noted to the ceiling lining at some isolated areas. Recommend maintenance/repairs.

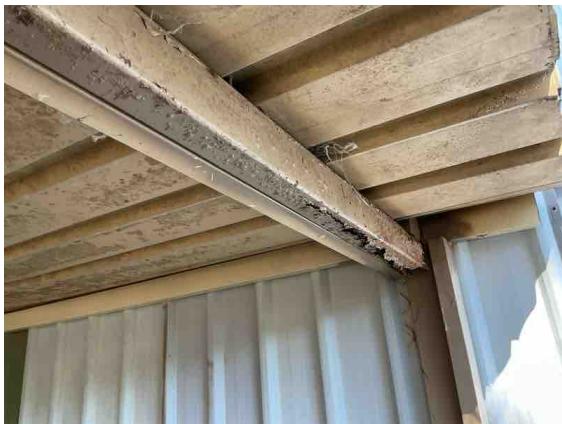
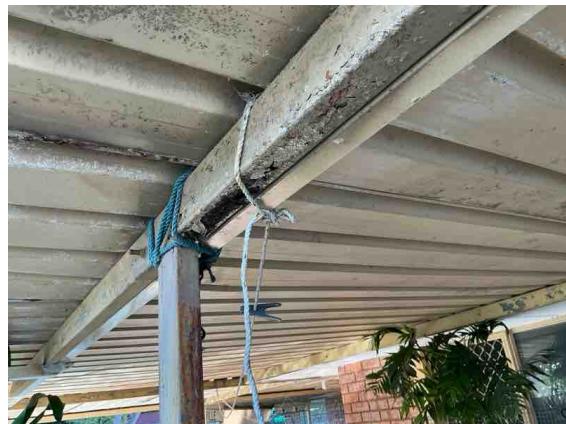
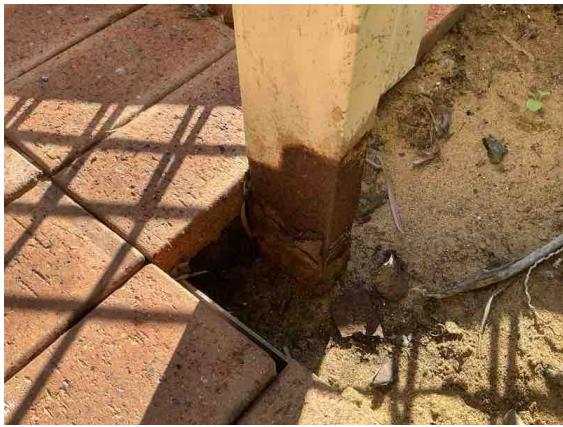
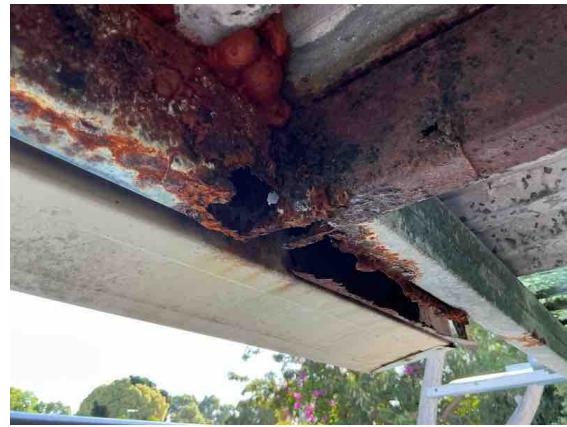
Site Defect 1. - Patio

Rust to patio structure

Further deterioration and damage to surrounding elements

Significant rust noted to External patio structure to some areas. Recommend repairs or replacement.

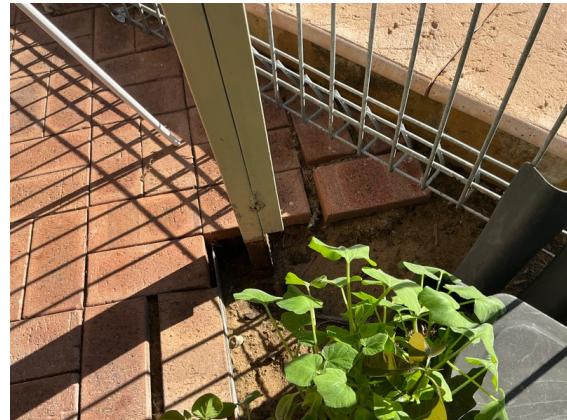
South Elevation - Some down pipes discharge next to the home. Recommend connecting all down pipes to stormwater system.

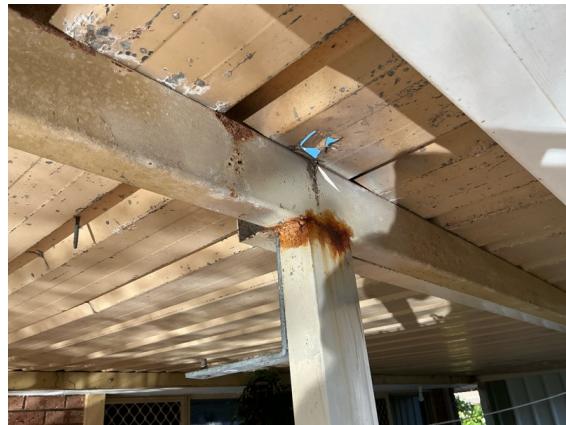
Surface rust noted to patio structure to some areas throughout the home. Recommend to treat rust and paint with protective coating.
