Pre-Purchase Timber Pest Inspection Report - Australian Standard AS4349.3-2010 Inspection of Buildings Part 3

Property Address: 95 Steerforth Drive Coodanup WA 6210
Client: Warren Sawyer **Date of the Inspection:** 28th March 2025
Persons in Attendance Home Owner **Weather Conditions:** Sunny

Structure Type:	Freestanding House
Structure Orientation:	North
Is the Building Furnished:	Yes
Construction Type:	Cavity Brick
Flooring Type(s):	Concrete Slab
Pier Type:	Not Applicable
Roof Structure(s):	Pitched Timber
Roof Covering(s):	Tiles
Roof Void Insulation:	Yes
Last record of timber pest treatment to home: (Durable Notice in meter box):	1989

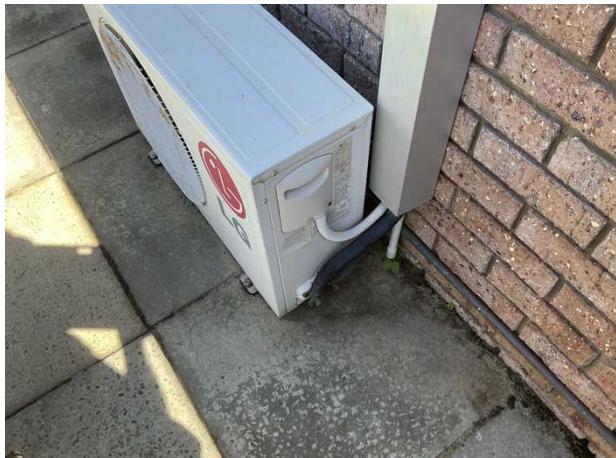
Hot water unit and/or Air Conditioning unit/s overflow next to building.

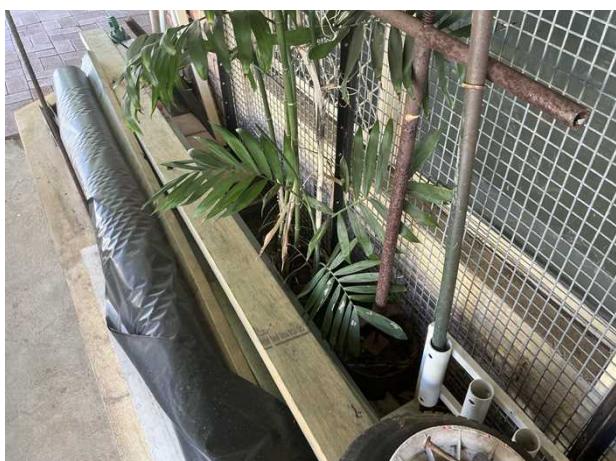
Garden beds/vegetation against the building provide a conducive condition for termite activity.

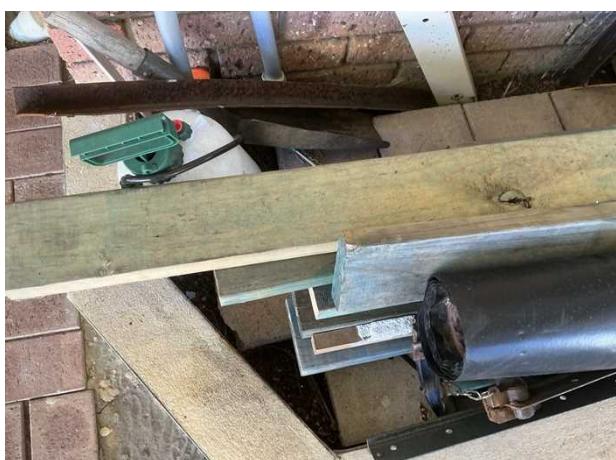
Timber's in contact with the ground.

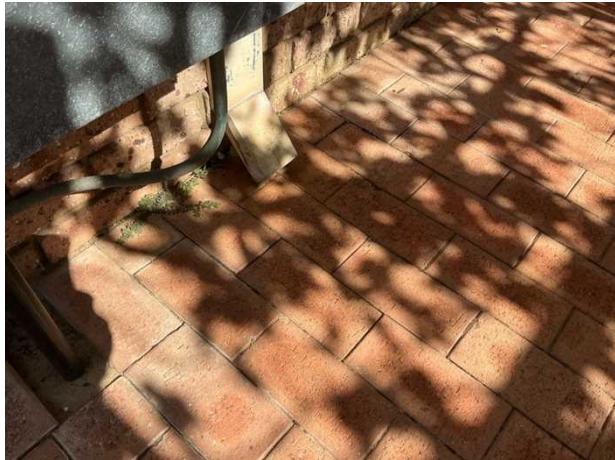
Some down pipes discharge next to the home.
Recommend connecting all down pipes to stormwater system.
