# Pre-Purchase Inspection - Residential Building Report

Complies with Australian Standard AS 4349.1- 2007 Inspection of Buildings Part 1: Pre-Purchase inspections - Residential buildings

19 Arnisdale Road  
Duncraig WA 6023

Major Structural Defects identified to the Residential Building on day of inspection

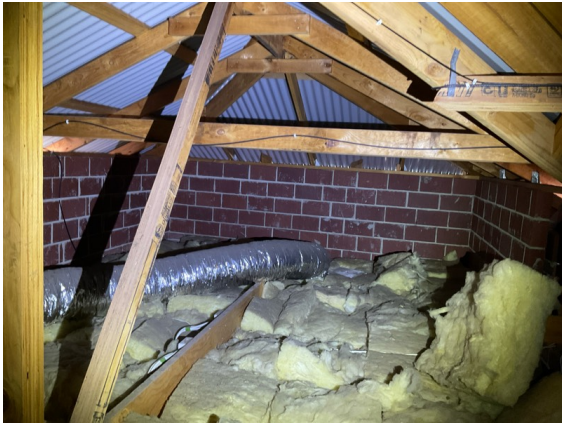
South elevation roof void

South Side

Roof tie down points inadequate/not apparent.

Possible uplift in high wind conditions.

**Note: This defect should be referred to a qualified building professional for the repairs/scope of work required.**

Building Professional Required: Builder, Carpenter

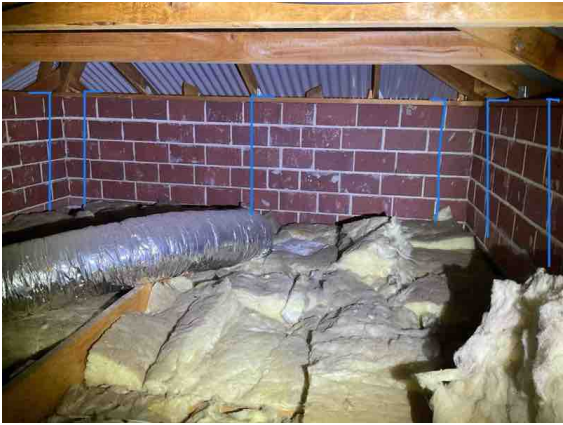
Rafters have been mechanically fixed to the wall plate. No evidence of perimeter tie downs to the wall plate. Recommend install hoop iron strap to the plate down 10c and install adequate wall fixings

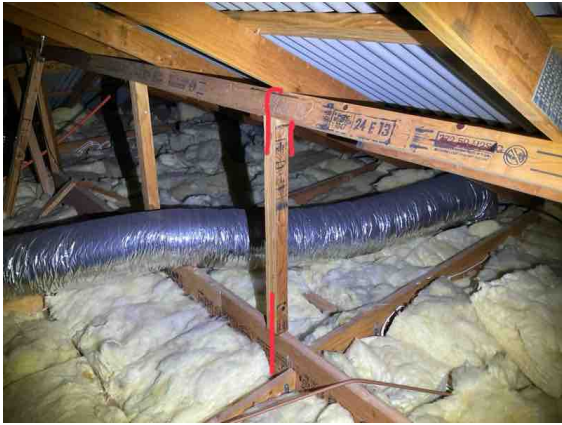
| Description: | Hoop Iron strap missing from butt jointed underpurlin/strut connection, Frame anchors missing from rafter/underpurlin connection |

Buildings from this era would ordinarily have additional strapping to the top and bottom of the strut to underpurlin connection. No loss of strength or serviceability was observed, and the roof frame is performing as expected.

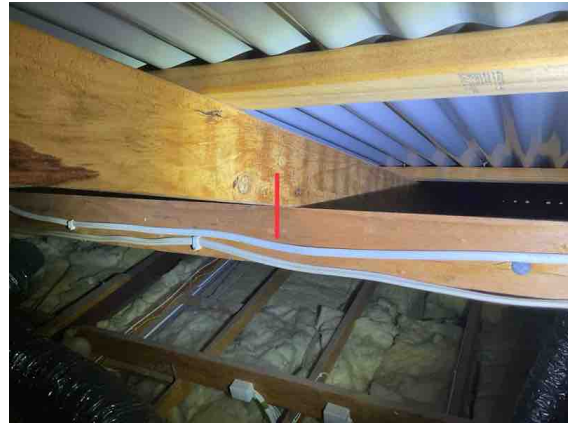
Buildings from this era would ordinarily have mechanical fixings installed at the rafters to underpurlin connections. No loss of strength or serviceability was observed and the roof frame is performing as expected.

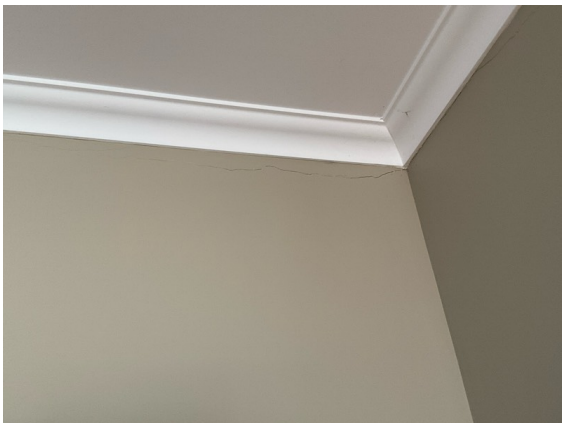
Minor appearance cracking noted at the ceiling cornice and wall junction in the dining and in various isolated areas throughout the home. Recommend repair and paint.

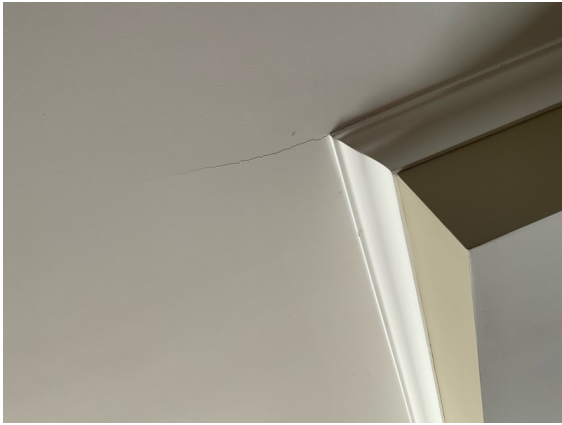
Minor appearance ceiling crack noted to the kitchen ceiling at the bulkhead. This is common with bulkhead ceilings at corners. Recommend repair and paint.

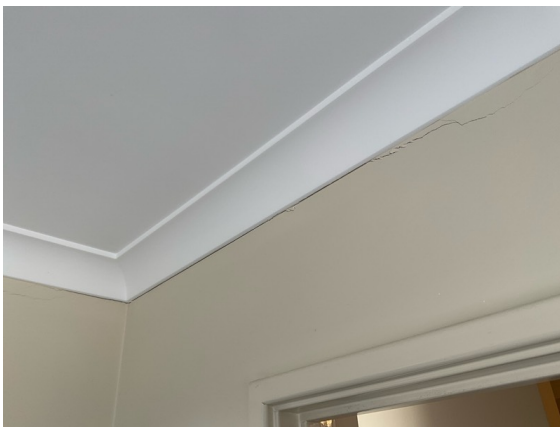
Minor appearance cracking noted at the ceiling cornice and wall junction in the en-suite and in various isolated areas throughout the home. Recommend repair and paint.

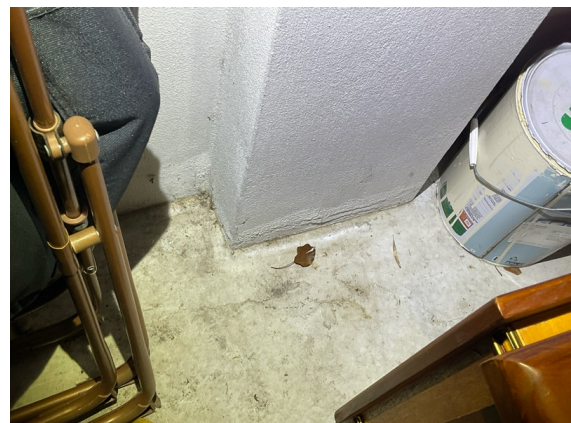
Evidence of typical moisture ingress to the lower areas of the garage walls. This is common for single skin walls and is caused by rising damp. Efflorescence is a deposit of mineral salts on surfaces of concrete and masonry walls and/or floors

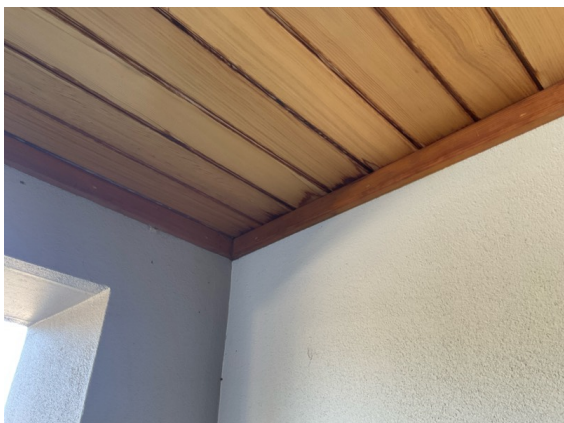
Evidence of moisture stain to the entry porch timber ceiling. This may be historical and is commonly caused by excess debris in gutters/valleys restricting stormwater flow or deteriorated roof flashings/seals. Recommend exterior roof cover inspection, repair and paint

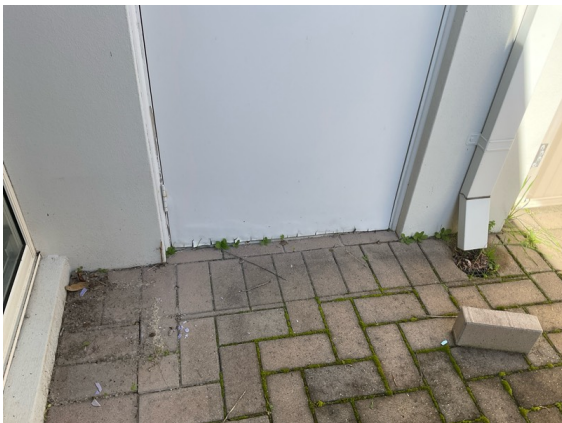
Deterioration noted to the garage rear door. This common with external doors. Recommend repair/treat and paint

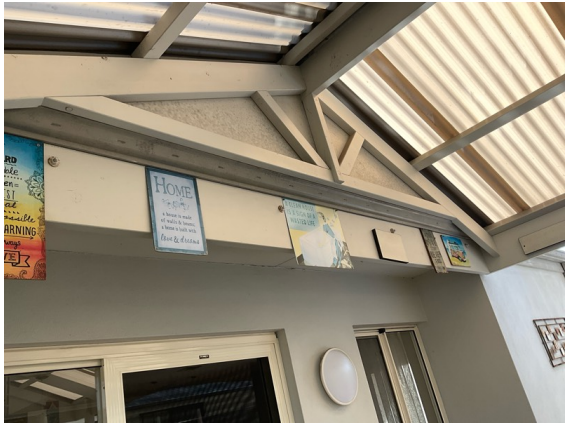
Patio connections to the main residence are adequate and performing on day of inspection
