## Timber Pest Inspection Report

## Pre-Purchase Timber Pest Inspection Report

29 Jul 2025 / Rick Gibbs / 19 Arnisdale Road, Duncraig, WA,  
6023 / 53291

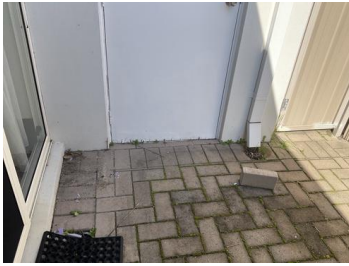
Photo 3

Yes, fungal decay and wood rot found and the details are:

I or wood rot to the garage rear door

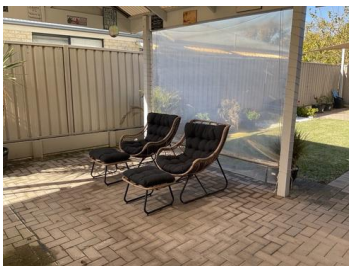
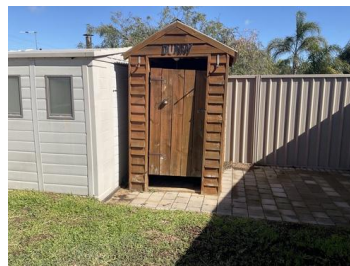
Yes

Timber in direct contact with soil  
– Recommend removing or isolating timber from soil contact to reduce termite risk.
