# Pre-Purchase Inspection - Residential Building Report

Complies with Australian Standard AS 4349.1- 2007 Inspection of Buildings Part 1: Pre-Purchase inspections - Residential buildings

Property Inspected Details: 4 Mahonia Place  
Duncraig WA 6023

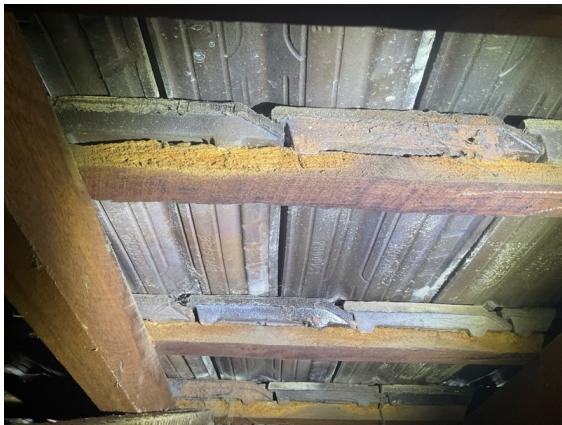
Delignification to some roof tile battens

Further deterioration to batten, generally in line with the expected service life of the tiled roof cover

Delignification to tile battens in some areas, this is typical of location and or life span of roof cover. Chemical Delignification is when the lignin (glue) within the timber breaks down. This type of timber deterioration is also commonly referred to as (hairy timber) as the fibres within the timbers outer surface detach once the lignin is broken down. Chemical Delignification is usually associated with terracotta tiles over 40 years old. It rarely effects more than 5% of the timber although it can look a lot worse due to the (hairy/fluffy look). No loss of performance was observed on the day of inspection. Recommend further invasive inspection by building inspector.

**Note: This defect should be referred to a qualified building professional for the repairs/scope of work required.**

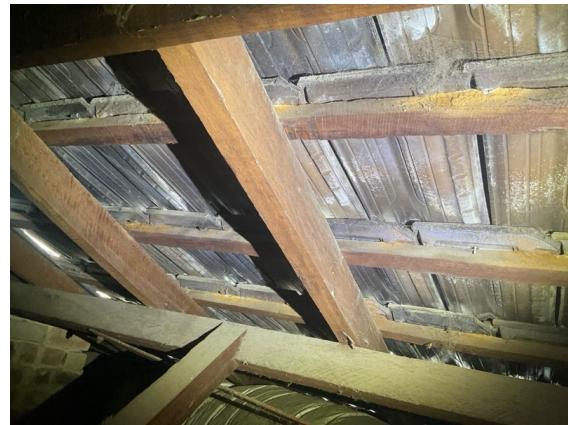
Delignification to tile battens in some areas, this is typical of location and or life span of roof cover.

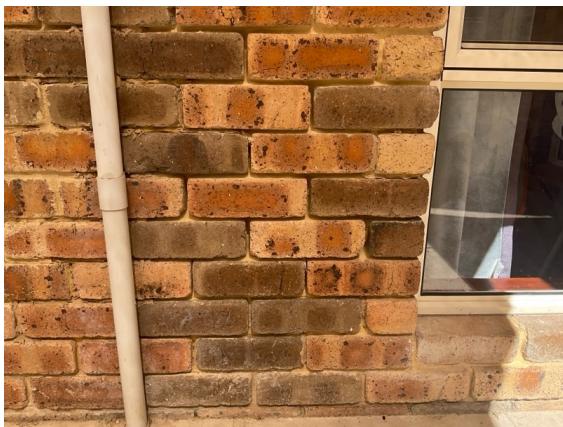
Minor mortar deterioration noted to the lower face brickwork on the east elevation and other isolated areas. This is common for lower face brick work commonly caused by wind. Recommend repair/repoint where required.

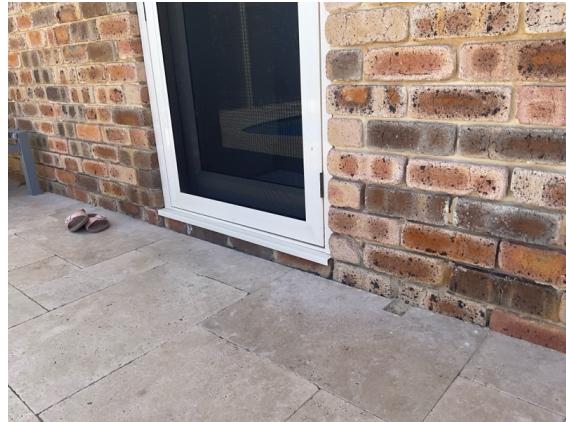
Minor mortar deterioration noted to the lower face brickwork on the south elevation and other isolated areas. This is common for lower face brick work commonly caused by wind. Recommend repair/repoint where required.

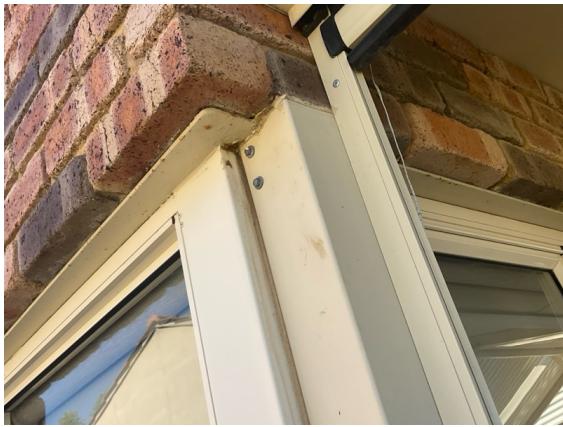
Evidence of surface rust noted to the west elevation external brick opening lintels. This is common when maintenance painting is not carried out. Recommend treat and paint

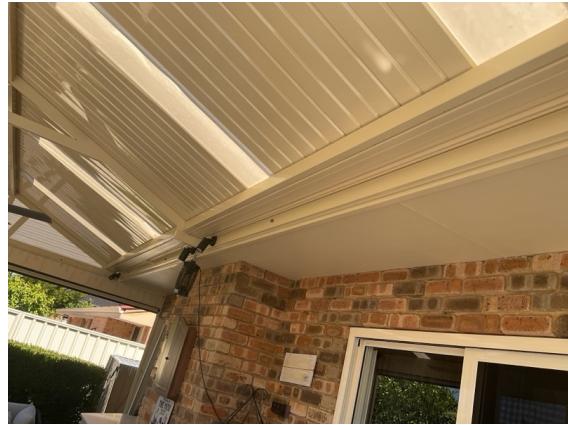
Patio connections to the main residence are adequate and performing on day of inspection
