## Timber Pest Inspection Report

## Pre-Purchase Timber Pest Inspection Report

16 Jan 2026 / Rick Gibbs / 4 Mahonia Place , Duncraig, Western Australia, 6023 / 75461

4 Mahonia Place , Duncraig, Western Australia, 6023

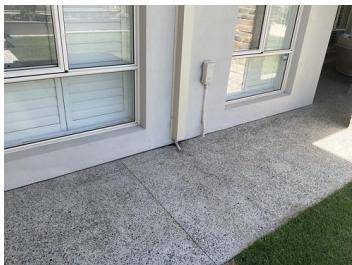
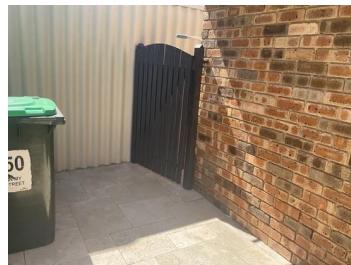
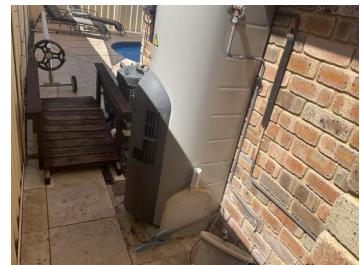
Yes

Timber in direct contact with soil  
- Recommend removing or isolating timber from soil contact to reduce termite risk.

Hot water drainage that discharges water close to the structure – Recommend redirecting the hot water drainage to discharge away from the foundation to prevent moisture accumulation near the structure.

Air conditioning drainage that discharges water close to the structure – Recommend redirecting the air conditioning drainage to discharge away from the foundation to prevent moisture accumulation near the structure.
