**PROCONSULT**  
BUILDING INSPECTIONS

# Building and Timber Pest Report

Property Address: 11/10 Clarence Street, Tuart Hill

Inspection Date: 16 Oct 2025

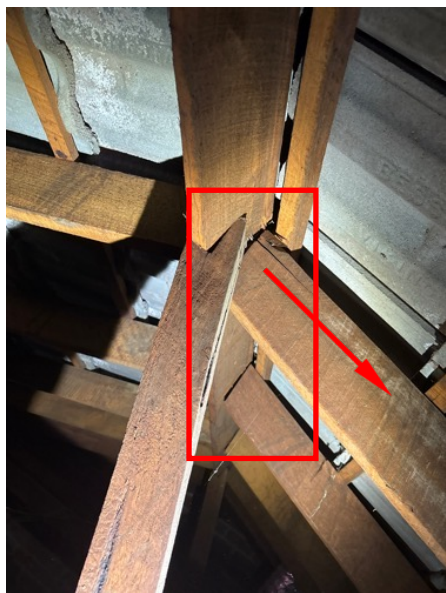
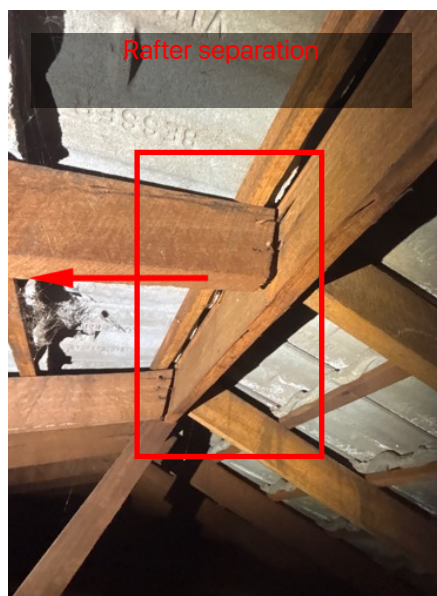
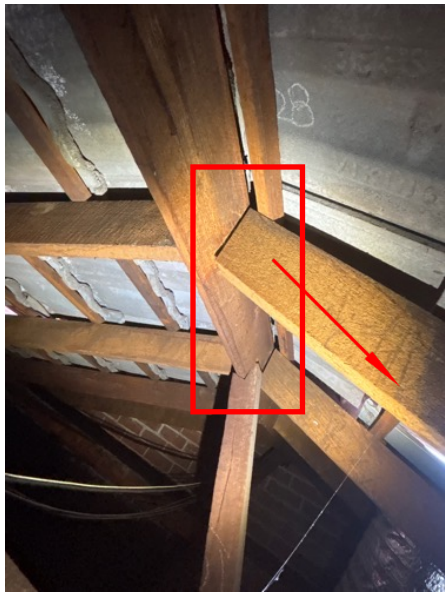
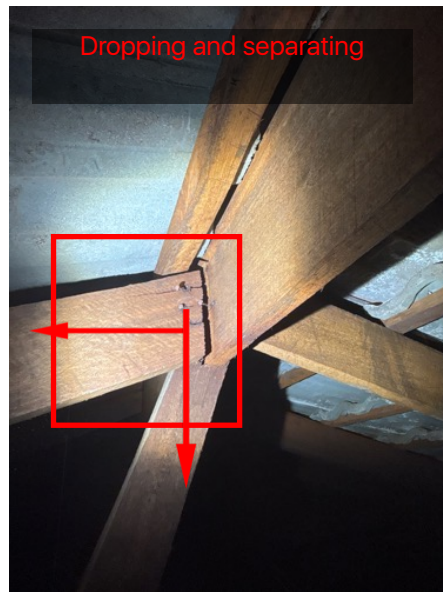
### Major Structural Defect 1.01

**Finding:** Rafter separation

A few rafters that have separated 10 or so mm from the ridge with one rafter in particular that has dropped 10mm also. The affected rafters require underidge neckties to tie the opposing rafters back together with laminated rafter extensions to the affected couple of rafters to reconnect firmly to the ridge. Very simply addressed.

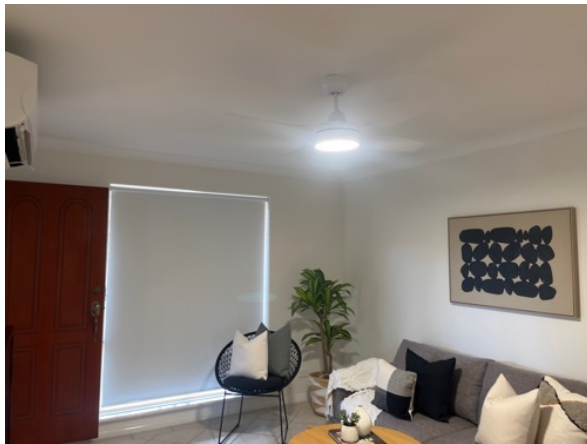
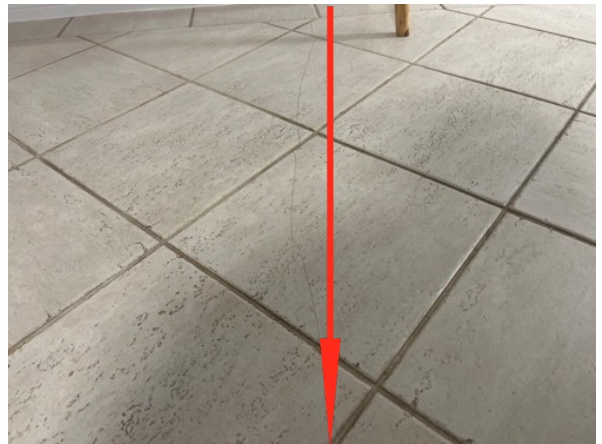
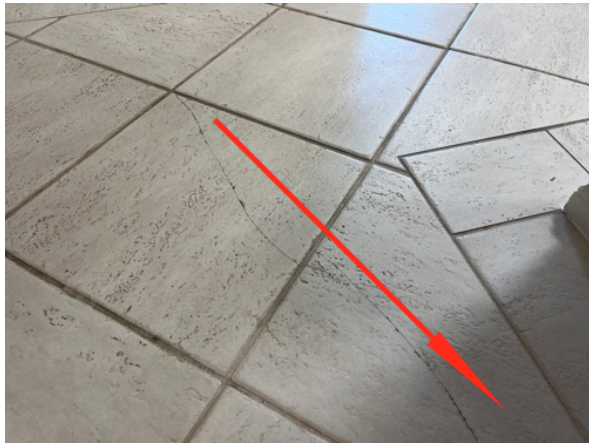
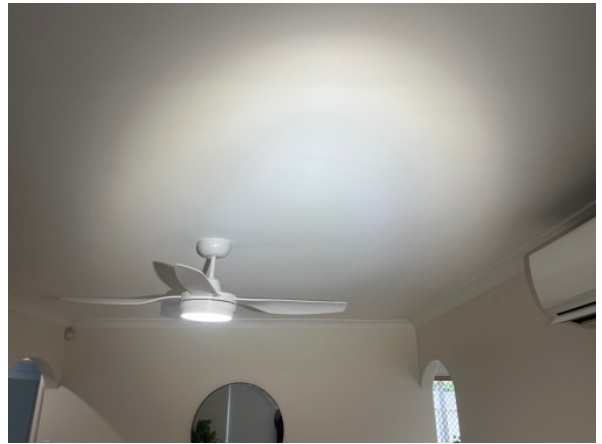
### Minor Defect 2.01

Minor floor tile cracking as marked not of a structural concern

Minor ceiling lining sag

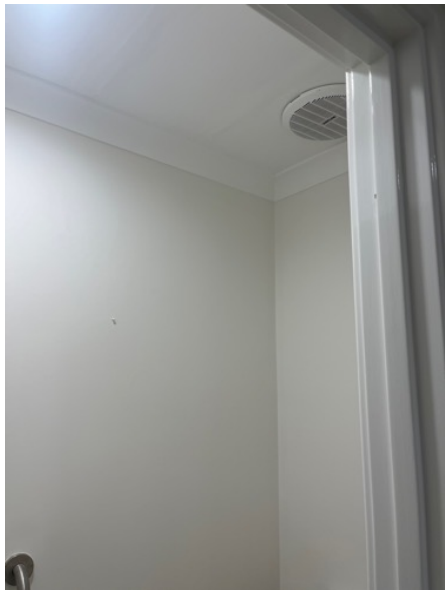
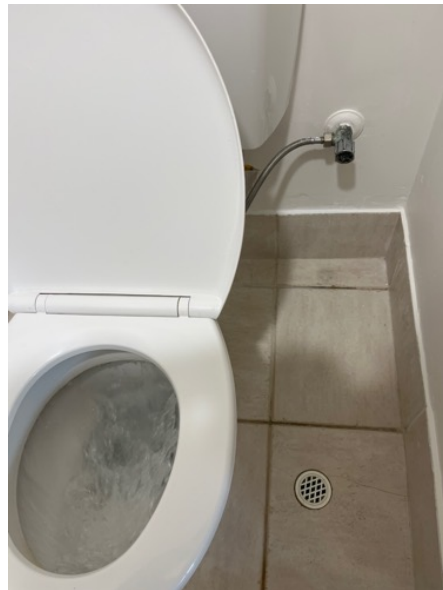
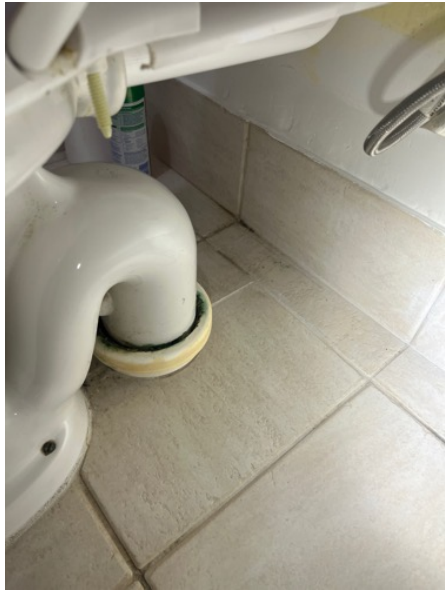
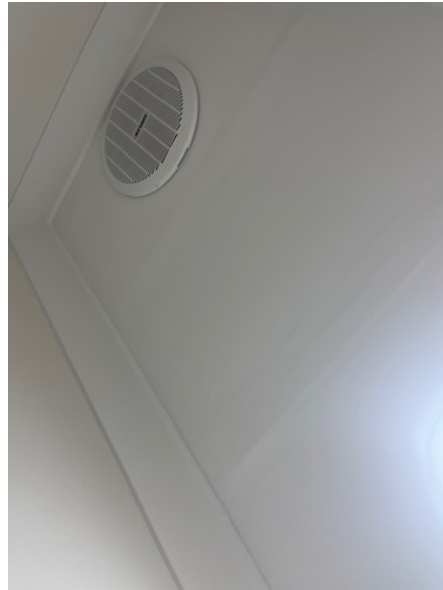
## Minor Defect 2.02

The toilet area is ok in general and the plumbing, drainage and extraction was working when checked.

Some previous ceiling joint patching

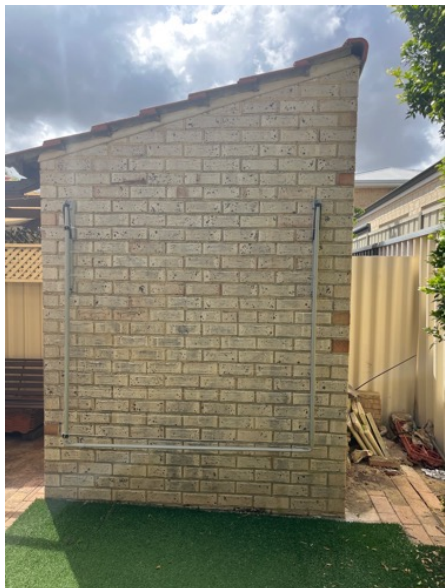
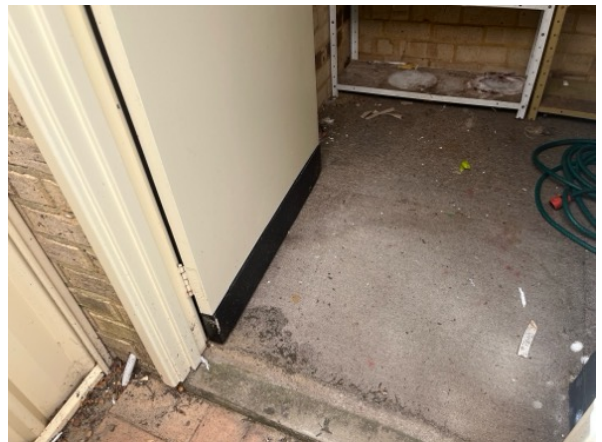
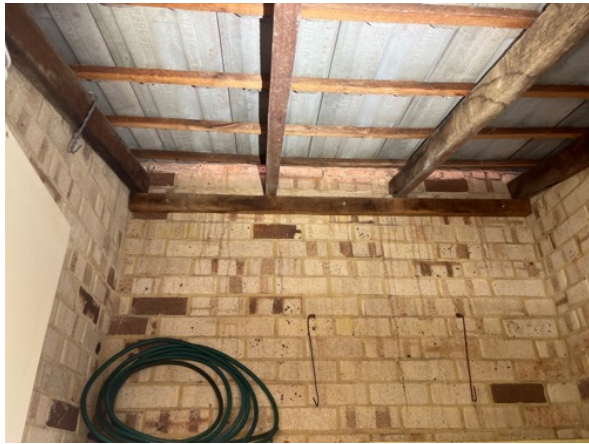
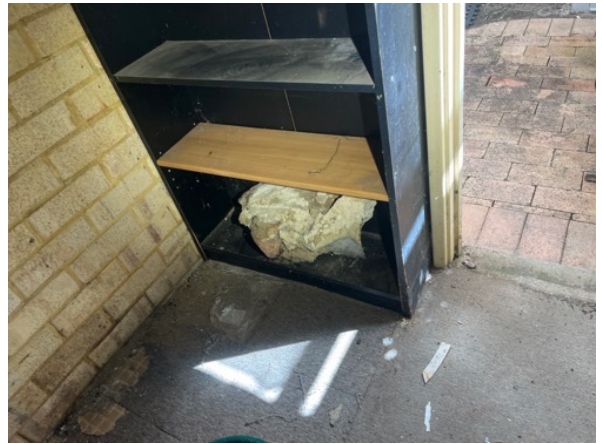
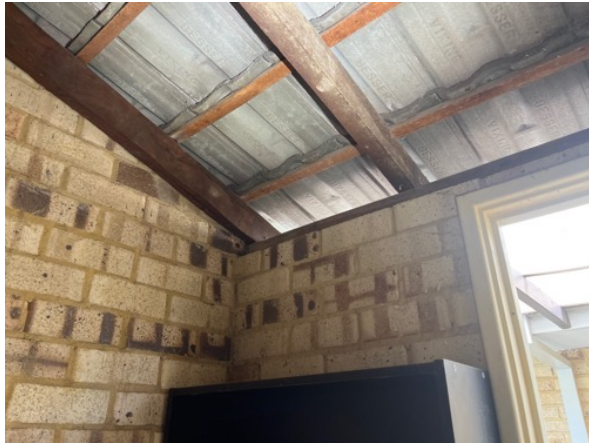
## Minor Defect 2.04

Previous door bottom swell.

Good termite housekeeping would ensure that you do not have any timber, cardboard or hardboard items standing on the concrete floor and against single skin garage walls.

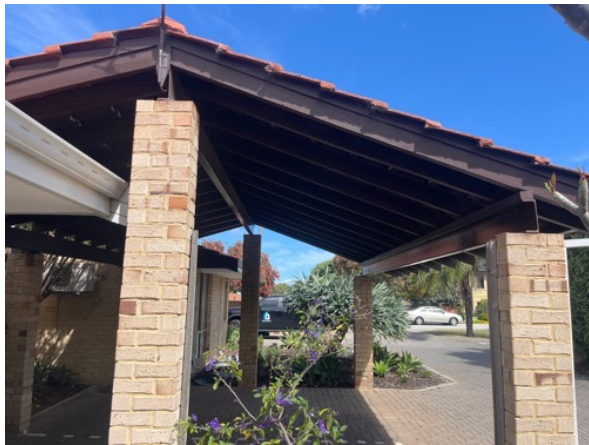
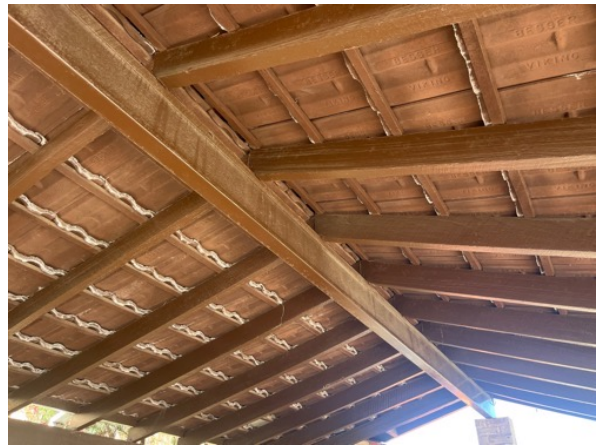
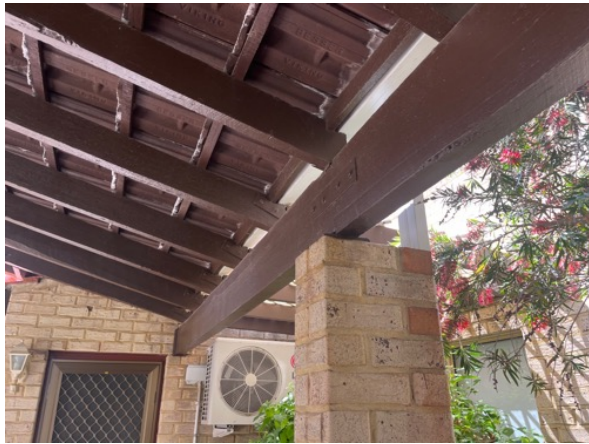
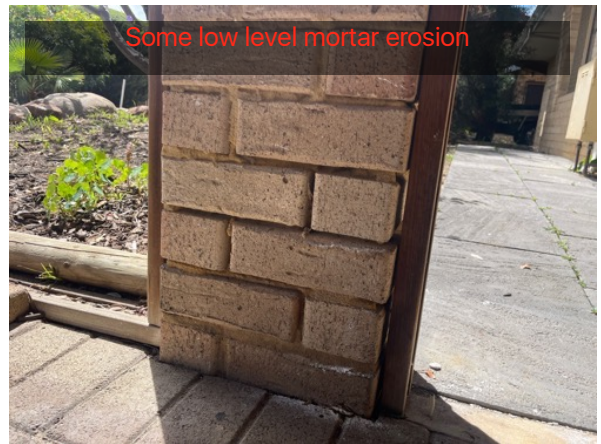
## Minor Defect 2.05

The carport structure and area appears ok in general.

Some low level mortar erosion on the pillars

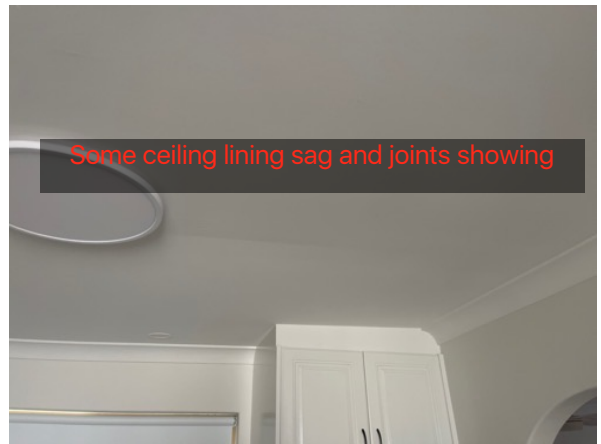
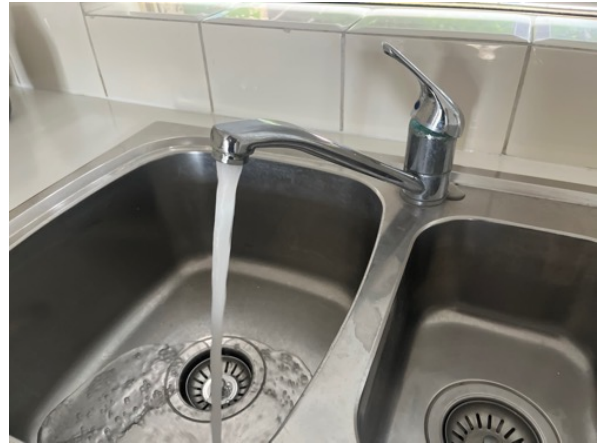
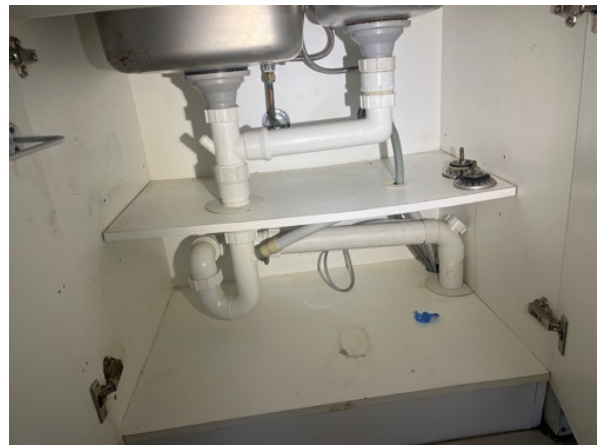
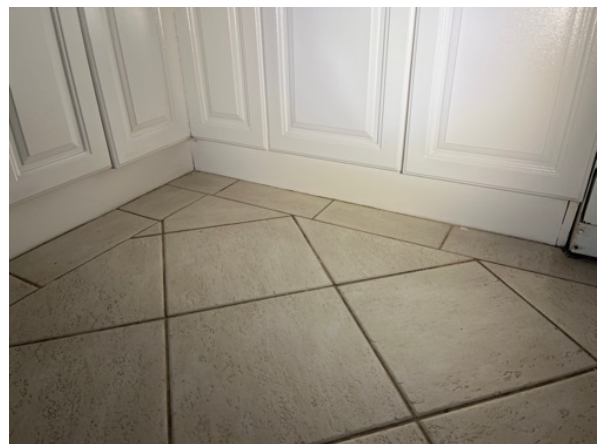
However the flick mixer was drip leaking when turned on as marked.

The kitchen cupboard doors have been recently painted.

The kitchen area is ok in general and no real concerns were seen.

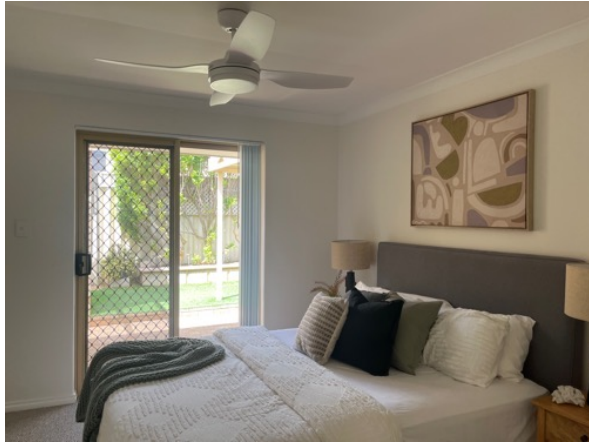
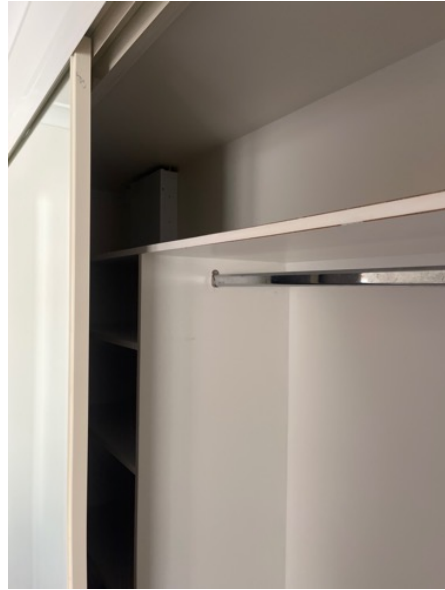
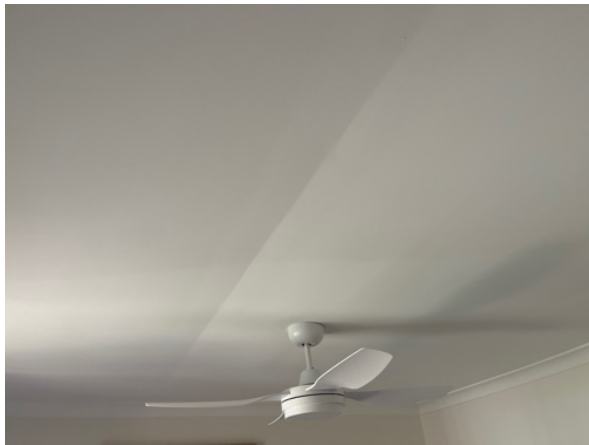
## For your information 3.02

However minor ceiling lining sag and joints showing.  
Recommend additional glue blocks be installed above in due course and monitor over time.  
Plasterboard sheets fixed to hardwood joists throughout the home and not Plasterglass linings bandaged to the hardwood joists.

Not structural as the lining only.

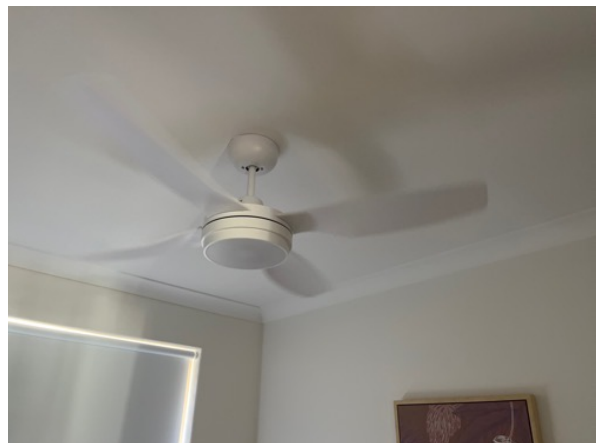
### For your information 3.05

**Finding:** Area ok in general and no real concerns seen

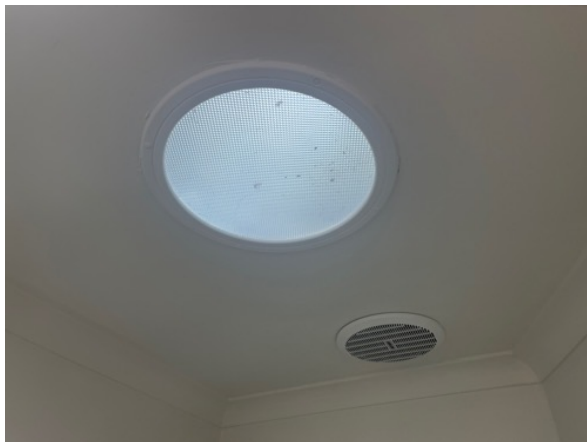
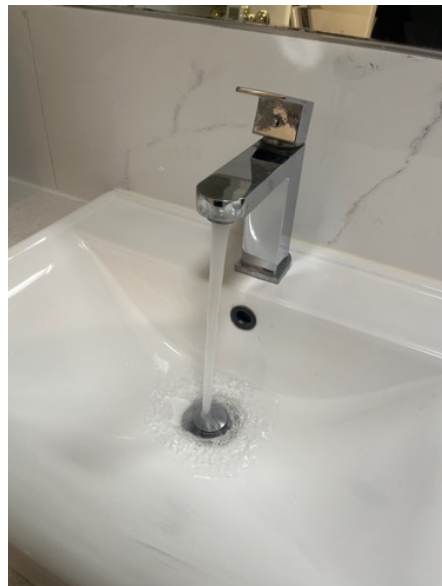
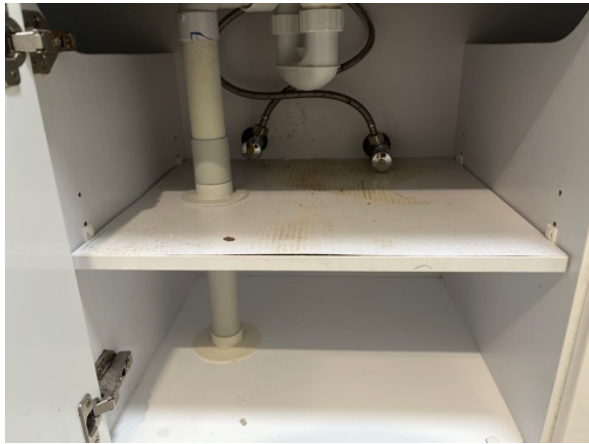
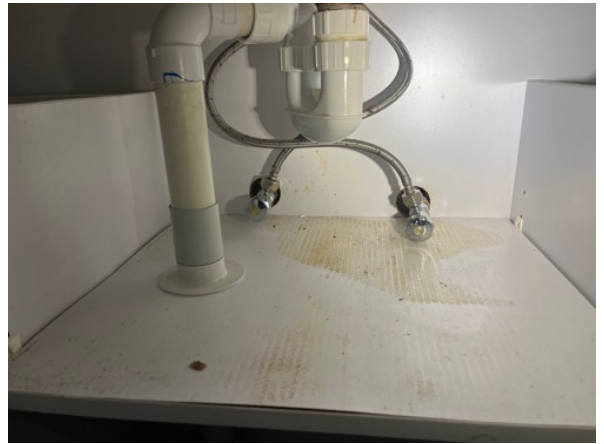
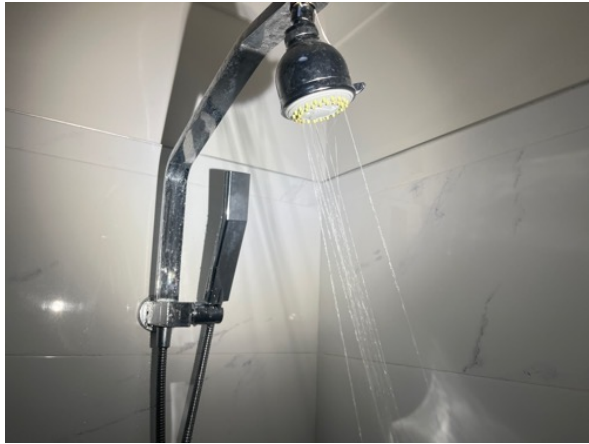
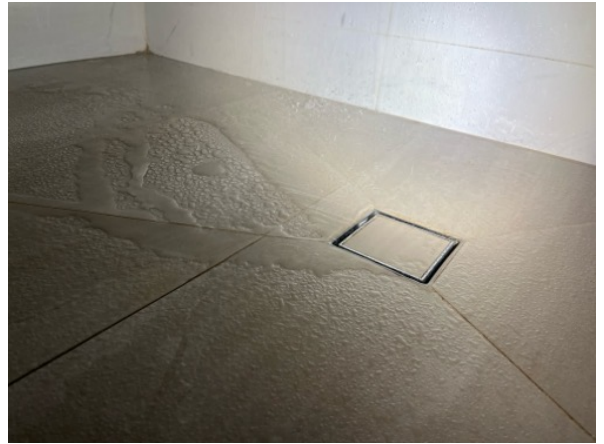
## For your information 3.06

General shower notes for ongoing general knowledge only.

The grout and internal corners of the floor and wall tiles need general maintenance and sealing especially at the lower level and floor junctions and should be checked on a regular basis. Grout can look fine however can break down and become more porous after 5 -10 years. The floor and low level wall tile grout is always the most affected area requiring regular maintenance as this can cause damp penetration on the adjacent areas. Also ensure that all pipe penetrations behind the plumbing escutcheons are well sealed. Also note damp environments can also attract termite.

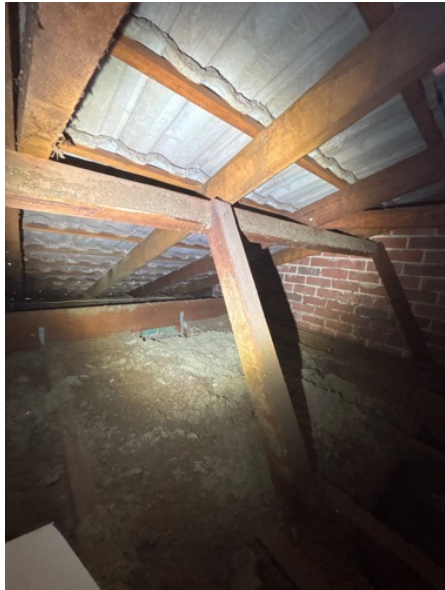
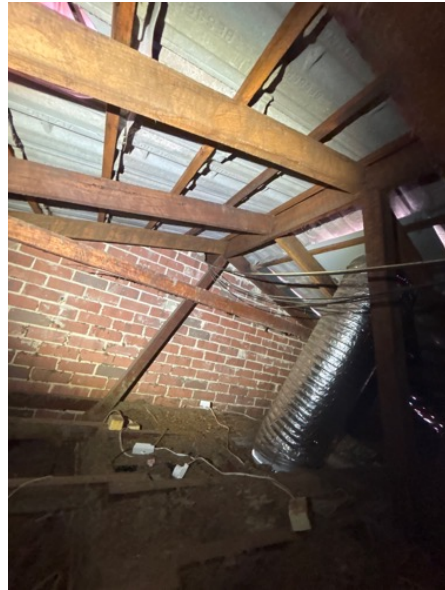
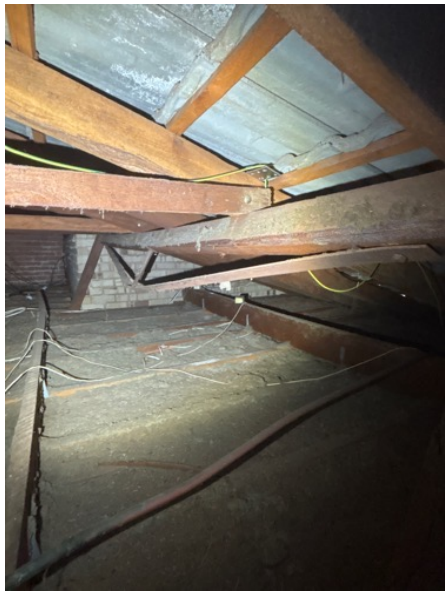
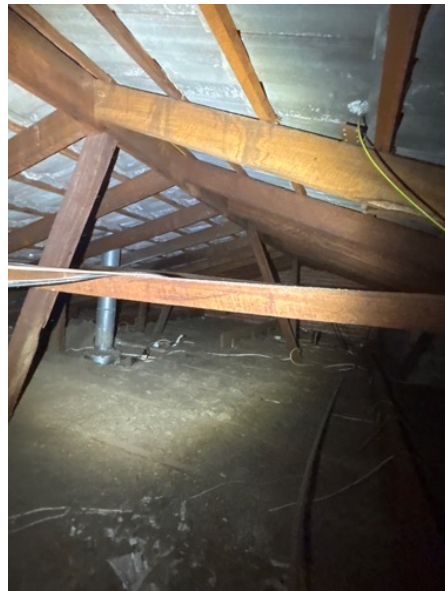
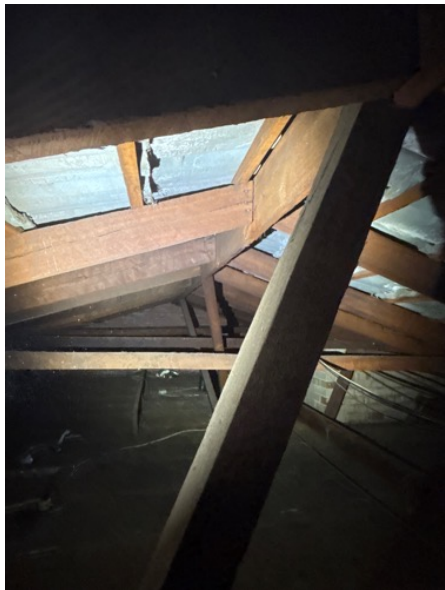
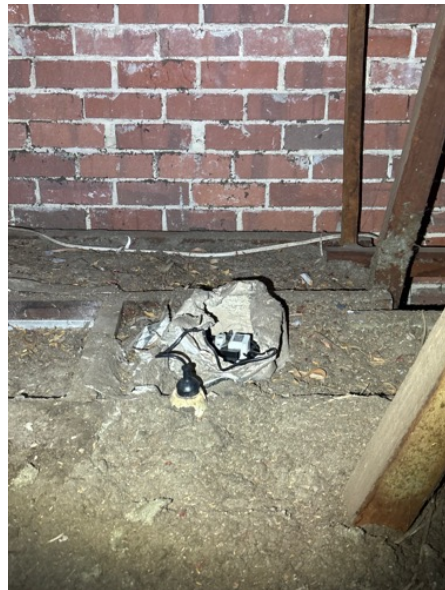
## For your information 3.07

The roof structure of the property appears to be in overall okay condition for its age, with no abnormal movement, bowing, or twisting detected internally or externally other than noted. However, due to limitations and restrictions, full visibility and access to all areas of the roof void were not possible.

It is noted that the roof structure may not fully comply with the current building codes as outlined in AS 1684 (Roof Framing Code). However, the construction is generally consistent with common practices at the time of construction. This inspection is based on the AS4349.1 standard, and unless specific concerns are highlighted, the construction is considered generally acceptable.

Despite these deviations, there are no immediate concerns observed, given the age of the property and the absence of any real movement to date.

Loose fibre Insulation has been installed.

The mechanical extraction fans are not all ducted to roof or eave penetrations. This ideally should be carried out to prevent possible condensation issues within the roof space however the roof is tiled with more ventilation than a tin roof.

The dividing party wall has not been built up completely to the under side of the roof tiles near the ridge on both ends. This is of a fire and smoke related concern and should be infilled to help prevent transfer of smoke or flames and gain the 1hr rating. Possible safety hazard and noted however a fairly standard procedure of the time when built and not of a structural issue.

- 1) As marked there is a horizontal split through one of the ridges, the top runs in line with the adjacent ridge with no drop however there has been some natural split to the timber, we recommend this be strapped to strengthen and prevent further splitting over time.

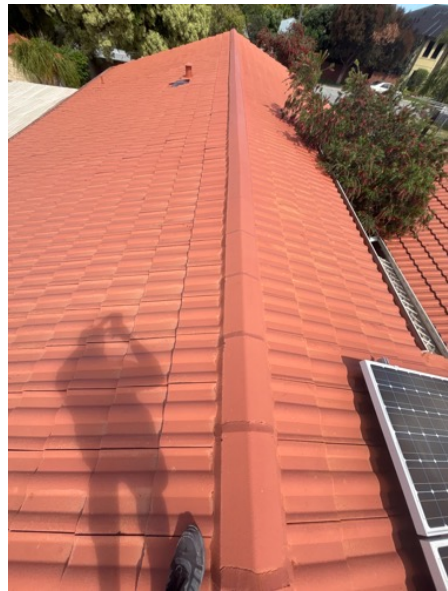
Some weathering to the barge board tail end as marked, this has been painted.

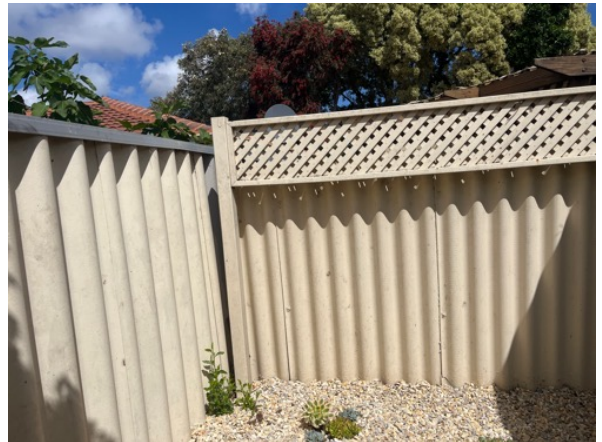
### For your information 3.10

**Finding:** The side fence is asbestos based however sealed and painted and ok.  
The rear fence panels are not asbestos based.
