Property Inspection Report

10 Fermoy Link, Darch, 6065

Inspection prepared for: Realmark North Coastal Date of Inspection: 12/9/2025 Time: 9:00 AM

Details of a Pre Purchase Building Inspection

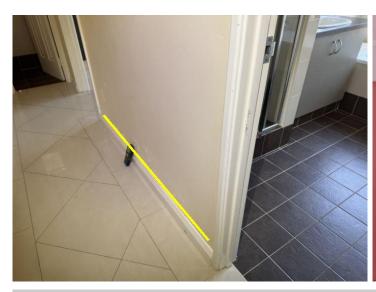
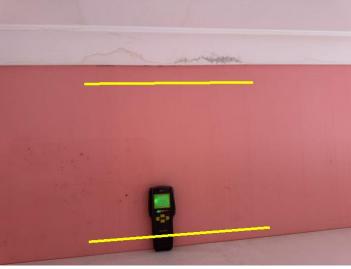
- There is evidence of dampness at the base of the wall adjacent to the family shower recess. This is most likely due to the tile joints (grout) becoming porous, or small cracks occurring. We recommend that the shower recess is re sealed. This does not appear to have affected the structural integrity of the masonry walls in any way. Repairs to wall surfaces can be carried out as general maintenance. There is no evidence to suggest that this is a plumbing issue.

- Moisture mark to front bedroom wall noted tested damp at time of inspection. Likely residual moisture from adjacent gutter overflowing in the past. Recommend monitoring and if required engaging a qualified roof plumber to evaluate.

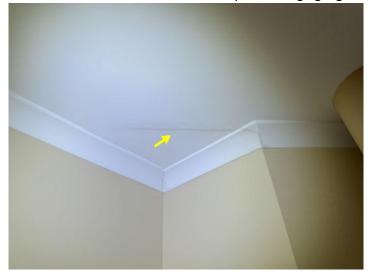
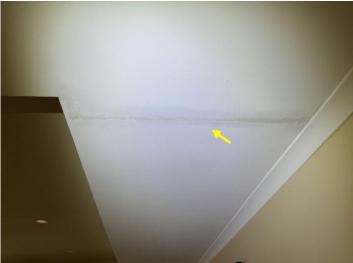
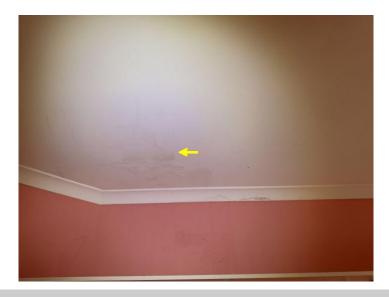
- Photos are indicative only and not limited.
- The ceiling has minor hairline joint cracks between the joints of the sheets in some locations. This is normally due to minor movement in the roof structure. This does not appear to have affected the structural integrity of the ceilings but may require some maintenance in the future.
- Moisture mark to front bedroom ceiling noted tested dry at time of inspection.

Likely from adjacent gutter overflowing in the past. Recommend monitoring and if required engaging a qualified roof plumber to evaluate.

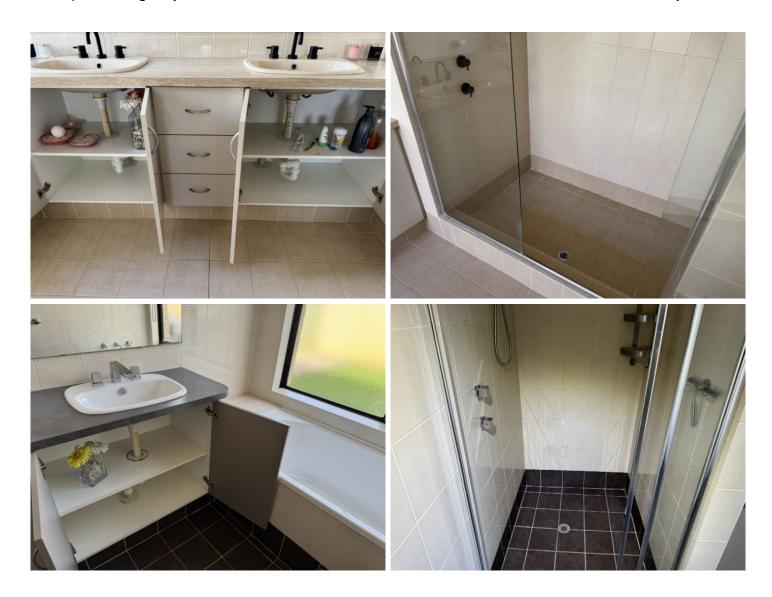
- Cabinets appeared to be in satisfactory condition for their age.
 Shower walls See "Internal Areas" "Wall Observations" for further details. Recommendations:
- As a preventative measure, we always recommend sealing tile grout and joints to prevent water infiltration into walls. Grout should be resealed every 5 years.

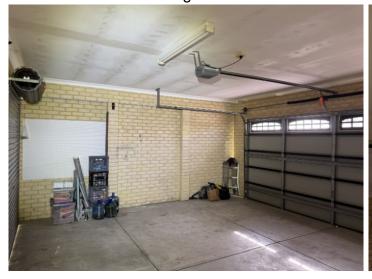
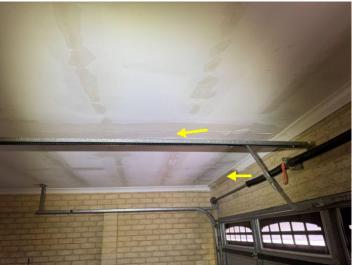
- The attached brick garage appears structurally sound. Observations:
- The ceiling sheeting in the garage has cracks between some of the sheets, and evidence of past repairs. This does not appear to be structurally significant and can be maintained normally.

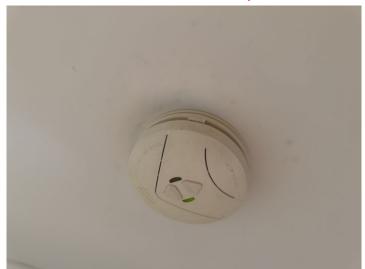
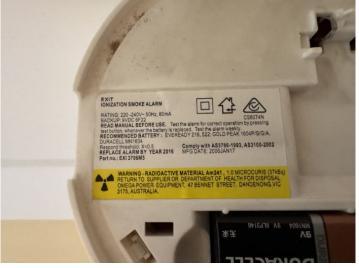
• Smoke alarms are out of date and need to be replaced. Legislation now states that hardwired smoke alarms must be under 10 years old and positioned relative to living and sleeping areas. Installation of new smoke alarms is required to be carried out a licensed electrical contractor at the vendors expense.

Expired 2016.

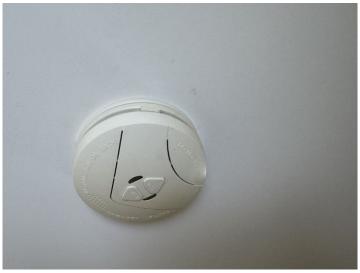
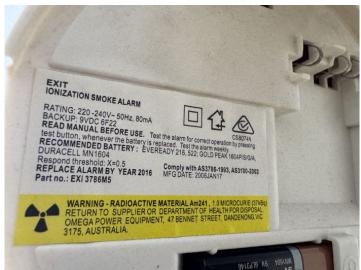
Expired 2016.

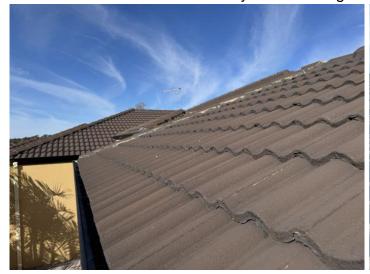
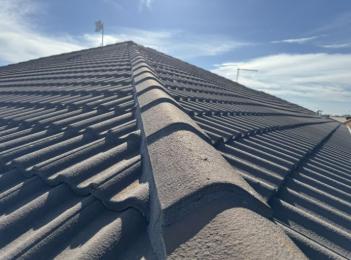
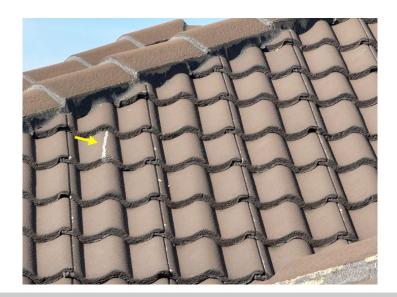
- The tiled roofing material appeared to be in satisfactory condition for age.
- Inspected from within the roof space.
- Inspected at various locations around the home from a ladder. Observations:
- There are several chipped tiles, but none of these appear to warrant replacement or repair of the tiles.
- There are previous silicone repairs noted. These tiles should be monitored, and ideally at some stage replaced as silicone can deteriorate over time.

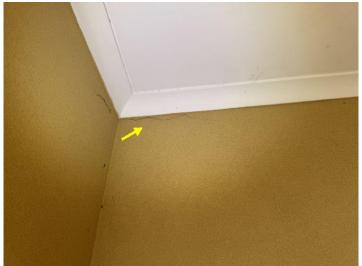
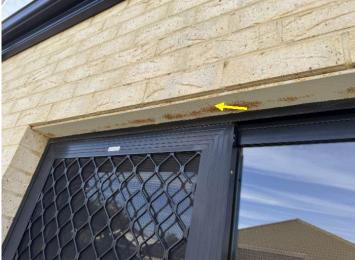
- Wall covering is in an acceptable condition.
- Observations:
- Photos are indicative only and not limited.
- Due to normal movement within the property or foundations as they settle, cracks have appeared on some of the external walls of the house. These cracks do not appear to have affected the overall structural integrity of the property and are within acceptable tolerances. Generally patching and painting will suffice.
- There are lintels in various locations that have surface rust. If these lintels continue to rust they may expand causing horizontal cracks in the brickwork being supported. It is recommended that the lintels are prepared and painted with a rust guard coating to prevent any further rust from occurring.

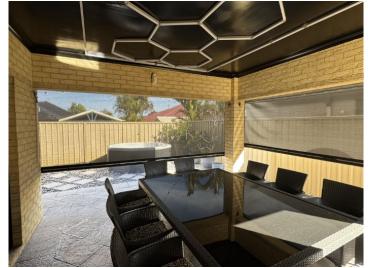
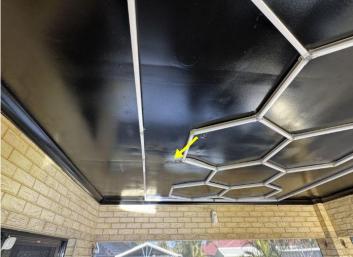
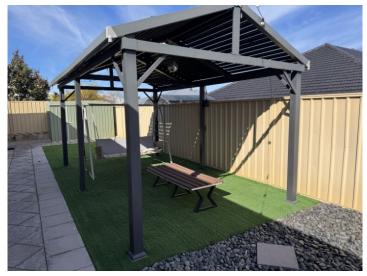
• There is evidence of past moisture damage and repair to al fresco ceiling.
