Timber Pest Inspection Report

10 Fermoy Link, Darch, 6065

Inspection prepared for: Realmark North Coastal

Date of Inspection: 12/9/2025 Time: 9:00 AM

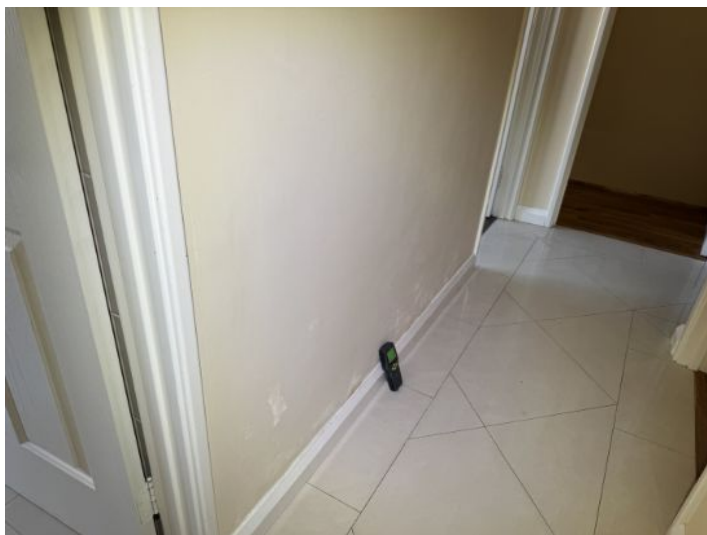
- A moisture meter confirmed the presence of excessive moisture in wall adjacent to family shower.
- See 'Grading and Drainage' section of the report for more information.

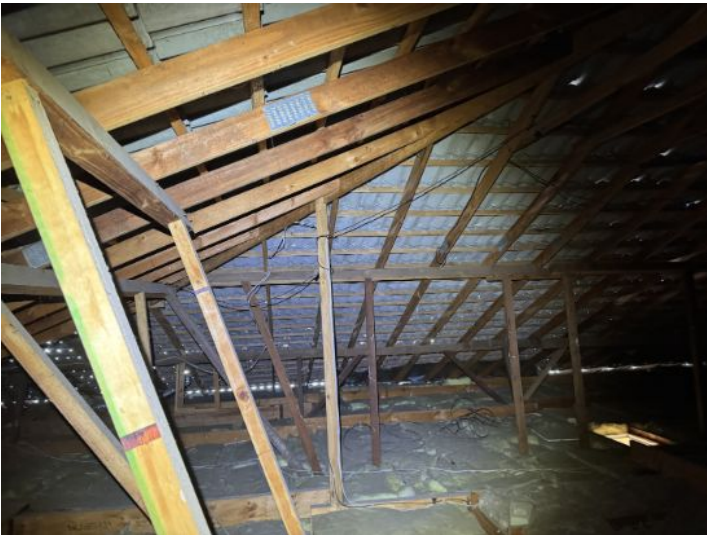
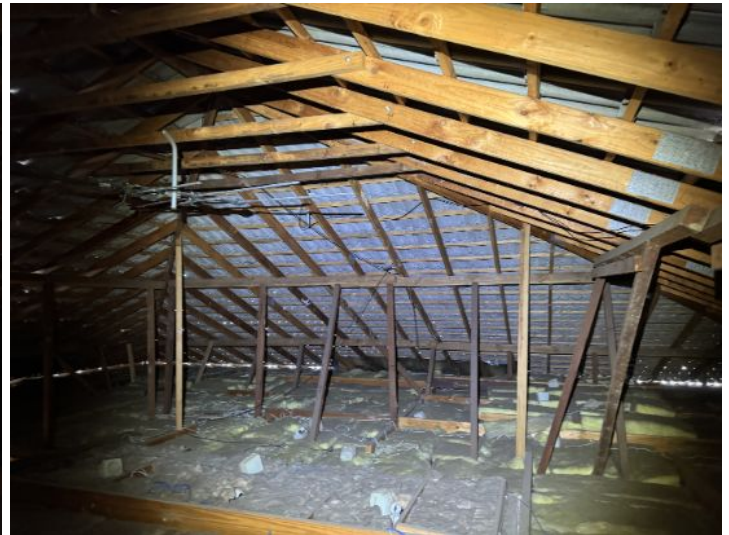
- Access was available through a manhole in the hallway.
- Limited visibility and access due to insulation and pitch.

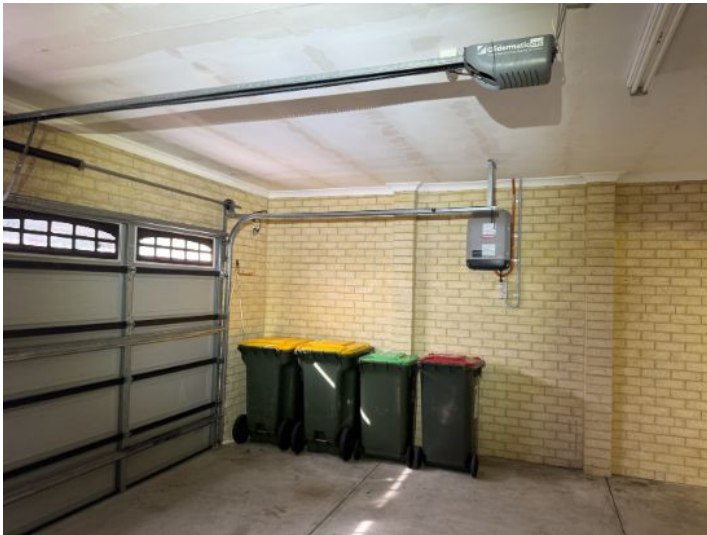
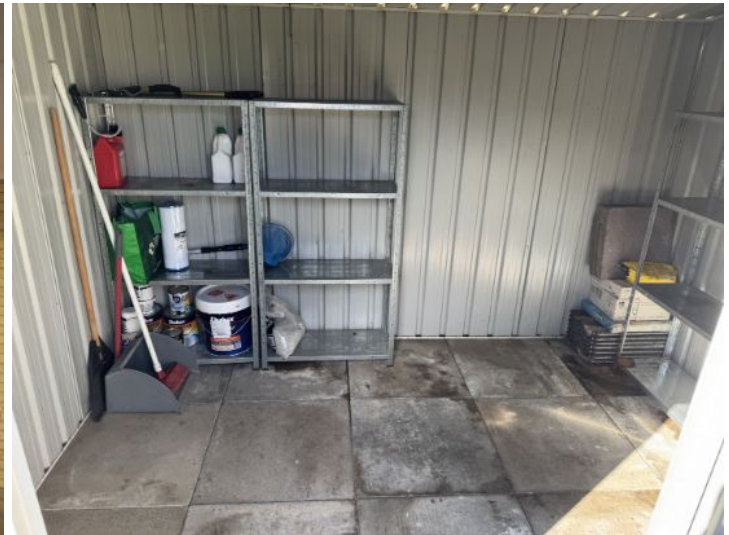
- Often the gap between the slab in the garage and the slab for the home can be a susceptible area for attack. Monitor this area for termite activity in the future.

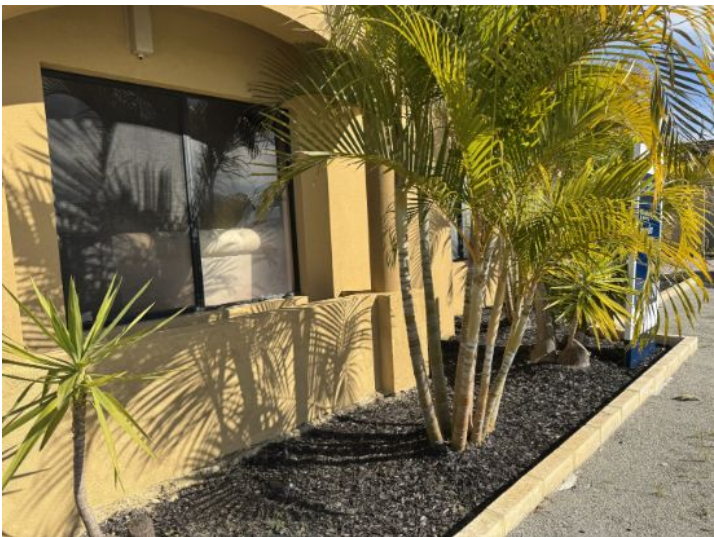
- There are garden beds which are abutting external walls. This can result in water moisture affecting the structure over time. It is recommended that either the beds be removed or a water barrier be placed between the flower bed and the external walls. If these beds are retained it is important that any watering is directed away from the building and kept to an absolute minimum and is controlled. These are risk area for termite activity.

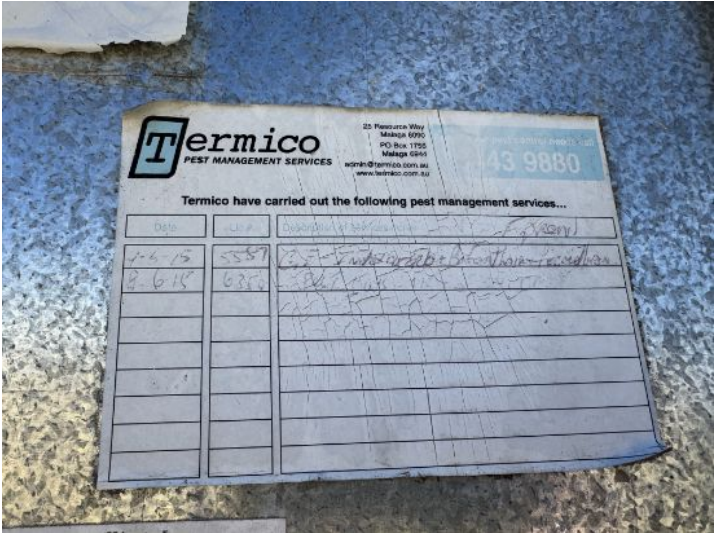
- Comments:
- It is recommended that any available records and associated paperwork from the current property owner is requested with regard to previous treatment.
 - A termite management plan should be put in place. AS 3660.2 recommends that a routine inspection for termite management purposes be carried out at least annually.
 - If termite activity or damage is noted it is possible that further termite damage may be present in concealed areas.
 - There is no record of any recent termite barrier treatment to the property.

- Termite inspections are recommended every 12 months.
- Update to termite barrier treatment is recommended.
