AUCTION PACK

27 Melissa Street
DUNCRAIG
WA 6023

Market Ready Pre Sale Summary

27 Melissa Street, Duncraig, 6023

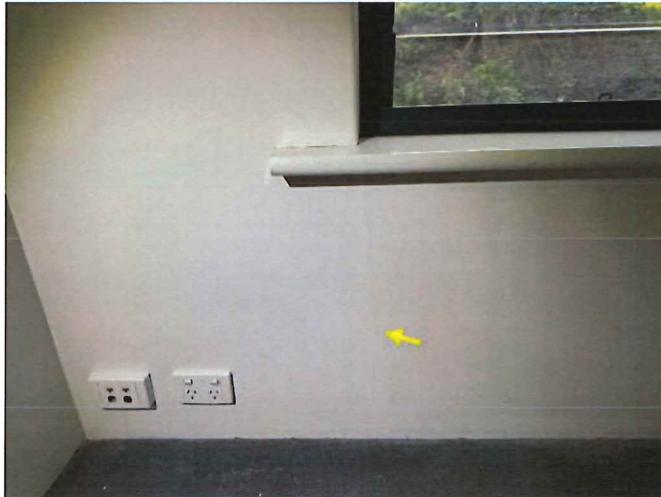
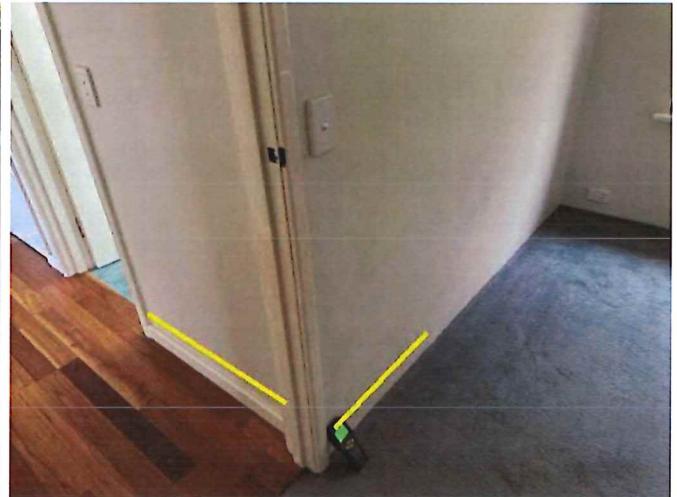
- Photos are indicative only and not limited.
- Due to normal movement within the property or foundations as they settle, cracks have appeared at various locations within the home. These cracks do not appear to have affected the overall structural integrity of the property and are within acceptable tolerances. Generally patching and painting will suffice.
- There is evidence of dampness at the base of the wall adjacent to the shower recess. This is most likely due to the tile joints (grout) becoming porous, or small cracks occurring. We recommend that the shower recess is re sealed. This does not appear to have affected the structural integrity of the masonry walls in any way. Repairs to wall surfaces can be carried out as general maintenance. There is no evidence to suggest that this is a plumbing issue.

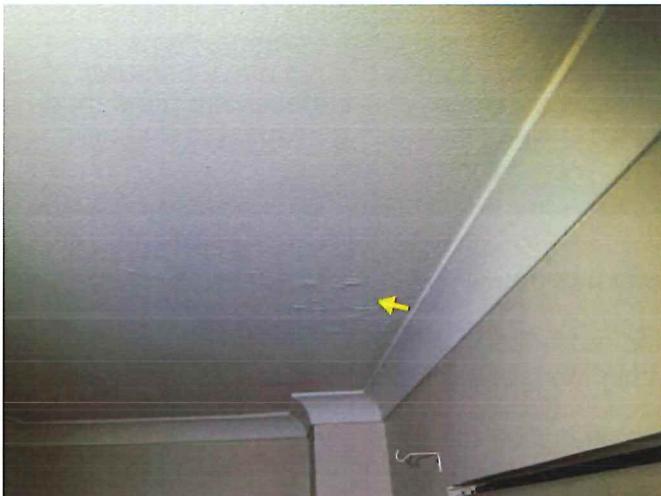
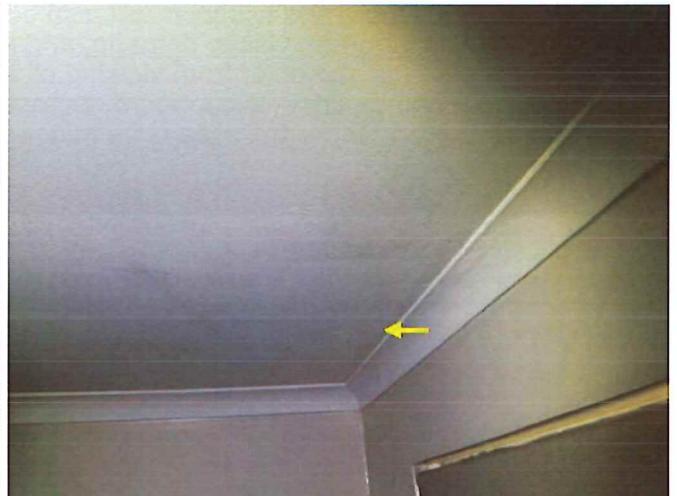
- Photos are indicative only and not limited.
- Some of the ceiling paint has flaked and is peeling. Evidence of past repairs noted.

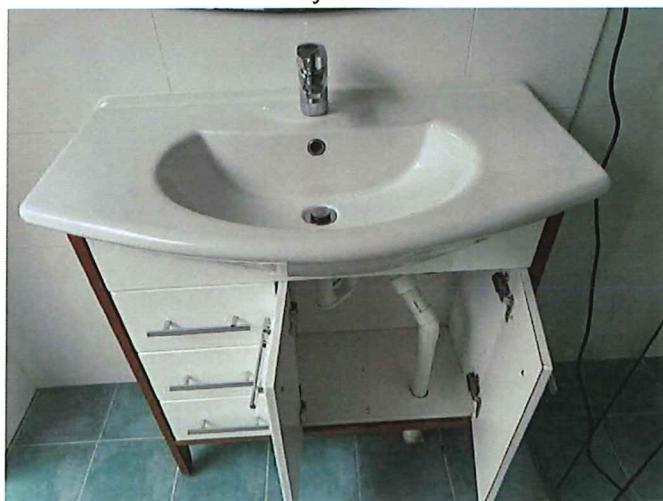
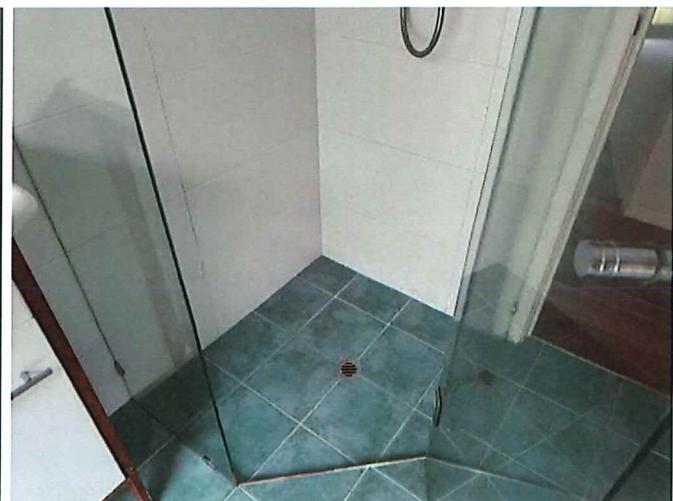
- Cabinets appeared to be in satisfactory condition for their age.
- Shower walls - See "Internal Areas" "Wall Observations" for further details.

- As a preventative measure, we always recommend sealing tile grout and joints to prevent water infiltration into walls. Grout should be resealed every 5 years.

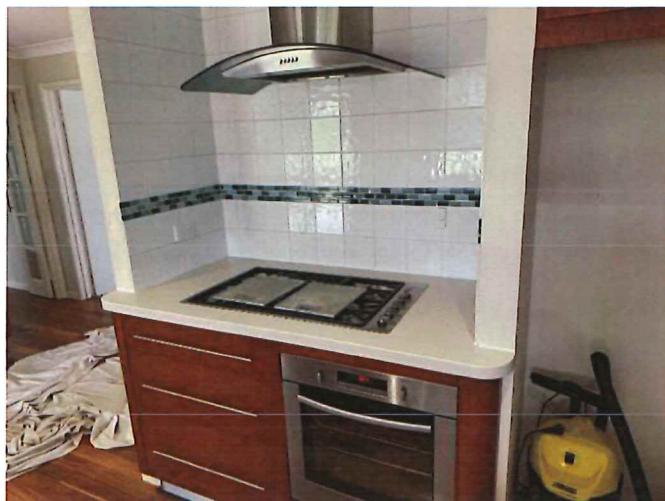
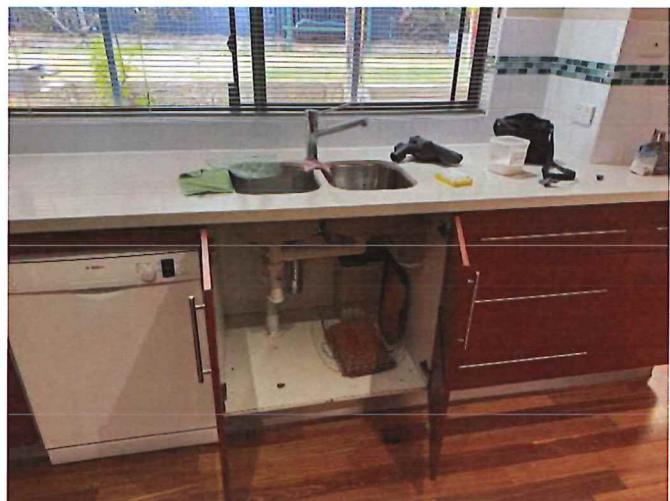
- Cabinets appeared to be in satisfactory condition for their age.

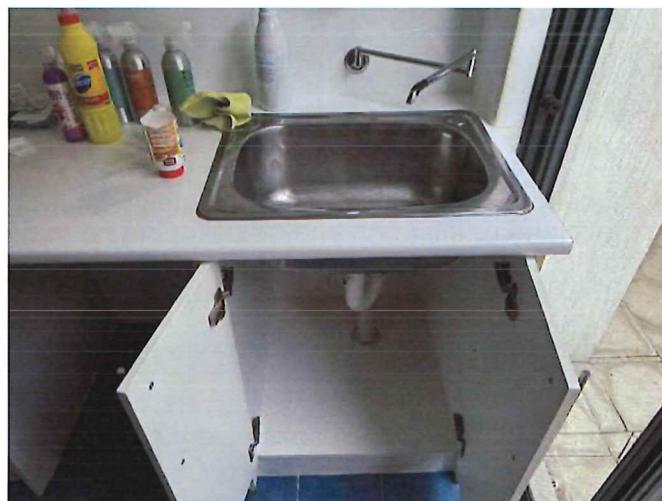
- Cabinets appeared to be in satisfactory condition.

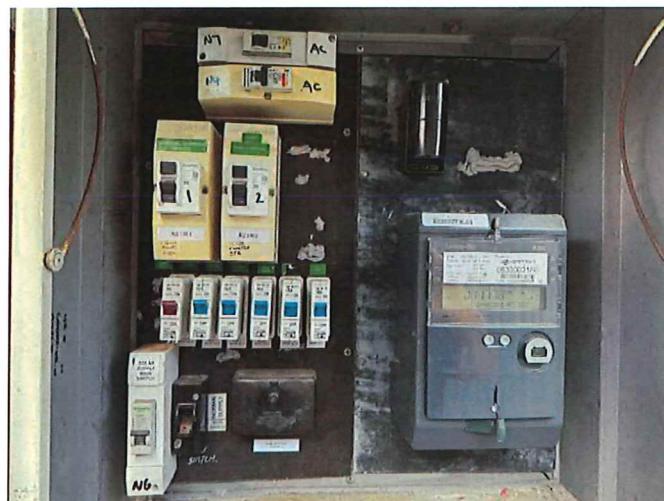
- There are at least two RCD's covering the power and lighting circuits.

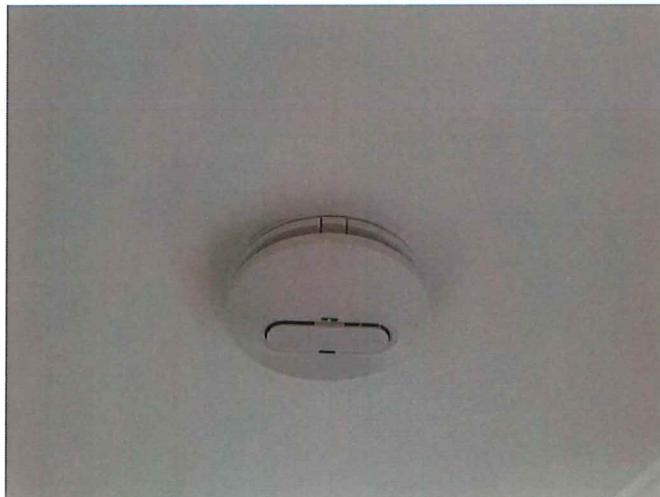
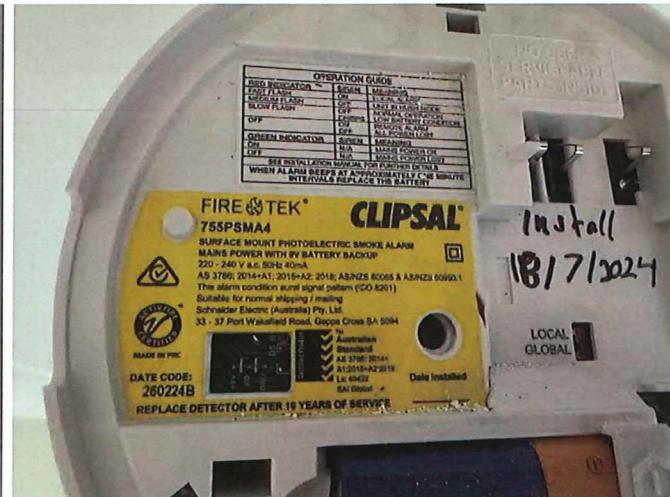
- There is a hardwired smoke alarm installed - Not tested.

Expiry date 2034.

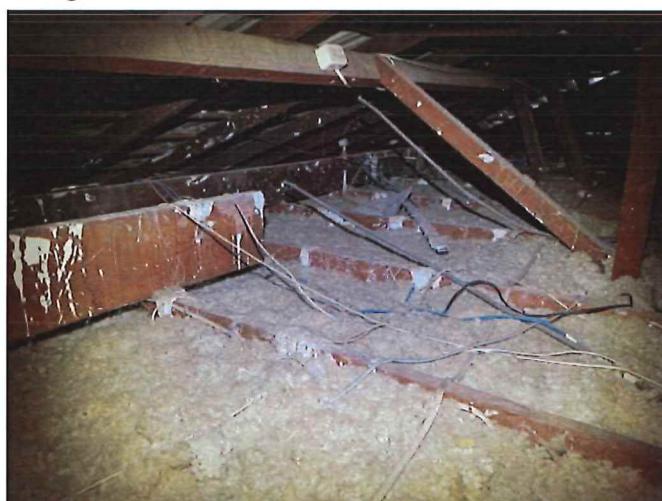
- Loose fill insulation noted in the ceiling space appears to be of adequate coverage.

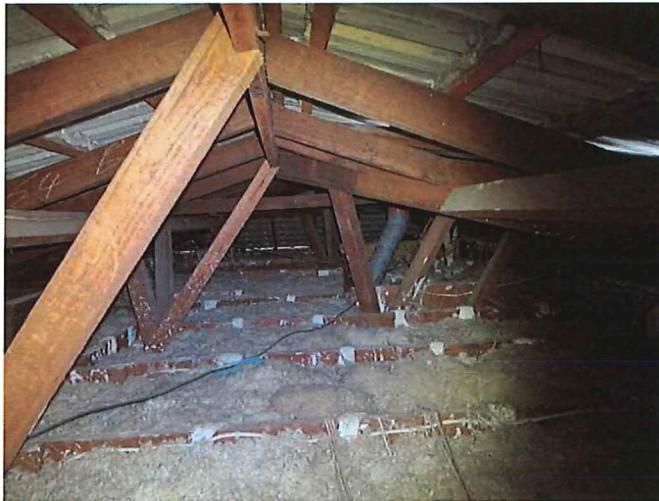
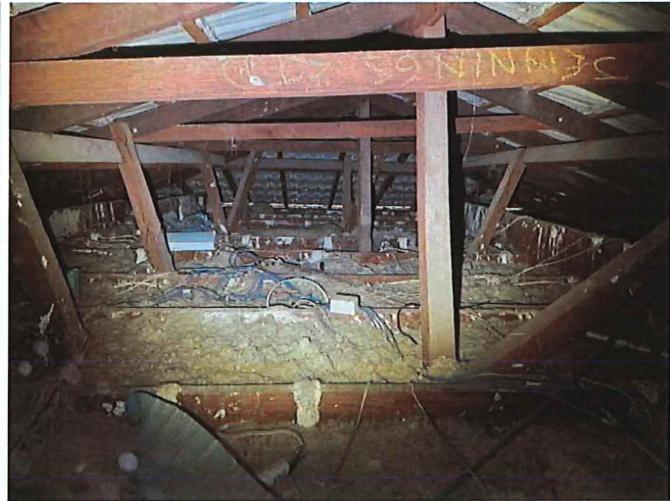
- The timber roof structure appeared satisfactory.

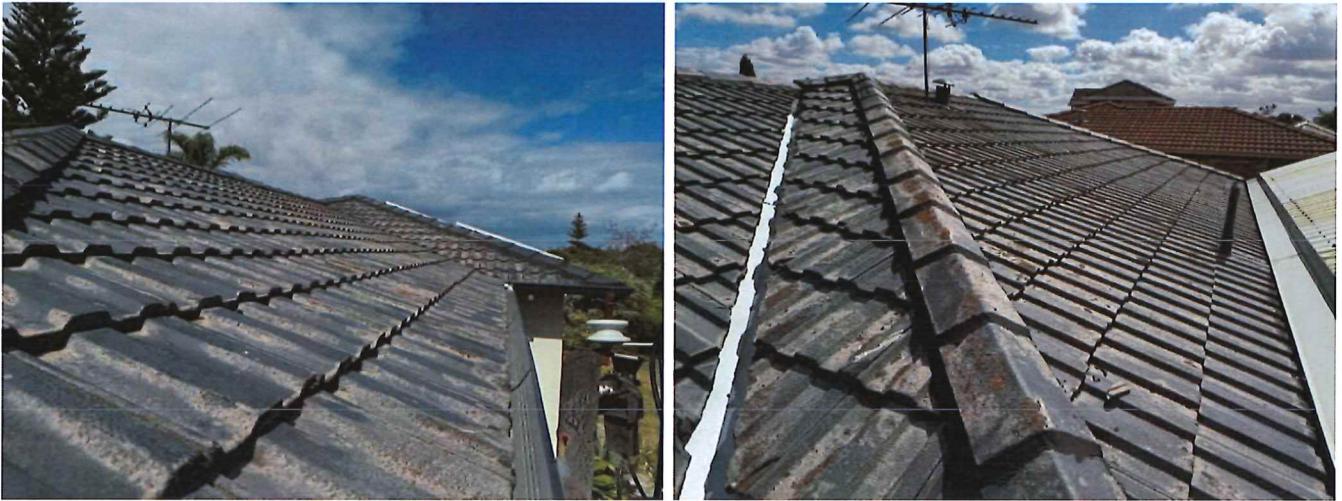
- The tiled roofing material appeared to be in satisfactory condition for age.
- Inspected from within the roof space.
- Inspected at various locations around the home from a ladder.

- There are several chipped tiles, but none of these appear to warrant replacement or repair of the tiles.

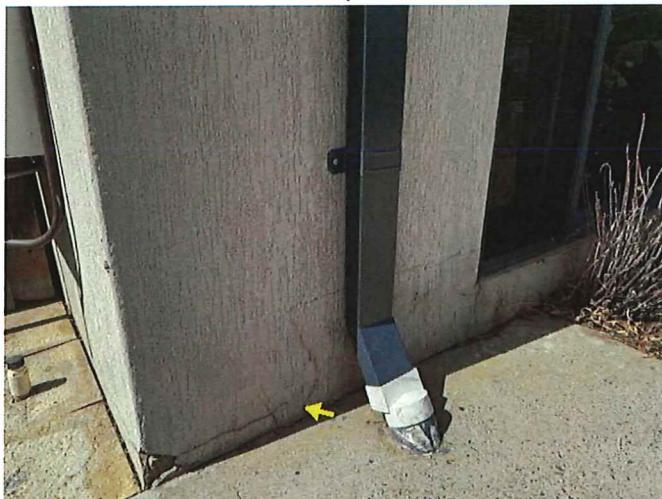
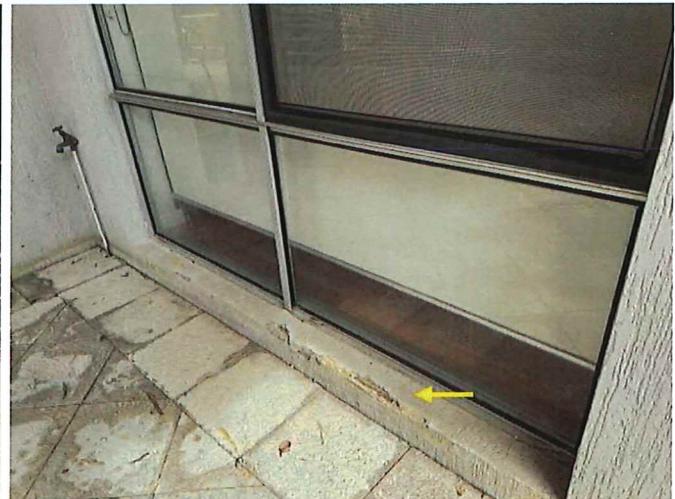
- Photos are indicative only and not limited.
- Due to normal movement within the property or foundations as they settle, cracks have appeared on some of the external walls of the house. These cracks do not appear to have affected the overall structural integrity of the property and are within acceptable tolerances. Generally patching and painting will suffice.
- The rendered wall coating is lifting off and chipped in some areas, this is often due to moisture ingress. Recommend patching and painting as required.

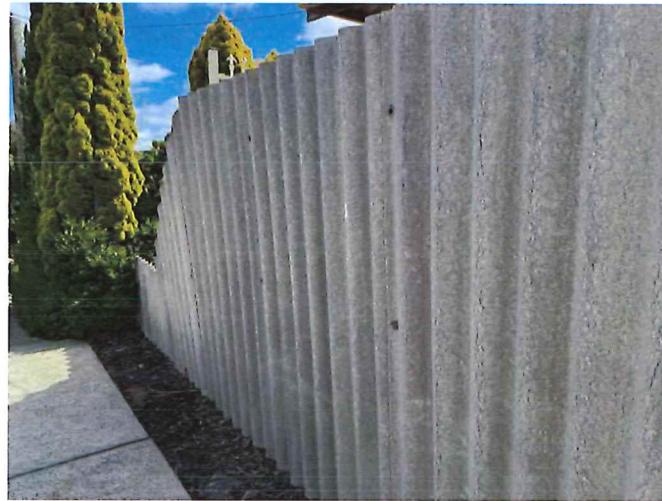
- The boundary fence has some areas that are damaged and is leaning in areas. Some maintenance will be required.

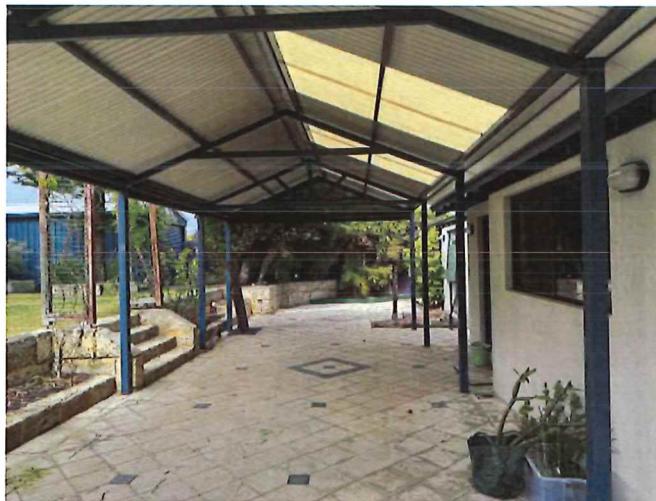
- Patio / Alfresco appears in satisfactory and functional condition. Appears to be structurally sound.

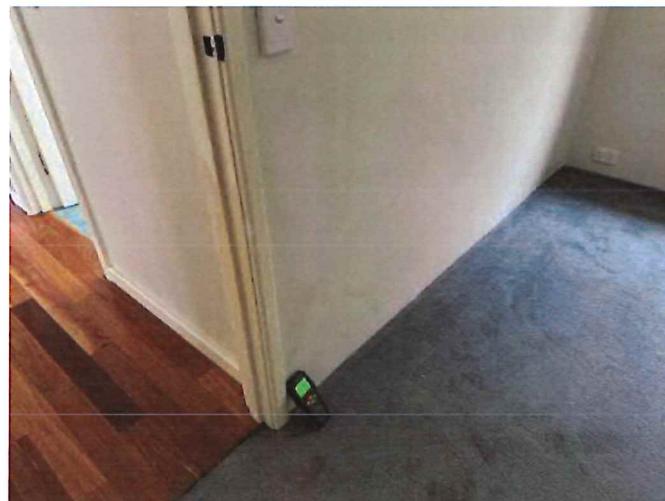
- A moisture meter confirmed the presence of excessive moisture in walls adjacent to shower.
- See 'Grading and Drainage' section of the report for more information.

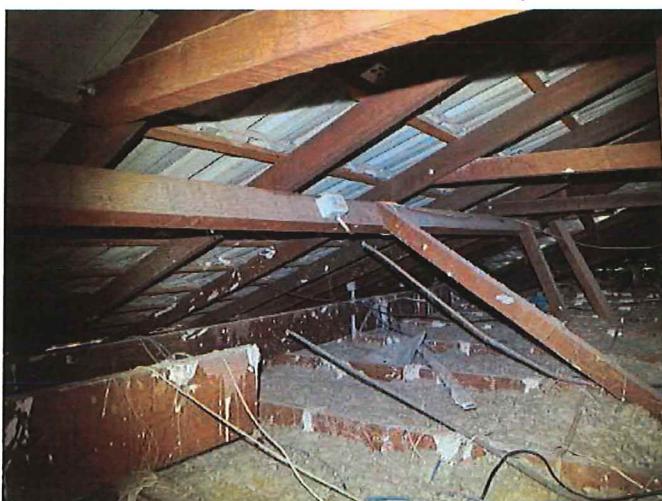
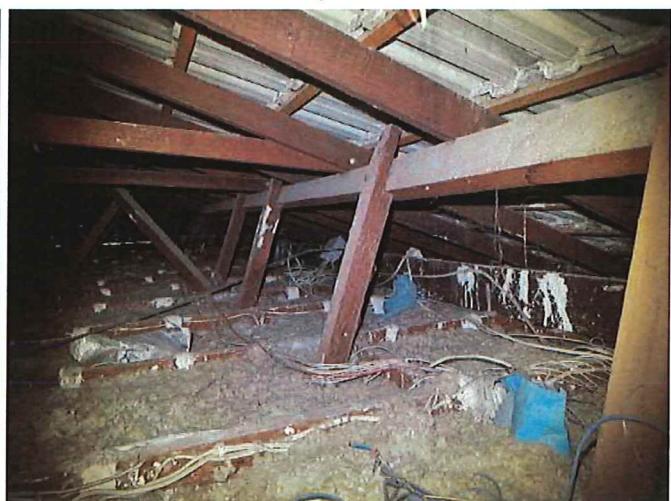
- Access was available through a manhole in the hallway.
- Limited visibility and access due to insulation and pitch.

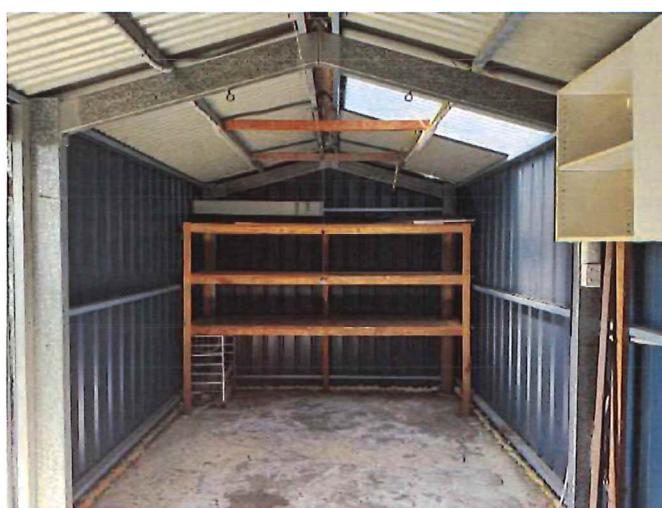
- Shed appeared satisfactory.

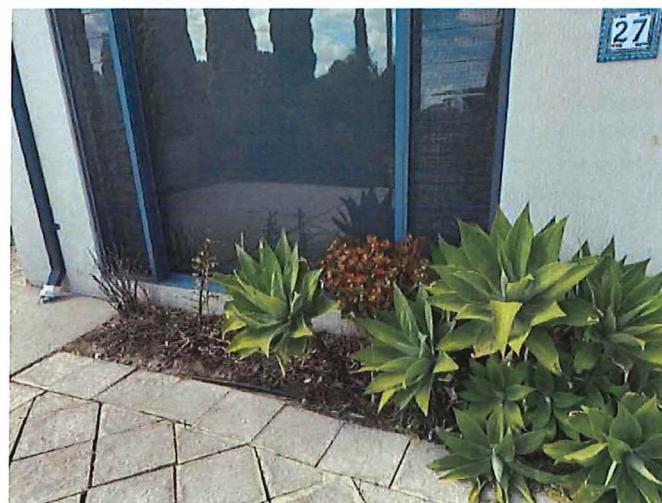
- There are garden beds which are abutting external walls. This can result in water moisture affecting the structure over time. It is recommended that either the beds be removed or a water barrier be placed between the flower bed and the external walls. If these beds are retained it is important that any watering is directed away from the building and kept to an absolute minimum and is controlled. These are risk area for termite activity.
