Visual Timber Pest Inspection & Report in accordance with AS 4349.3-2010 **(For use in all States & Northern Territory but not the Australian Capital Territory)**

Address of Property Inspected: 18 Edwin Cr

Suburb: Bluff Point Post Code: 6530

Inspection Date: 28/03/2024

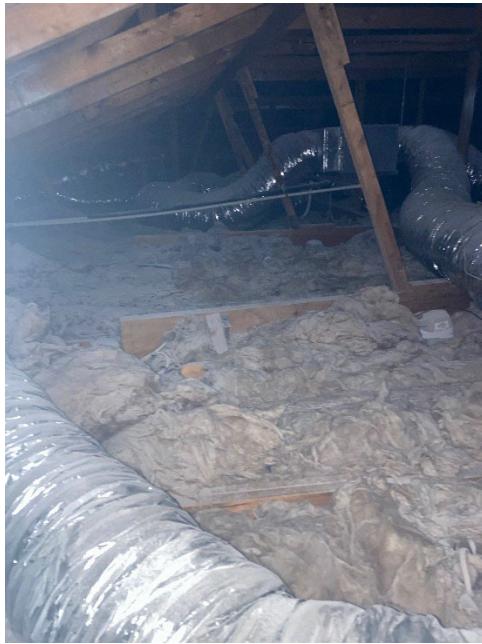
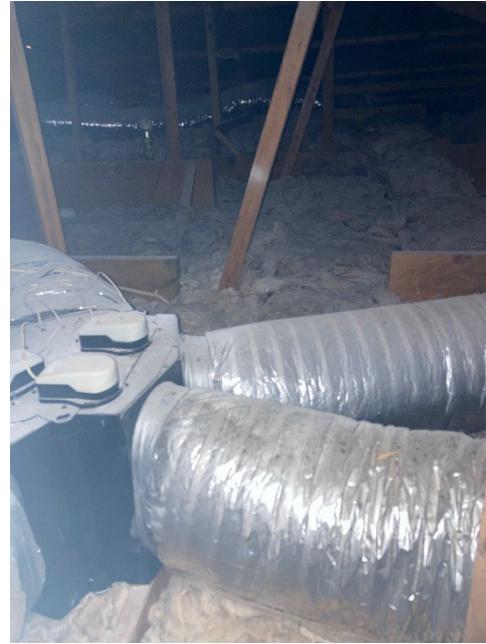
1.4 Area(s) in which Visual Inspection was Obstructed or Restricted and the Reason(s) why include: **Roof void due to insulation & Ducted Aircon covering ceiling joists.**

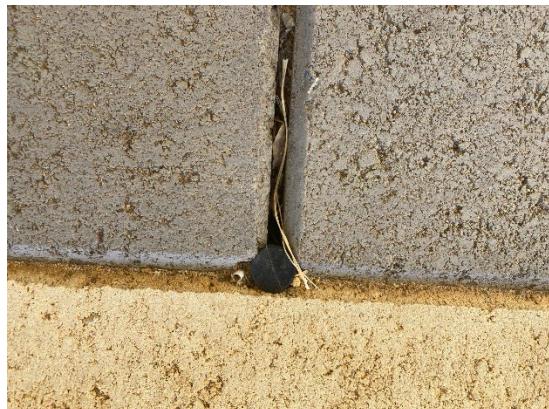
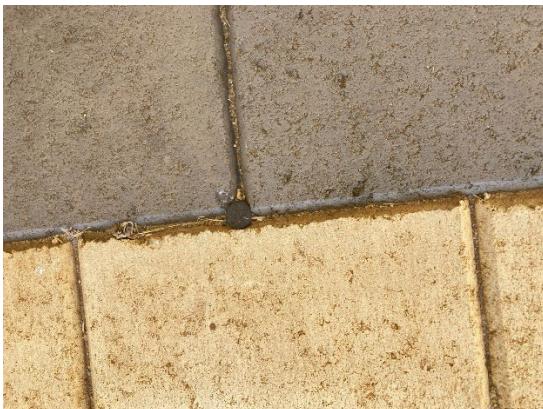
2.5 Previous Treatment Evidence: Drill holes were found that may be evidence of a possible previous termite treatment. Carried out in February of 2022 using Biflex @ 0.5%.

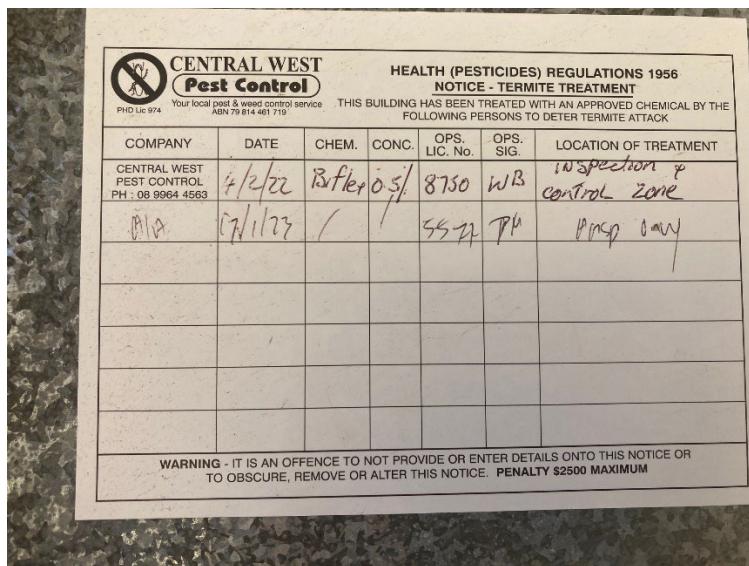
2.6 A Durable Notice (Termite Management Notice) was located. It could not be read due to poor condition
