Pre-Purchase Building Inspection Report

BBS24047

Lot 60 (18) Edwin Crescent, Bluff
Point.

Photographic Appendix 1

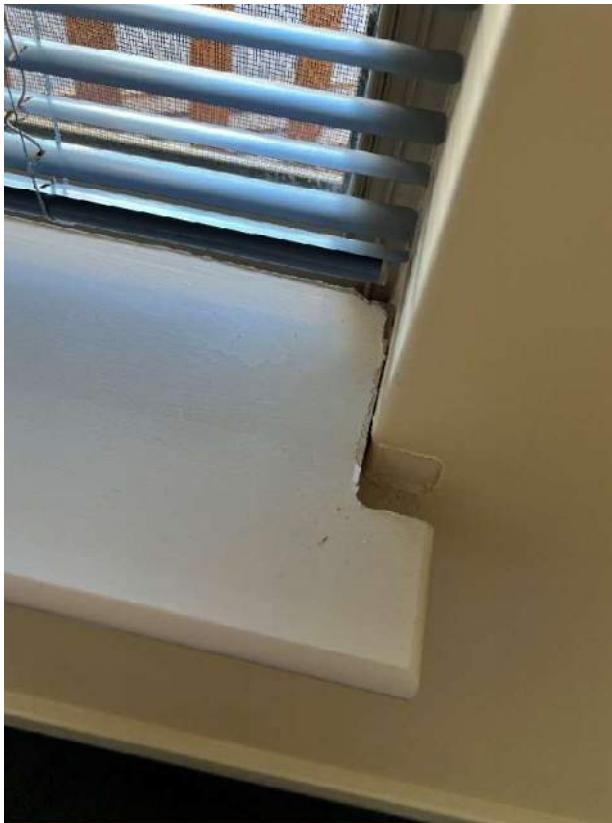
Photo Item No. 7
Defect Category - Minor

7.	The MDF sill to the front living room has disconnected from its fixings.	Minor
Internal Walls	8.	Minor wall cracking was found to each side of the supporting brackets for the roller door to the Garage. The cracking extends one course high and extends along the mortar joint on the right-hand side. This cracking is approximately 1-2mm in width. Minor cracking extends within the mortar joints on the left-hand side of the roller door bracket. The cracking is approximately 1-2mm in width.	Minor

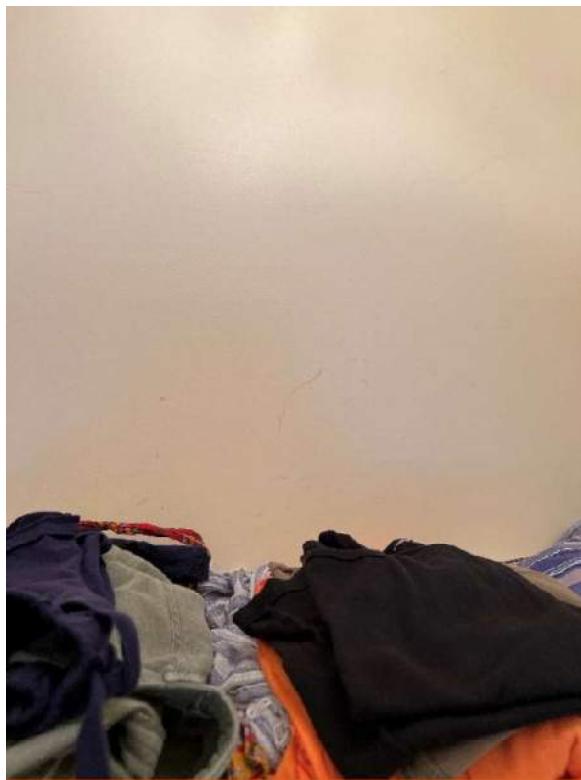
Photo Item No. 9
Defect Category - Minor

9.	Only some small chips and marks and hairline cracks were found mainly through the Bedrooms and the Bedroom Robes. This has been from use of the rooms and workmanship from trades.	Minor
Internal Skirtings	10.	The miter joints to the MDF skirtings have cracked in multiple locations.	Minor
Internal Ceilings	11.	Minor cracking was noted at the joints of the ceiling cornice.	Minor
Kitchen	12.	The left side Kitchen cupboard under the sink does not close properly.	Minor
Plumbing	13.	Minor surface corrosion was located on the WC flexi hose.	Minor

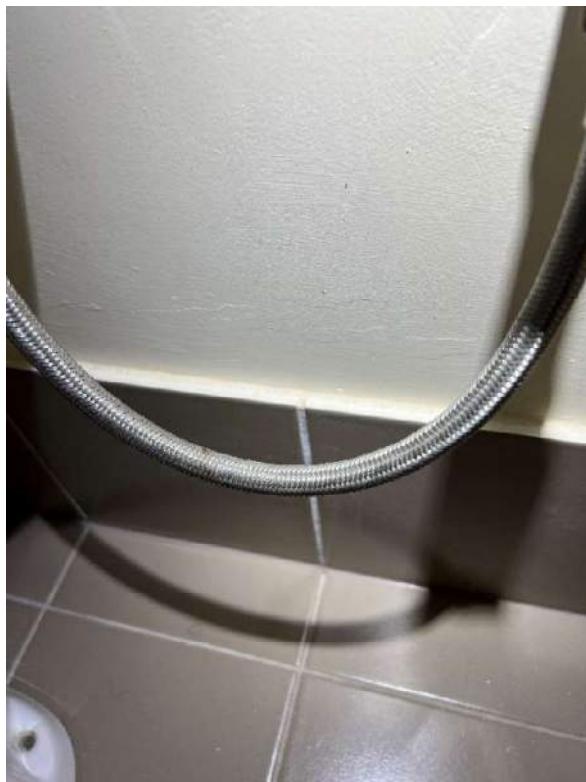
Photo Item No. 13

Defect Category - Minor

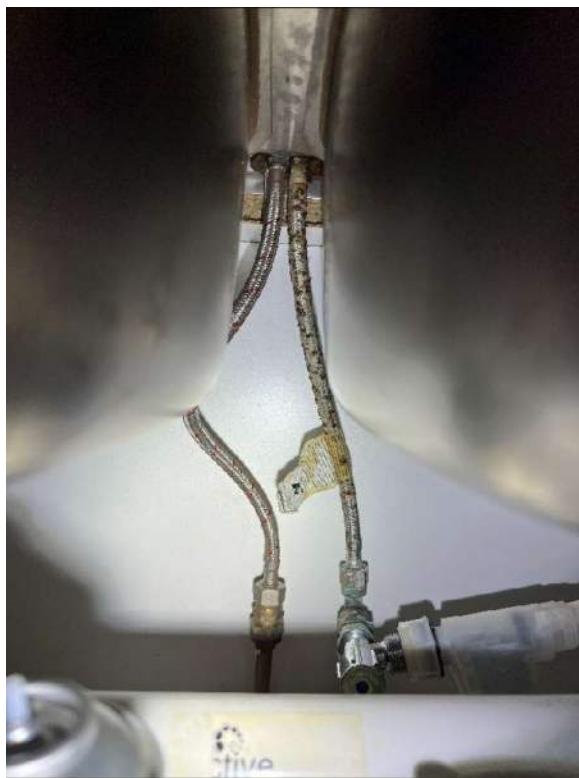
Photo Item No. 14

The dwelling is of substantially good condition structurally. At the time of the inspection only minor items were found. Only one major item was noted from the inspection which was the highly corroded flexi hose to the Kitchen sink. The minor defects which range from minor cracking to minor surface corrosion found on the lintels will not affect the performance of the building or create unsafe conditions. These items are related to the care and maintenance of the dwelling and general building movement due to the site location.

14.	Major surface corrosion was found on the cold water flexi hose to the Kitchen sink.	Major
Stormwater	15.	All stormwater is directed to soakwells on site and all paving surrounding the dwelling has been laid to fall away from the dwelling.	N/A
Roof Cladding/External	16.	The external roof cladding is in good condition at the time of the inspection.	N/A
Roof Space/Internal Ceiling Cavity	17.	The roof framework was found to be in good condition.	N/A

Defect Category - Major

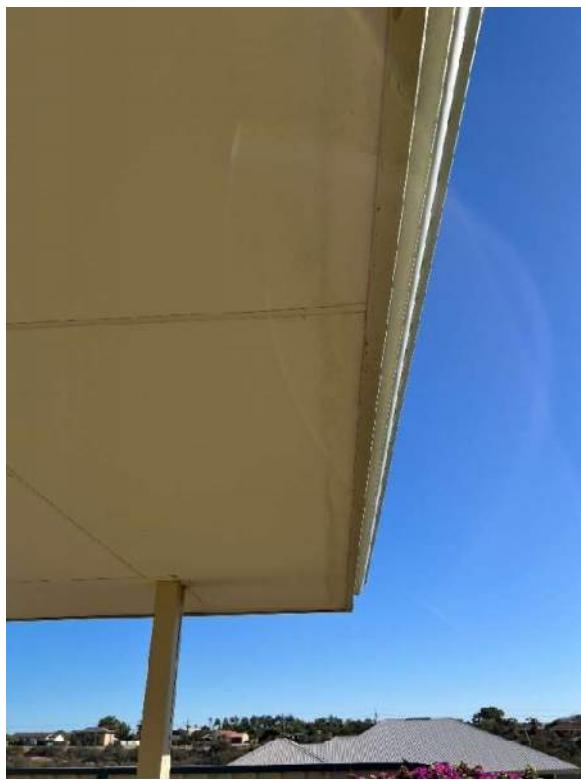
Photo Item No. 18

No split timbers were found at the time of the inspection and all supports and straps were in good condition.	
Eave Cladding	18.	The eave cladding had stains located at the front and rear of the property where the rain water pipes are located. This indicates there have been leaks in these locations.	Minor
Exposed Steelwork	19.	Minor surface corrosion was found to the galvanised lintels over the front bay windows.	Minor

Defect Category - Minor

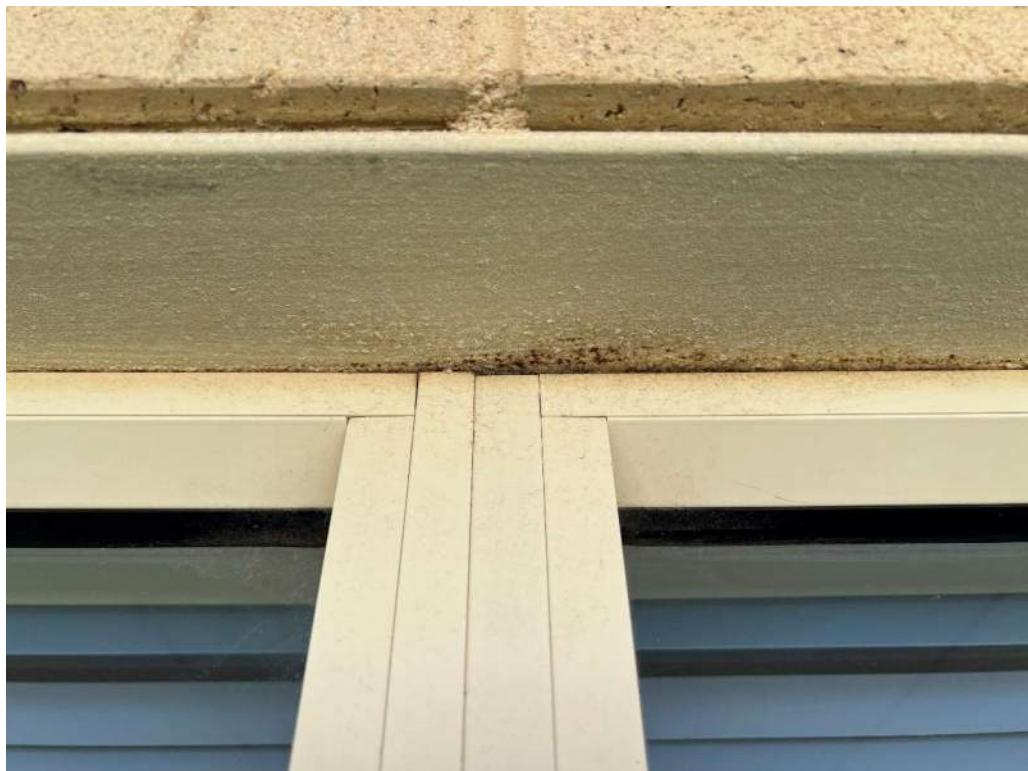
Photo Item No. 19

Defect Category - Minor

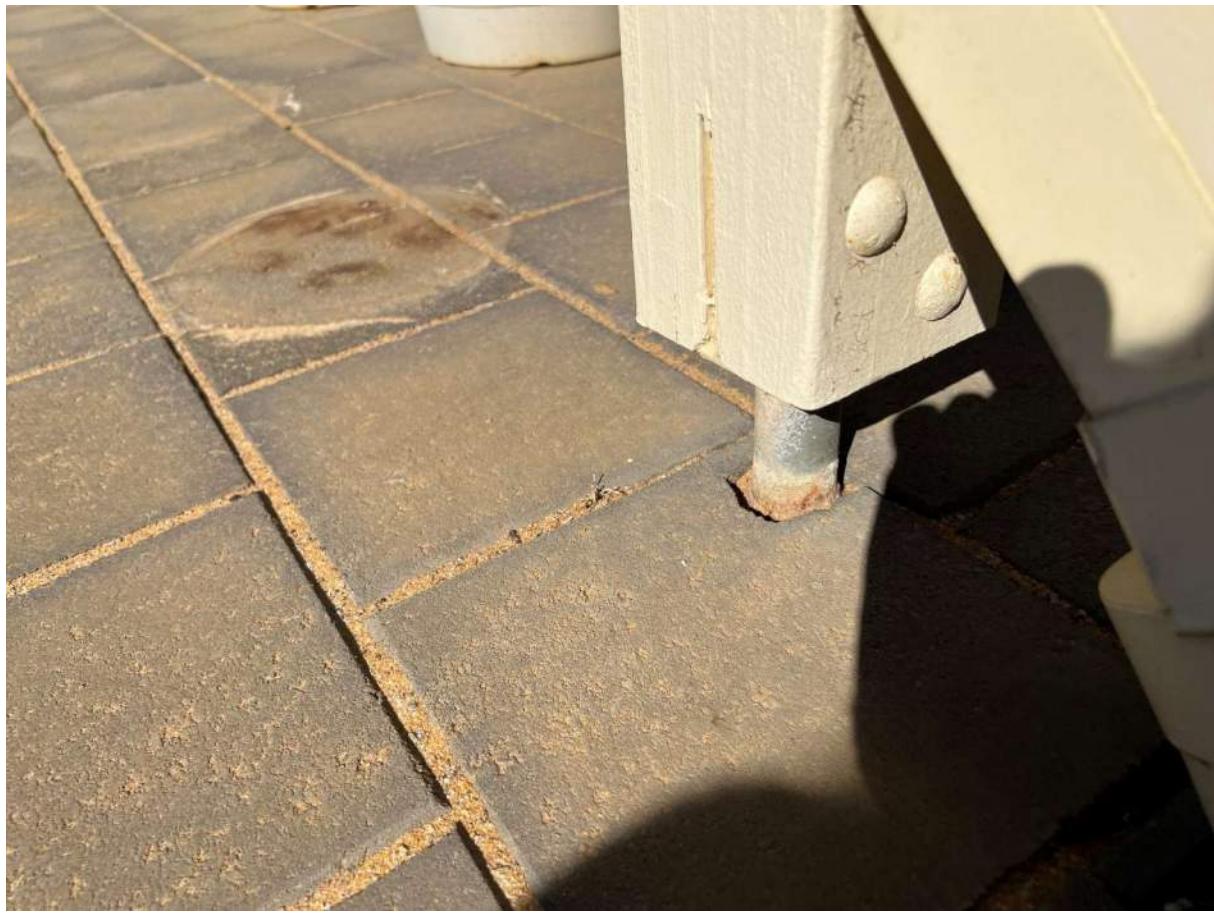
Photo Item No. 20

20.	The column stirrups located at the front verandah outside the bay window had some minor corrosion.	Minor
	21.	The column stirrups located at the rear of the dwelling to the outdoor living area had minor surface corrosion.	Minor
Gutter and Rainwater Down Pipes	22.	The gutters and the rain water pipes were found to be in good condition at the time of inspection.	N/A
Smoke Alarms/Fuse Box	23.	The smoke alarms are located in the correct locations and were in good condition at the time of the inspection.	N/A

Defect Category - Minor
