# **Houspect**

**Pre purchase inspection**

**Job ID:** 92652

**Address:** 10 Walker Close, Millars Well WA

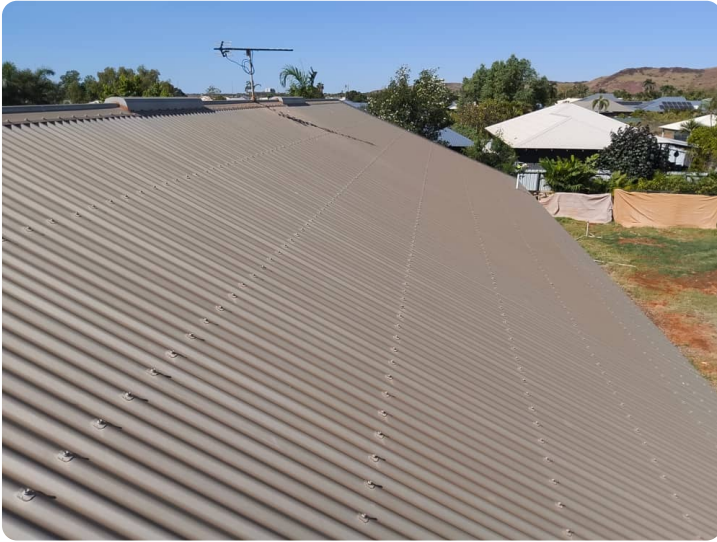
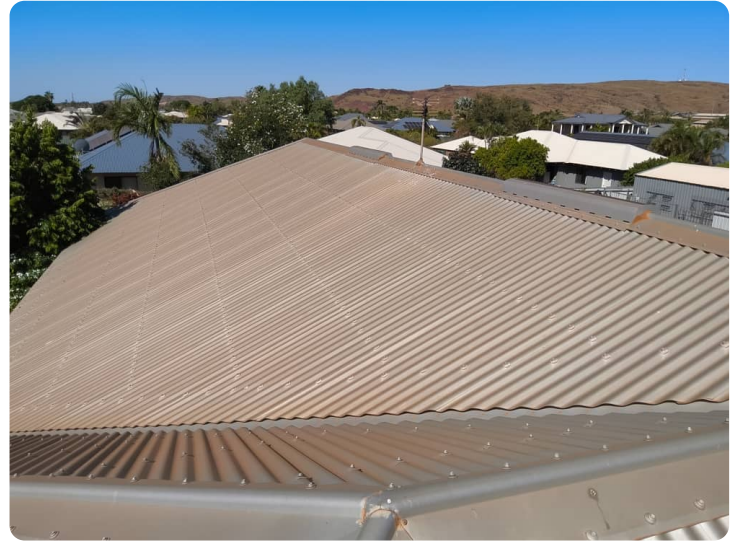
## 1. Roof covering

The roof covering is constructed of colorbond. The condition of the roof covering is satisfactory in relation to its age and will require normal ongoing maintenance.

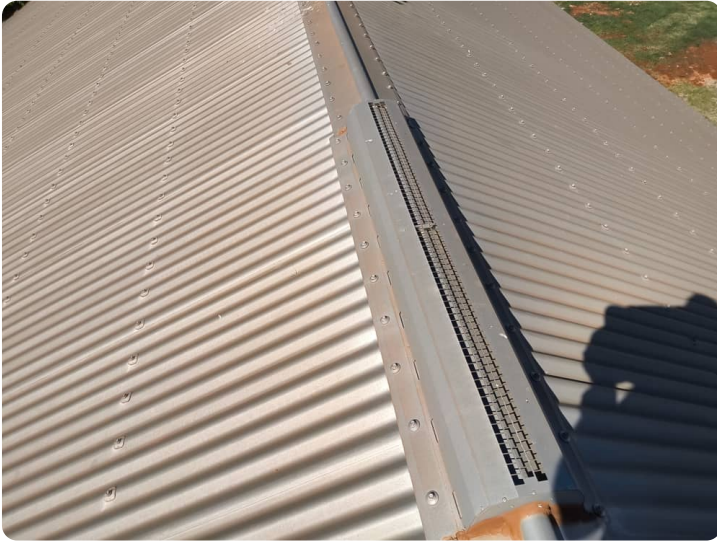
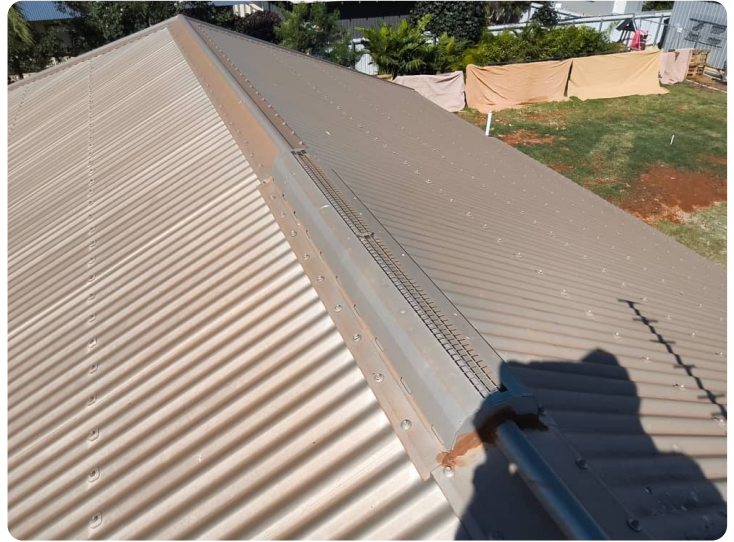
### 3. Roof vents

The roof vents are galvanised and constructed of metal. The condition of the vents is satisfactory in relation to their age and will require normal ongoing maintenance.

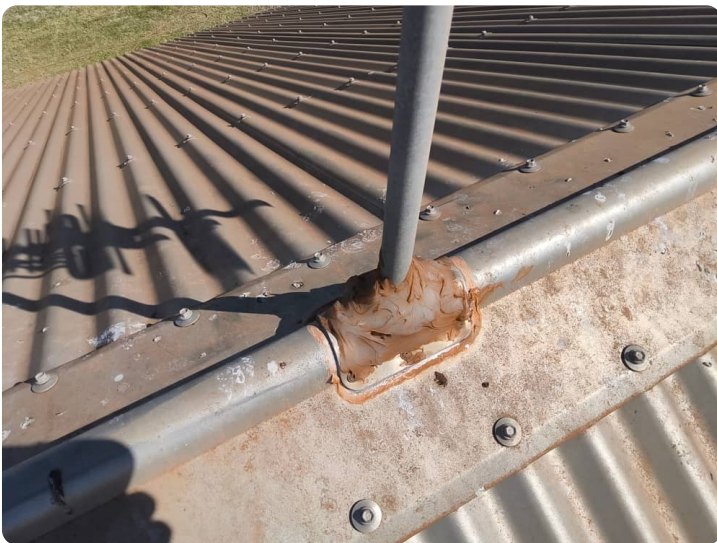
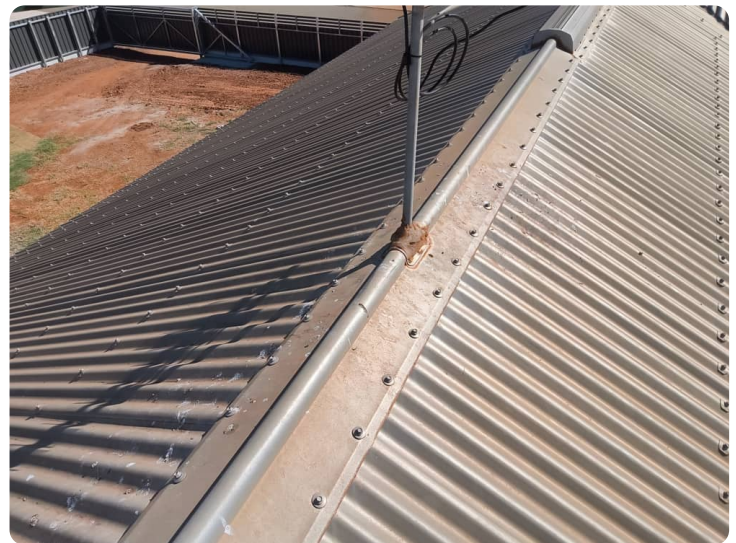
##### 4.1 Flashings general - only silicone

There is insufficient or no flashing installed around the roof penetrations which have only been silicone sealed. Installing flashing around these penetrations is recommended to prevent water ingress into the roof space.

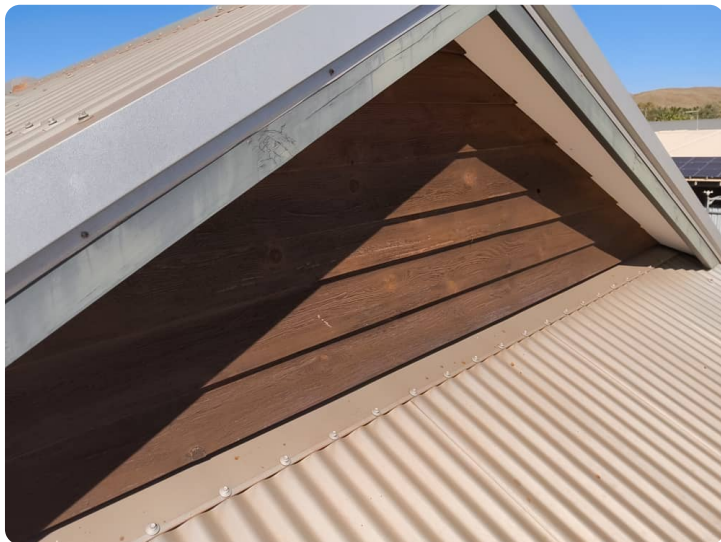
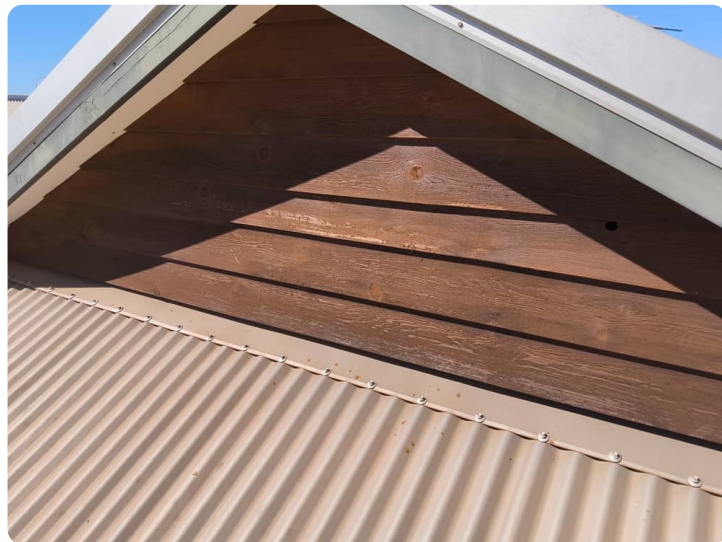
## 5. Gables

The gables are weathered and constructed of timber. The condition of the gables is satisfactory in relation to their age and will require normal ongoing maintenance.

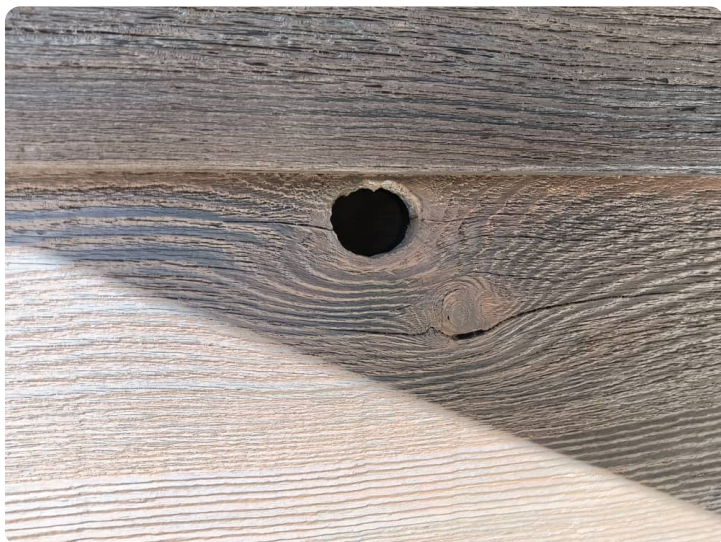
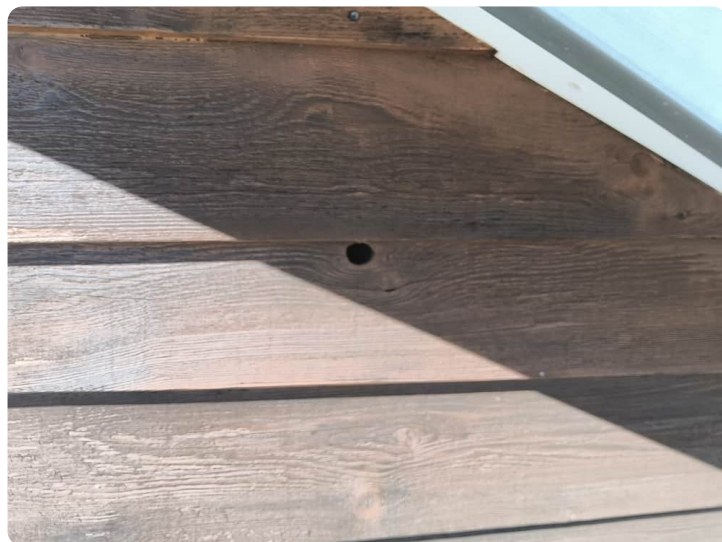
### 5.1 Gable timber missing, damage or rotten

The timber on the gable is missing, rotten or damaged. Repairs or replacement is recommended.

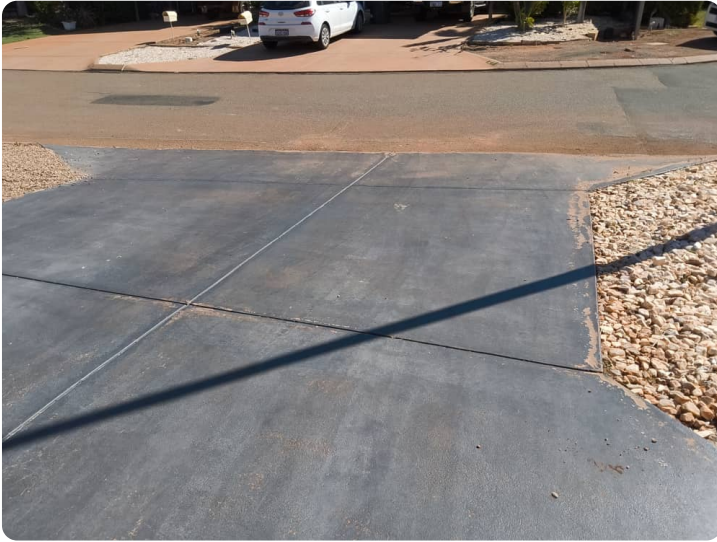
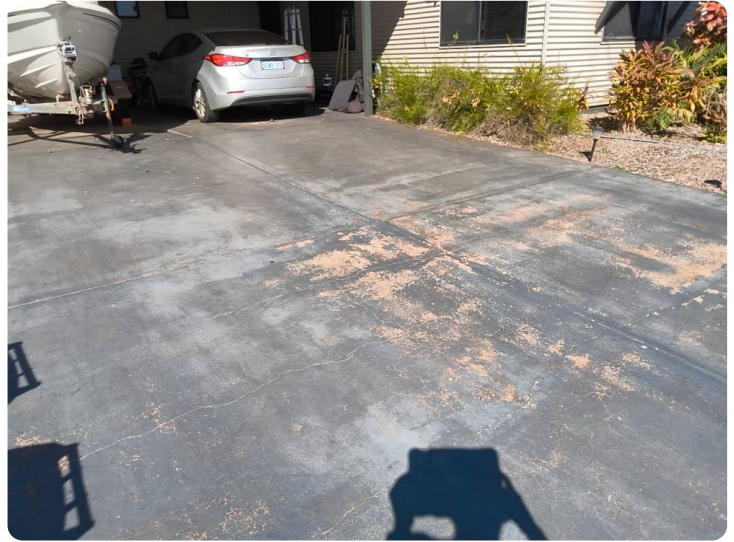
## 20. Driveway

The driveway and cross over is constructed of concrete. The condition of the driveway is satisfactory in relation to its age and will require normal ongoing maintenance.

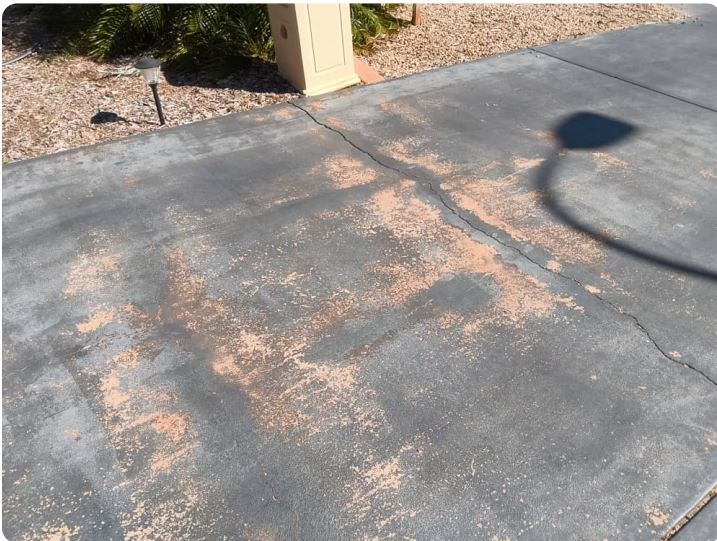
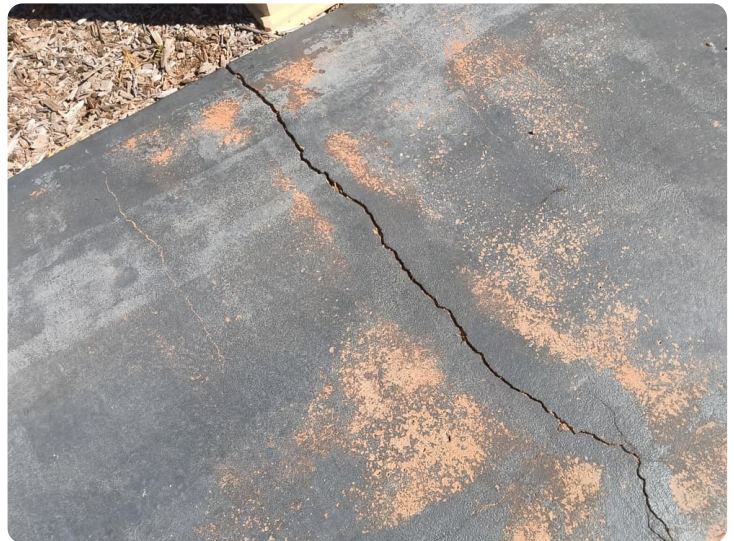
### 20.1 Concrete cracking - major

Significant cracking was noted to the concrete paving. This is not of a structural concern however repairs are required.

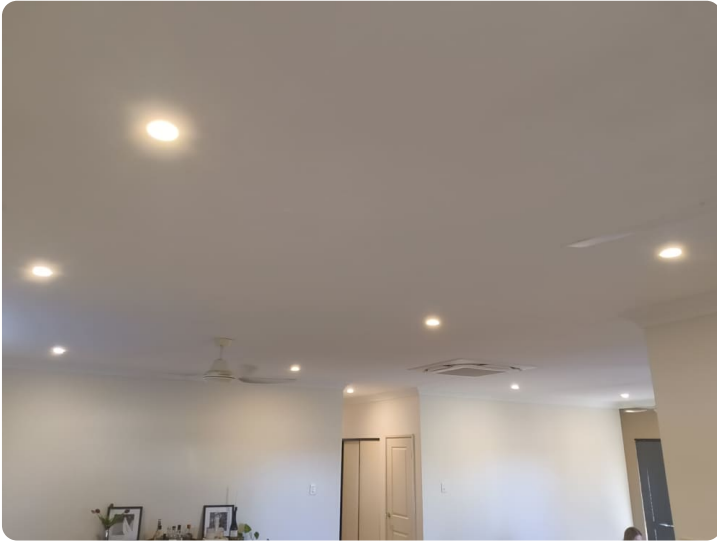
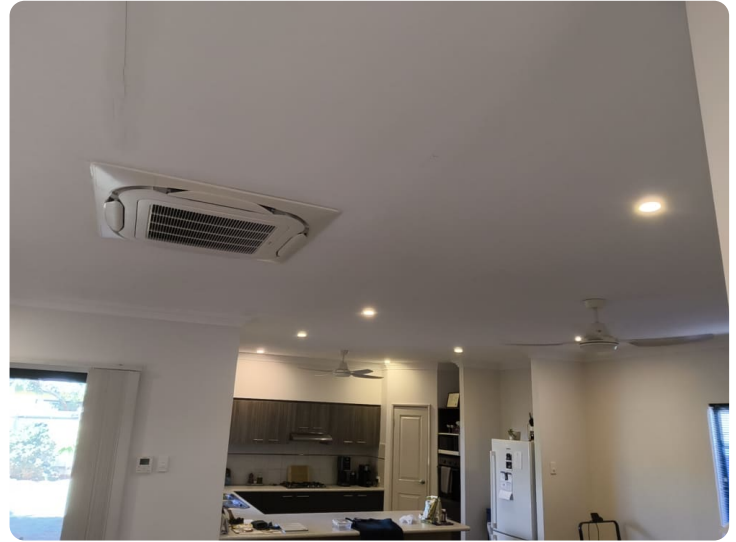
## 27. Ceilings

The ceilings are constructed of plasterboard with cornices constructed of plasterboard. The condition of the ceilings is satisfactory in relation to its age and will require normal ongoing maintenance.

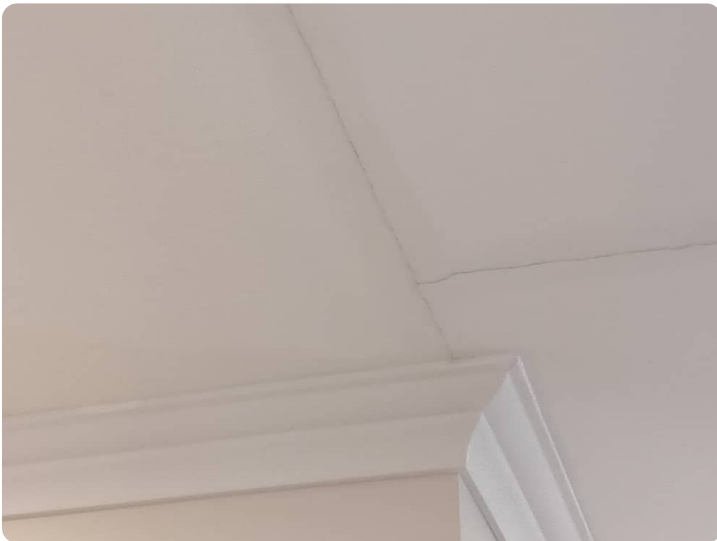
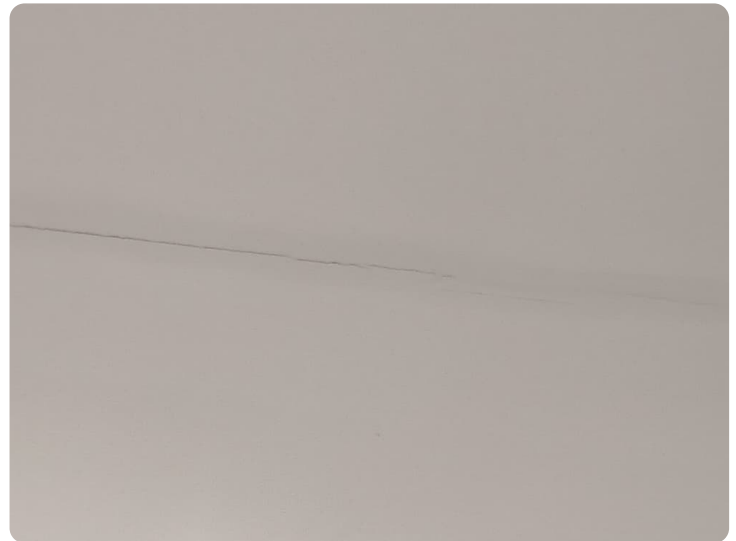
### 27.1 Cracking - minor

The ceilings in the images contain multiple cracks, likely caused by thermal expansion and contraction. This is not a structural issue but repairs are required.
