# Pre-Purchase Timber Pest Inspection Report

10 Walker Close, Millars Well WA, Australia

24 Aug 2026

**AS 4349.3-2010: Inspection of Buildings - Timber Pest Inspections**

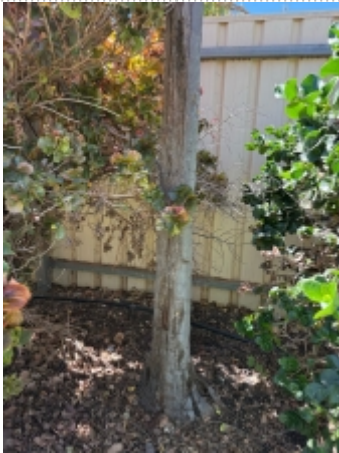
| Location(s): | Palm tree in rear yard found with pre-existing termite workings/damage |

Pre-existing termite damage found at rear of house in Palm tree. No live termites found at time of inspection.

| Additional Comments: | Termite management system is recommended to be installed around the perimeter of building |
