Houspect

Building inspection

Job ID: 91152

Address: 20 Flinders Crescent, Dampier WA

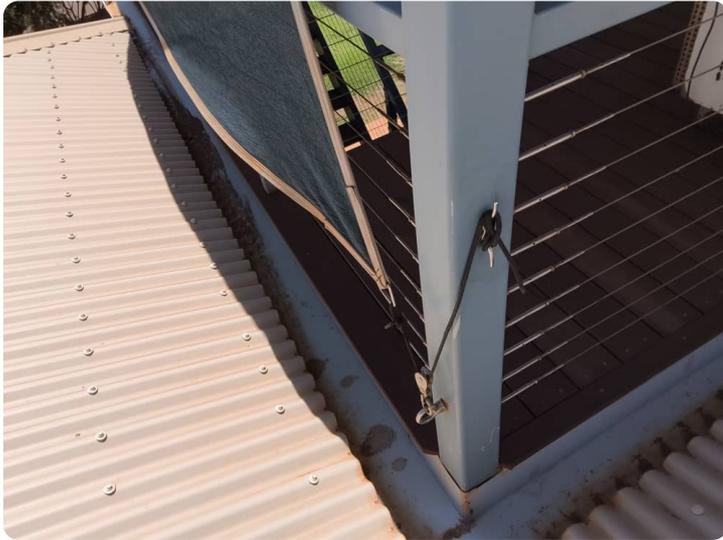
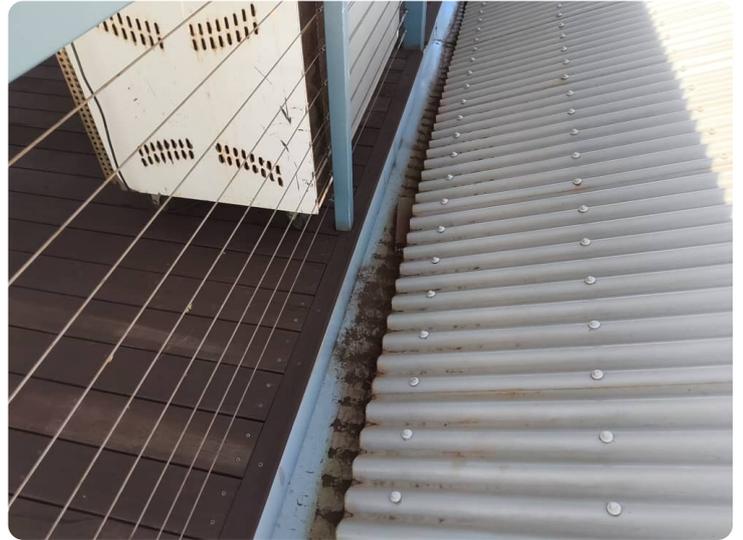
The box gutters are constructed of metal and they have a colorbond covering. The condition of the box gutters is satisfactory in relation to their age and will require normal ongoing maintenance. The box gutters need to be cleared of debris.

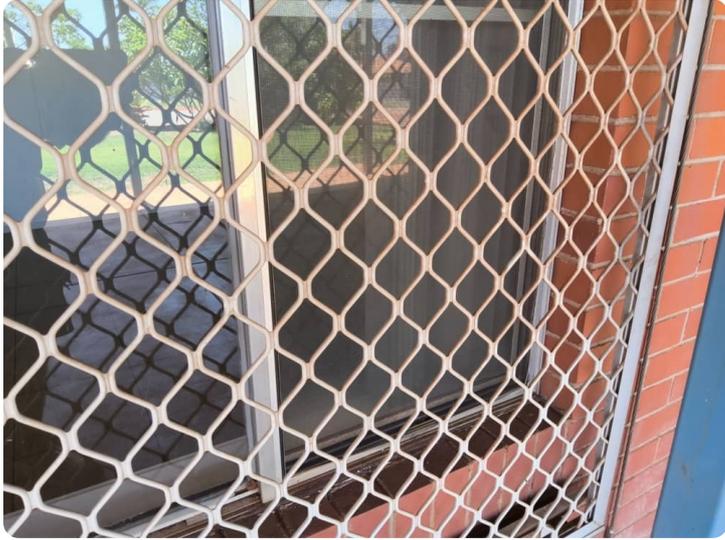
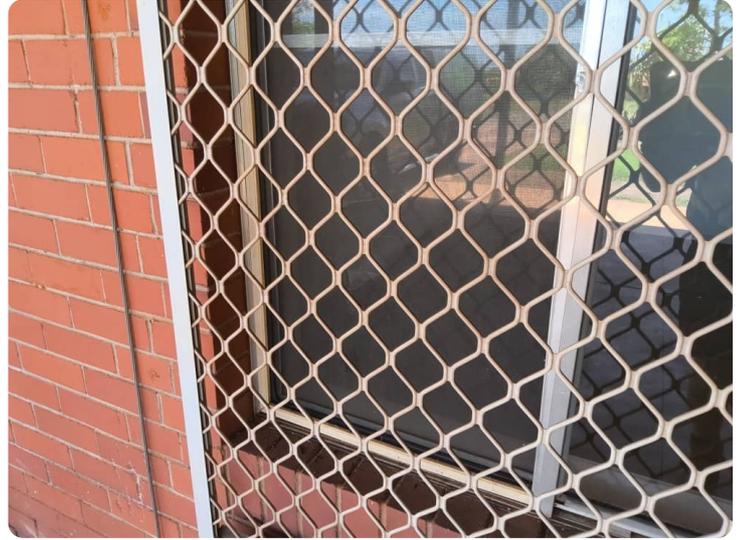
Fly screens have been installed to all of the windows. The condition of the window fly screens is generally fair in relation to its age and will require ongoing maintenance.

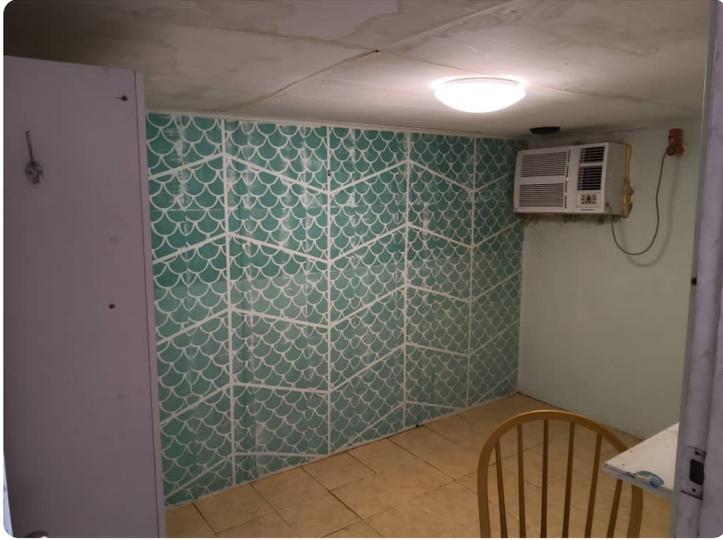
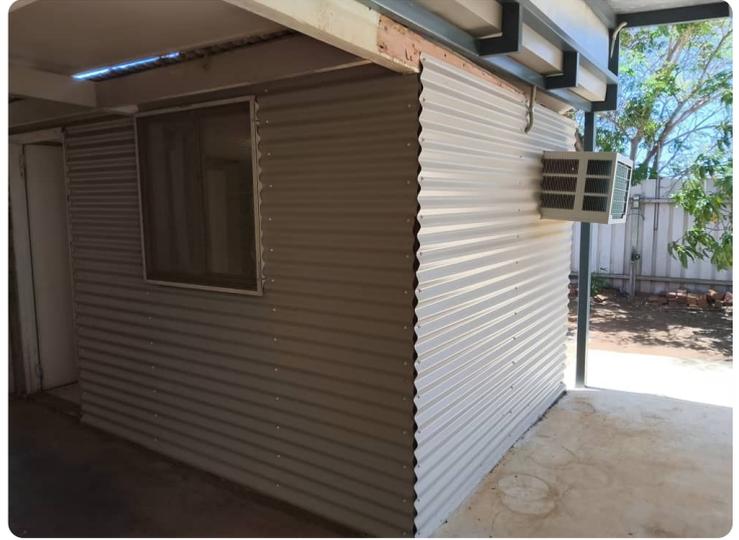
An external storeroom for the property is located adjacent and under the main roof of the building. The condition of the storeroom is fair in relation to its age and will require ongoing maintenance.

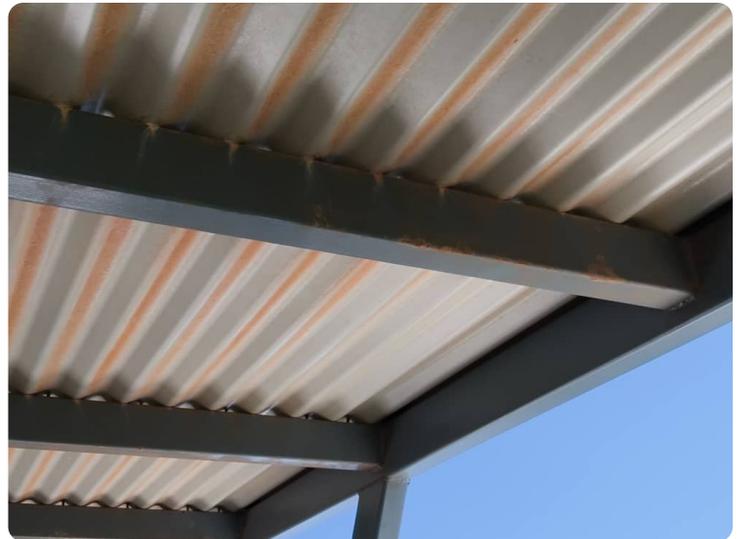
24.1 Metal frames rusted - minor

Metal frames are rusted and require maintenance to prolong their life.

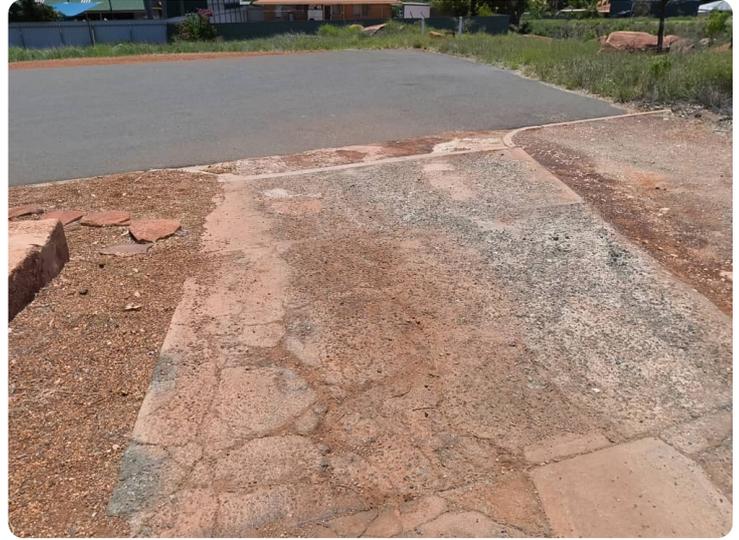
The driveway and cross over is constructed of concrete. The condition of the driveway is poor in relation to its age.

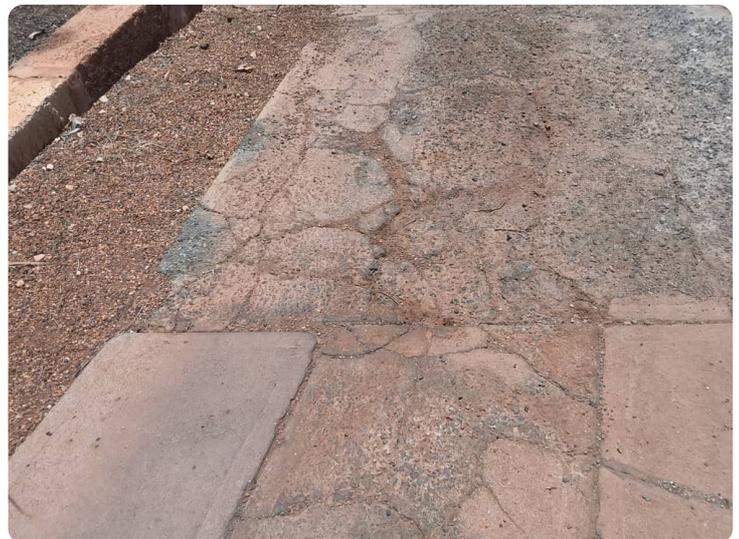
27.1 Concrete cracking - major

Significant cracking was noted to the concrete paving. This is not of a structural concern however repairs are required.

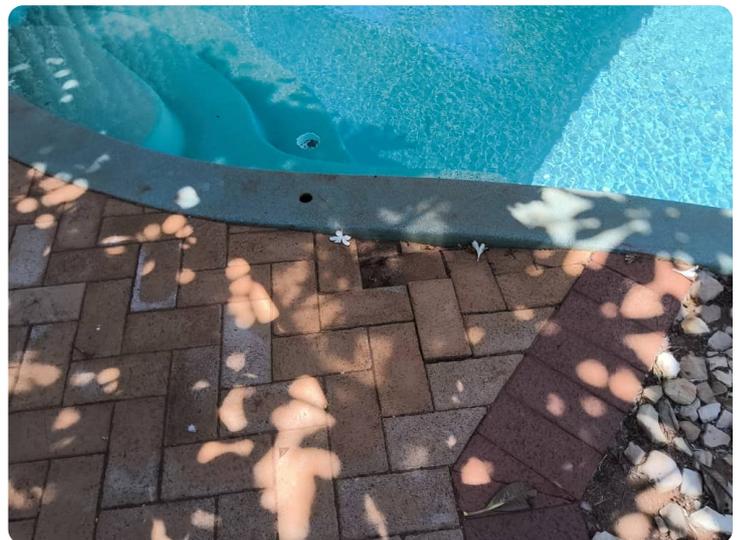
31.1 Pool surrounds subsidence

It was noted that there was minor subsidence to the ground surrounding the pool. Repairs and maintenance should be undertaken as required.

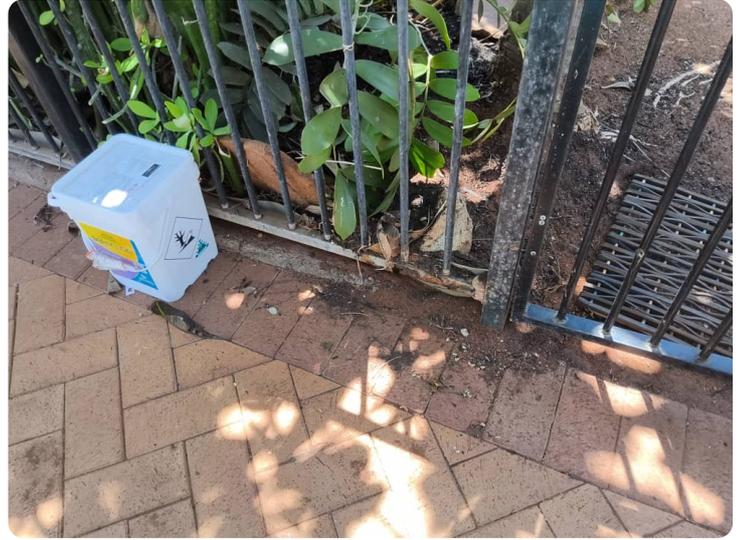
31.2 Pool fence rusting

The pool fence has rusted parts these need repairing or replacing before they become a compliance issue. A pool compliance certificate should be obtained. Remediation work should be undertaken as required.

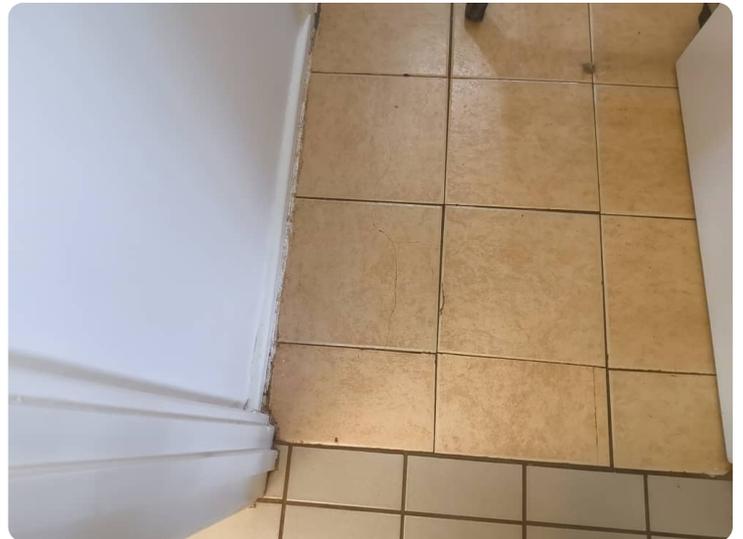
39.1 Tile damage - minor

As per the images provided there is damage to the wall or floor tiles requiring repairs or replacement.

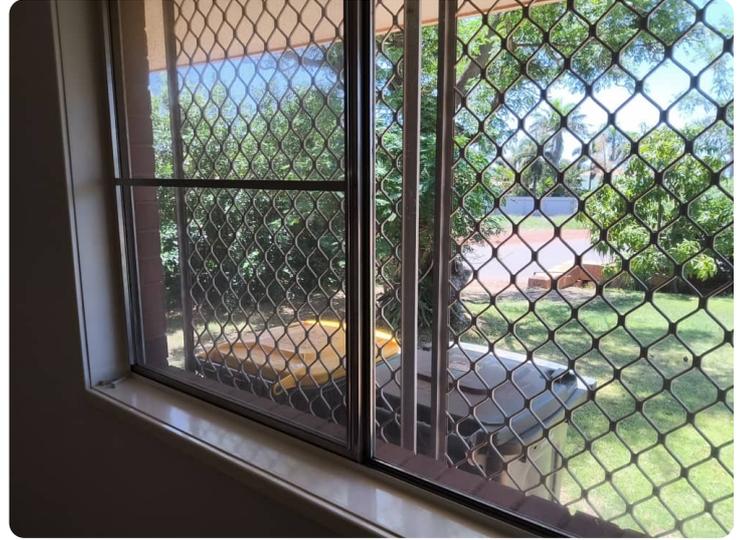
The condition of the windows, as viewed from within the property, is fair in relation to its age and will require ongoing maintenance. Window locks have been installed to none of the windows.

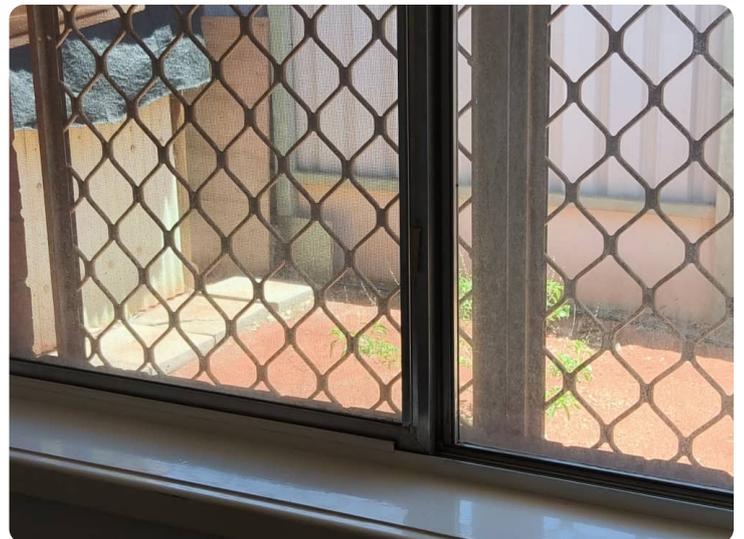
40.1 Window latches, catches or opening mechanism, damaged, broken or missing

As per the images the window latches, catches or opening mechanism is missing damaged or requires repairs or replacement.

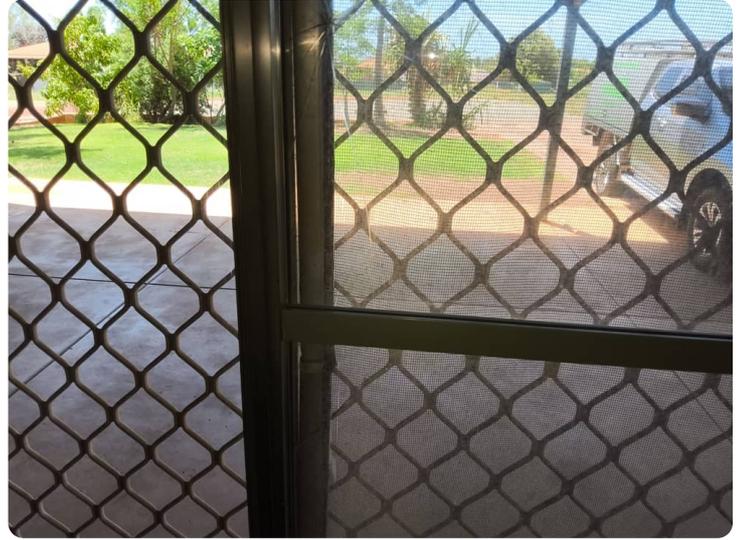
40.2 Glass pane broken

There is a broken window pane which requires replacement.

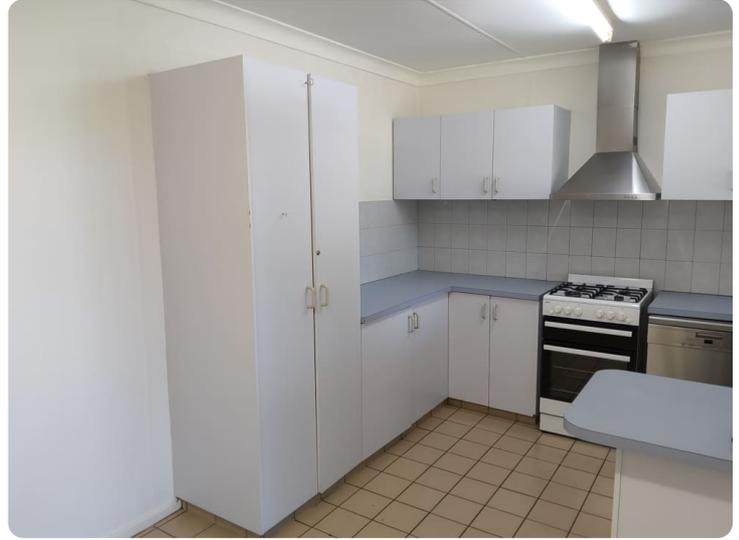
The condition of the kitchen cabinets in general is fair in relation to its age and will require ongoing maintenance.

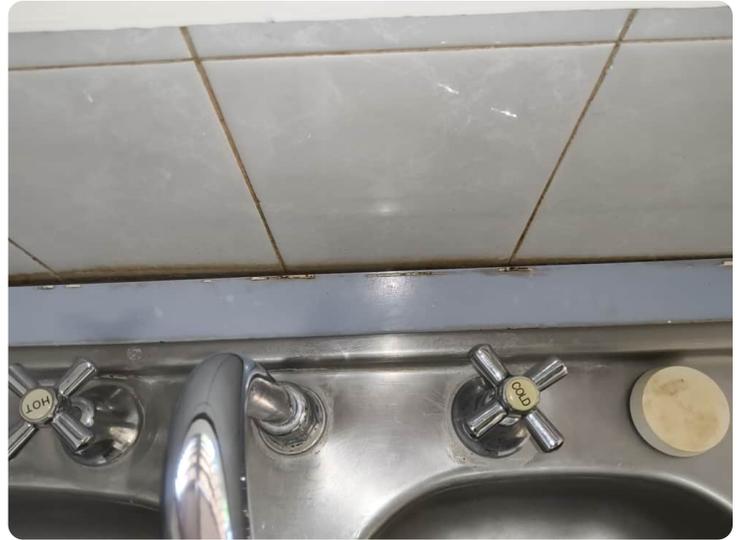
42.1 Bench top damage

As per the images the kitchen benchtop is damage requiring repairs or replacement.
