**PILBARA
PEST Co**

Pre-Purchase Timber Pest Inspection Report

20 Flinders Crescent, Dampier WA, Australia

VISUAL TIMBER PEST INSPECTION REPORT

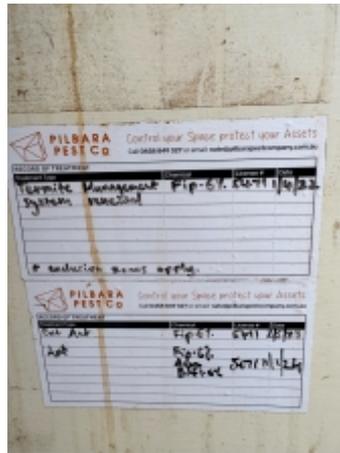
Durable Notice Photos

Was evidence of a previous treatment located? (this may include drill holes, dusting or baiting) ■ Yes

Description of the evidence found: ■ Treatment sticker in meter box

Evidence of drilled holes in ground

Was a durable Notice found at the time of this inspection? ■ Yes

The Inspection undertaken is a visual inspection only and therefore no representations can be made with regard to work historically performed. We strongly recommend that if possible, the client requests copies of any reporting related to previous activity or treatments including related warranties and dates of actions.
