## Pre-Sale/Auction Summary

9 Feb 2026 / 23A Westborough Street, Scarborough, Western Australia, 6019 / 76379

# Pre-Purchase Inspection - Residential Building Report

Complies with Australian Standard AS 4349.1- 2007 Inspection of Buildings Part 1: Pre-Purchase inspections - Residential buildings

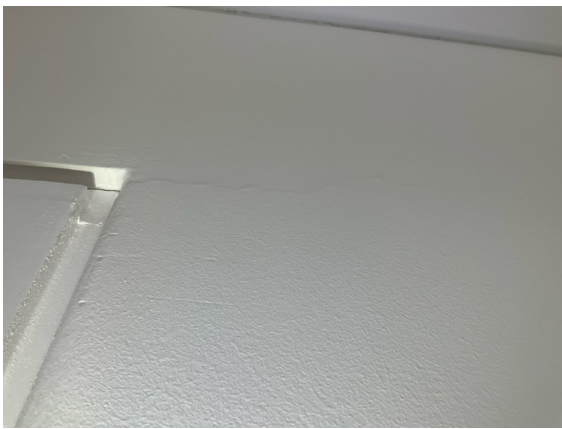
Patched and painted appearance cracking to interior walls in some areas, This is typical of the construction type and age. Recommend repair and paint as part of ongoing maintenance, Cracks should be monitored to ensure that they do not deteriorate. If deterioration occurs professional advice should be sought.

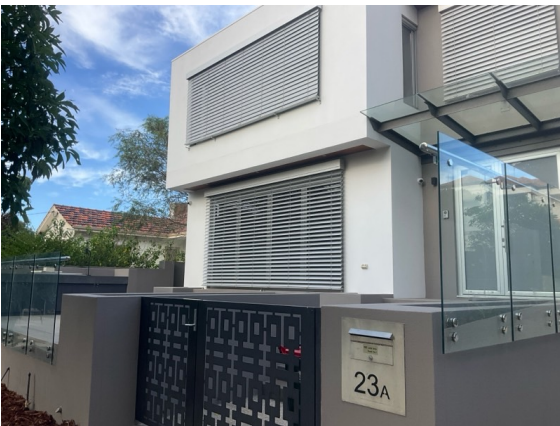
Eastern elevation. Exterior walls and some elements have been recently painted.

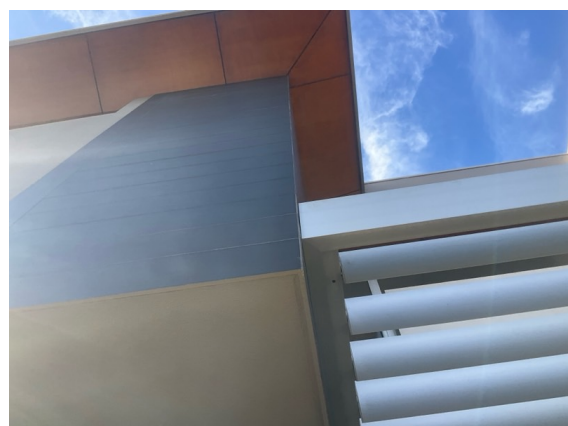
Deterioration to exterior wall tiles grouting and seal. Recommend repair / seal and monitoring.

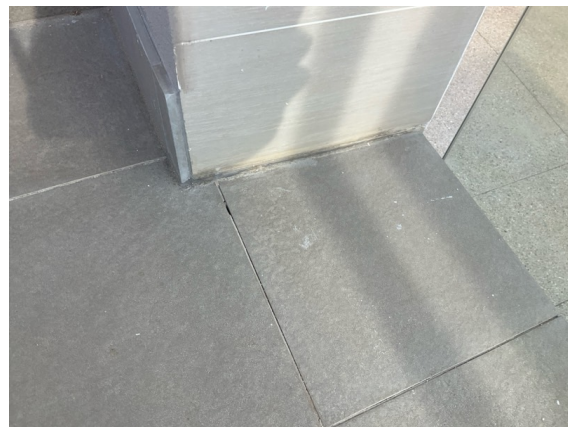
Visible deterioration to balcony tile grouting and seal. Recommend re-grout and seal to balcony tiles.
