# Property Inspection Report

14 Camelot Street, Carine, 6020

Inspection prepared for: Annie Caldwell  
Date of Inspection: 11/8/2026 Time: 12:45 PM  
Weather: Sunny 16C  
Inspector: Nick Jacques

## Details of a Pre Purchase Building Inspection

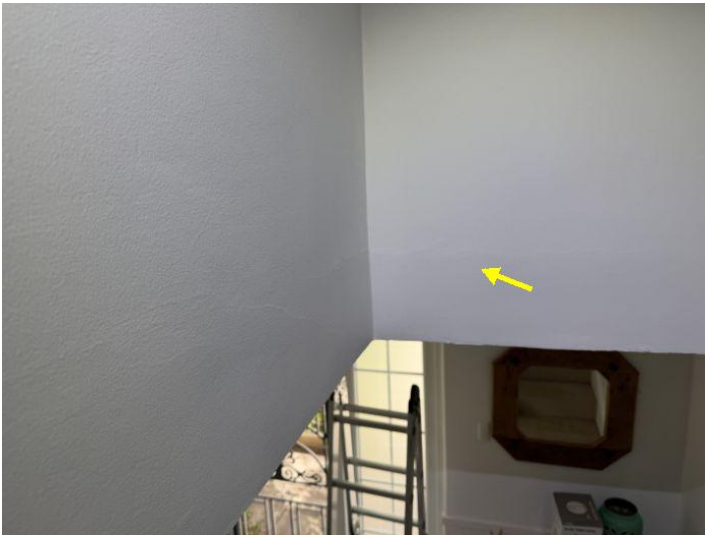
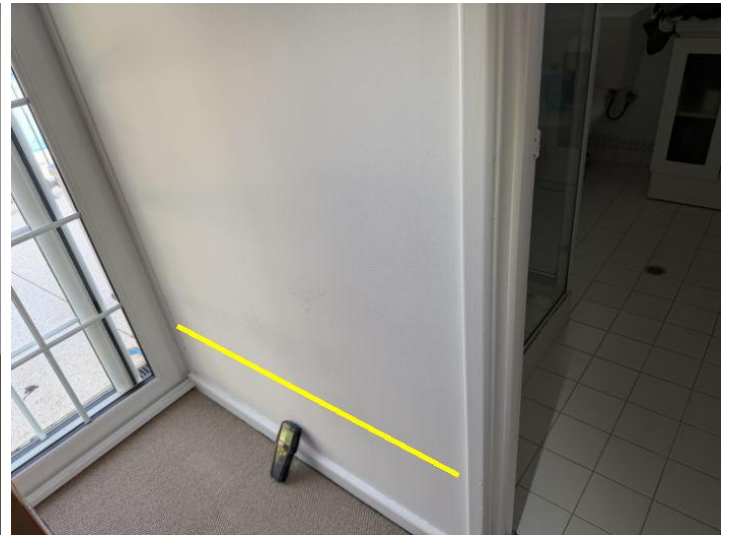
- Photos are indicative only and not limited.
- Due to normal movement within the property or foundations as they settle, cracks have appeared at various locations within the home. These cracks do not appear to have affected the overall structural integrity of the property and are within acceptable tolerances. Generally patching and painting will suffice.
- There is evidence of dampness in the wall adjacent to the ground floor shower recess. This is most likely due to the tile joints (grout) becoming porous, or small cracks occurring. We recommend that the shower recess is re sealed. This does not appear to have affected the structural integrity of the masonry walls in any way. Repairs to wall surfaces can be carried out as general maintenance.

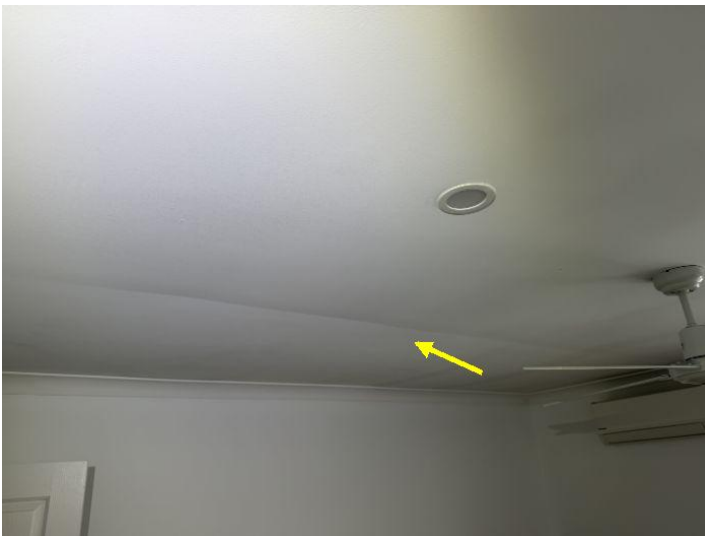
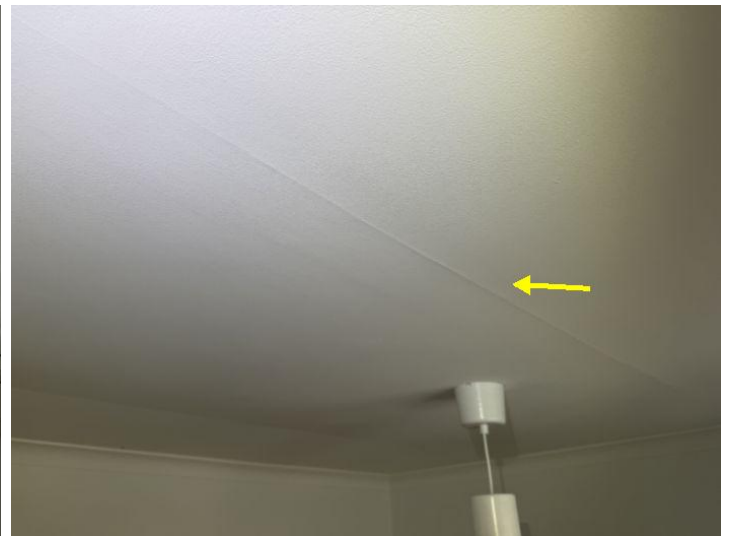
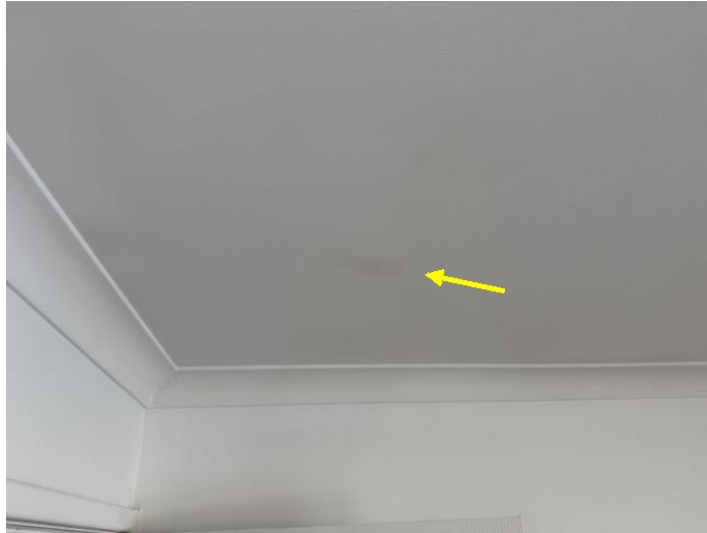
- Photos are indicative only and not limited.
- Some of the plaster ceiling sheets have deflected causing the joints between the ceiling sheets to become visually prominent and cracks to form in the underside of some sheets. This does not appear to have affected the structural integrity of the ceilings but may require some maintenance in the future.
- There is a stain to the ground floor bedroom ceiling which tested damp at the time of the inspection. The visual inspection from the roof top and restricted inspection from the internal roof space could not identify the cause of the moisture. Recommend monitoring during wet weather.

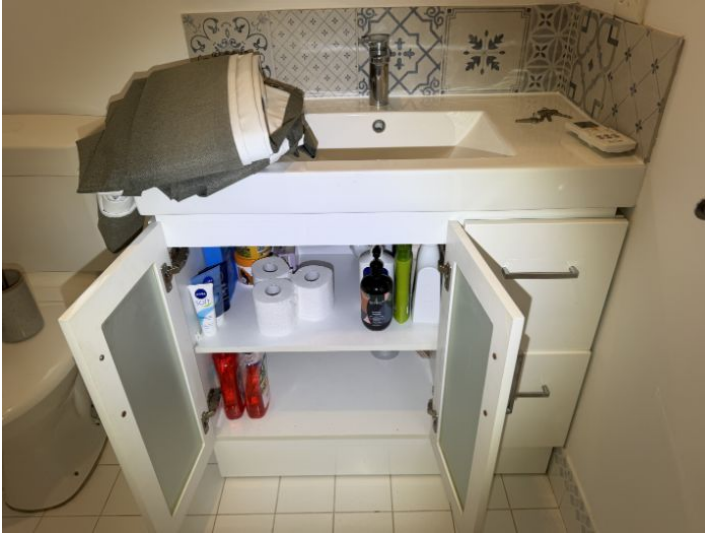
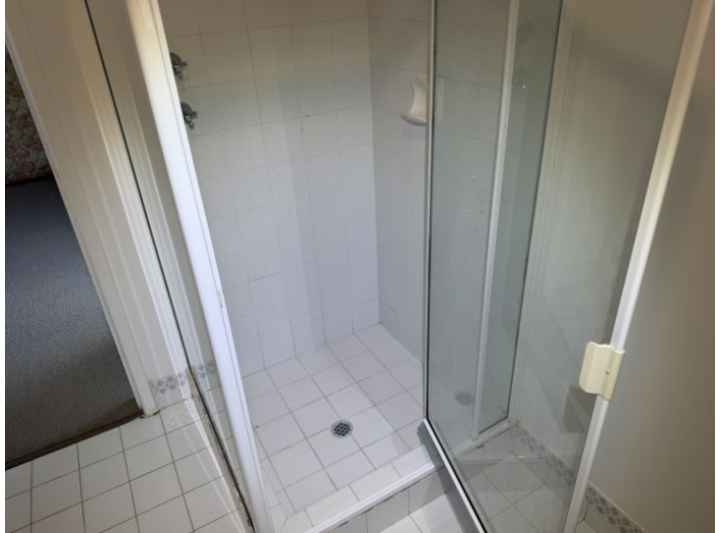
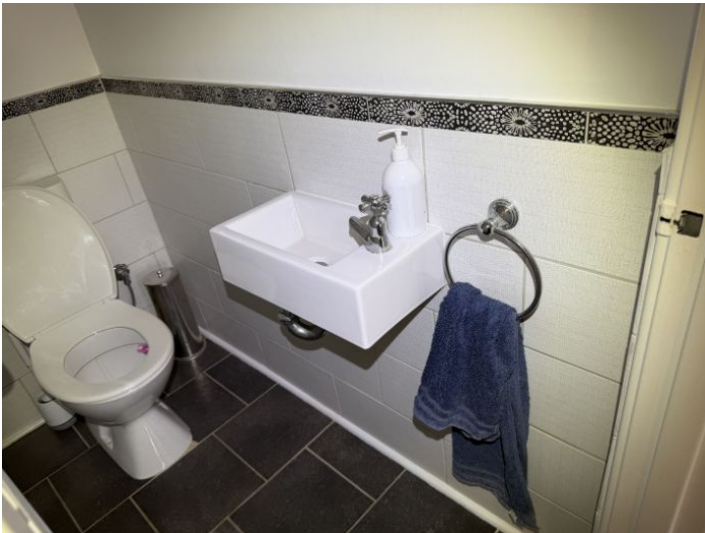
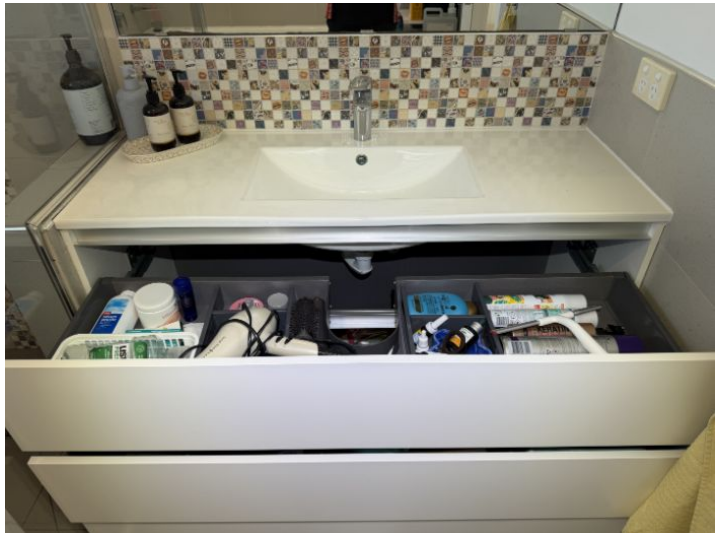
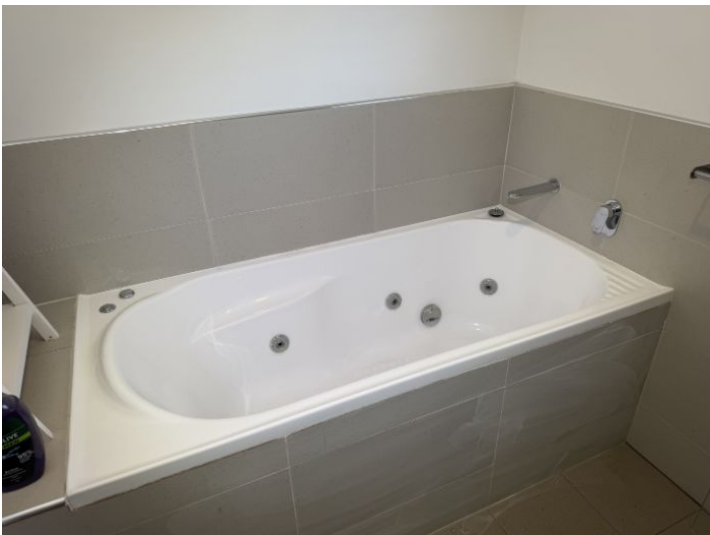
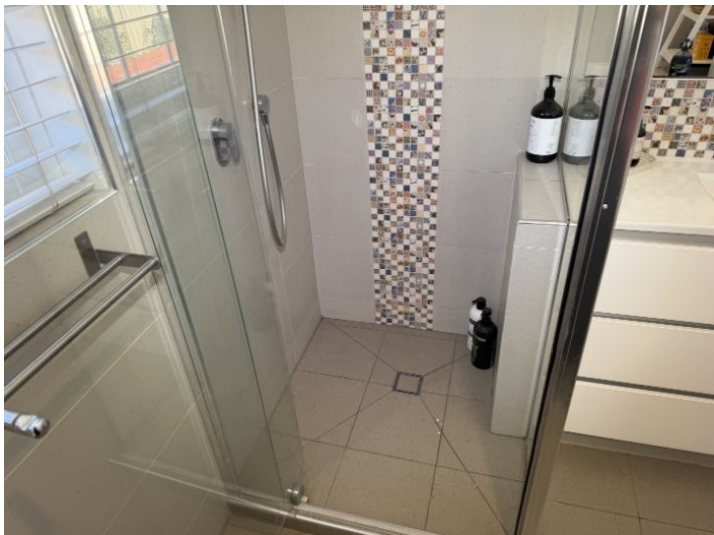
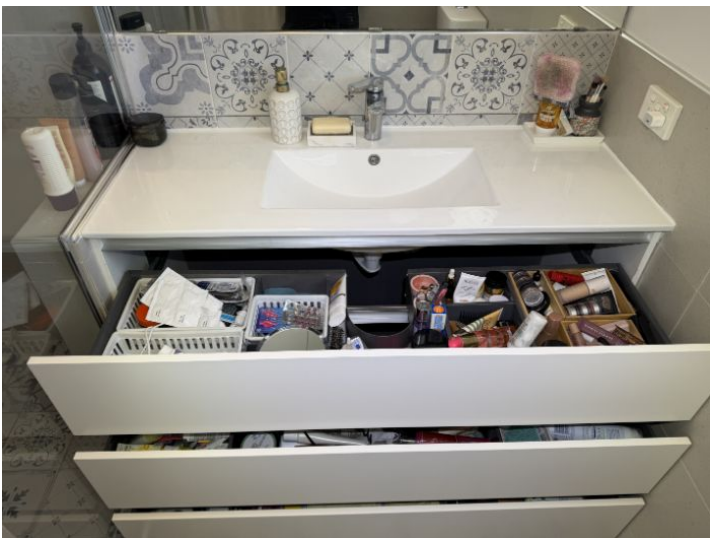
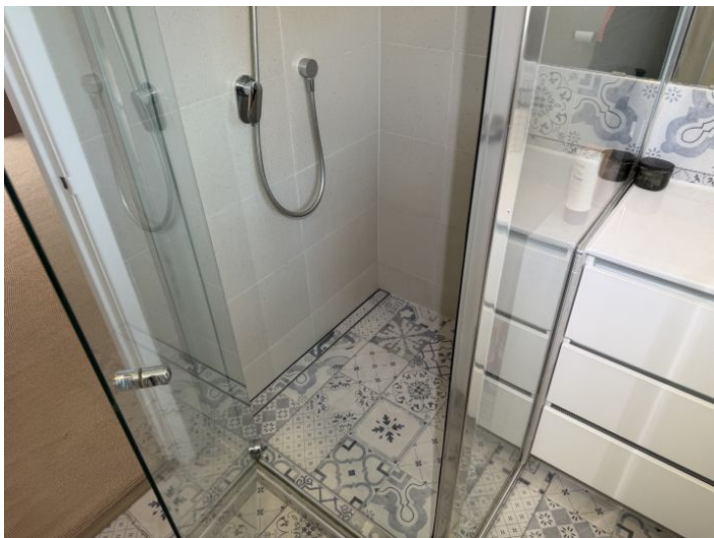
- Cabinets appeared to be in satisfactory condition.
- Shower walls - See "Internal Areas" "Wall Observations" for further details.

- As a preventative measure, we always recommend sealing tile grout and joints to prevent water infiltration into walls. Grout should be resealed every 5 years.

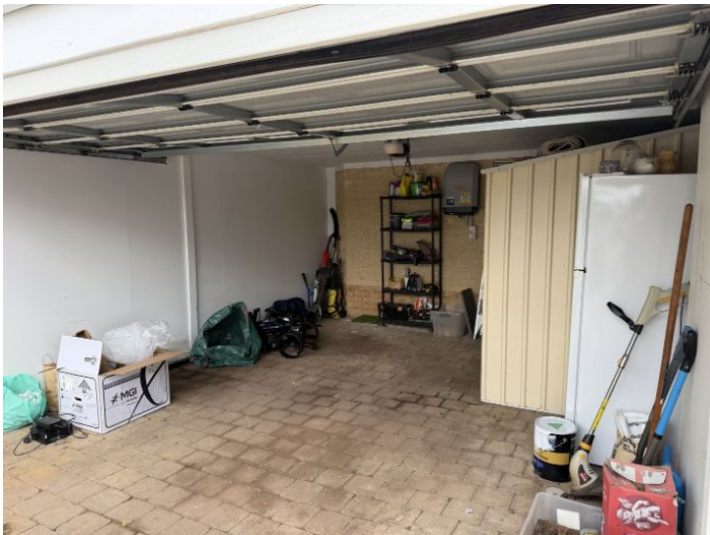
- Materials:
- The attached carport has been enclosed with stud walls and cladding and appears structurally sound.
  - The vendor advised that repairs were carried out following termite damage to the original carport. Due to access restrictions the internal roof space inspection was limited to what was visible from the manhole in the laundry.

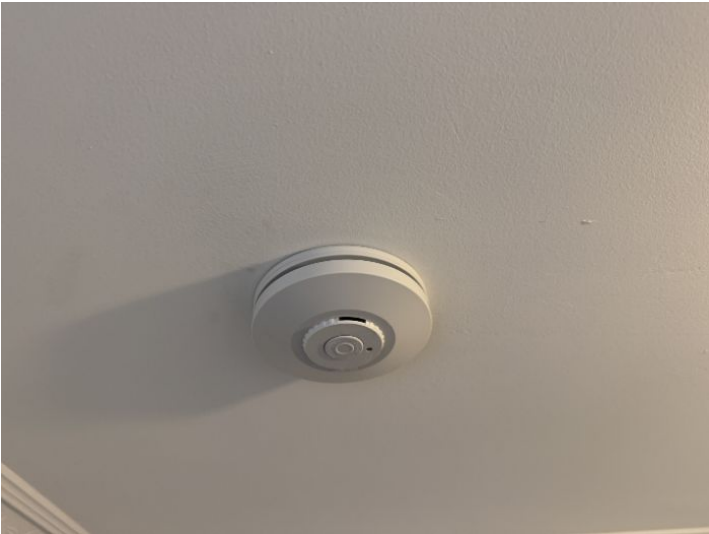
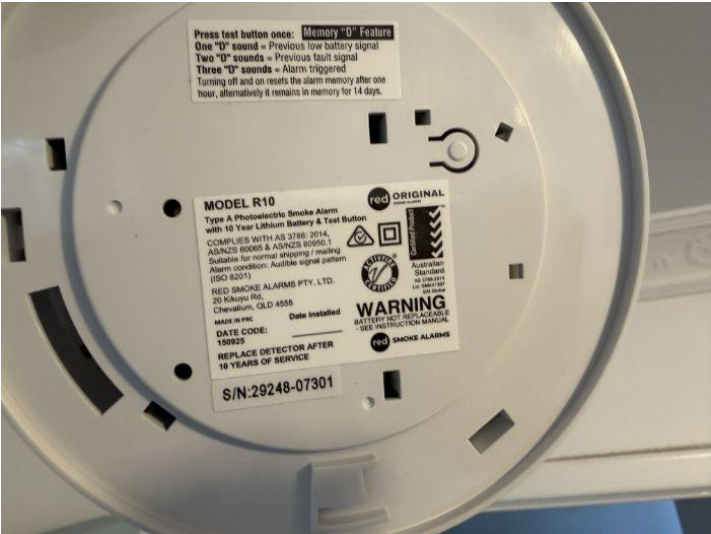
Expiry date 2035.

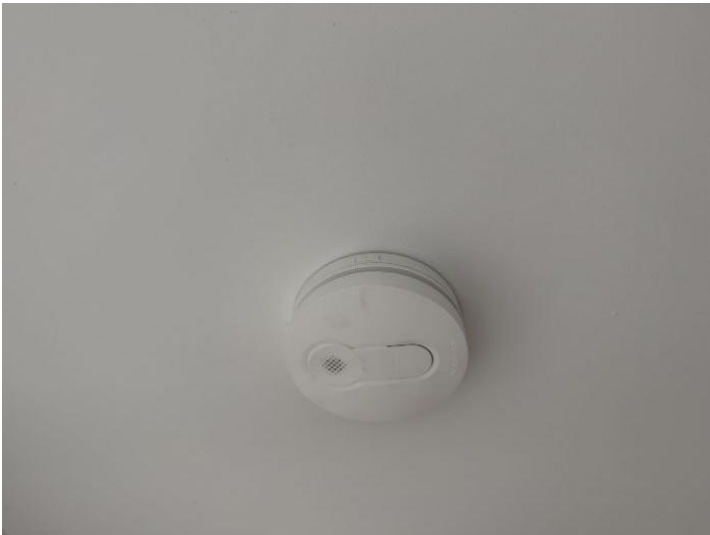
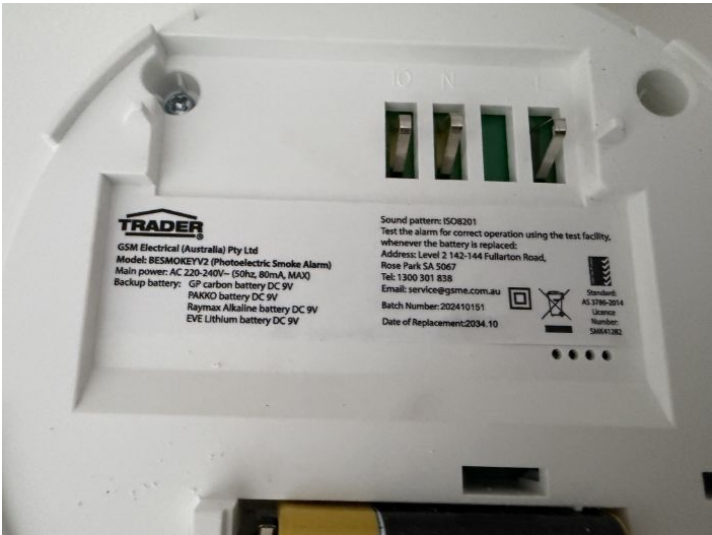
Expiry date 2034.

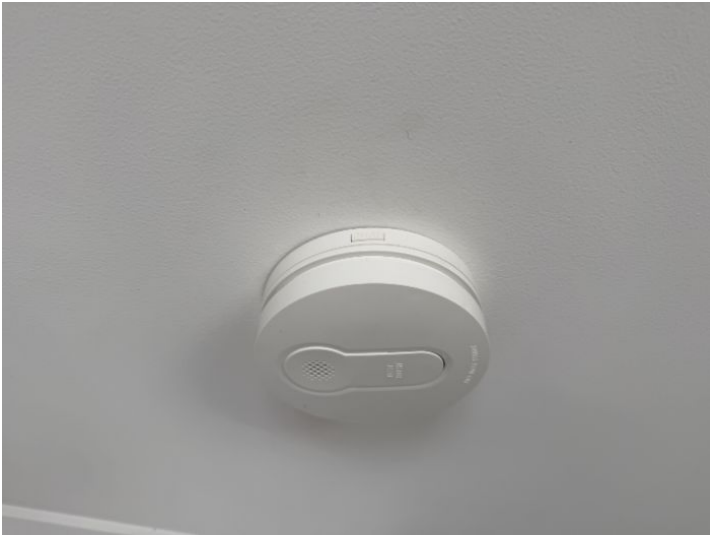
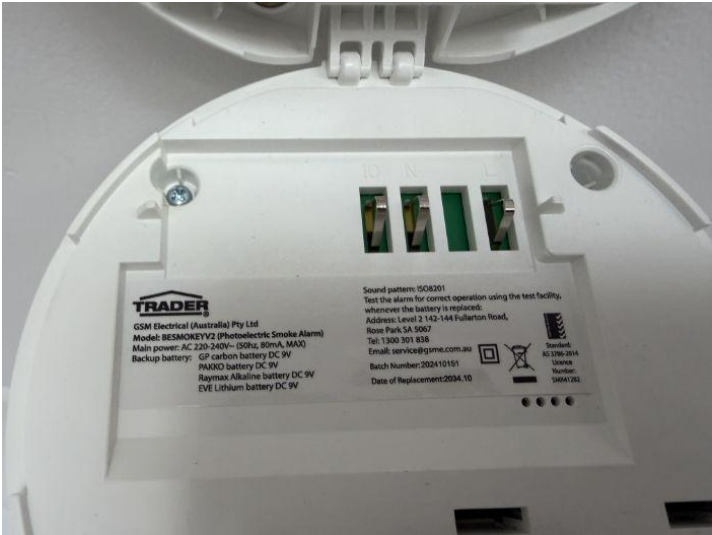
Expiry date 2034.
