Auction Buyers Guide

24 Tristania Rise, Duncraig

Market Ready Pre Sale Summary

24 Tristania Rise, Duncraig, 6023

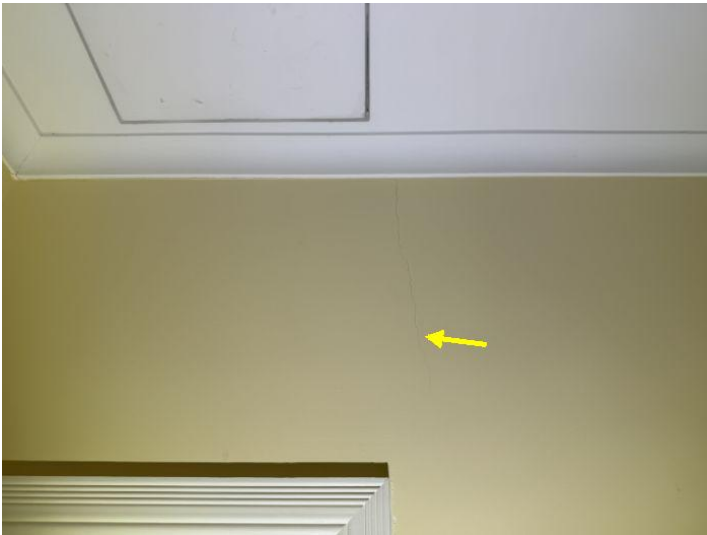
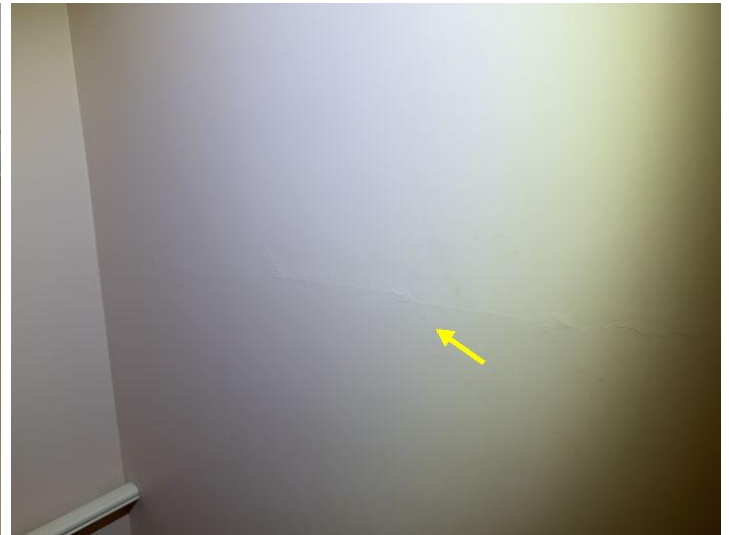
- Photos are indicative only and not limited.
- Due to normal movement within the property or foundations as they settle, cracks have appeared at various locations within the home. These cracks do not appear to have affected the overall structural integrity of the property and are within acceptable tolerances. Generally patching and painting will suffice.

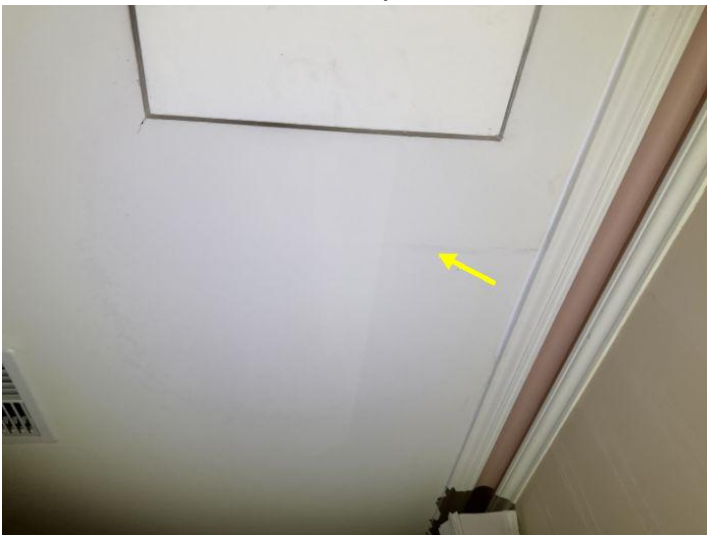
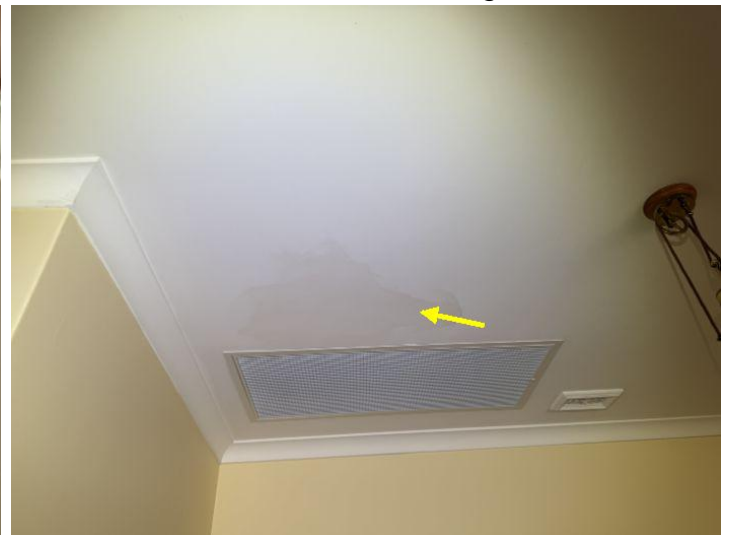
- Photos are indicative only and not limited.
 - The ceiling has minor hairline cracks in some locations. This is normally due to minor movement in the roof structure. This does not appear to have affected the structural integrity of the ceilings but may require some maintenance in the future.
 - Moisture mark to ground floor ceiling noted - tested dry at time of inspection.
- Suspect leak from a/c has been fixed. Recommend monitoring.

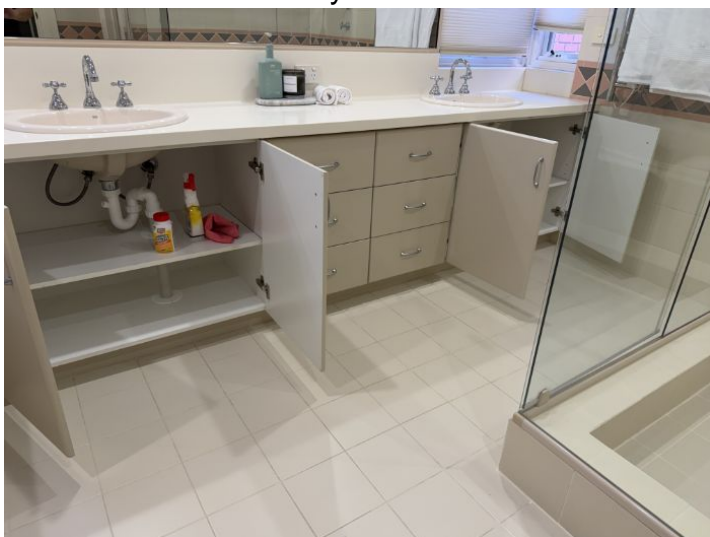
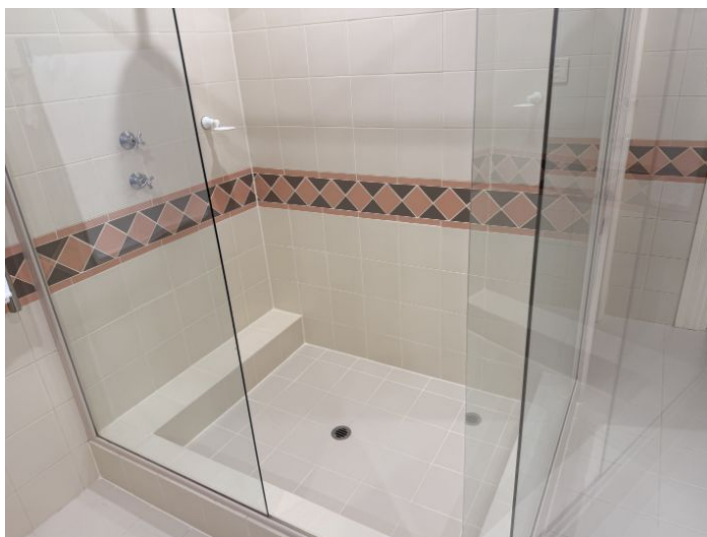
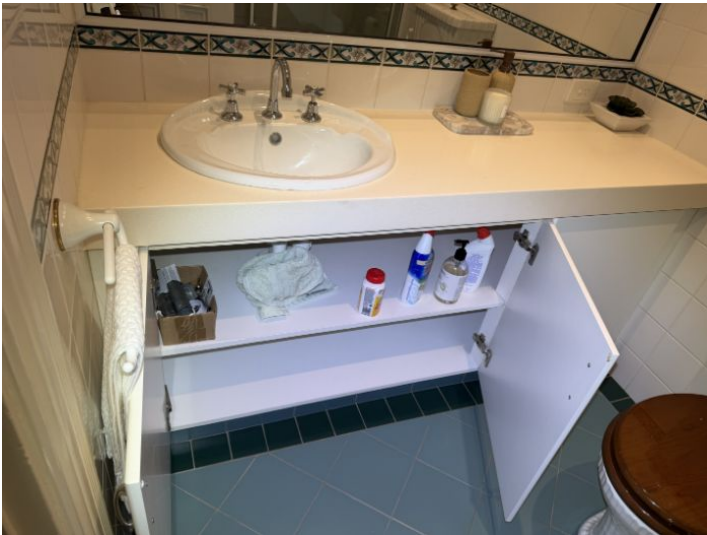
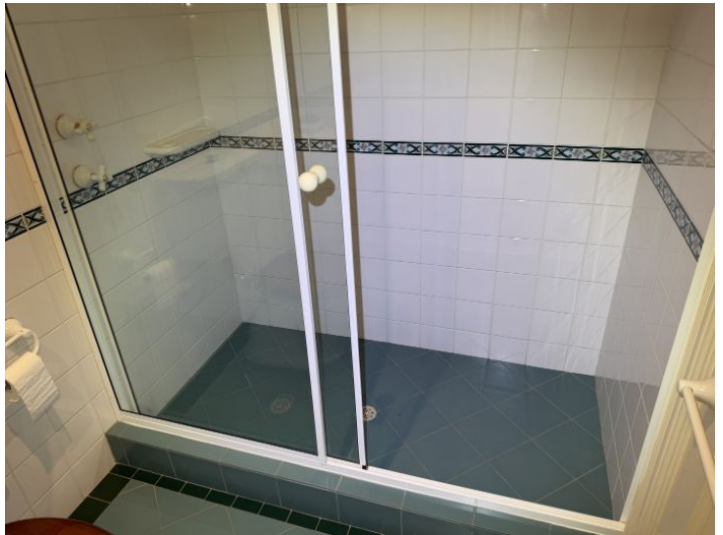
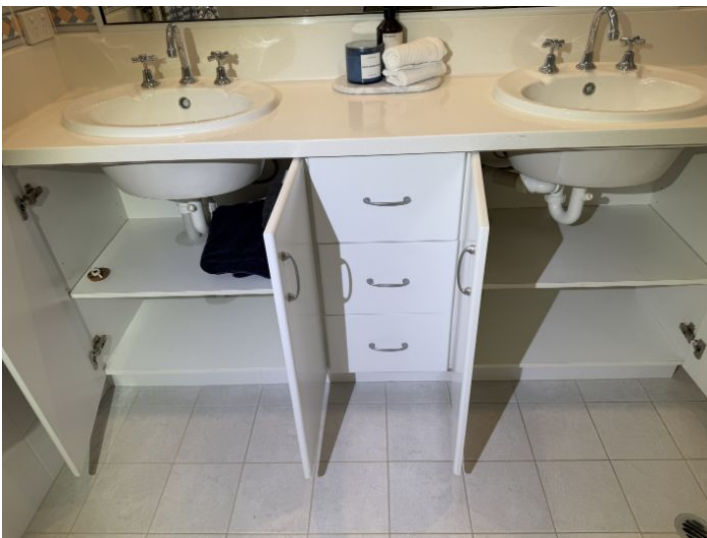
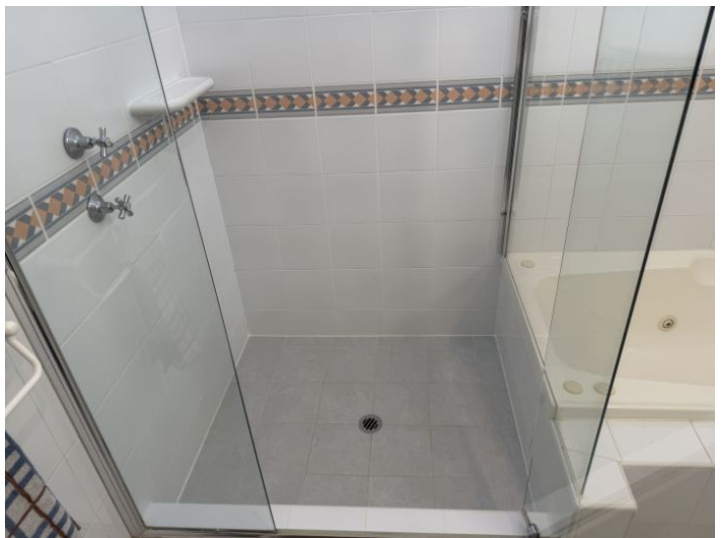
- Cabinets appeared to be in satisfactory condition for their age.
- Moisture testing on adjacent side of the walls were negative.

- As a preventative measure, we always recommend sealing tile grout and joints to prevent water infiltration into walls. Grout should be resealed every 5 years.

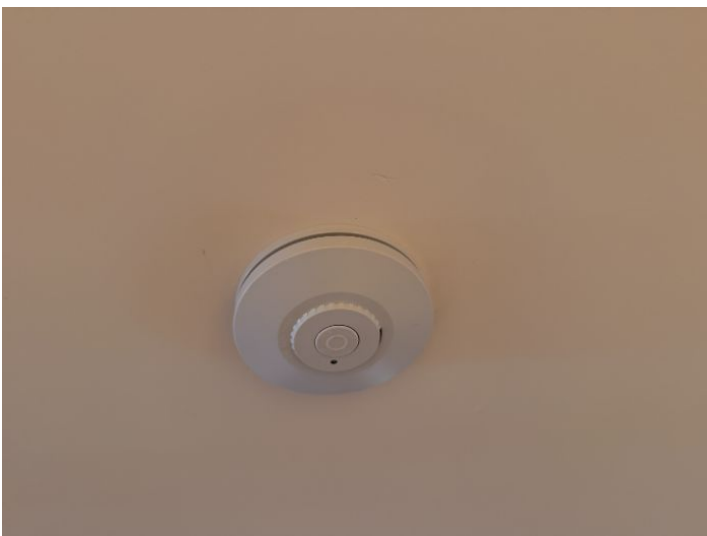
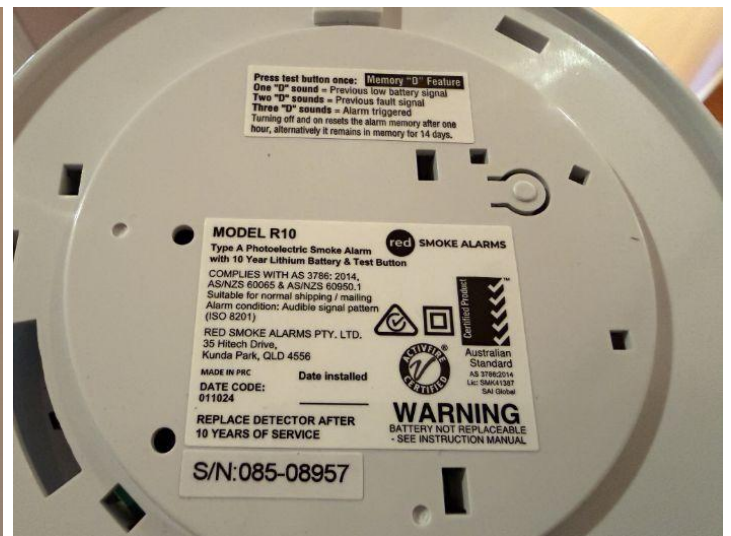
- Ground floor: There is a 10 year lithium battery smoke alarm installed - Not tested.
- First floor: There is a hardwired smoke alarm installed - Not tested.

Expiry date 2034.

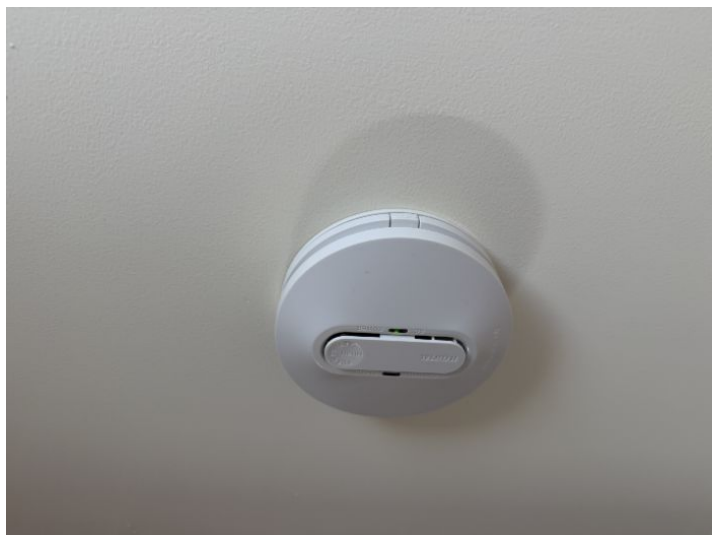
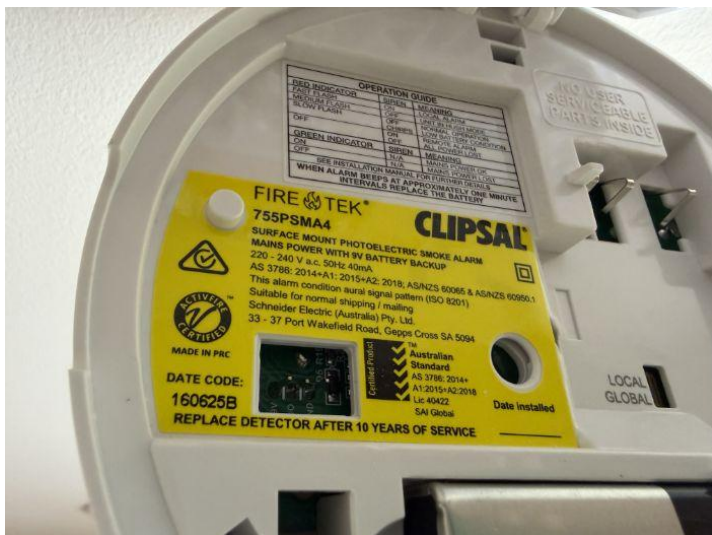
expiry date 2035.

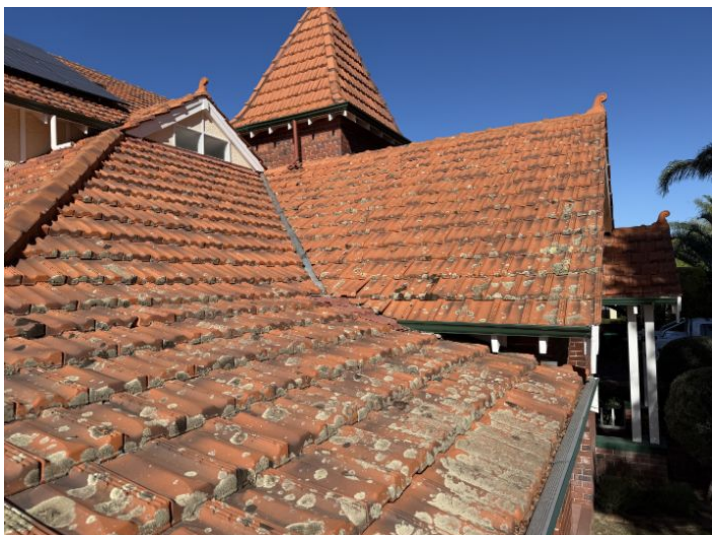
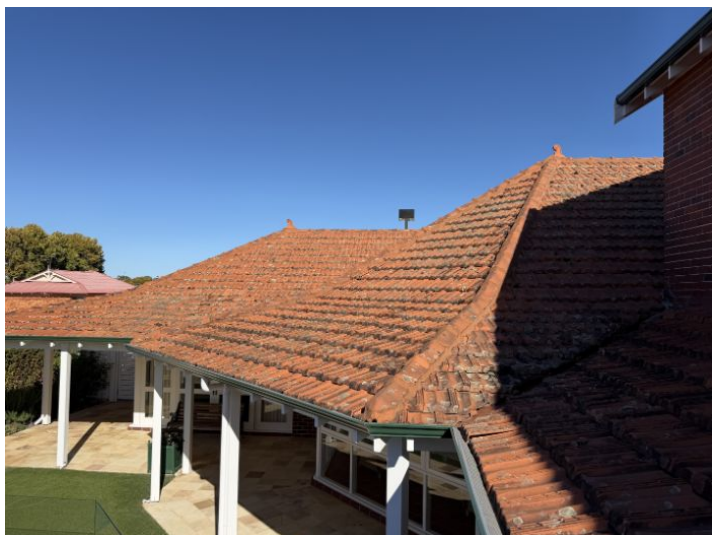
- The tiled roofing material appeared to be in satisfactory condition for age.
- The top storey roof was not walked upon for the inspection due to inaccessibility and height restrictions.
- Inspected from within the roof space.
- Inspected from ground level from various locations with binoculars. Due to property and roof configurations, some areas of the roof may be visually restricted from inspection.
- Ground floor inspected at various locations around the home from a ladder.

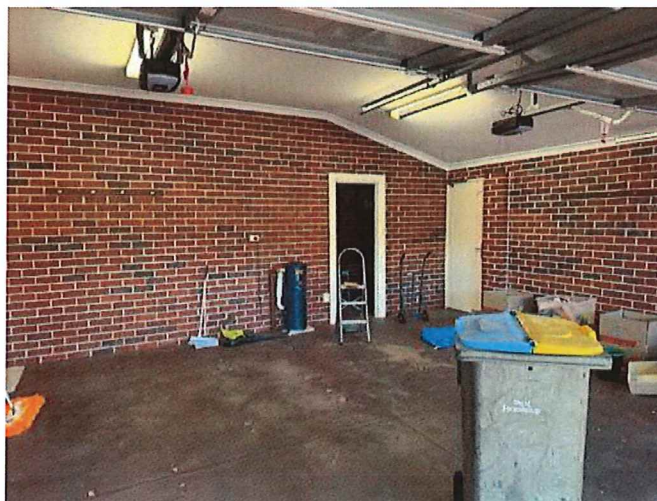
Comments:
 • Garage appeared satisfactory.
 Observations:
 • Often the gap between the slab in the garage and the slab for the home can be a susceptible area for attack. Monitor this area for termite activity in the future.

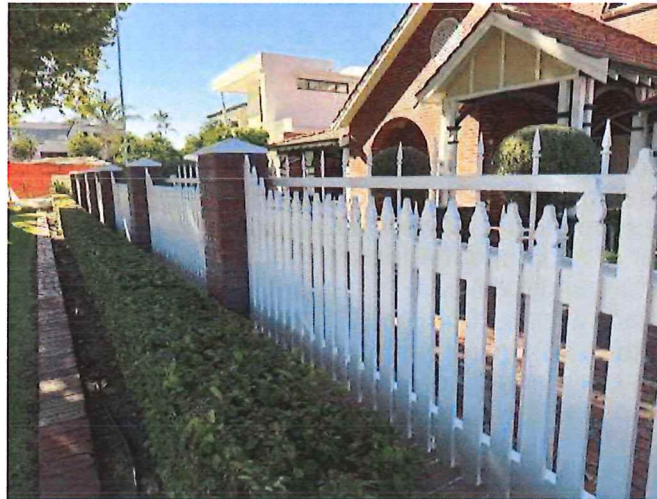
- Timber fences are in fair condition.

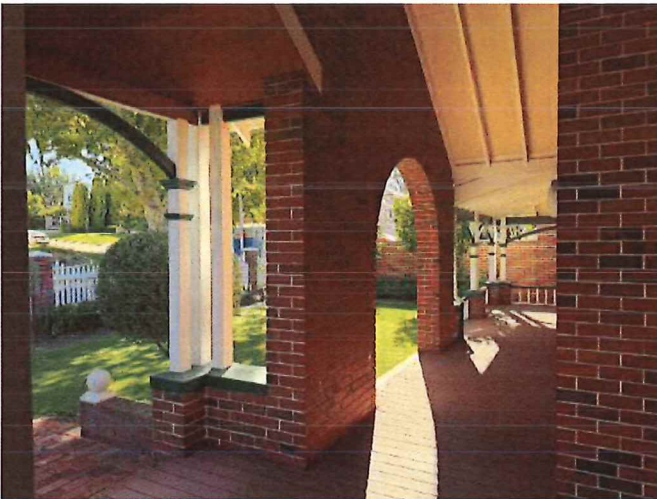
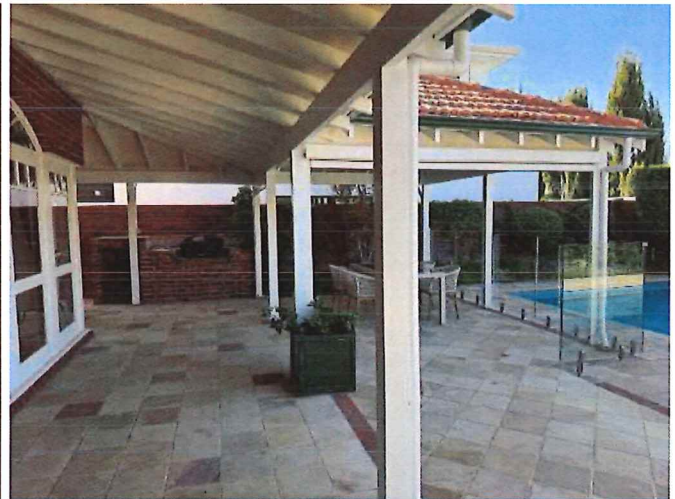
- There are brick piers and timber posts in contact with the ground which may allow termite access to the structure.

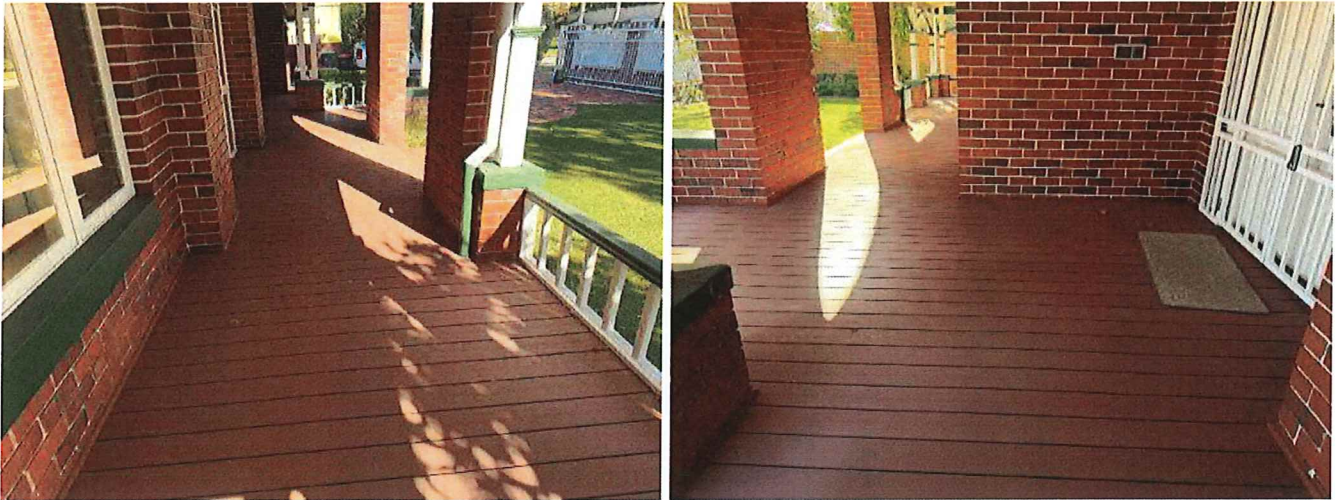
- Inspected deck is a composite material, however the substructure appears to be timber.
- Inspected deck can cause a bridge over any termite installed barriers. It is recommended that the deck should be isolated from attaching to the property, or the soil under and next to the deck should be treated.
