# 10 Year Maintenance Plan

## Bey Apartments

112 Goderich Street

Strata Plan 5186

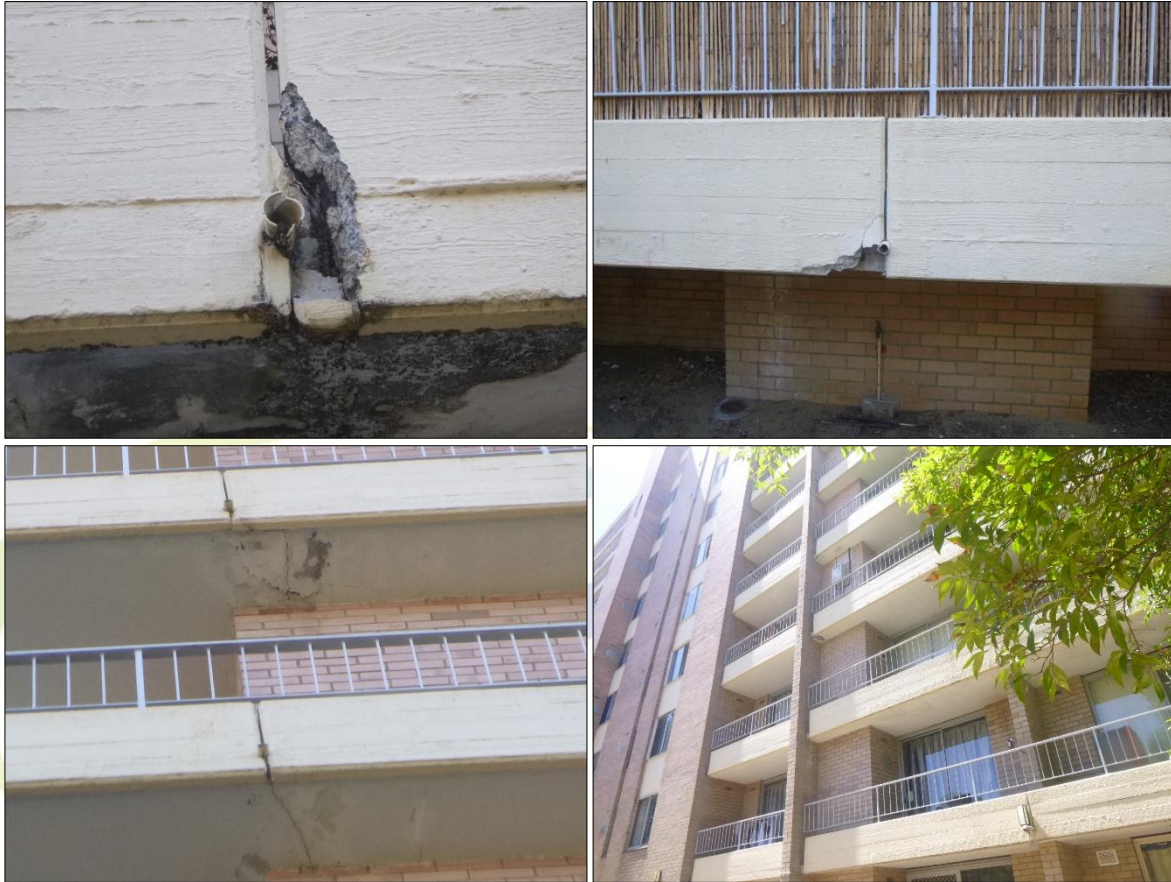
#### BUILDING EXTERIOR

The balcony slabs and concrete balustrade walls especially to the northern side of the building were in poor condition and showing signs of concrete deterioration at the time of inspection. We have included an allowance for an inspection and repairs in the early years of the report. The general painted external elements were in poor condition at the time of inspection. We have included an allowance for repairs in the early years of the report.

| Expenditure Item | Current Cost | Year 1 (2026) | Year 2 (2027) | Year 3 (2028) | Year 4 (2029) | Year 5 (2030) | Year 6 (2031) | Year 7 (2032) | Year 8 (2033) | Year 9 (2034) | Year 10 (2035) | Year 11 (2036) | Year 12 (2037) | Year 13 (2038) | Year 14 (2039) | Year 15 (2040) |
|---|---|---|---|---|---|---|---|---|---|---|---|---|---|---|---|---|
| Repair concrete deterioration to balcony walls and slabs (Total: 1 Item) - 10% | 25,000 | - | - | 27,301 | - | - | - | - | - | - | - | - | - | - | - | - |

16. ENGINEERS REPORT - We recommend an engineer inspect the property and report on the concrete deterioration to a number of balcony balustrade walls and slabs. We also suggest an engineer inspect and report on the metal rooftop. Money has been allocated towards remedial works to these areas, but this will vary subject to the recommendations of the engineer. We have been advised that the walls to the lift room have already been inspected by an engineer.

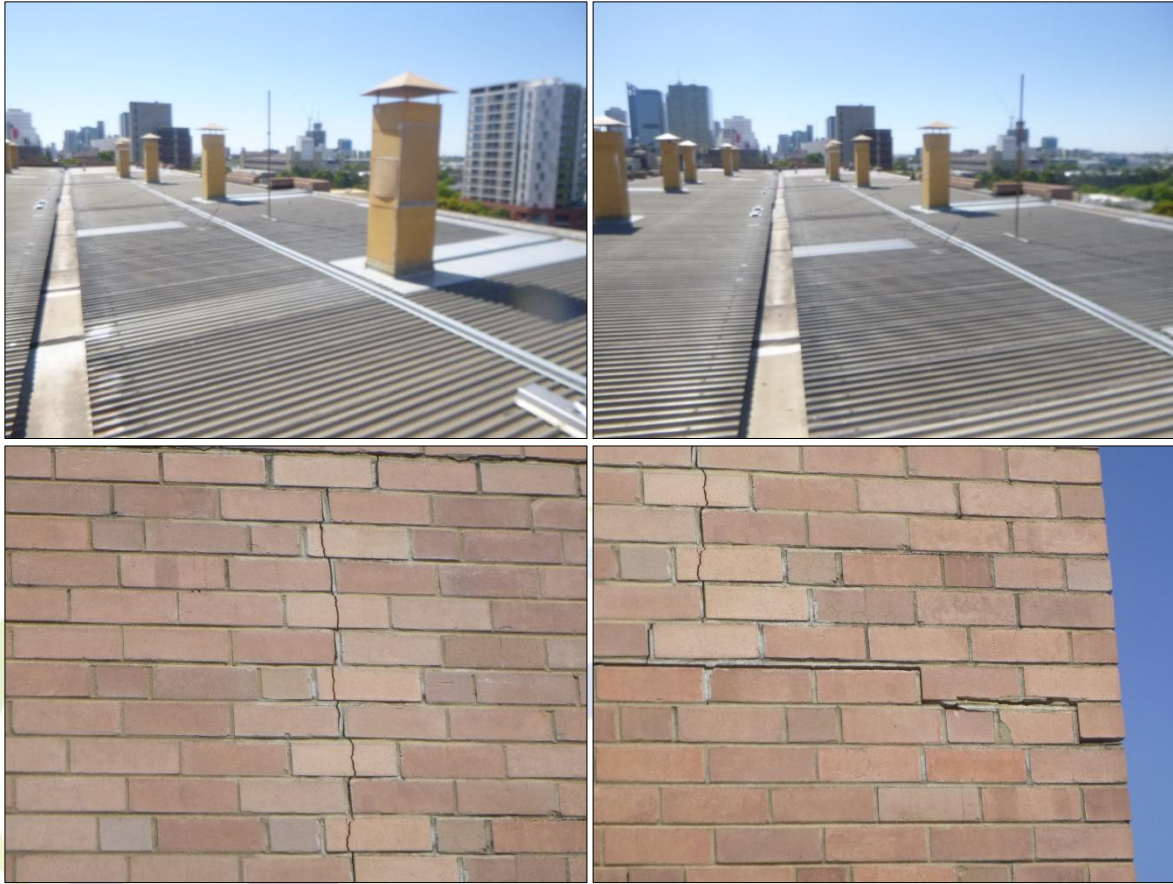
**Item Group****ROOFTOP**

The metal rooftop was in poor condition at the time of inspection. We have included an allowance for an inspection and repairs in the early years of the report. The brickwork to the lift motor room walls was in poor condition at the time of inspection. We have been advised this has been inspected. We have allowed an allowance for repairs in the early years of the report

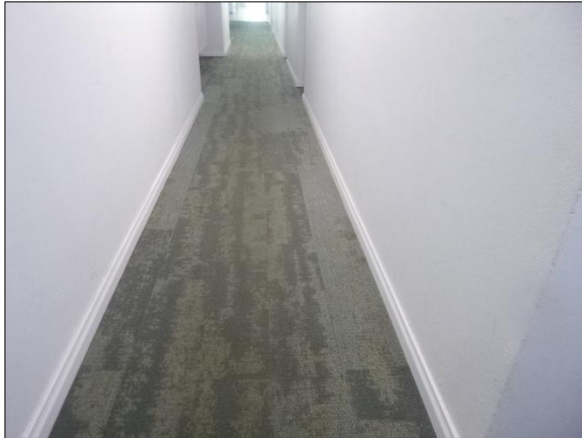
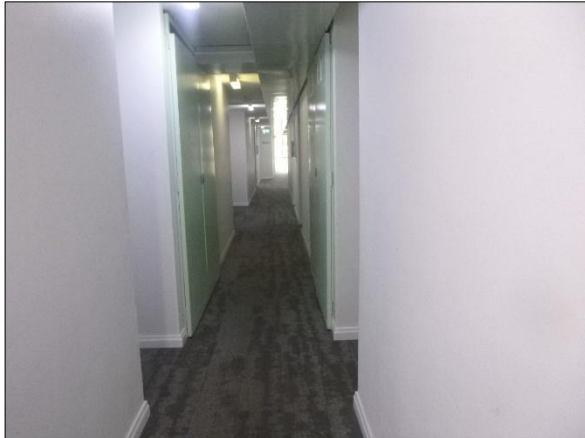
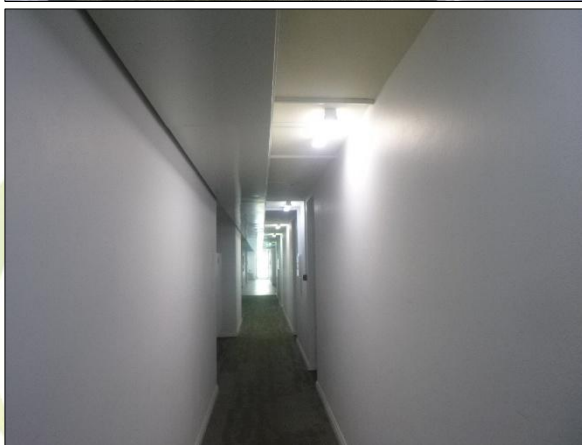
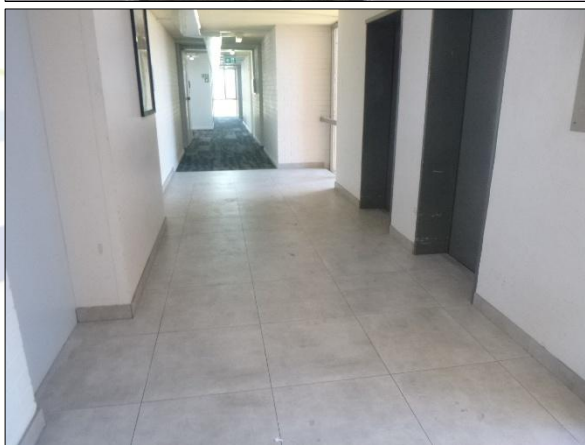
**Item Group****HALLWAYS**

The hallways were in good condition at the time of inspection. As the property ages repairs will be required and an allowance has been included in the report.

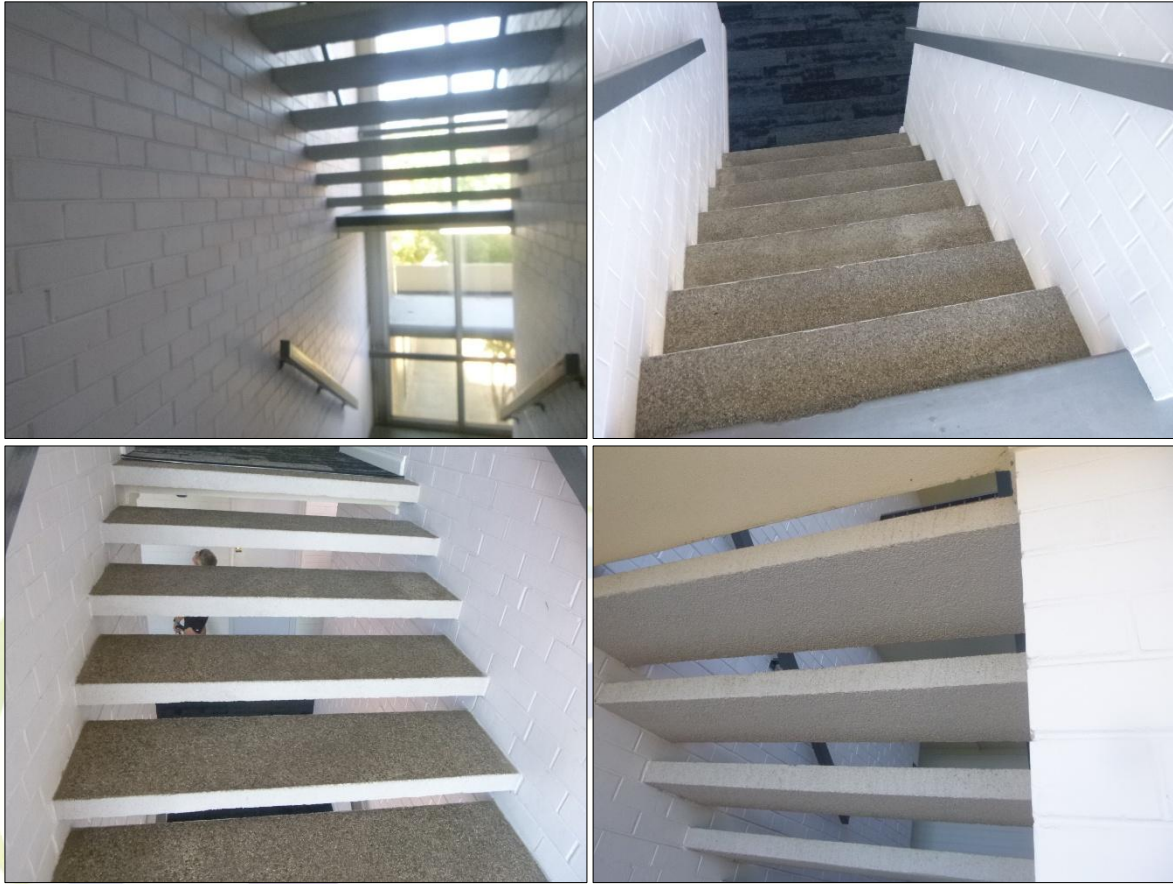
**Item Group****OPEN STAIRWELL**

The open stairwell was in good condition at the time of inspection. As the property ages repairs will be required and an allowance has been included in the report.

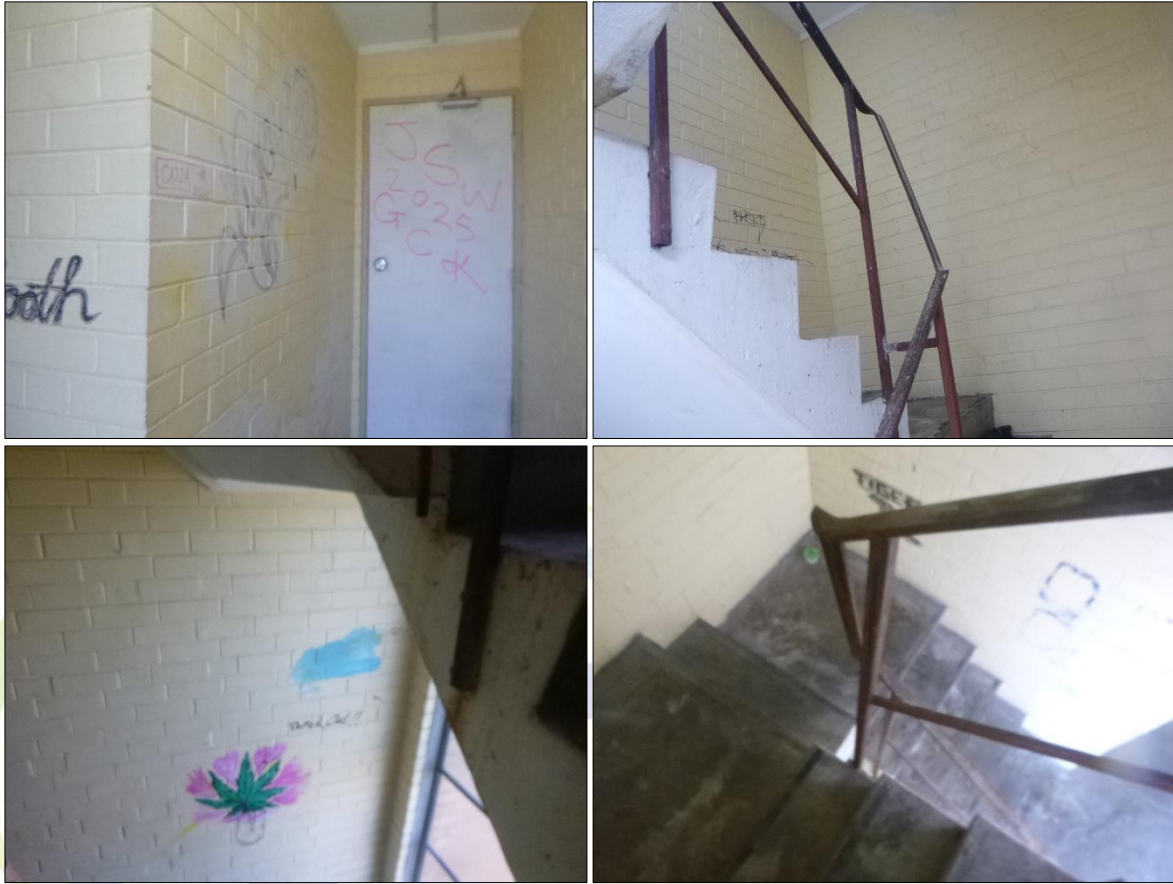
**Item Group****FIRE STAIRWELL**

The fire stairwell was in poor condition at the time of inspection as a result of multiple instances of graffiti and miss use. We have included an allowance for repairs in the early years of the report.

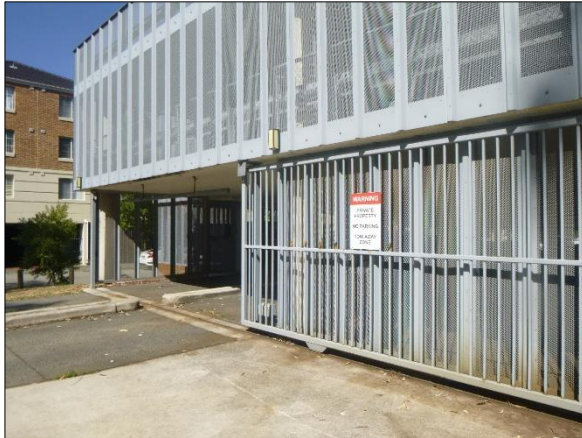
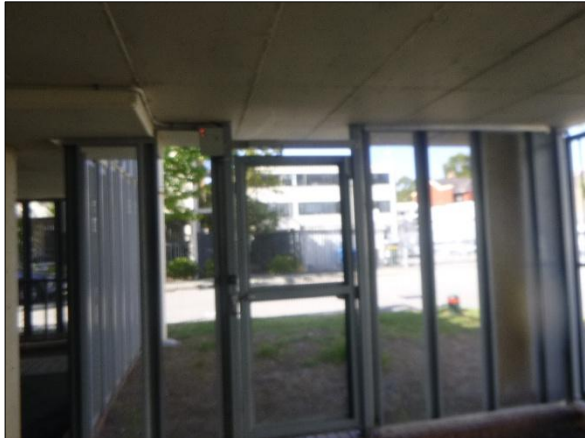
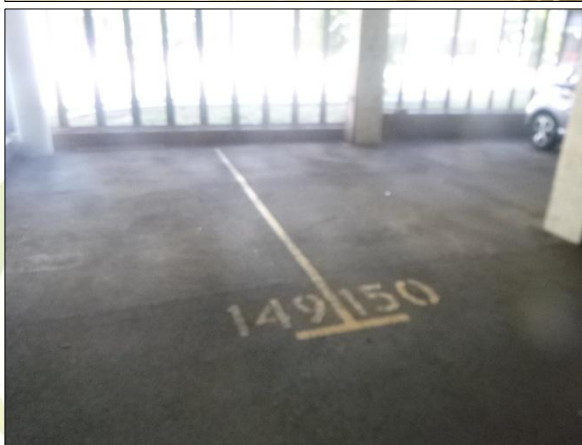
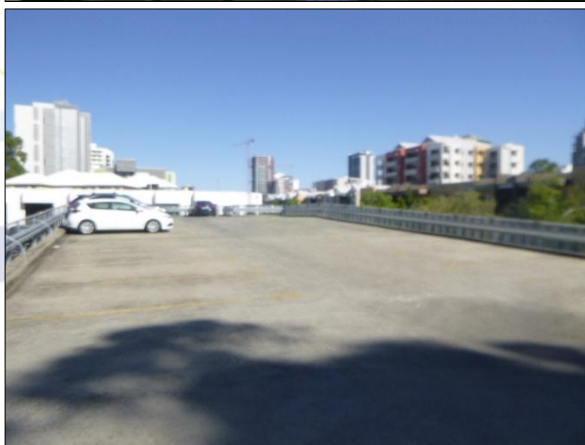
**Item Group****VEHICLE ACCESSWAYS/ CARPARK**

The vehicle accessways/ carpark was in good condition at the time of inspection. As the property ages repairs will be required and an allowance has been included in the report.

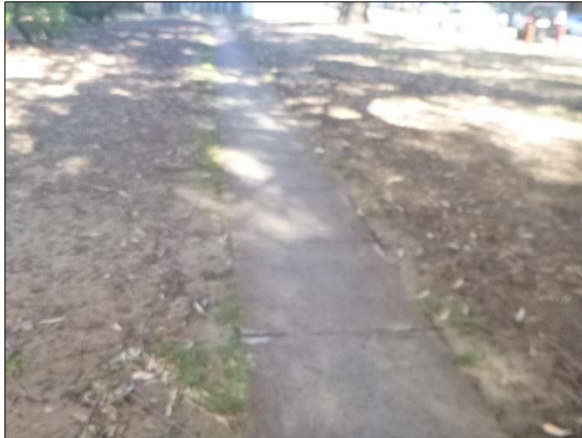
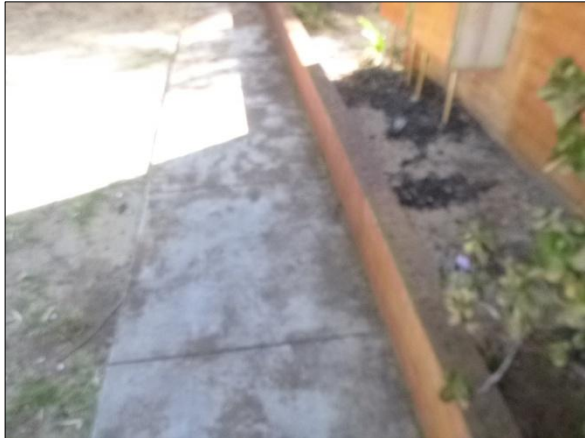
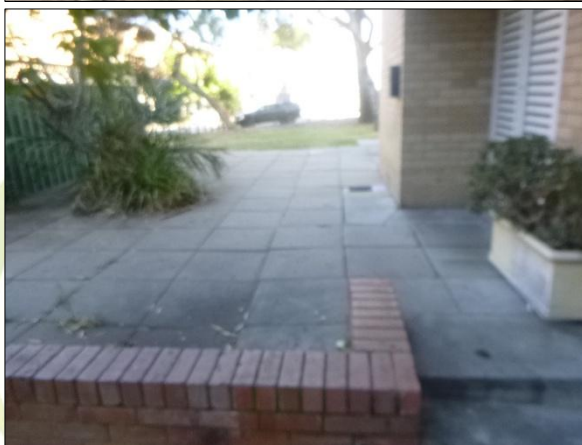
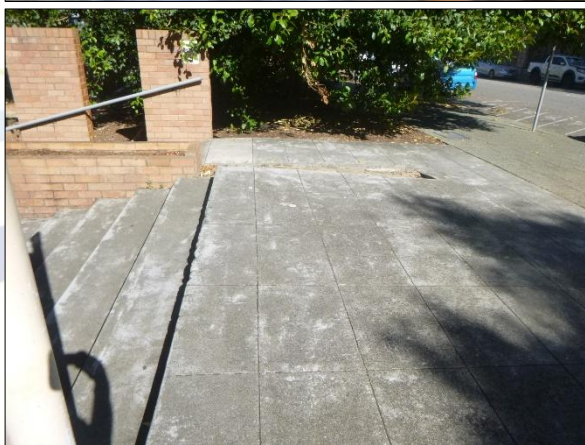
**Item Group****PEDESTRIAN ACCESSWAYS**

The pedestrian accessways were in fair condition at the time of inspection. Some signs of deterioration have been observed, and repair provisions have been included in the report.

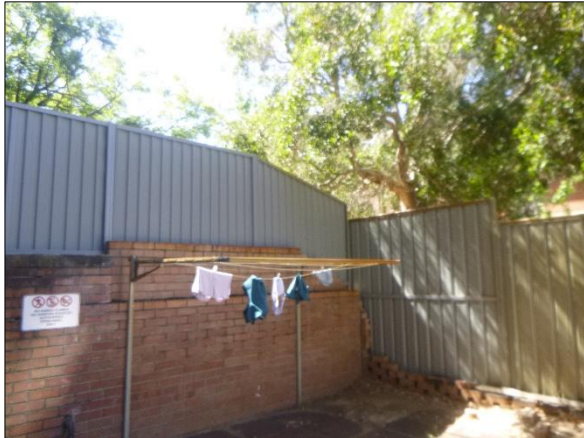
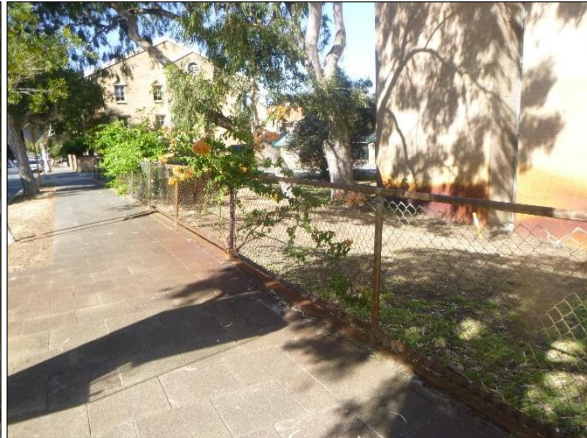
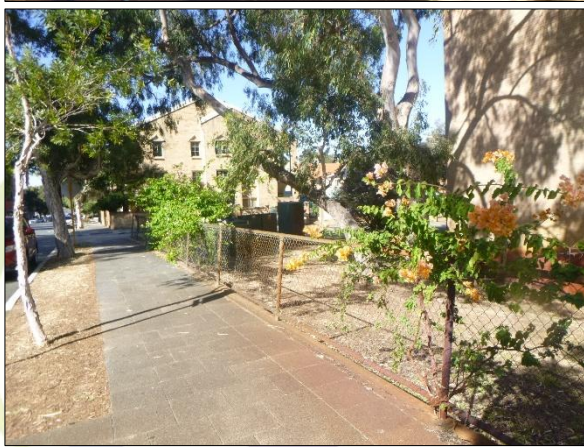
**Item Group****FENCING**

The chain mesh fencing was in poor condition at the time of inspection. We have included an allowance for repairs in the early years of the report. The metal ribbed fencing was in fair condition at the time of inspection. Some signs of deterioration have been observed and repair provisions have been included in the report.

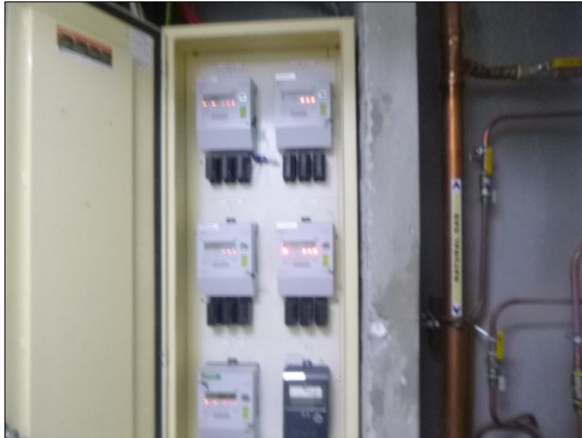
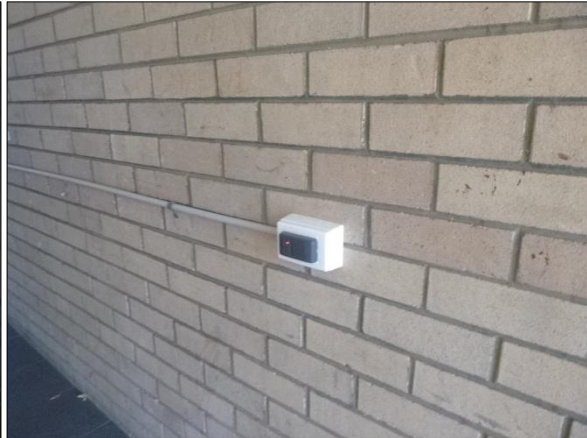
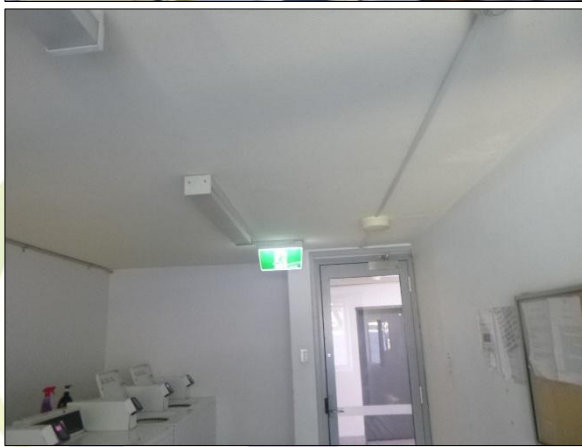
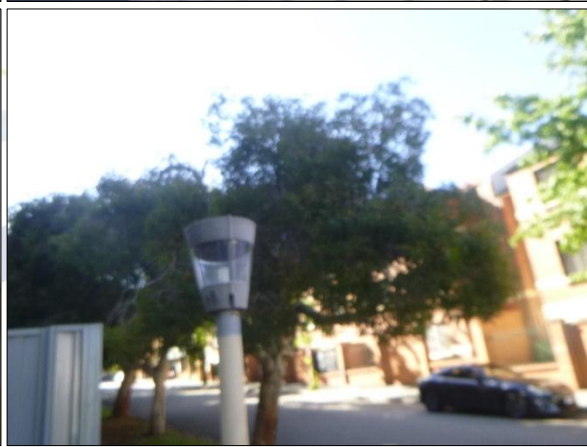
**Item Group****ELECTRICAL**

The lights were in fair condition at the time of inspection. Some signs of deterioration have been observed, and repair provisions have been included in the report. The other general electrical elements were in good condition at the time of inspection.

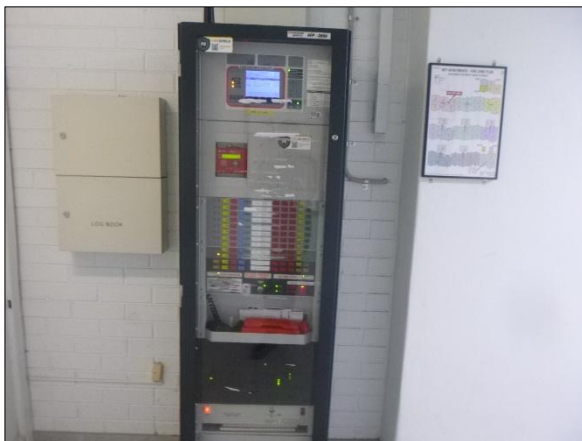
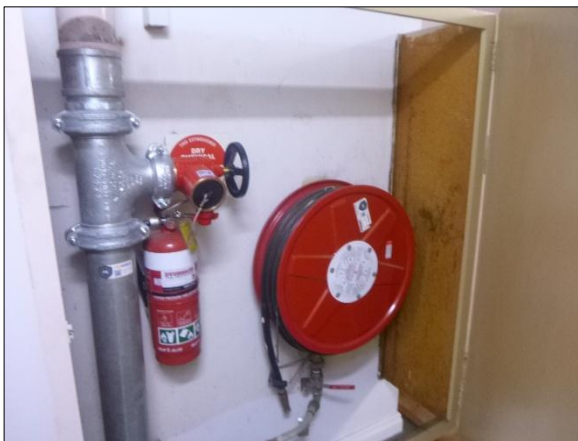
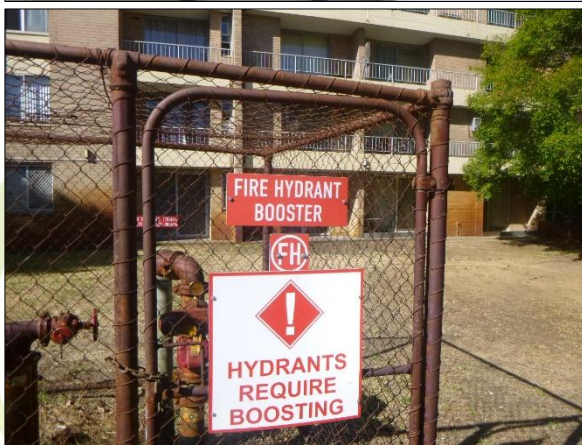
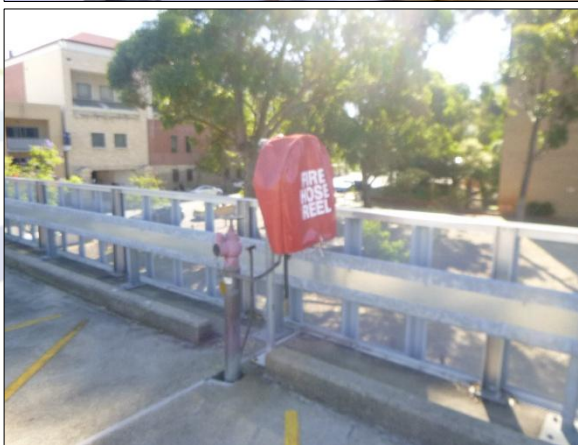
**Item Group****FIRE**

The fire control elements were in good condition at the time of inspection. As the property ages repairs will be required and an allowance has been included in the report.

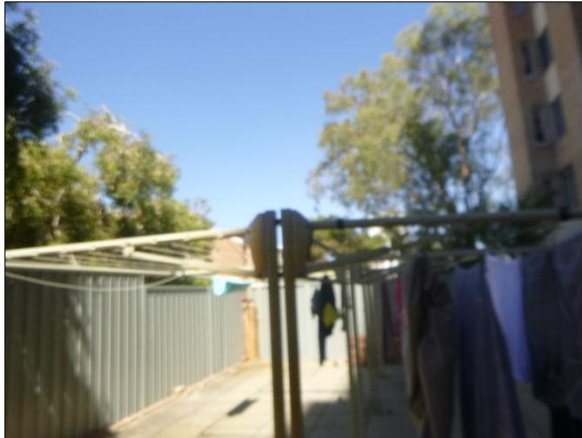
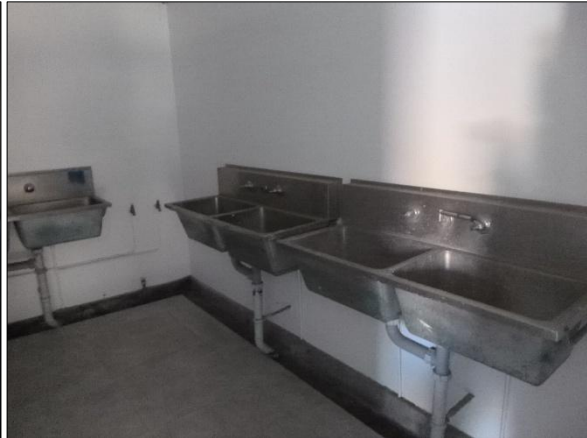
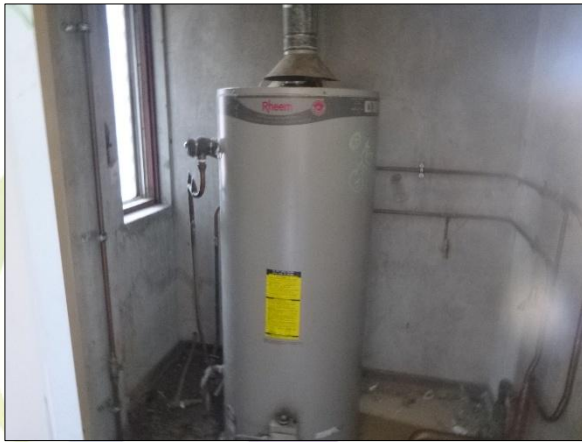
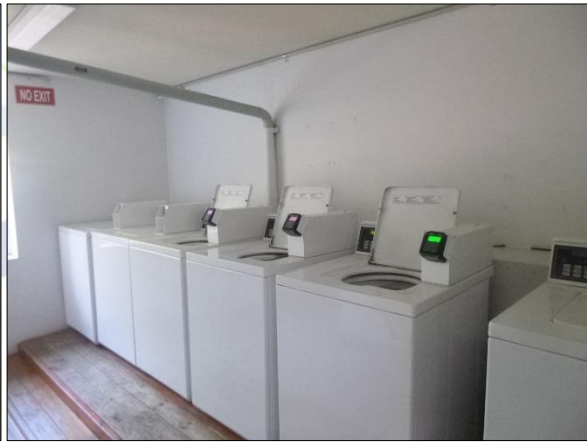
**Item Group****LAUNDRY**

The clotheslines, troughs and hot water unit were in fair condition at the time of inspection. Some signs of deterioration have been observed, and repair provisions have been included in the report. The other general laundry elements were in good condition at the time of inspection. As the property ages repairs will be required and an allowance has been included in the report.

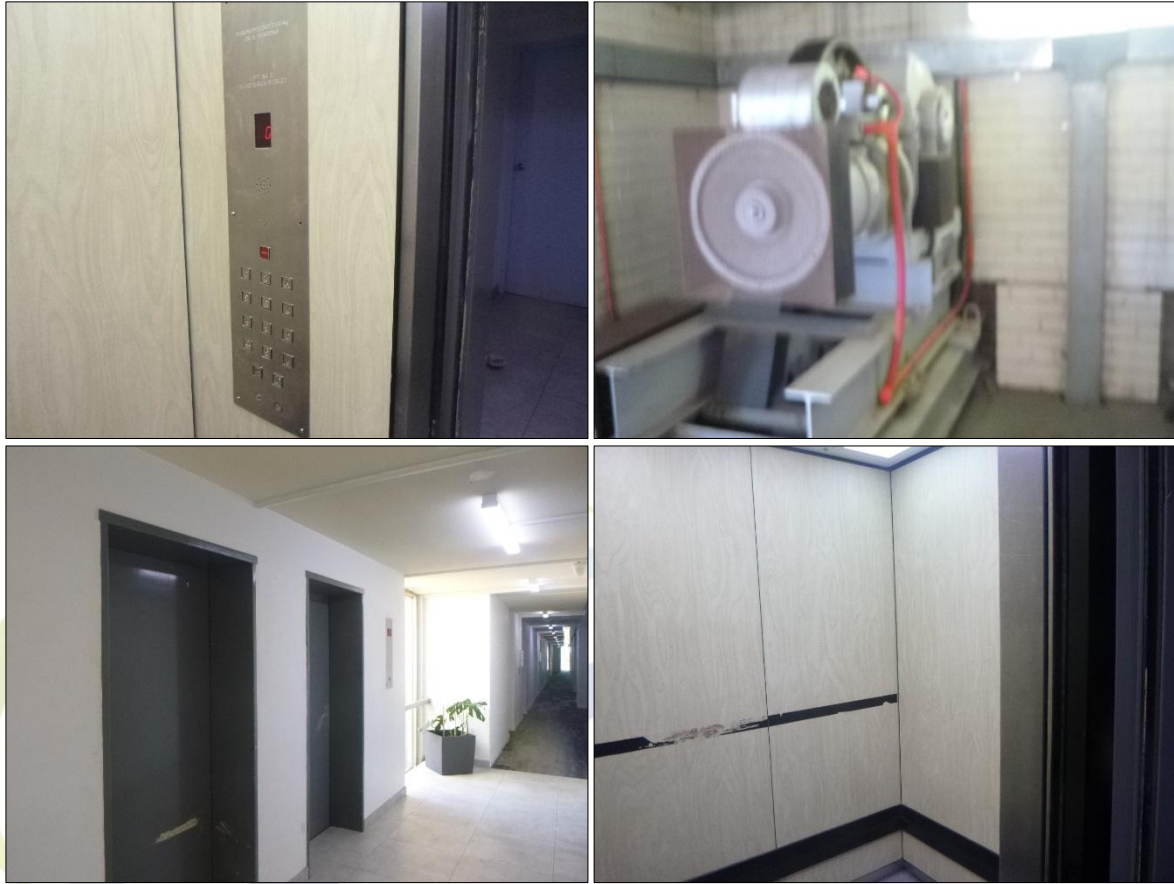
**Item Group****LIFTS**

The lifts were in poor condition at the time of inspection. We have included an allowance as provided by our meet on site contact for replacement of lifts in the early years of the report. Also as advised we have spread the cost of this replacement over 2 years.
