PRE-PURCHASE STANDARD TIMBER PEST REPORT

Report number:	30812
Inspection date:	13 May 2026
Property address:	23 Malcolm Street Bluff Point Geraldton WA 6530

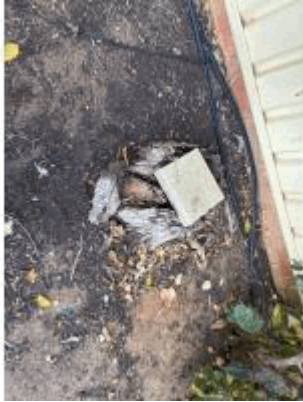
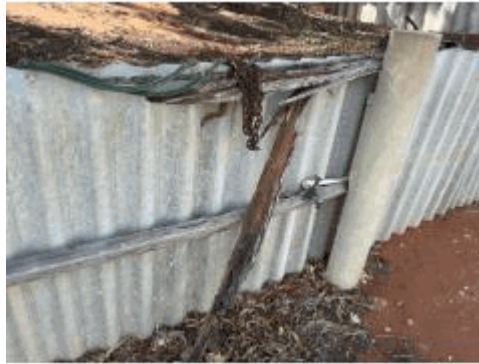
D3 Termite workings and/or damage

Was evidence of termite workings or damage found?	Yes
The extent of any visible damage appears:	Localised - see Details and Recommendation below.

Termite workings/damage to tree stumps and fence timbers.

Is a Subterranean Termite Management Proposal recommended?	Yes (As per D5)
Is this Consultant engaged to provide a management proposal?	No
