# Asset Condition Report & 10-Year CAPEX

Strata Plan S043221, 1 Museum  
Place, Geraldton 6530 –  
Northshore Apartments

VPG Property,

1 July 2024

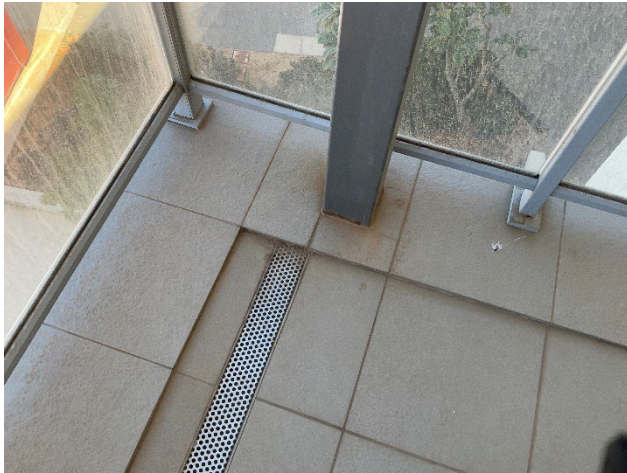
| Ref | Location | Level / Location | Element | Material | Photo | Year of Installation | Remaining Service Life | Description | Recommended Works | Condition | Risk | Priority | Quantity | Unit | Responsive / Cyclical / Planned | Maintenance / Infrastructure | Present Value | First Year Cost Occurs | One off or Recurring | Frequency Cost Occurs | 1.0000 | 1.0300 | 1.0609 | 1.0927 | 1.1255 | 1.1593 | 1.1941 | 1.2299 | 1.2668 | 1.3048 | Total | |
|---|---|---|---|---|---|---|---|---|---|---|---|---|---|---|---|---|---|---|---|---|---|---|---|---|---|---|---|---|---|---|---|---|
| 1.02 | Columns | Balcony | Posts | Steel | 1.02 | 2012 | 48 | Painted steel posts supporting cantilevered balconies present with surface corrosion at the base. | Prepare and Paint | 3 | 3 | Priority 2 | 1 | Item | Cyclical | Maintenance | \$ 5,800 | 3 | Recurring | 5 | \$ - | \$ - | \$ 6,153 | \$ - | \$ - | \$ - | \$ 7,133 | \$ - | \$ - | \$ - | \$ 13,286 | |

1.02 Painted Steel posts supporting cantilevered balconies

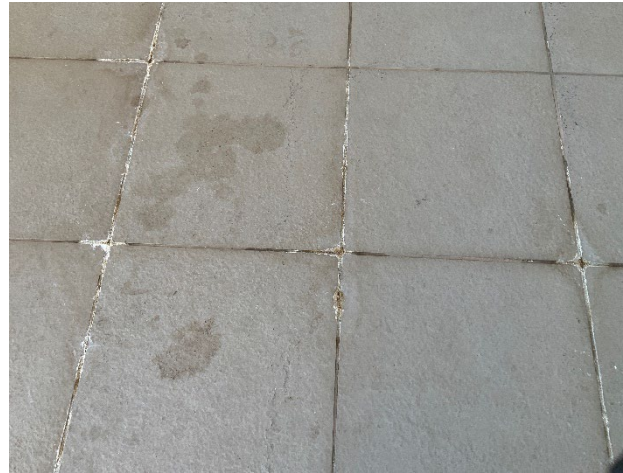
1.03 Calcium deposits and chalky residue to tiled grout lines

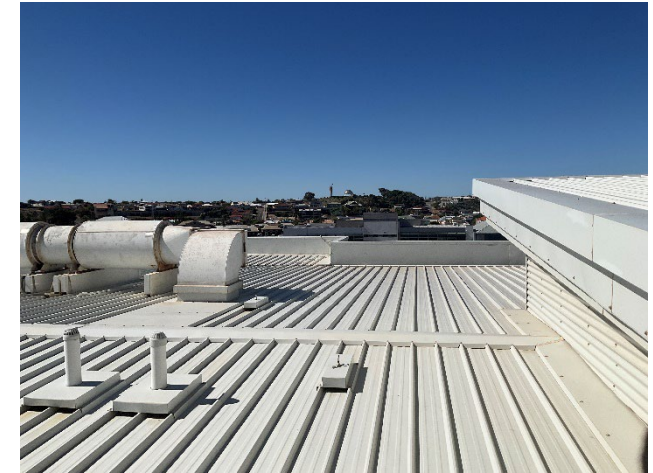
2.01 Roof sheets were assessed to be in good condition

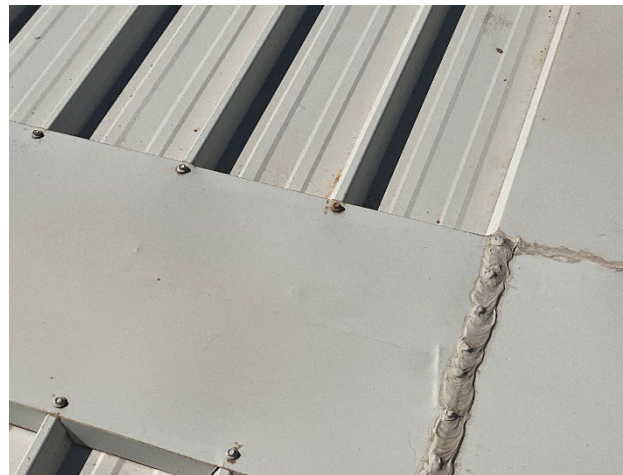
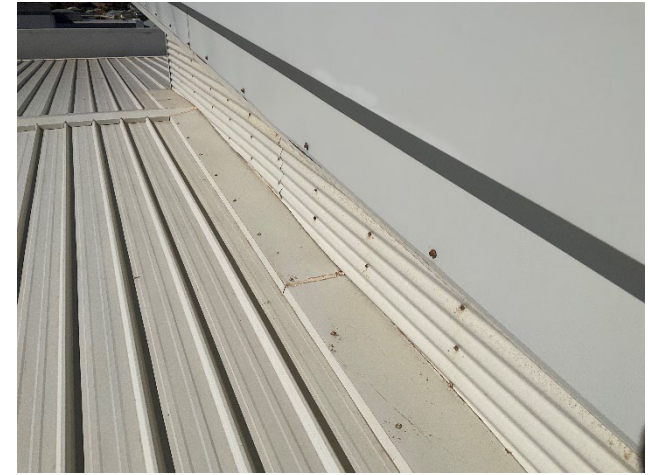
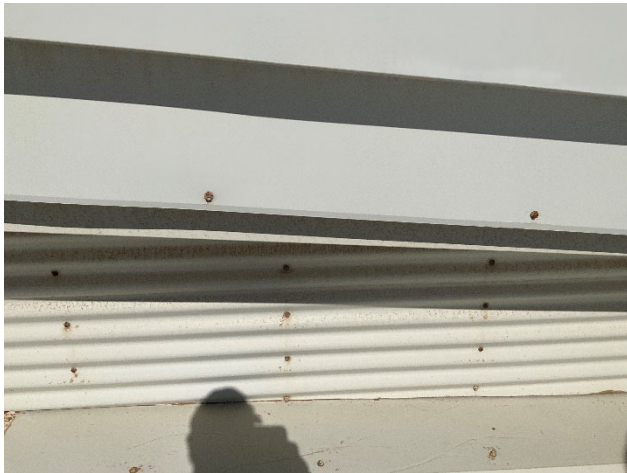
The roof areas were generally in fair condition. Corrosion was observed in the roof fasteners and localised areas of roof steel framing and trims.

2.03 Roof fasteners with corrosion

2.03 Corrosion to fasteners

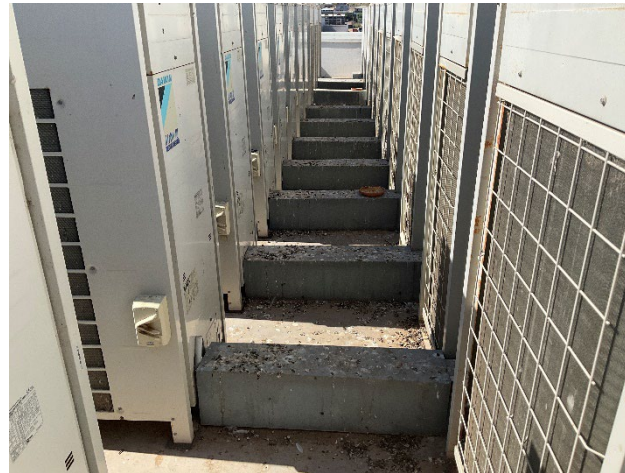
2.07 The concrete roof section is heavily soiled with contaminants

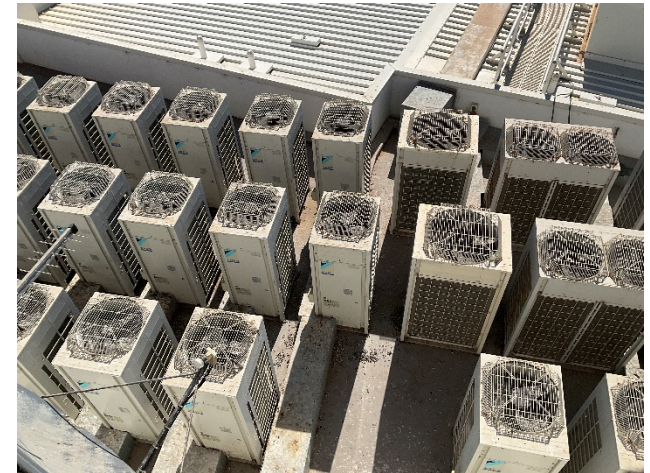
2.07 Consideration for bird proof enclosure

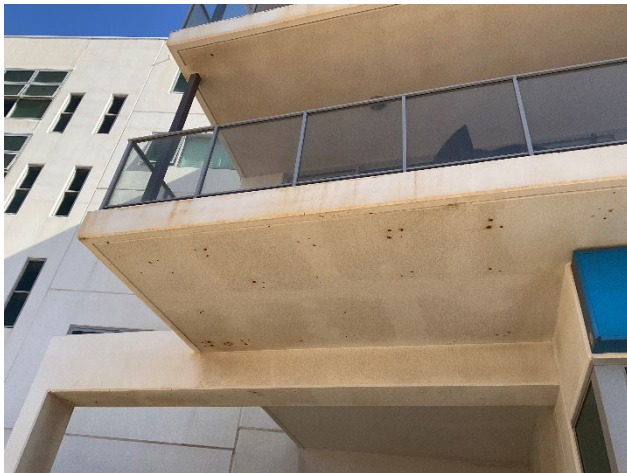
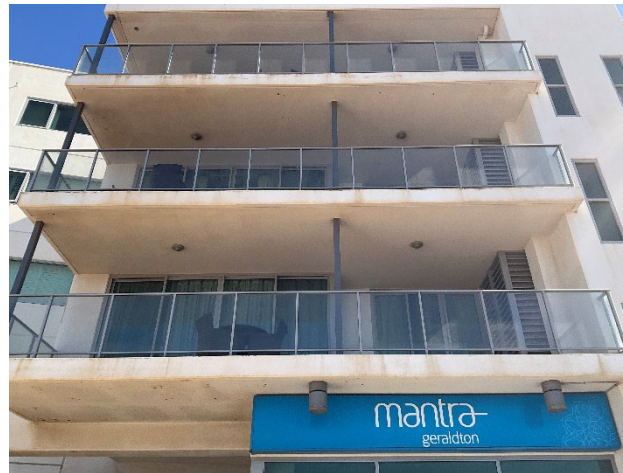
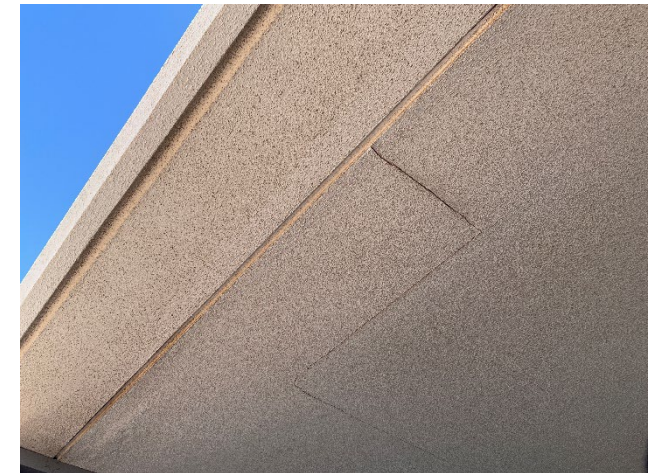
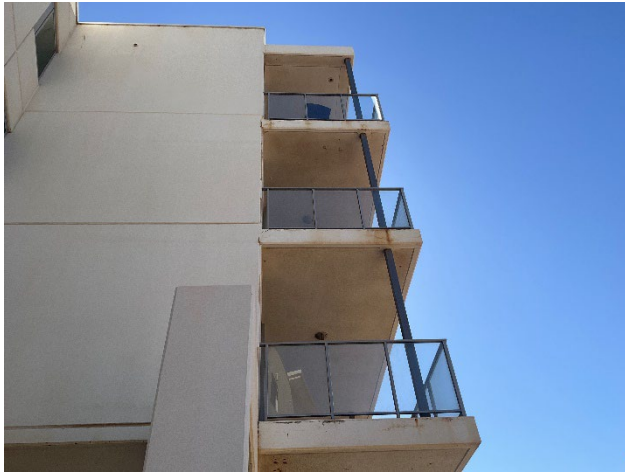
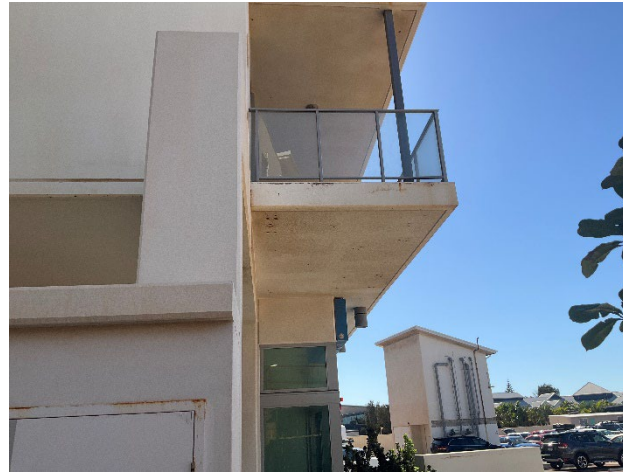
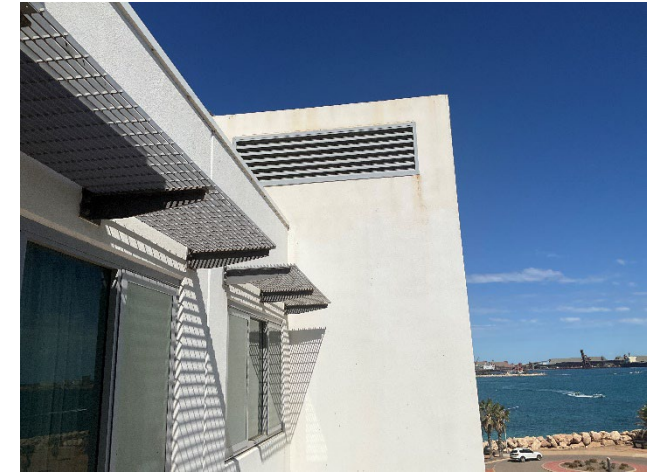
3.06 The external façade is demonstrating signs of paint and render deterioration.

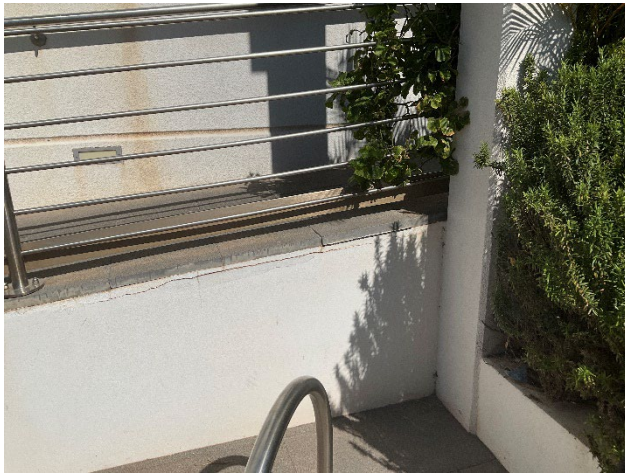
3.03 Waterproofing to planter boxes typically has a design life of 10 -15 years.

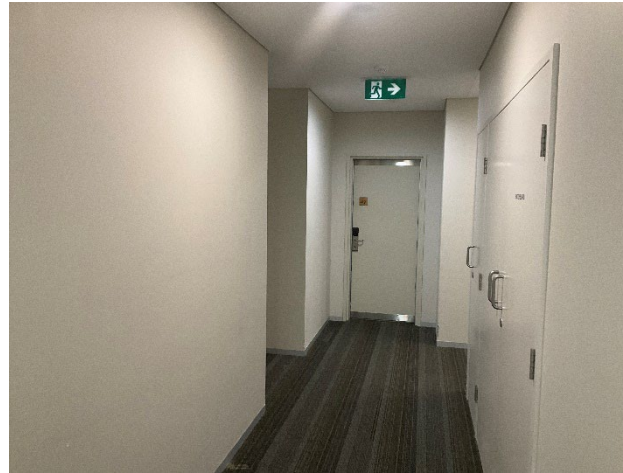
4.04 Common areas x 3 will require redecoration to maintain appearance.

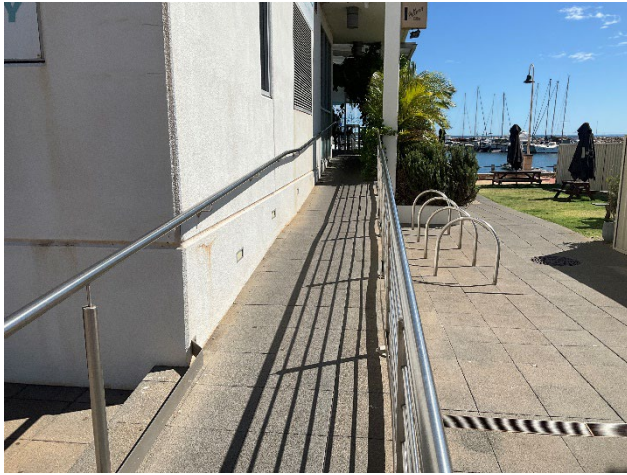
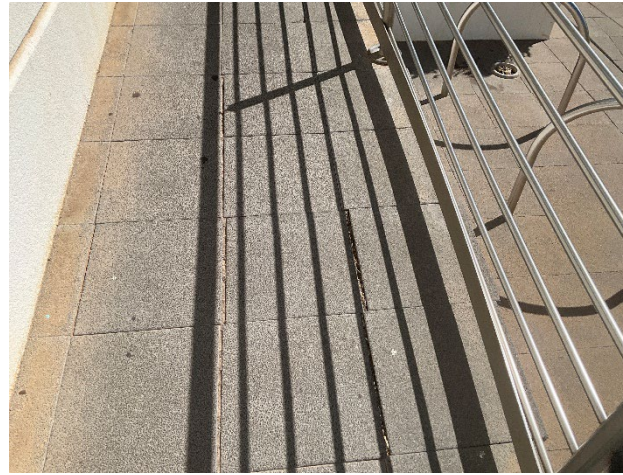
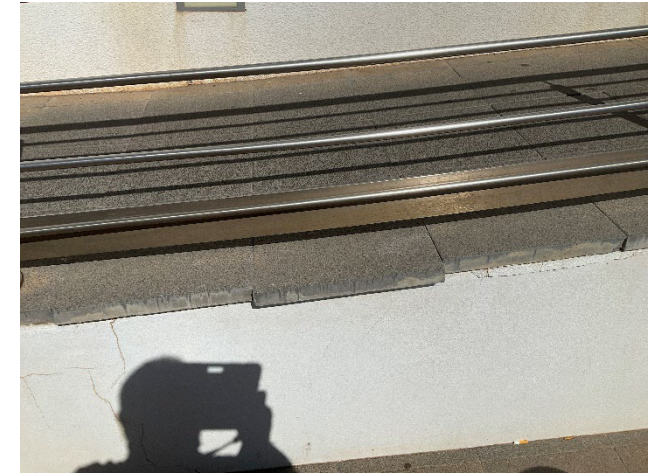
| Overall Condition and Key Findings | | |
|---|---|---|
| <ul style="list-style-type: none"><li>External common areas are limited to small paving areas, steps and access ramps to access points to the commercial and residential tenancies.</li><li>Minor areas of paving noted to be loose or uneven and will require repair.</li></ul> | | |

5.01 Lift and reset dislodged pavers to commercial tenancy area.

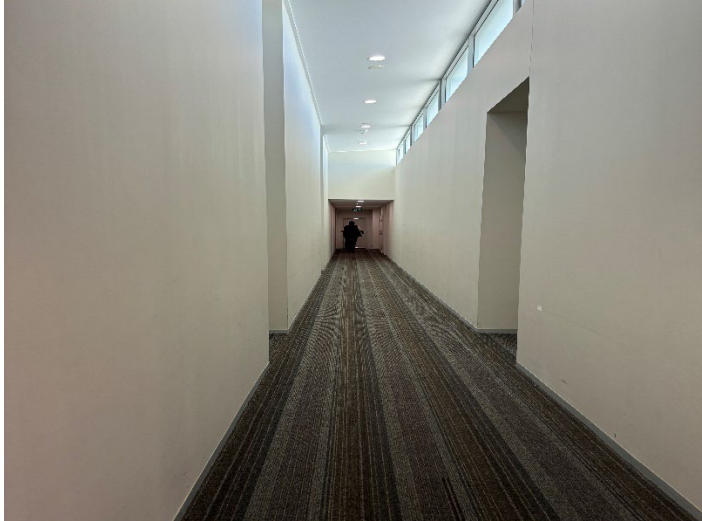
- In a Class 3 building, public corridors serving sole-occupancy units (SOU's) are required to be divided at intervals of not more than 40m with smoke-proof walls. This was required at the time of approval/construction, however, no smoke separation is provided to corridors, which appear to exceed 40m. In the absence of an existing performance solution, a fire-engineer should be engaged to review the existing arrangement and provide recommendations on upgrade/remedial measures. This may involve construction of smoke-proof walls to each storey.

Corridor exceeds 40m – no smoke separation

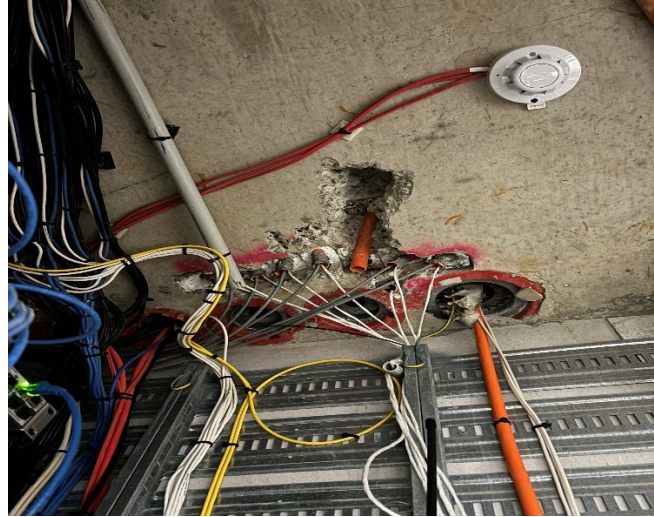
Poorly protected services penetrations – DB enclosure

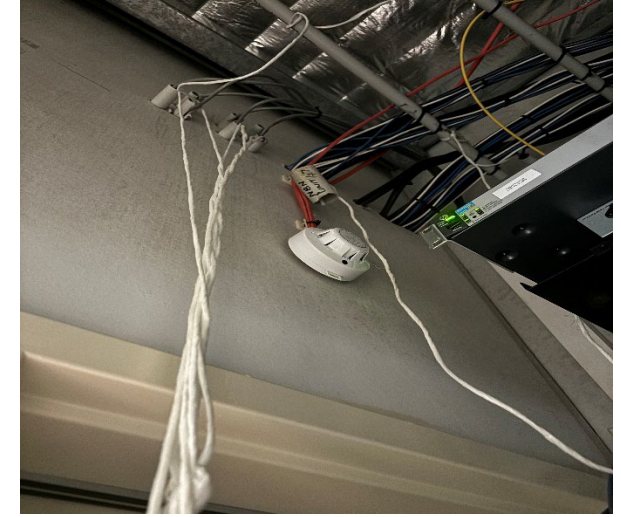
Poorly protected services penetrations & Wall mounted smoke detector

- The following **minor** issues were noted:
  - Smoke detection to DB enclosure is wall mounted in lieu of ceiling mounted – re-locate existing detector to ceiling.
