**PILBARA  
PEST CO**

# Pre-Purchase Timber Pest Inspection Report

29 Stickney Way, Baynton WA, Australia

22 Sep 2026

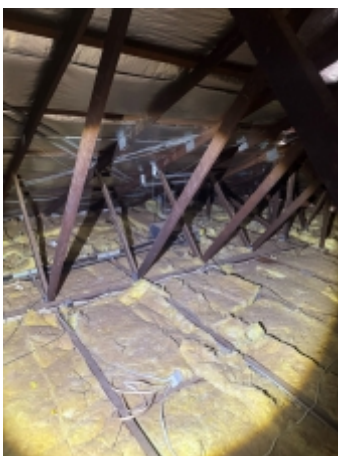
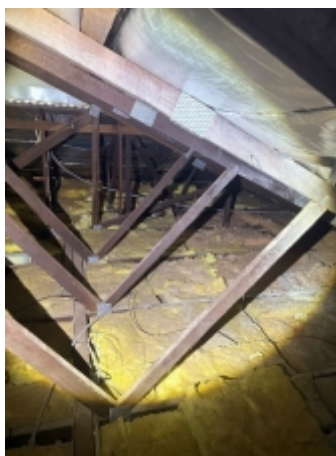
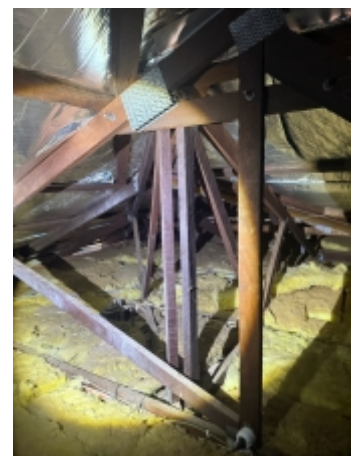
Items, fixtures and furniture etc hinder view

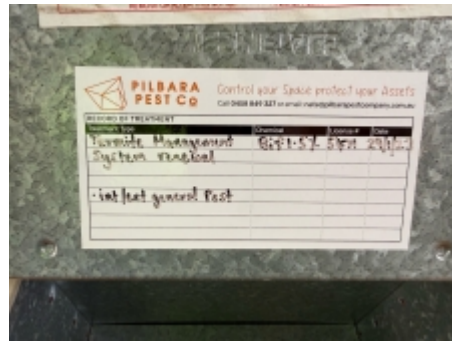
**Durable Notice Photos**

Description of the evidence found: Treatment sticker in meter box
