# **Houspect**

### **Pre purchase inspection**

**Job ID:** 92961

**Address:** 29 Stickney Way, Baynton WA 6714

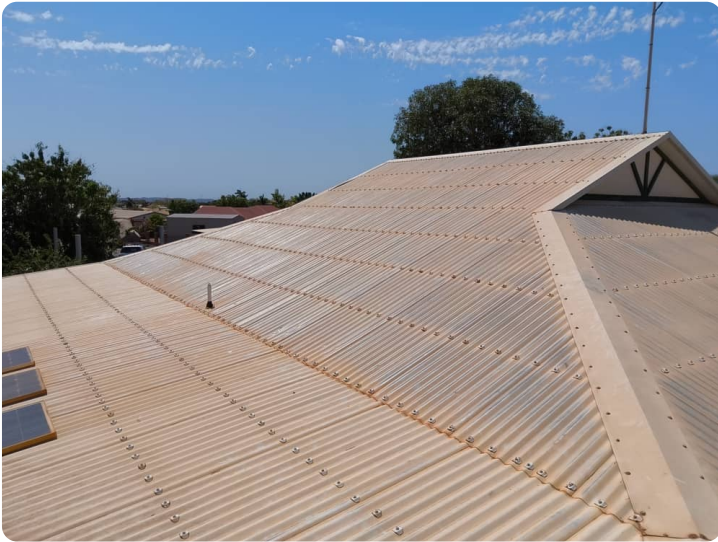
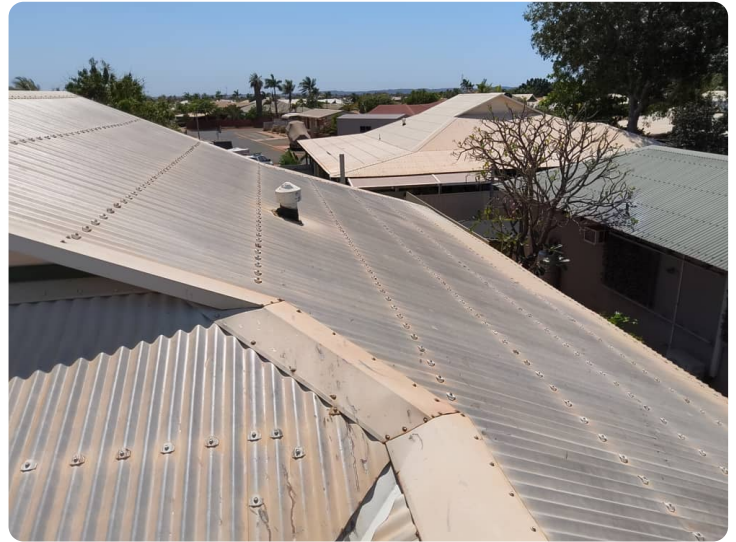
### 1.1 Metal (colorbond) roof colour faded

As per the images there the colorbond roof sheeting has or is losing its colour on most of the roof, leaving the zincalume finish. This is a cosmetic issue and does not diminish the sheets performance broader performance.

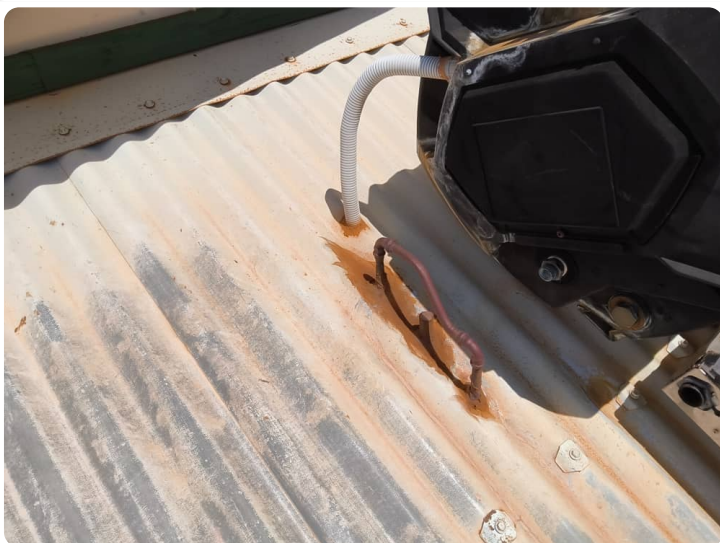
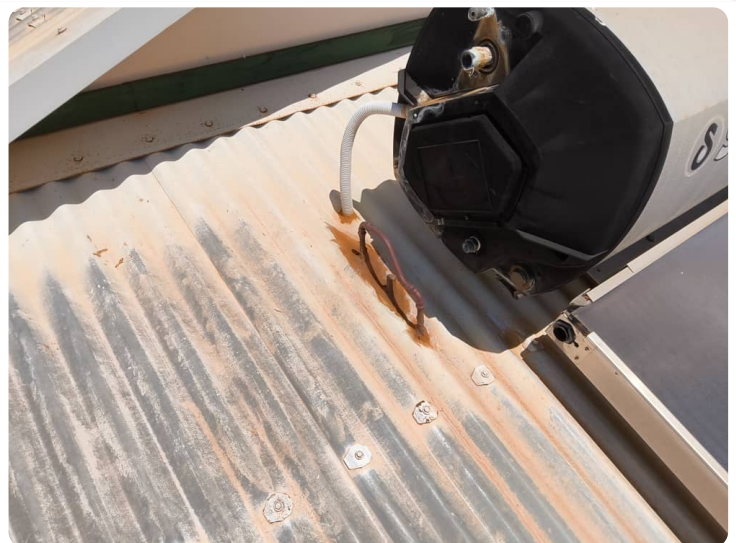
#### 3.1 Flashings general - only silicone

There is insufficient or no flashing installed around the roof penetrations which have only been silicone sealed. Installing flashing around these penetrations is recommended to prevent water ingress into the roof space.

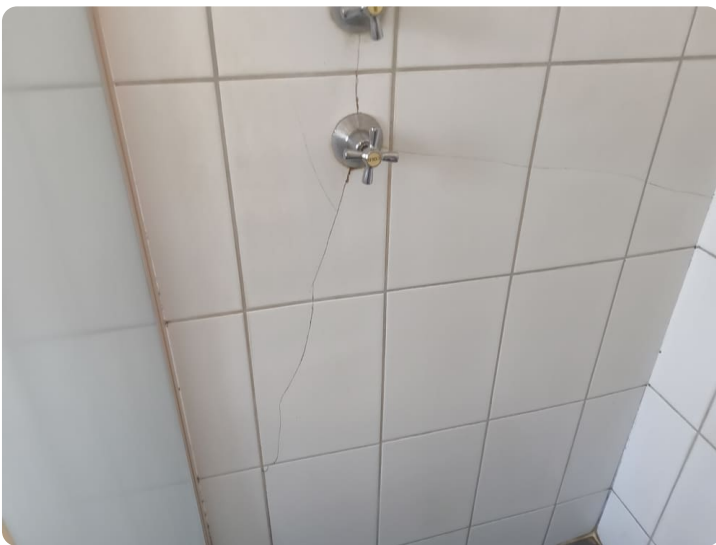
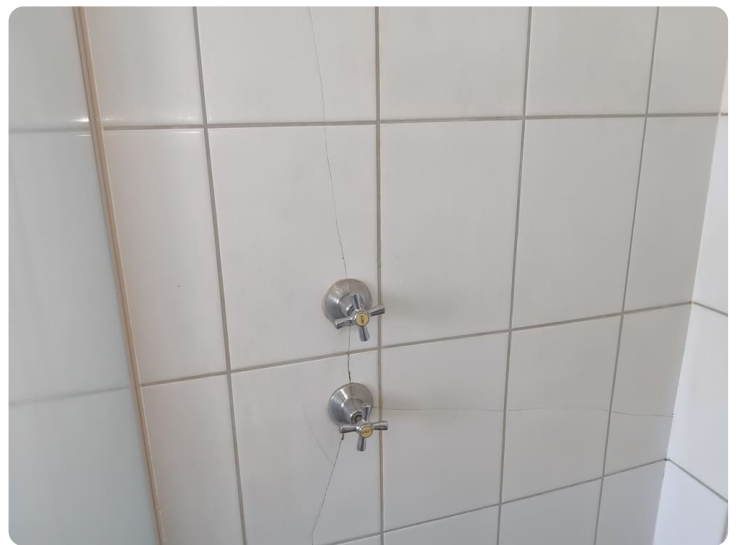
#### 39.1 Tile damage - major

| Inspection item | Inspection issue |
|---|---|
| 39. Tiled floors and walls | 39.1 Tile damage - major |

**Issue flag:** Major Non Structural Defect

As per the images provided there is significant damage to the wall or floor tiles requiring repairs or replacement.

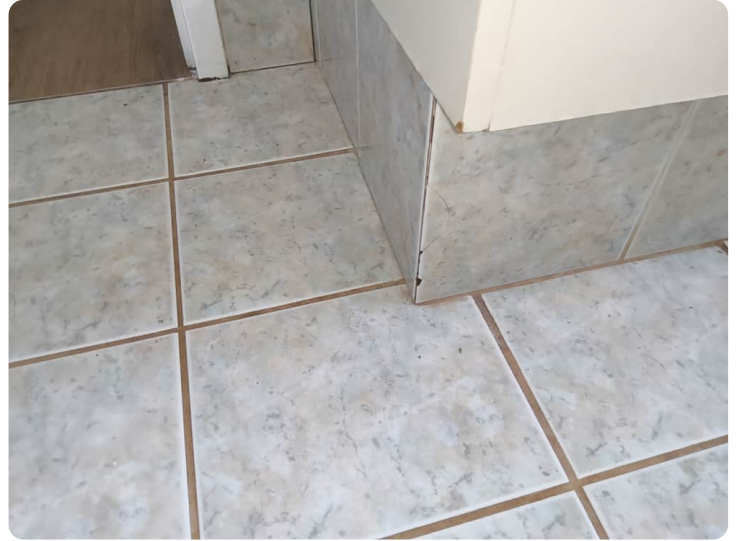
### 39.2 Tile damage - minor

As per the images provided there is damage to the wall or floor tiles requiring repairs or replacement.

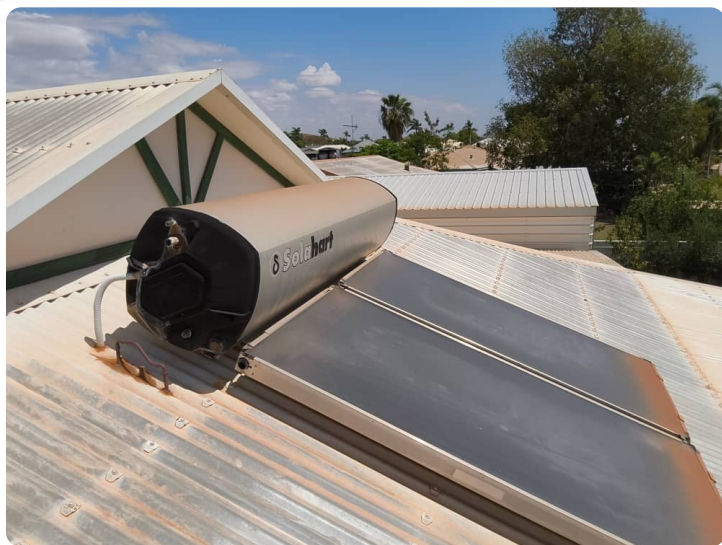
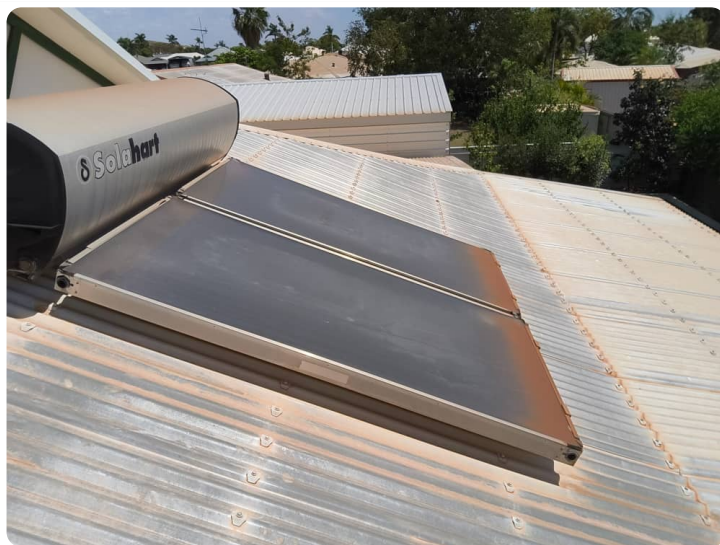
### 46.1 Hot water unit - potentially obsolete

There appears to be an obsolete hot water system on or in the roof. Recommend that the position is confirmed and the system removed if no longer in use.

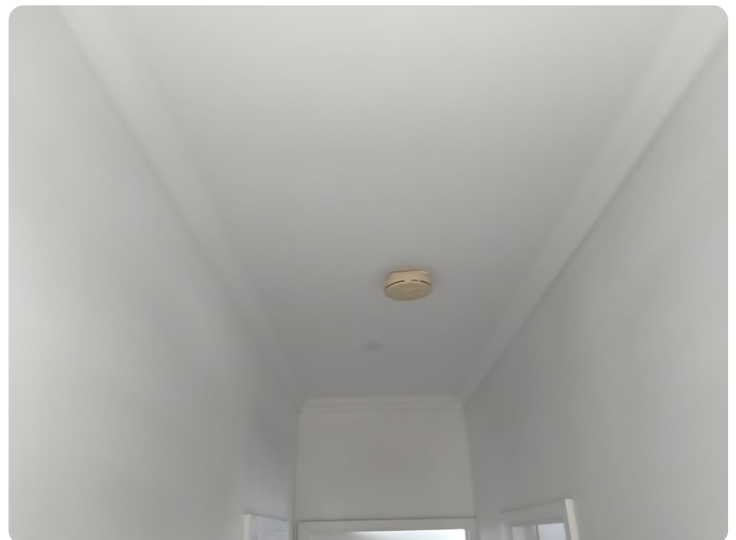
While on site the inspector checked the age of the smoke alarm via a date stamp on the rear of the alarm. The date indicated that the alarm was older than 10 years. Under WA laws smoke alarms must be less than 10 years old. It is recommended that an Electrical Contractor be engaged to review and provide an Electrical Compliance Certificate.
