# **Residential Tenancy Entry Condition Report**

**39 Leonard Way, Nickol, WA 6714**

Report completed on Monday 30/03/2026

## Property Condition Report

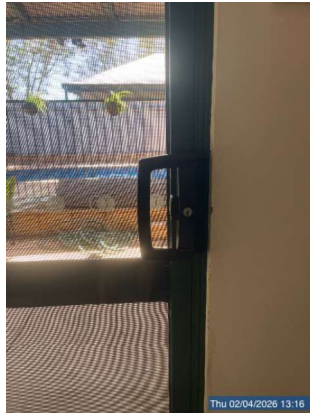
**SECURITY/ SAFETY:** keys/other opening devices (photo 1 of 1)

| Agent section | | | | Tenant section | |
|---|---|---|---|---|---|
| keys/other opening devices | | | | All deadlocks are in working condition.<br>All security doors are in working condition.<br>All window latches are present and working. | Y<br>Sliding door to back patio won't lock or unlock with key from outside (1 photo, page 138) |

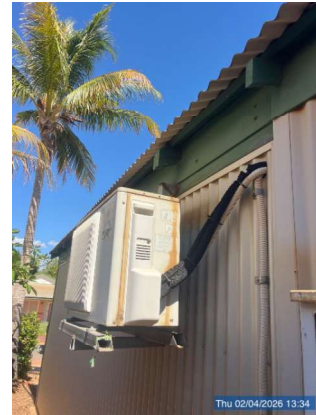
**FRONT:** Air Conditioners (photo 1 of 1)

| Agent section | | | | Tenant section | |
|---|---|---|---|---|---|
| Air Conditioners | | | | Air con unit on side of garage.<br>Casing all intact, piping and pipe covers intact, some weathering. | Y<br>(1 photo, page 138) |

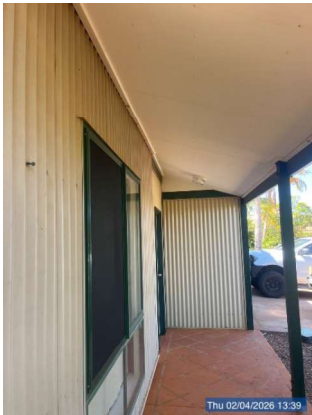
**PORCH:** Ceiling (photo 1 of 1)

| Ceiling | | | | Painted with no damage, light dust marks, clean. Edging is peeling. Redundant security camera secure to corner, aged. | Y | (1 photo, page 138) |

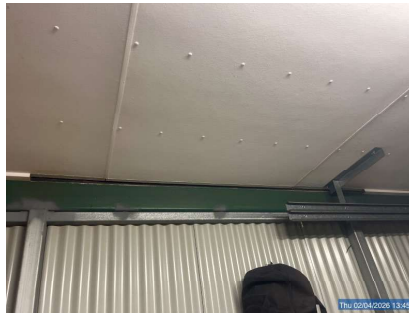
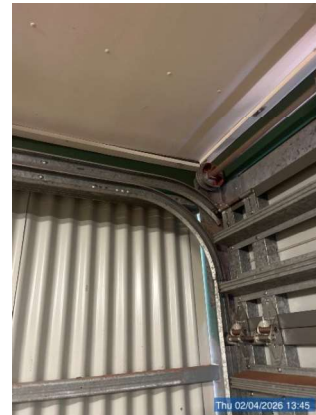
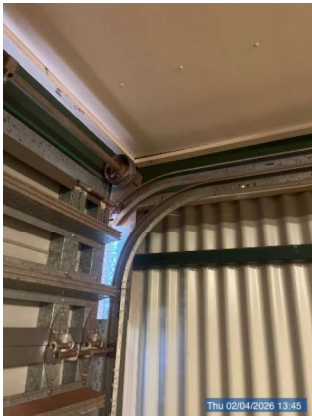
| Ceiling/Cornice | | | | Painted with light marks, no damage, clean. 3 screw holes & mark by screen door. 4 round holes by door opener. Security camera in corner, redundant. (2 photos, page 36) | Y | Trim peeling near roller door. 1 full piece missing. (3 photos, page 138) TB |

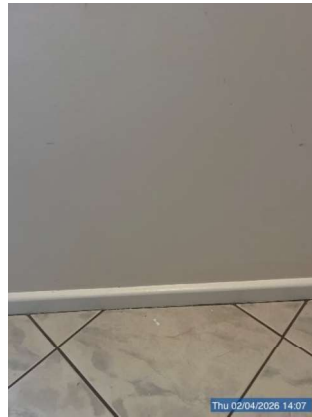
**ENTRY:** Floorcoverings (photo 1 of 1)

| Floorcoverings | | | | Tiles with no chips, marks or damage visible. Clean. | Y | Paint drips (1 photo, page 139) TB |

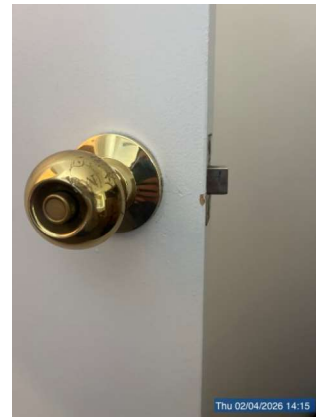
**BEDROOM - MASTER:** Internal Door (photo 1 of 1)

| Internal Door | | | | Painted door and frame.<br>Clean with no visible damage.<br>Hinges, lock and knobs secure and working.<br>Painted frame, clean, scrape at top, minor chipping. (3 photos, page 50) | Y | Chip near knob (1 photo, page 139) TB |

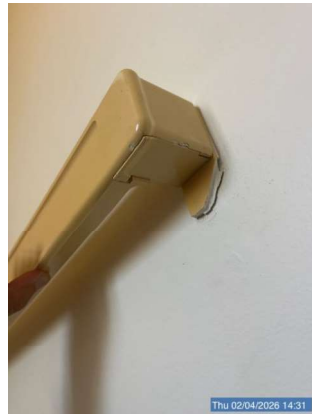
**ENSUITE:** Towel Rail (photo 1 of 1)

| Towel Rail | | | | Cream double towel rail, intact and secure to wall. | N | Single towel rail brittle and cracking, not secure (1 photo, page 139)TB |

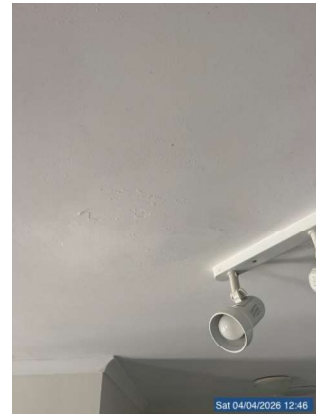
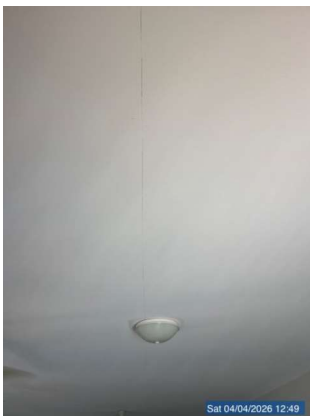
| Ceiling/Cornice | | | | Painted with no damage, clean. Water mark near centre and at edge by kitchen. | Y | Poor repair near triple light. Cracking (2 photos, page 139) TB |

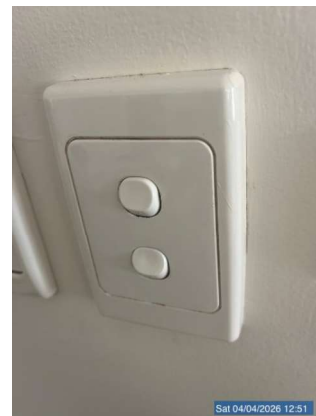
**LIVING ROOM:** Light Fittings (photo 1 of 1)

| Light Fittings | | | | 3 round lights. Covers present, clean and undamaged with no bugs. Bulbs working. (3 photos, page 65) | Y | Top switch damaged (1 photo, page 139) |

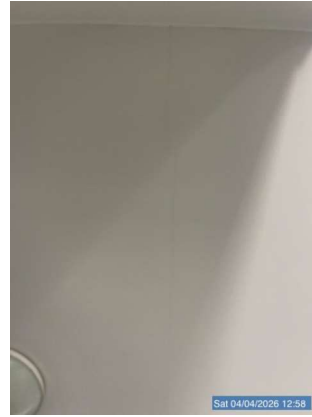
**KITCHEN: Ceiling/Cornice (photo 1 of 1)**

| Ceiling/Cornice | | | | Painted with no marks or damage, clean. | Y | Cracking (1 photo, page 140) |

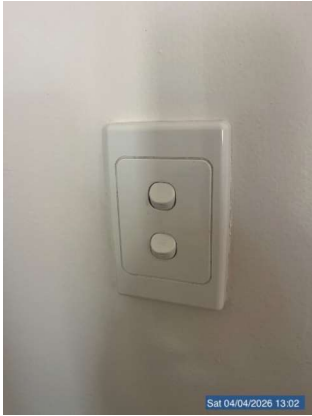
**KITCHEN: Powerpoints (photo 1 of 1)**

| Powerpoints | | | All power points and switches are clean, intact and secure.<br>Oven switch cover is cracked. | N | Switches for exhaust fan and pantry light damaged (1 photo, page 140) |

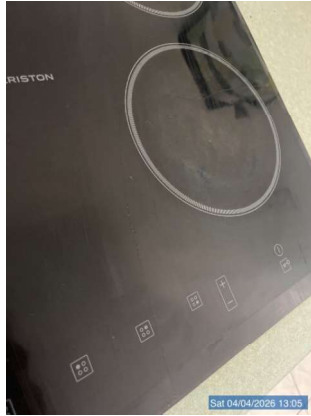
**KITCHEN: Cooktop (photo 1 of 1)**

| Cooktop | | | Ariston ceramic cooktop<br>4 elements, no burnt on marks, some scraping wear.<br>Grease free and clean, undamaged and working. (1 photo, page 78) | N | Cooktop glass cracked (1 photo, page 140)<br>Front right element TB |

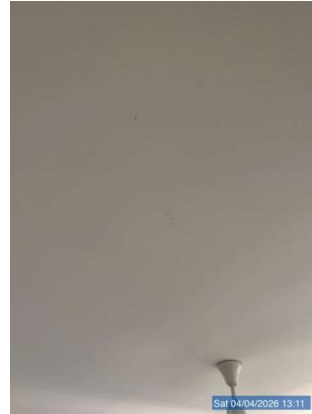
**BEDROOM - LEFT: Ceiling/Cornice (photo 1 of 1)**

| Ceiling/Cornice | | | | Painted with no marks or damage, clean. | N | Marking (1 photo, page 140) TB |

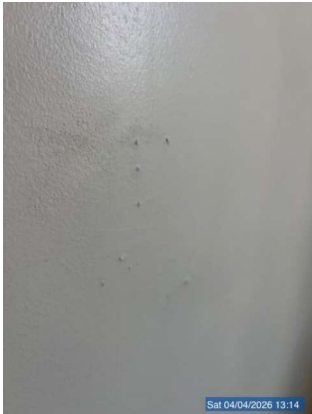
**BEDROOM - LEFT: Walls (photo 1 of 1)**

| Walls | | | | Painted and clean with no hooks, screws, scuffs or dents unless listed below:<br>1 door knob stopper<br>Uneven paint on wall to patio around to window<br>Repair behind wardrobe door knob (6 photos, page 87) | N | Wall to patio, many poor repairs (1 photo, page 140) TB |

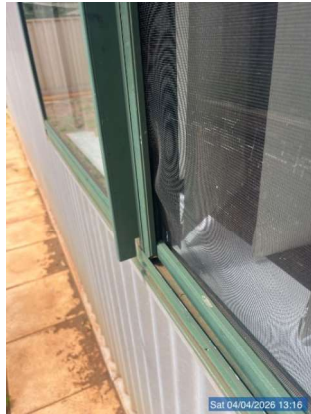
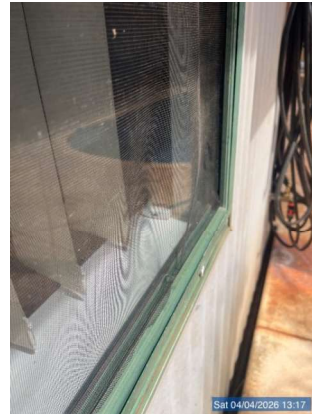
| Screens | | | | Aluminium framed fly screen.<br>Frame is well fitted to window and undamaged.<br>Screen is slightly dusty, no holes. | N | Screen is ill fitting and damaged (2 photos, page 140)TB |

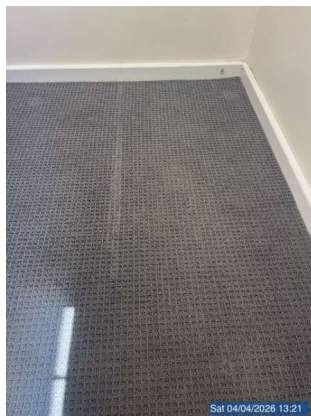
**BEDROOM - LEFT: Floor (photo 1 of 1)**

| Floor | | | | Grey self squared carpet in generally good condition, felted near centre, 2 small burn marks on window side.<br>Professionally cleaned. | Y | Clean but very strong odour (1 photo, page 140)No previous pets at house TB |

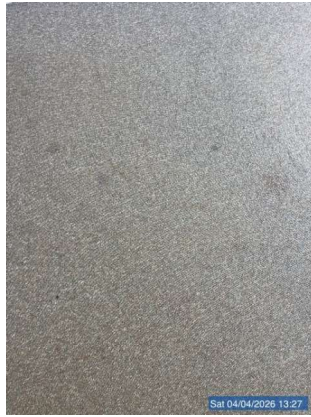
**BEDROOM - BY LAUNDRY:** Floor (photo 1 of 1)

| Floor | | | | Grey carpet in older but good condition, some small marks. Professionally cleaned. (2 photos, page 95) | Y | Strong odour (1 photo, page 141)<br>No previous pets at house TB |

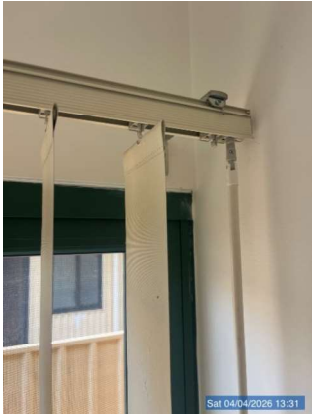
**LAUNDRY:** Door Treatments (photo 1 of 1)

| Door Treatments | | | | Vertical blinds, clean, intact and secure.<br>Undamaged, no missing slats.<br>Wand is present and working. Cord and chain are present and working.<br>All weights present. (2 photos, page 99) | N | Slat missing on right side (1 photo, page 141) TB |

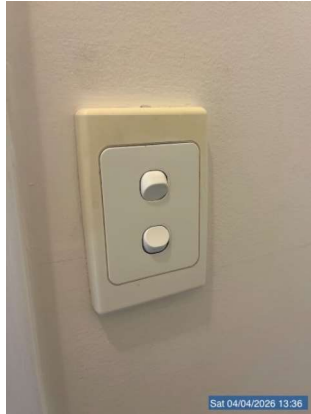
**TOILET:** Powerpoints (photo 1 of 1)

| Powerpoints | | | | Switch is clean, intact and secure. | Y | Light switch (top) damaged. (1 photo, page 141) TB |
